**RE: TREE CONSERVATION REPORT FOR 949 NORTH RIVER ROAD**

949 NORTH RIVER ROAD AT ONTARIO STREET

**PROPOSED 5 STOREY CONDOMINIUM BUILDING**

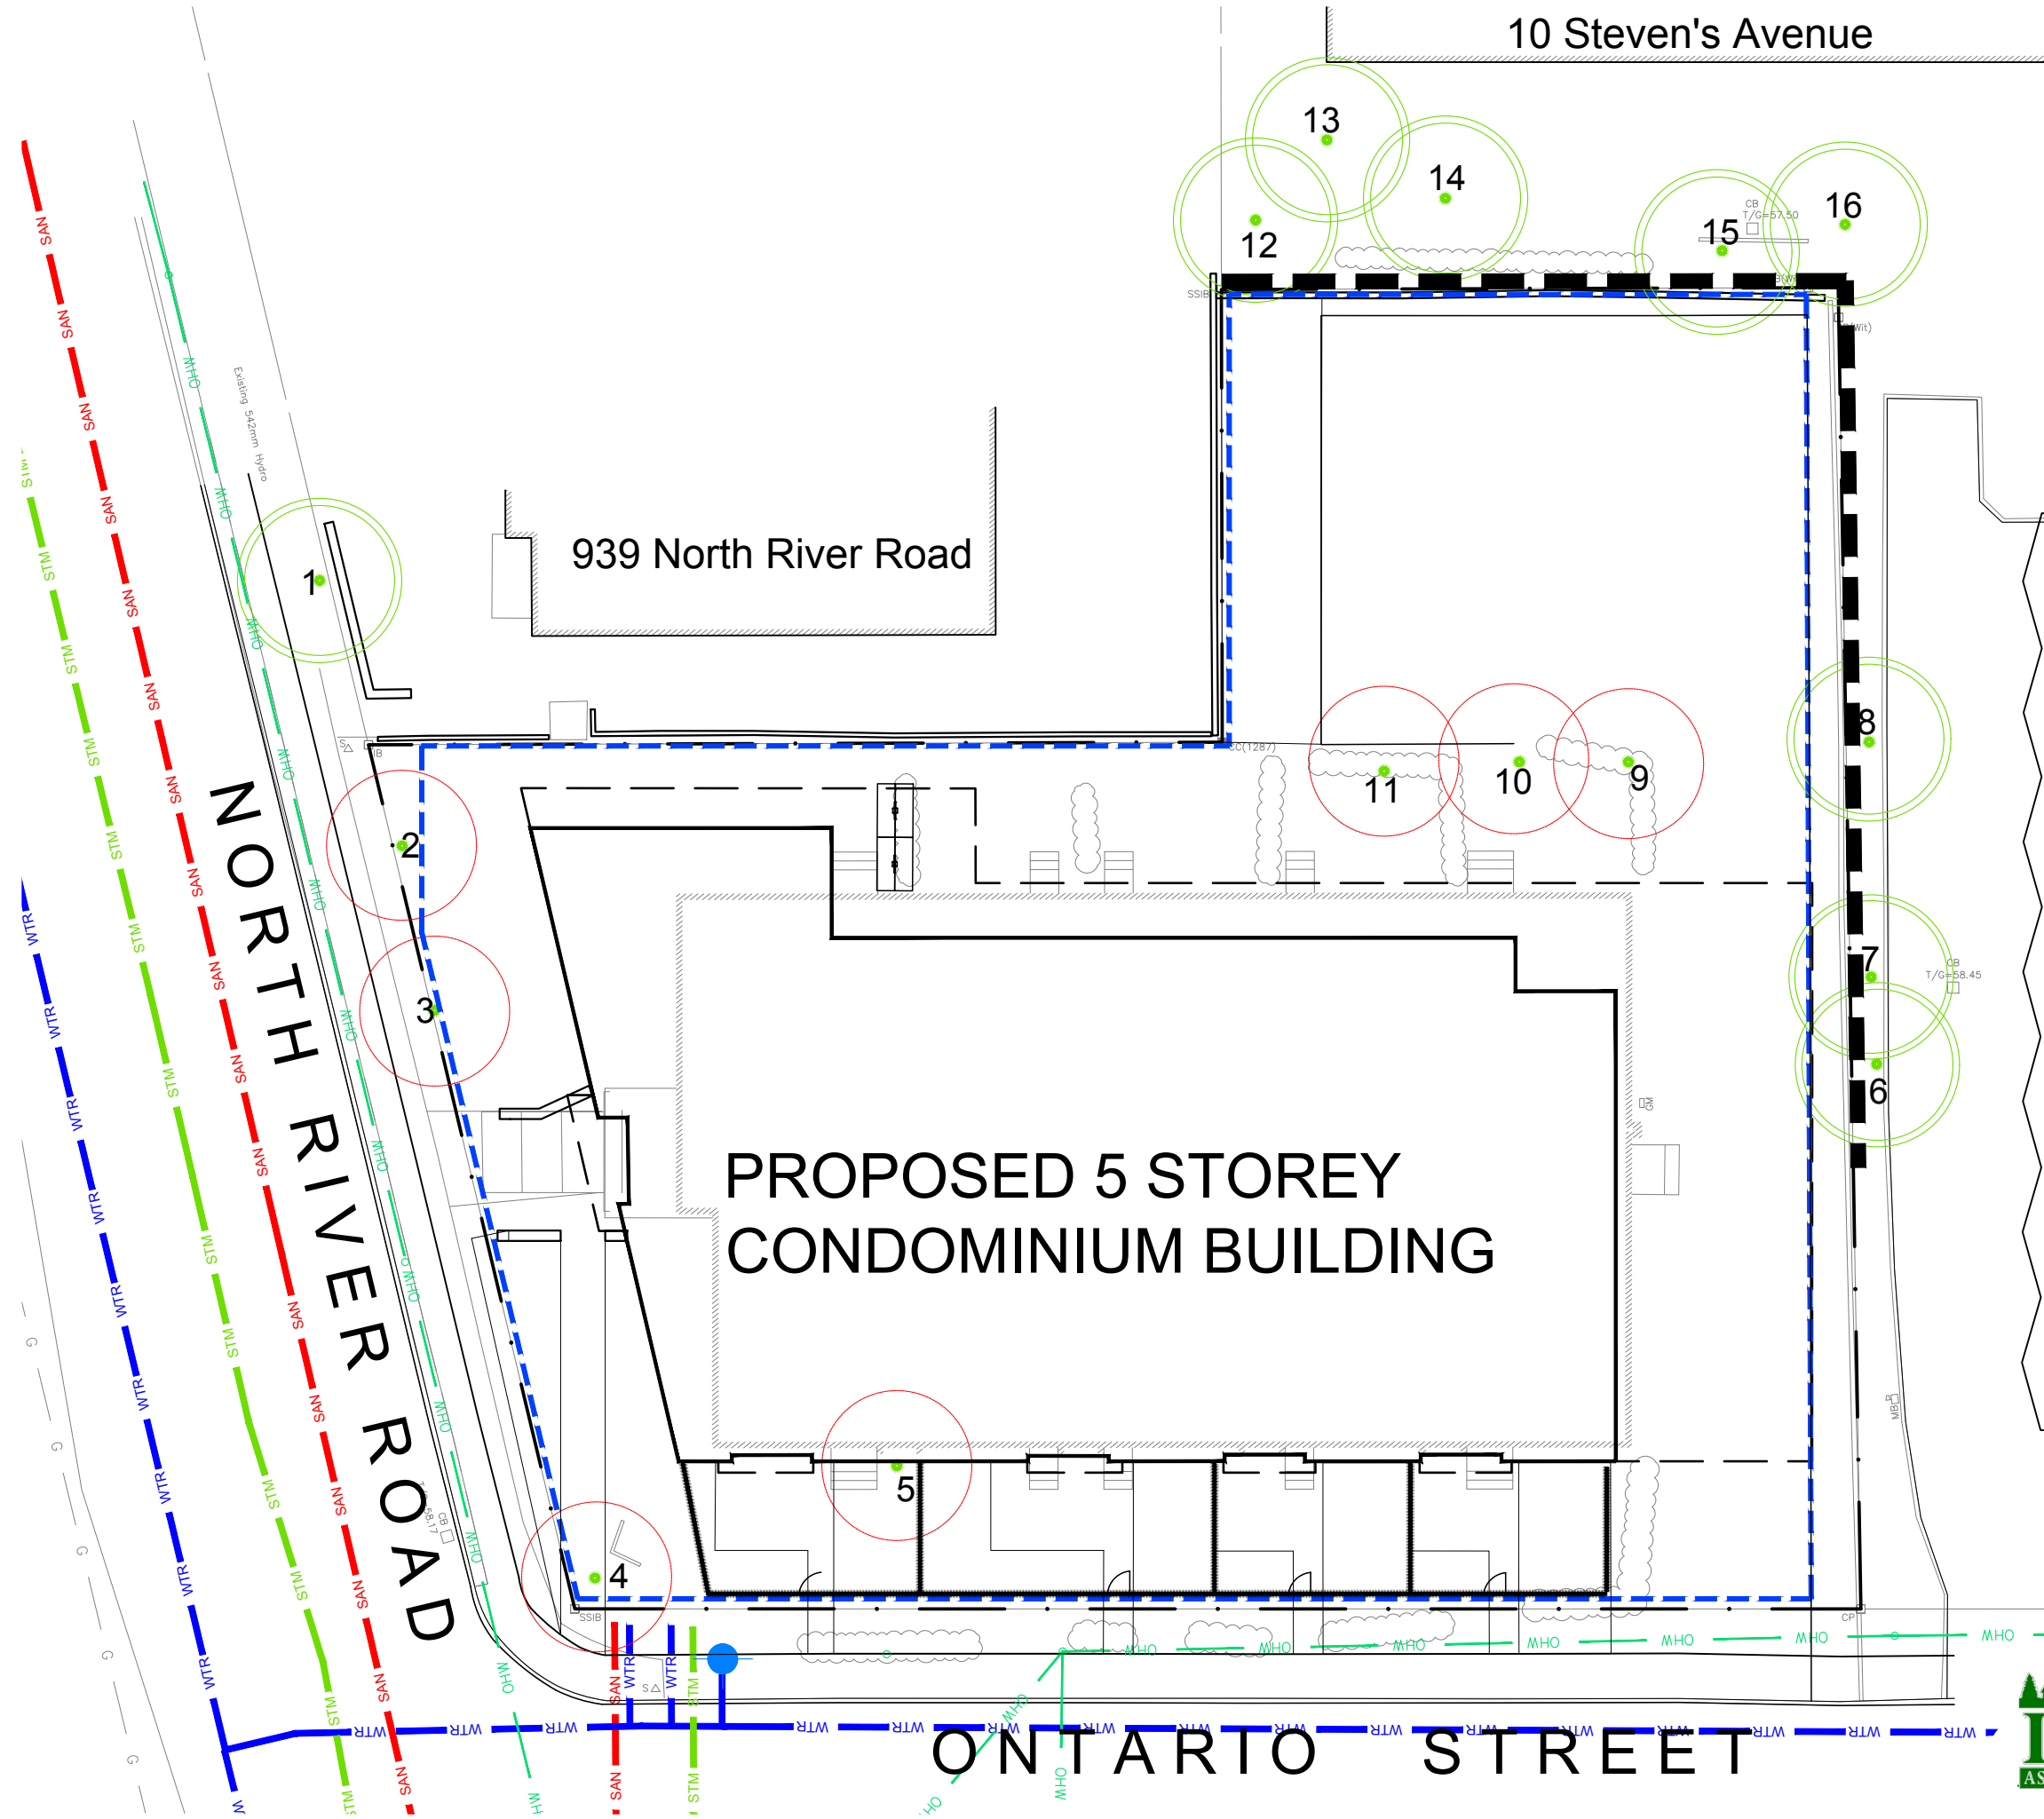
TCR TREE CONSERVATION REPORT

Table 1 on pages 2 and 3 of this report details the species, condition, size (diameter), ownership and status of the individual trees on and adjacent to the subject property. Each of these trees is referenced by the numbers plotted on the tree conservation plan included on page 4.

1. As per the City of Ottawa's tree protection barrier specification, erect a fence as close as possible to the CRZ of the tree(s);
2. Do not place any material or equipment within the CRZ of the tree(s);
3. Do not attach any signs, notices or posters to any tree;
4. Do not raise or lower the existing grade within the CRZ without approval;
5. Tunnel or bore instead of trenching within the CRZ of any tree;
6. Do not damage the root system, trunk or branches of any tree;
7. Ensure that exhaust fumes from all equipment are NOT directed towards any tree's canopy.

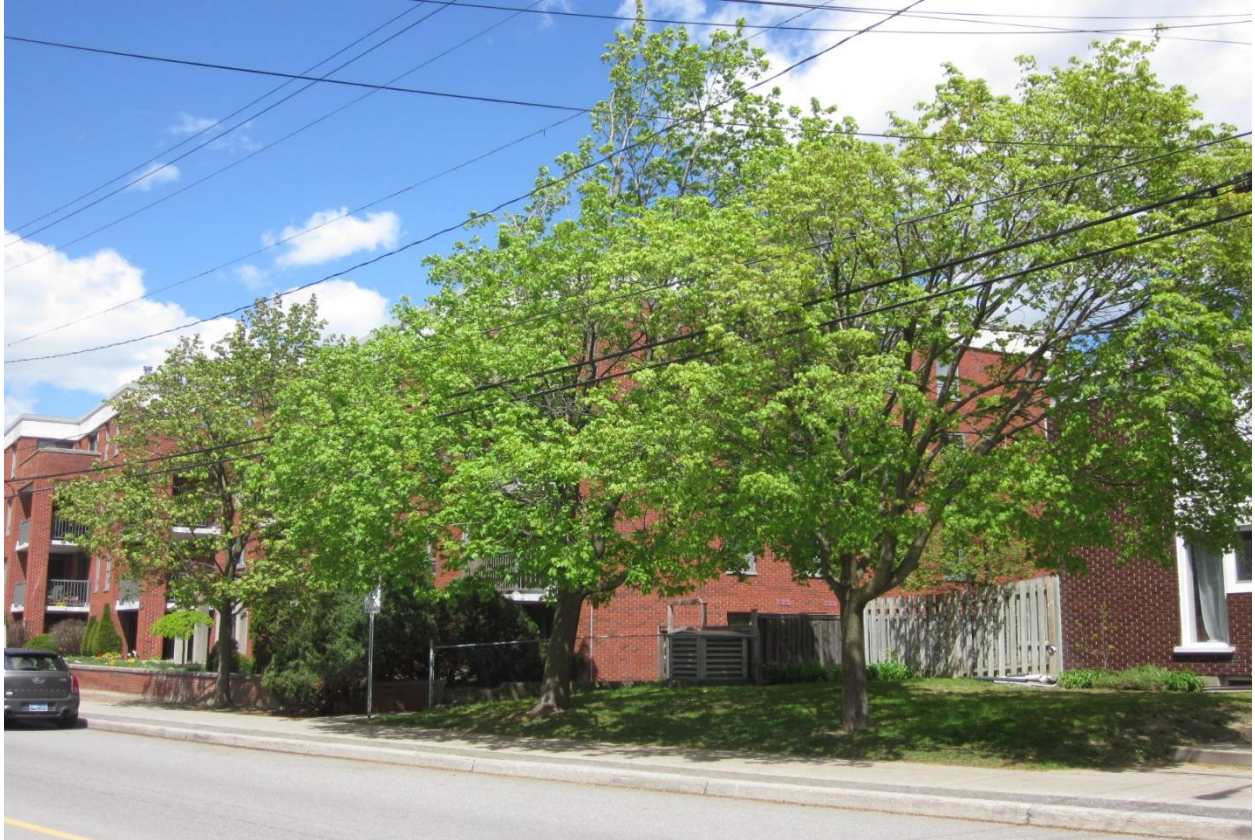
| Tree No. | Tree species | Condition (VP→E) | DBH <sup>1</sup> (cm) | Owner -ship | Age class, tree condition notes & <b>preservation status</b> (to be removed or preserved and protected) |
|---|---|---|---|---|---|
| 1 | Norway maple<br>( <i>Acer platanoides</i> ) | Fair | 24.0 | City | Maturing; central main stem with competing lateral on southeast at 1.75m from grade; major wound at 0.25-1.5m on east side of stem (plow damage); only visible root flare on east side of root collar – with two binding roots; introduced invasive species; <b>to be preserved and protected</b> |
| 2 | Norway maple | Good | 37.4 | City | Mature; co-dominant stems at 2.25m with strong union; broad crown – moderately pruned from overhead Hydro lines; good root collar; <b>to be removed</b> (conflicts with construction) |
| 3 | Norway maple | Fair | 27.8 | City | Mature; central stem with branch cluster at 2m; central stem suppressed, laterals now dominant; no flaring on root collar – girdling roots likely; minor pruning from overhead Hydro lines; <b>to be removed</b> (conflicts with construction) |

Picture 1. Trees #1, 2 and 3 (left to right) located adjacent to 949 North River Road

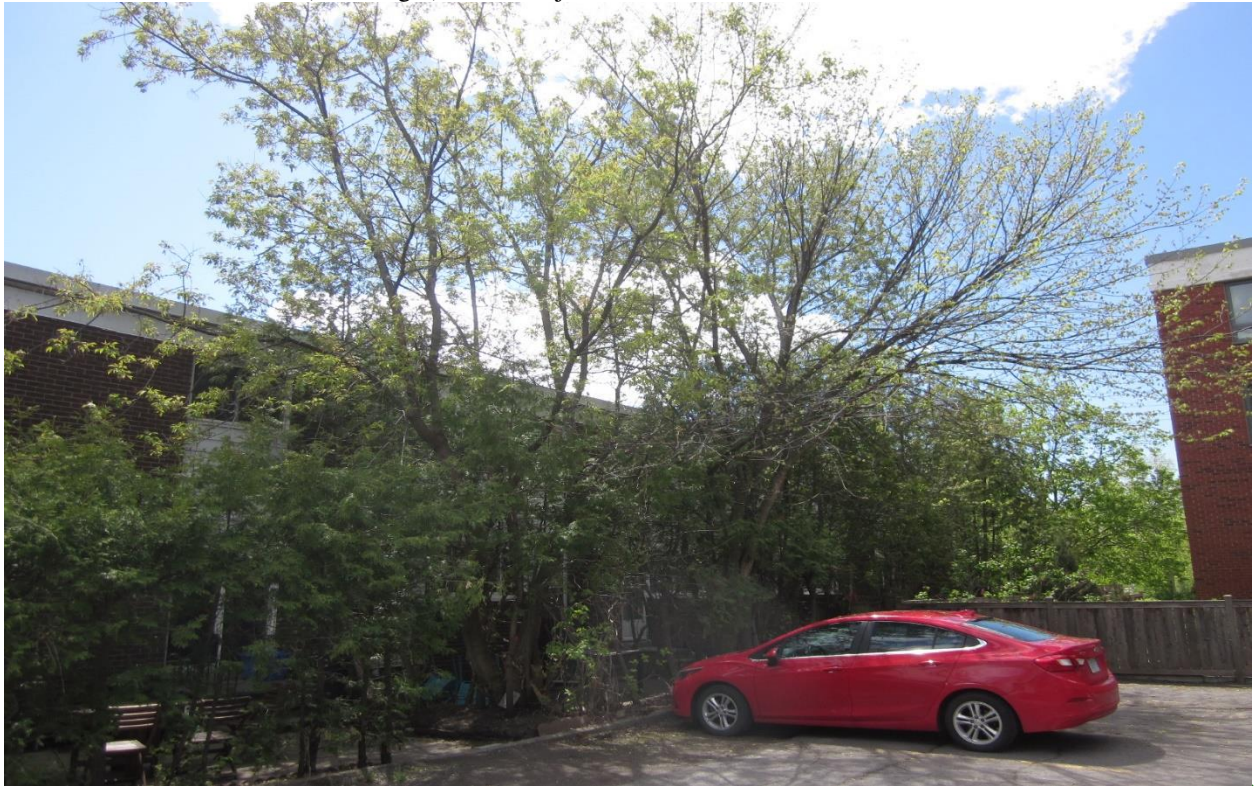
| Tree No. | Tree species | Condition (VP→E) | DBH <sup>1</sup> (cm) | Owner -ship | Age class, tree condition notes & <b>preservation status</b> (to be removed or preserved and protected) |
|---|---|---|---|---|---|
| 9 | Manitoba maple | Fair | 10.0, 19.2 & 23.5 | Private | Mature; tri-stemmed from grade – generally upright (stems only mildly divergent; fourth stem previously removed; <b>to be removed</b> (conflicts with construction) |
| 10 | White elm<br>( <i>Ulmus americana</i> ) | Good | 26.3 | Private | Mature; crown asymmetric towards north due to influence of trees #9 and 10; no outward signs of Dutch elm disease infection ( <i>Ophiostoma novo-ulmi</i> ); native species; <b>to be removed</b> (conflicts with construction) |
| 11 | Manitoba maple | Fair | 21.0 | Private | Mature; crown moderately divergent towards southeast due to influence of tree #10; <b>to be removed</b> (conflicts with construction) |

Picture 2. Trees #9, 10 and 11 (left to right) located at 949 North River Road

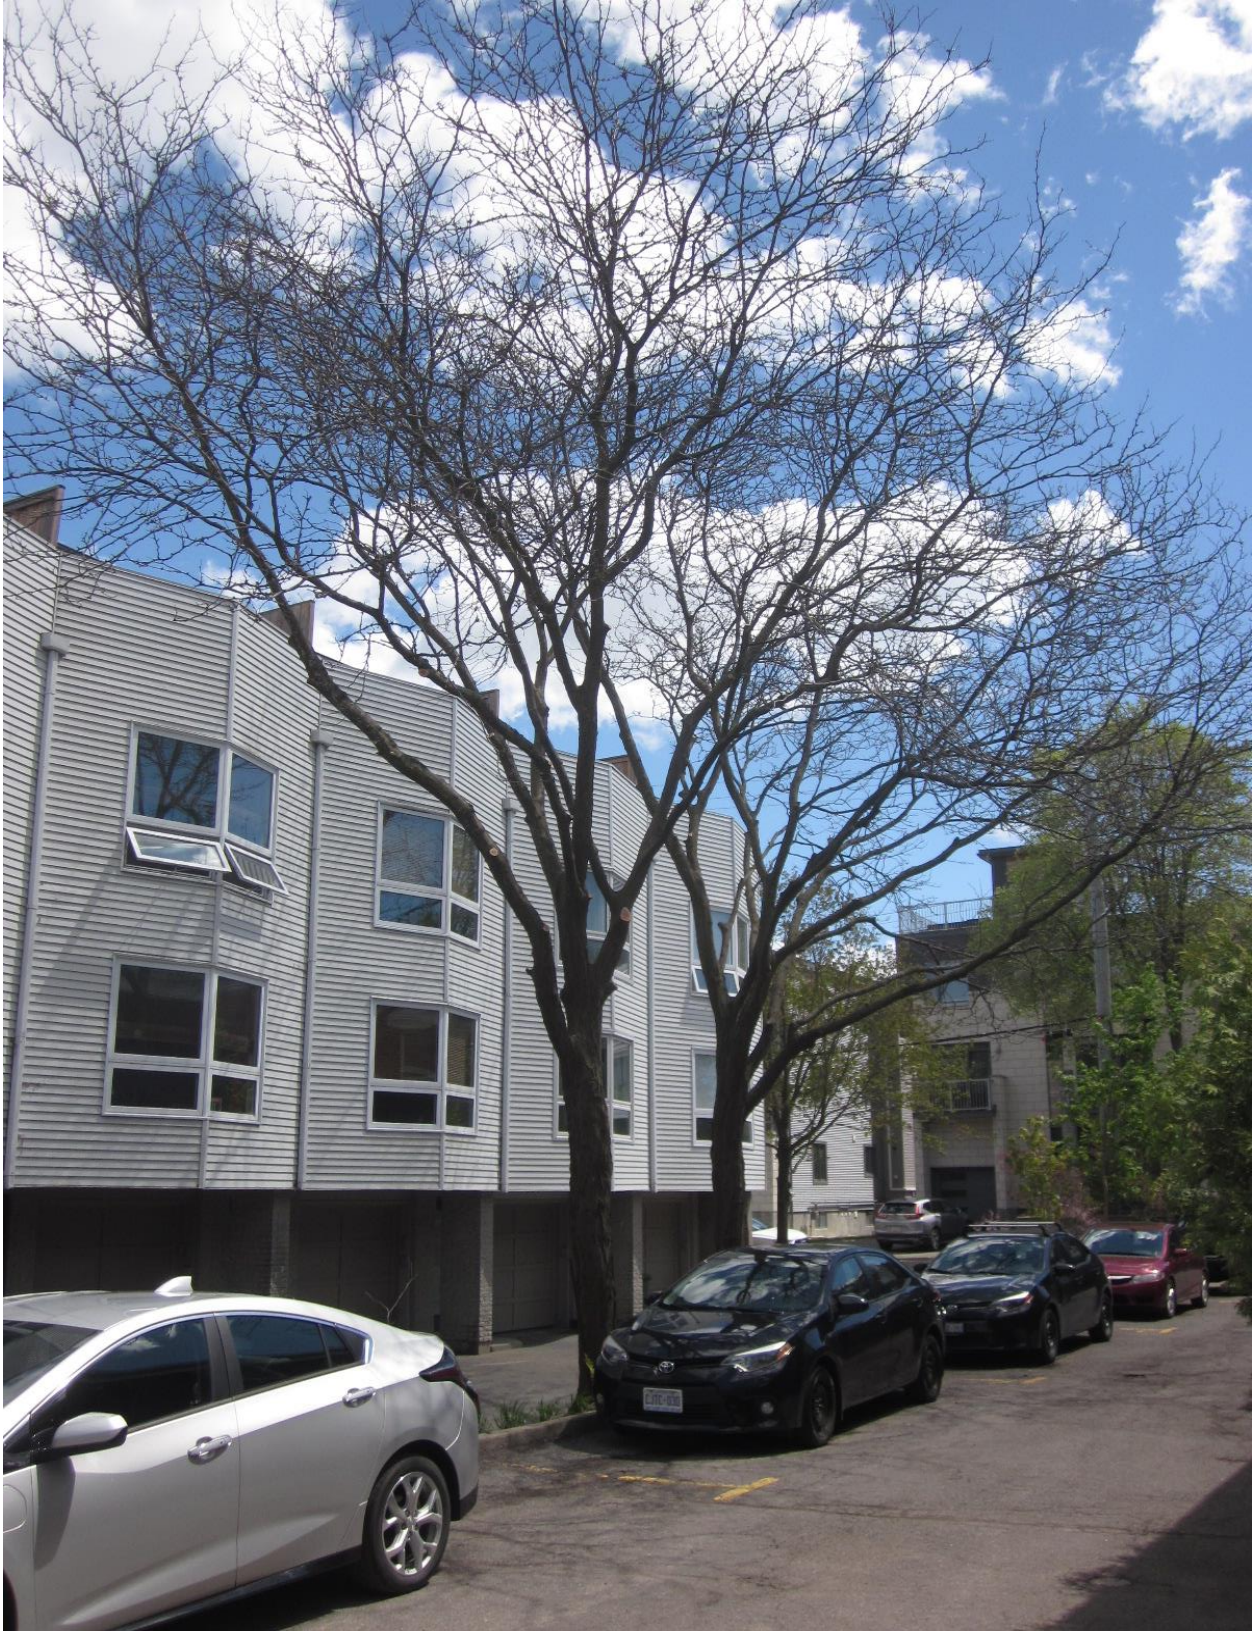
| Tree No. | Tree species | Condition (VP→E) | DBH <sup>1</sup> (cm) | Owner -ship | Age class, tree condition notes & <b>preservation status</b> (to be removed or preserved and protected) |
|---|---|---|---|---|---|
| 6 | Honey-locust<br>( <i>Gleditsia triacanthos</i> ) | Good | +/-40 | Neighbour | Mature; crown asymmetric towards south due to influence of tree #7; good growth increment even though located within a very limited rooting area; recently pruned; introduced species to Eastern Ontario; <b>to be preserved and protected</b> |
| 7 | Honey-locust | Good | +/-40 | Neighbour | Mature; crown asymmetric towards north due to influence of tree #6; good growth increment even though located within a very limited rooting area; recently pruned; introduced species to Eastern Ontario; <b>to be preserved and protected</b> |

Picture 3. Trees #6 and 7 (right to left) located adjacent to 949 North River Road

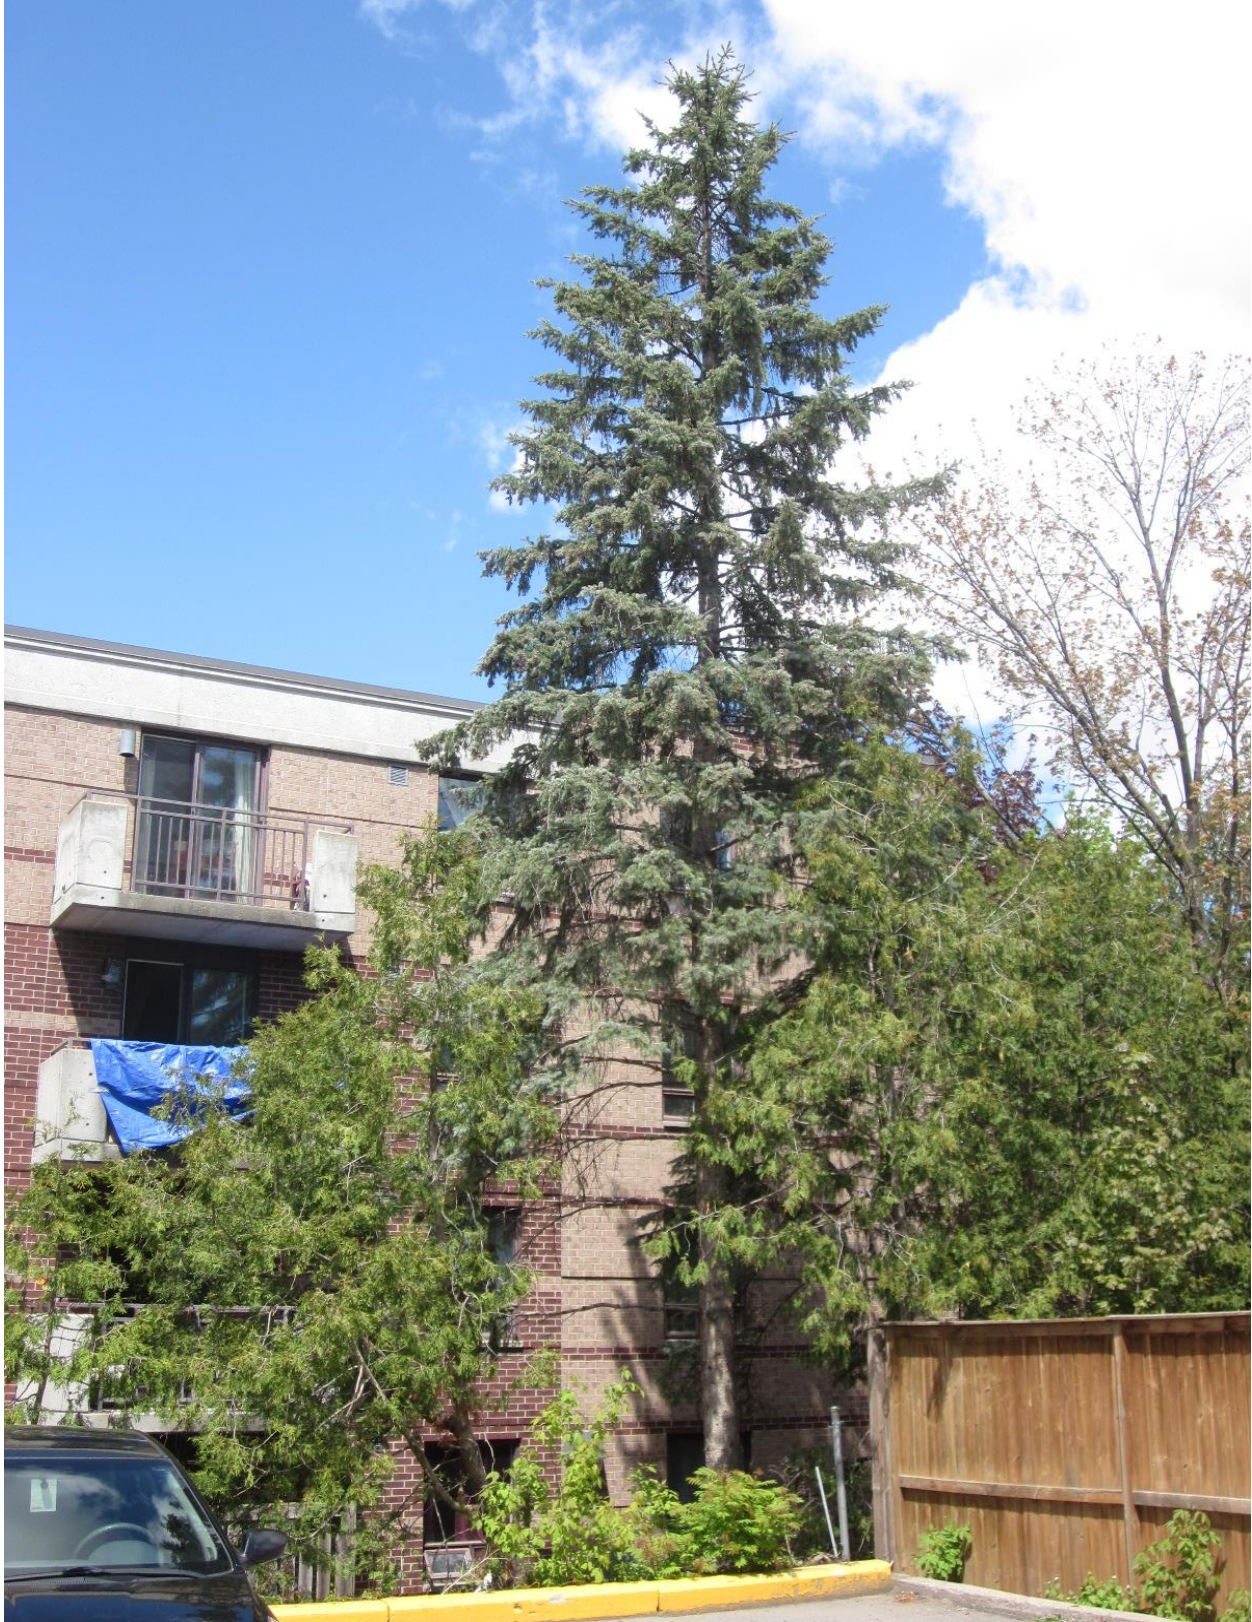
| Tree No. | Tree species | Condition (VP→E) | DBH <sup>1</sup> (cm) | Owner -ship | Age class, tree condition notes & <b>preservation status</b> (to be removed or preserved and protected) |
|---|---|---|---|---|---|
| 15 | White cedar<br>( <i>Thuja occidentalis</i> ) | Fair | +/-15 | Neighbour | Mature; moderately divergent towards northwest due to influence of tree #16; fair density, increment and colour native species; <b>to be preserved and protected</b> |
| 16 | Colorado spruce<br>( <i>Picea pungens</i> ) | Good | +/-30 | Neighbour | Mature; lower crown asymmetric and thin on inside due to influence of nearby cedar hedge; good density, increment and colour where directly exposed to sunlight; introduced species; <b>to be preserved and protected</b> |

Picture 4. Trees #15 and 16 (left to right) located adjacent to 949 North River Road
