Tree Conservation Report

150 Kanata Avenue

April 6, 2022

Stantec Consulting Ltd.
1331 Clyde Avenue
Ottawa ON K2C 3G4
Project No. 160410368

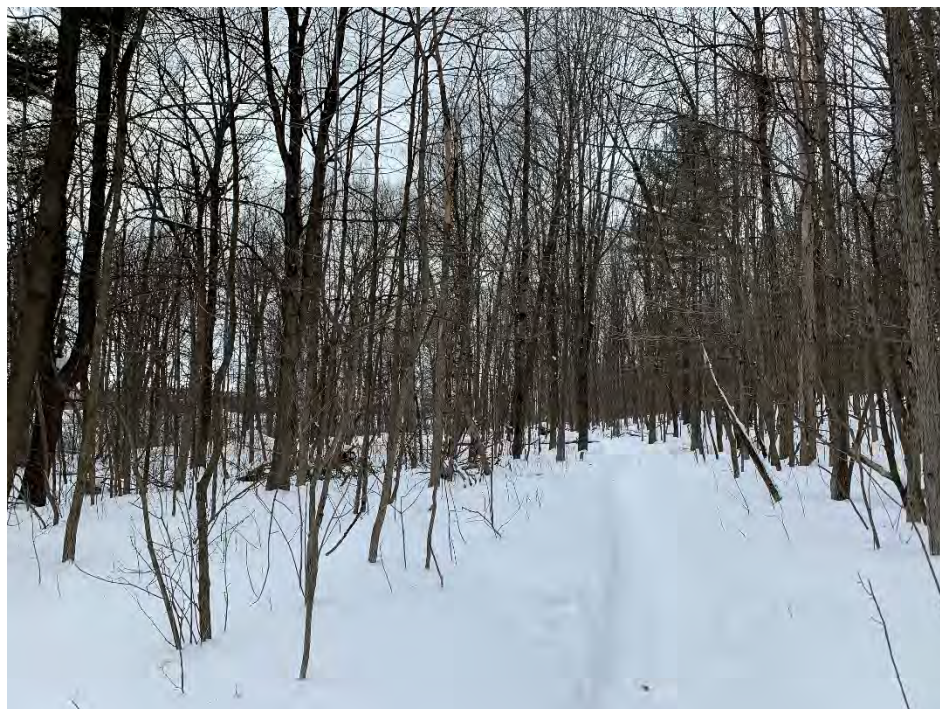
Photograph 1 – Presence of trails within the treed lot

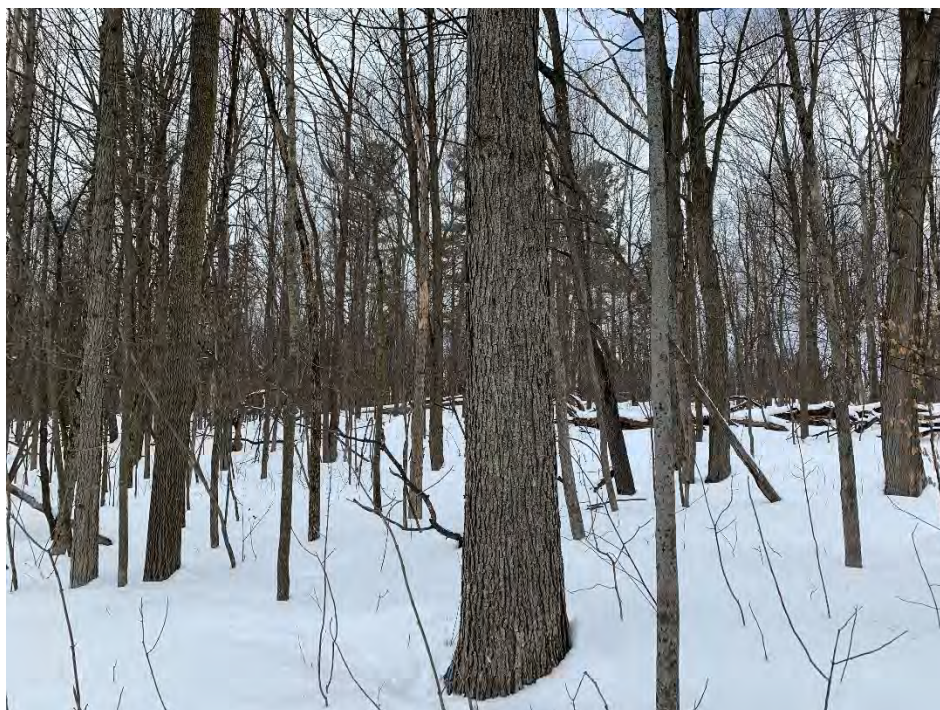
Photograph 2 – Variety of tree sizes

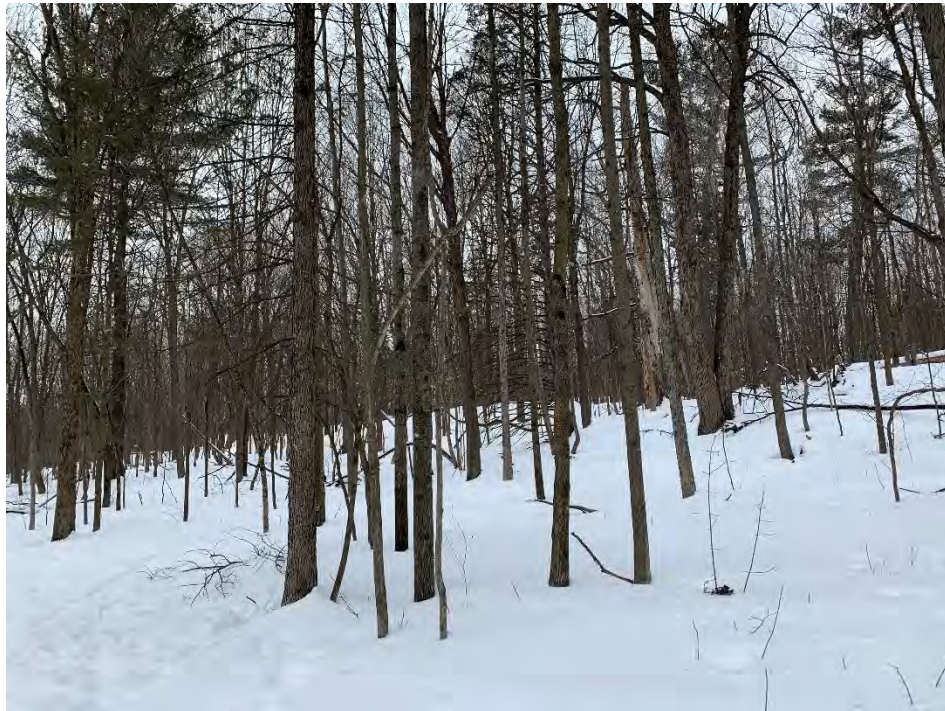
Photograph 3 – Sloped land

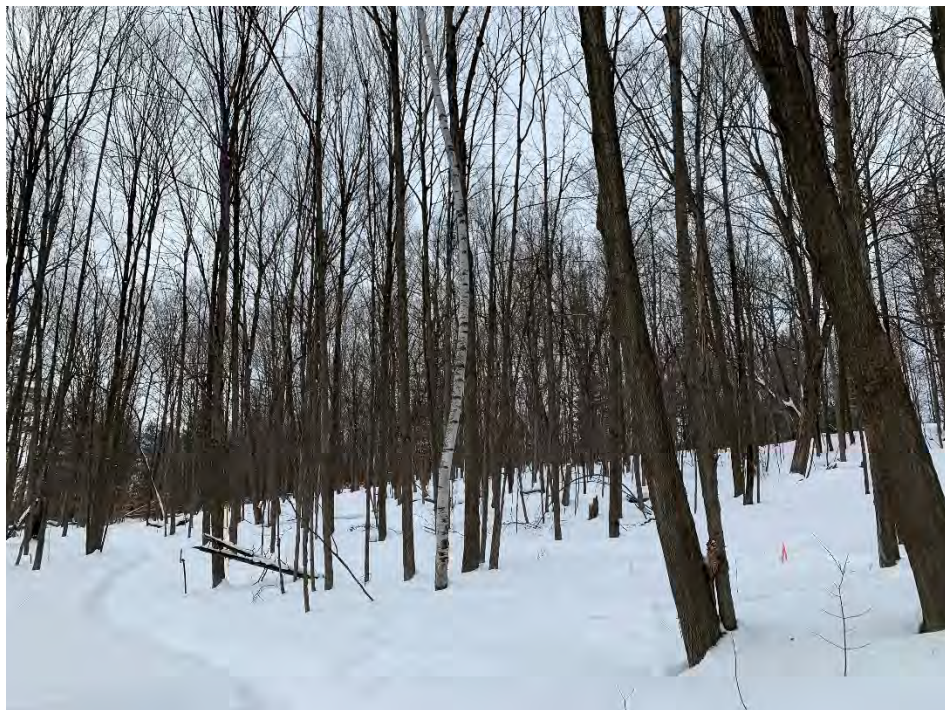
The trees are generally evenly naturally distributed on site with some open “pockets” without any trees; the presence of snow did not provide the opportunity to determine if these openings are the result of bedrock being at the surface. Other openings are created by fallen trees; a number of fallen trees have been observed on the Subject site.

Photograph 4 – Openings in the treed area

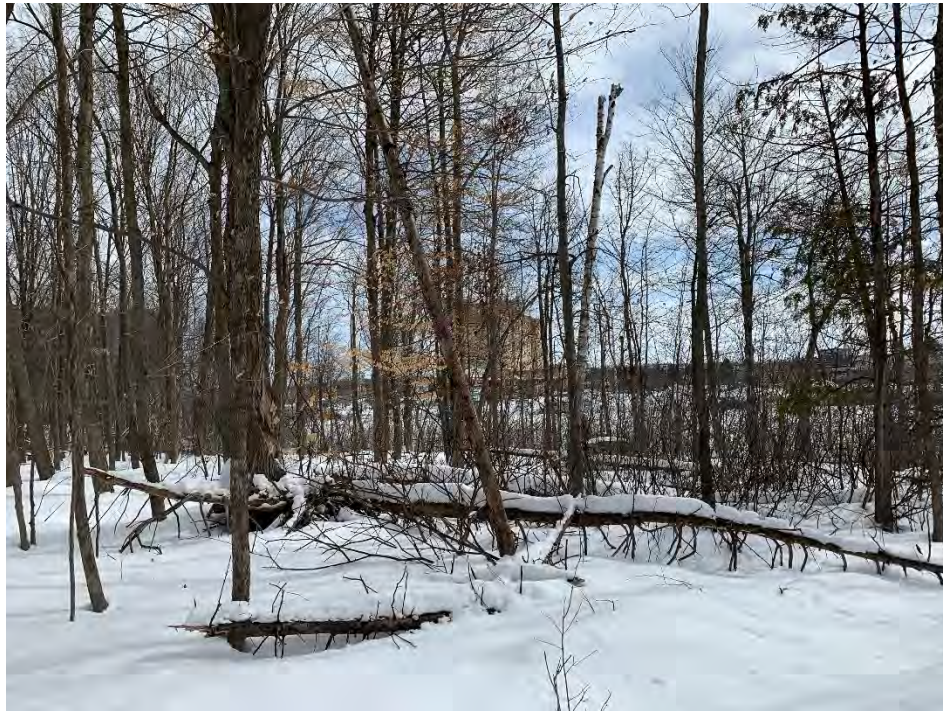
Photograph 5 – Presence of fallen trees

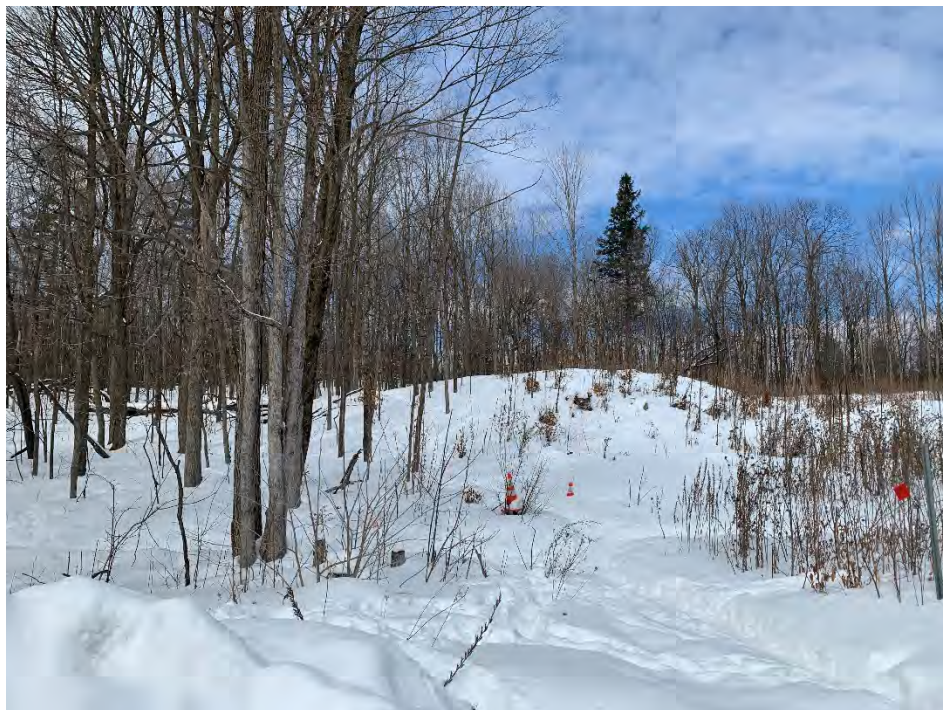
Photograph 6 – Opening to the right for the future roadway
