November 14, 2022

RE: TREE CONSERVATION REPORT FOR 1037 CARP ROAD, OTTAWA

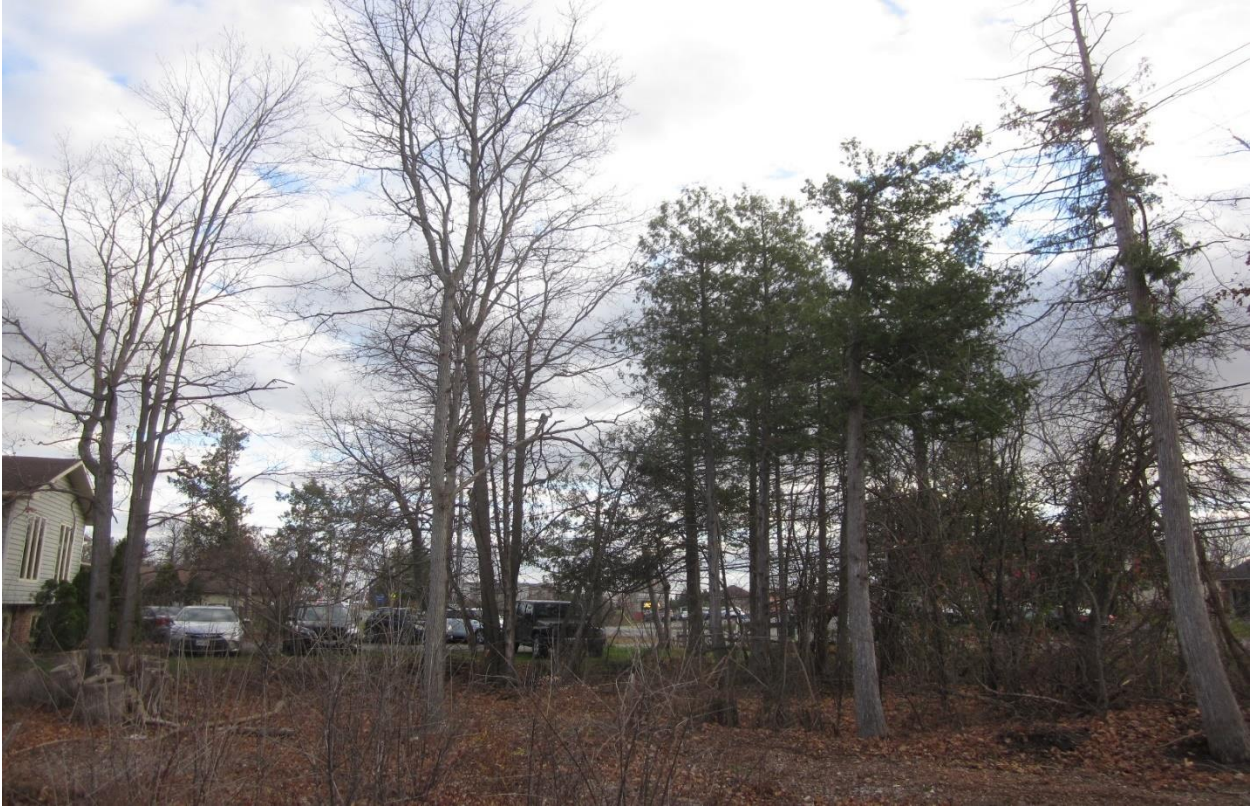
5	White cedar (<i>Thuja occidentalis</i>)	Private	31	Very poor; mature; main stem divergent towards south; 90 percent dead (very poor density, increment and colour); native species; to be removed
6	White cedar (<i>Thuja occidentalis</i>)	Private	31	Fair; mature; main stem divergent towards south; fair density, increment and colour; heavy vine (<i>Vitis</i> spp.) growth in crown; native species; to be removed
7	Sugar maple (<i>Acer saccharum</i>)	City	17	Good; maturing; dominant central stem; native species; to be removed
8	Crab apple (<i>Malus</i> spp.)	City	34	Poor; mature; double stemmed at 0.5m; both stems heavily divergent towards southwest; cultivar; to be removed
9	White elm (<i>Ulmus americana</i>)	Private	18	Fair; mature; heavily divergent towards south; no outward sign of Dutch elm disease (<i>Ophiostoma novo-ulmi</i>); native species; to be removed
10	White cedar (<i>Thuja occidentalis</i>)	Private	31	Good; mature; upright; fair density, increment and colour; crown asymmetric due to influence of tree #11; native species; to be removed

Tree No.	Tree species	Owner-ship ¹	DBH ² (cm)	Tree Condition; Age Class; Condition Notes; Species Origin & Preservation Status (to be removed or preserved and protected)
11	White cedar (<i>Thuja occidentalis</i>)	Private	26	Good; mature; upright; fair density, increment and colour; crown asymmetric due to influence of tree #10; native species; to be removed
12	Sugar maple (<i>Acer saccharum</i>)	Private	17	Good; maturing; upright; native species; to be removed
13	Bur oak (<i>Quercus macrocarpa</i>)	Private	28	Good; mature; single dominant upright stem with competing lateral on east; native species; to be removed
14	Sugar maple (<i>Acer saccharum</i>)	Private	33	Fair; mature; central stem with major suppressed lateral at 5m on east; native species; to be removed
15	Sugar maple (<i>Acer saccharum</i>)	Private	19	Fair; mature; upright form; suppressed lateral at 5m on south; native species; to be removed

Picture 1. Trees #5-15 (right to left) at 1037 Carp Road

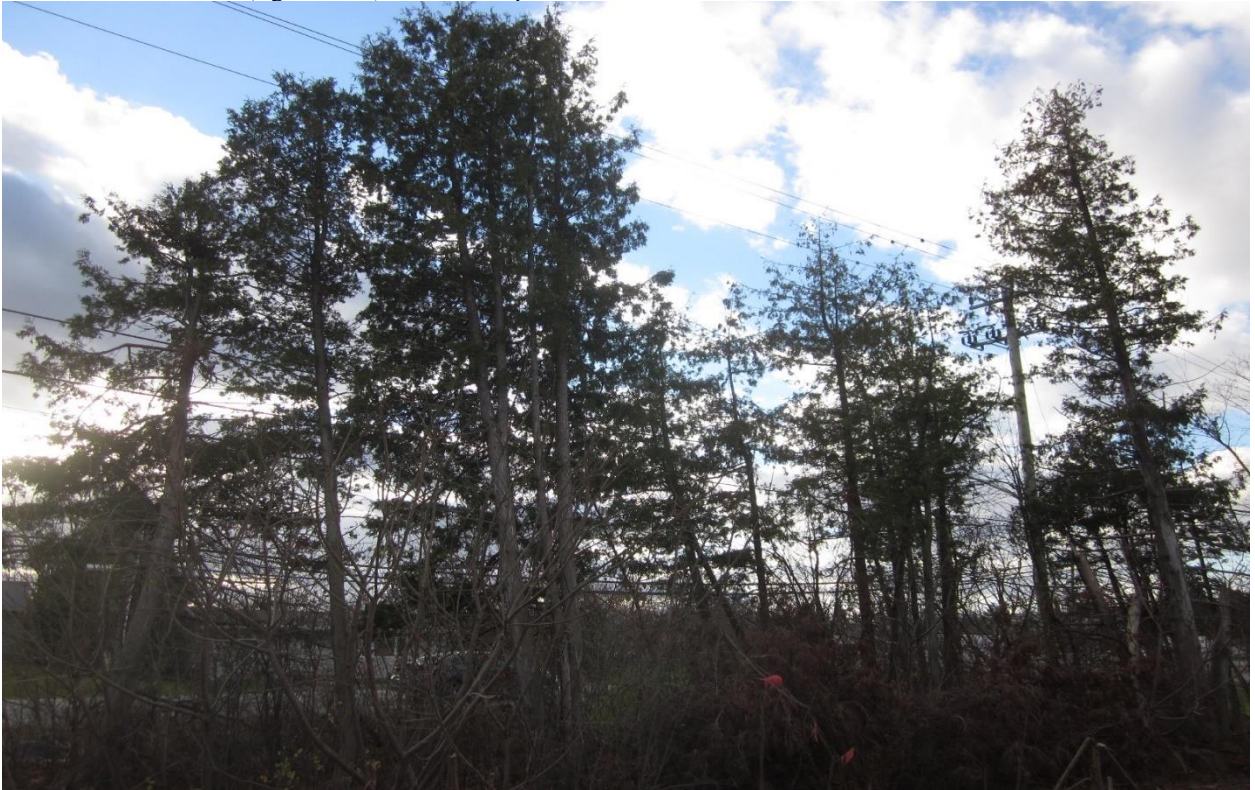
Tree No.	Tree species	Ownership ¹	DBH ² (cm)	Tree Condition; Age Class; Condition Notes; Species Origin & Preservation Status (to be removed or preserved and protected)
35	White cedar (<i>Thuja occidentalis</i>)	City	15 & 19	Fair; mature; double stemmed from grade; divergent towards southeast; fair density, increment and colour; native species; to be removed
36	White cedar (<i>Thuja occidentalis</i>)	City	23 & 25	Good; mature; double stemmed from grade; generally upright; fair density, increment and colour; native species; to be removed
37	White cedar (<i>Thuja occidentalis</i>)	Shared with city	18	Fair; mature; single stemmed; fair density, increment and colour; native species; to be removed
38	Sugar maple (<i>Acer saccharum</i>)	Neighbour	21	Fair; maturing; divergent form towards north; native species; to be preserved and protected
39	White elm (<i>Ulmus americana</i>)	Neighbour	15	Good; maturing; generally upright form; no outward sign of Dutch elm disease (<i>Ophiostoma novo-ulmi</i>); native species; to be preserved and protected

40	White elm (<i>Ulmus americana</i>)	Neighbour	17	Fair; maturing; single stem divergent towards northeast; no outward sign of Dutch elm disease (<i>Ophiostoma novo-ulmi</i>); native species; to be preserved and protected
41	White cedar (<i>Thuja occidentalis</i>)	City	27	Poor; mature; topped below Hydro lines; fair increment and colour; native species; to be removed
42	White cedar (<i>Thuja occidentalis</i>)	Private	10 avg.	Fair; mature; seven stemmed from grade – layered; fair increment and colour; native species; to be removed

Picture 2. Trees #36-41 (left to right) at 1037 Carp Road

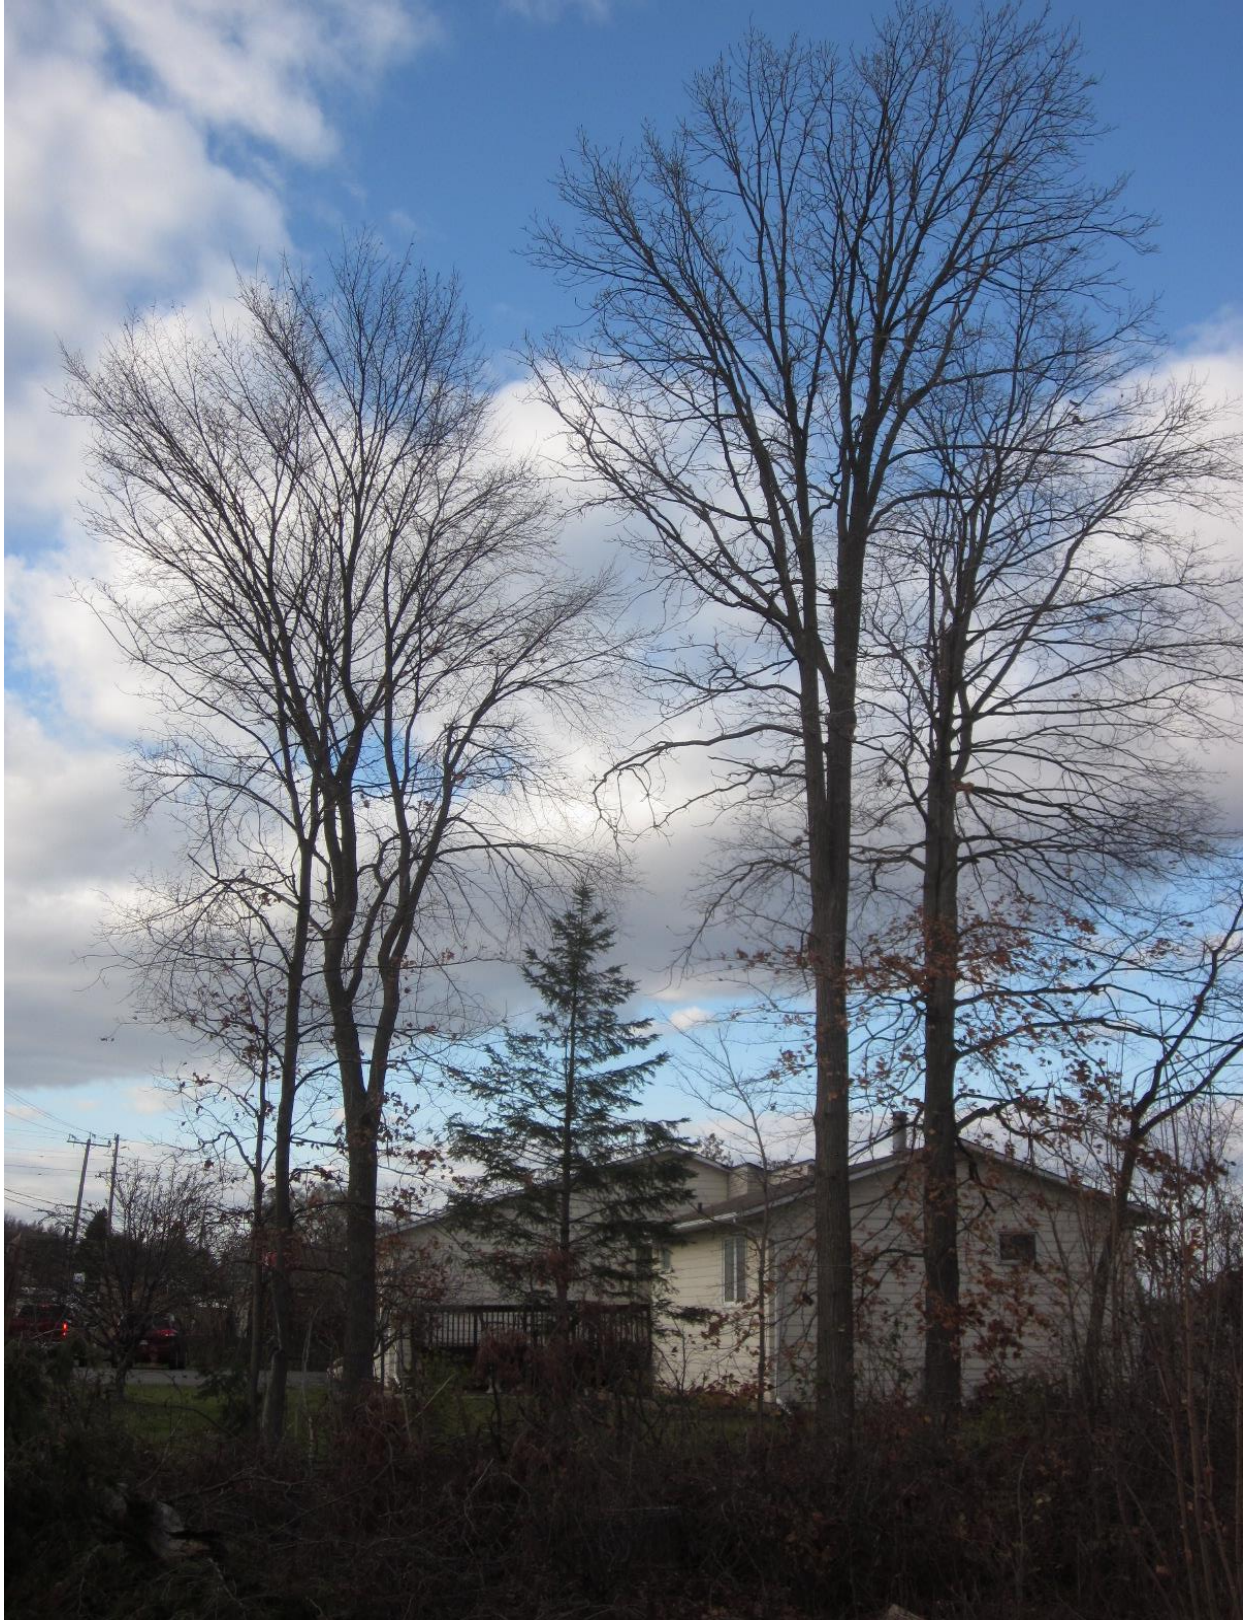
Tree No.	Tree species	Owner-ship ¹	DBH ² (cm)	Tree Condition; Age Class; Condition Notes; Species Origin & Preservation Status (to be removed or preserved and protected)
24	Sugar maple (<i>Acer saccharum</i>)	Private	20	Good; mature; single dominant stem and leader; living crown held high; prone to stem breakage and sunscald without surrounding trees; native species; to be removed
25	Sugar maple (<i>Acer saccharum</i>)	Private	38	Good; mature; central stem with one competing and two suppressed laterals at 10m; crown held high and asymmetric towards east; good root collar; native species; to be removed
26	White elm (<i>Ulmus americana</i>)	Private	29	Fair; mature; single stem divergent towards north; tri-dominant leaders at 10m; no outward sign of Dutch elm disease (<i>Ophiostoma novo-ulmi</i>); native species; to be removed
27	Sugar maple (<i>Acer saccharum</i>)	Neighbour	42	Good; mature; asymmetric towards north; native species; to be preserved and protected

28	Bur oak (<i>Quercus macrocarpa</i>)	Neighbour	45	Good; mature; upright form; parallel co-dominant stems at 12m; native species; to be preserved and protected
29	White elm (<i>Ulmus americana</i>)	Neighbour	36	Good; maturing; no outward sign of Dutch elm disease (<i>Ophiostoma novo-ulmi</i>); native species; to be preserved and protected
30	Sugar maple (<i>Acer saccharum</i>)	Neighbour	18	Good; mature; asymmetric towards east; native species; to be preserved and protected
31	White cedar (<i>Thuja occidentalis</i>)	Private	43	Poor; mature; one stem of three still standing; in advanced decline; native species; to be removed
32	White cedar (<i>Thuja occidentalis</i>)	City	18 & 18	Poor; mature; double stemmed from grade; divergent towards east; dominant stems broken at 2m; fair density, increment and colour; native species; to be removed
33	White cedar (<i>Thuja occidentalis</i>)	City	15 avg.	Poor; mature; four stemmed; fair density, increment and colour; native species; to be removed

Picture 3. Trees #27-30 (right to left) at 1037 Carp Road

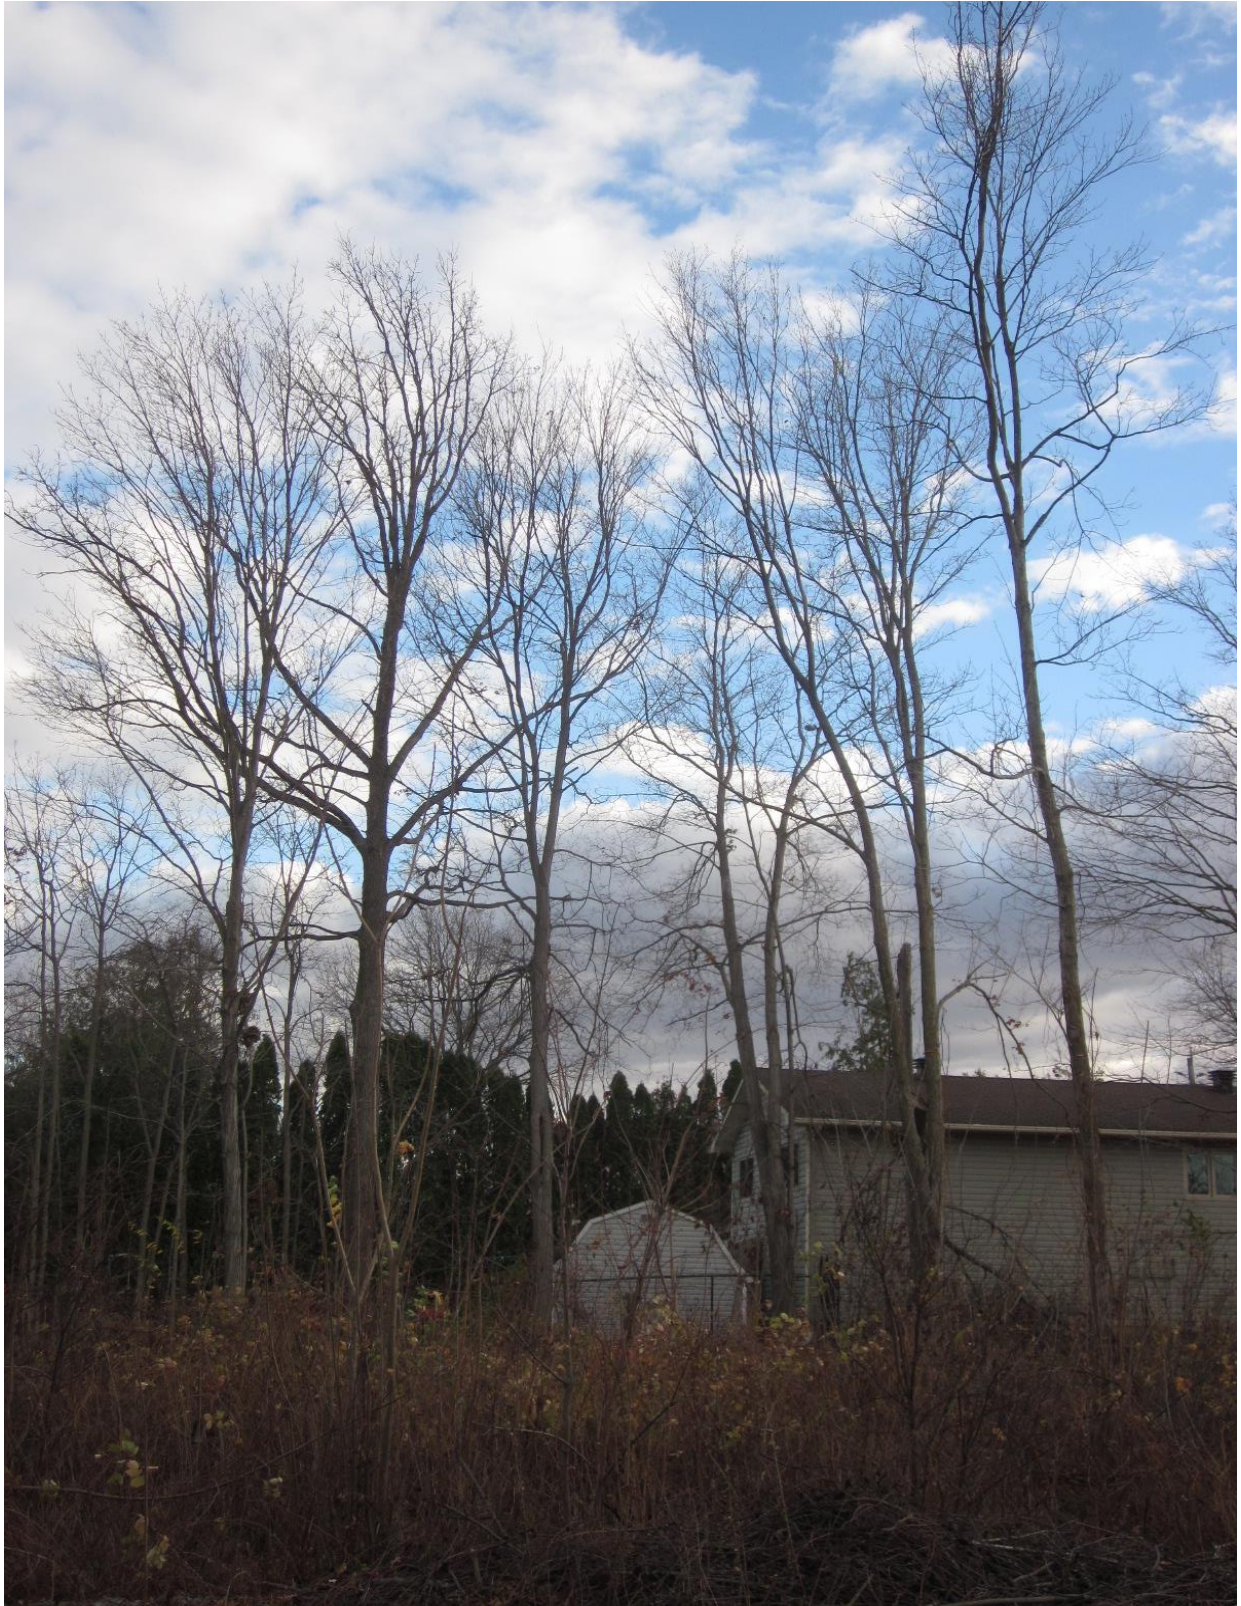
16	Sugar maple (<i>Acer saccharum</i>)	Private	23	Poor; mature; heavily suppressed by tree #17; divergent and asymmetric towards south; native species; to be removed
17	Sugar maple (<i>Acer saccharum</i>)	Private	29	Fair; mature; upper crown divergent and asymmetric towards south; native species; to be removed
18	Sugar maple (<i>Acer saccharum</i>)	Private	32	Fair; mature; co-dominant stems at 3m; lateral at 1m on southeast broken at 8m; native species; to be removed
19	Sugar maple (<i>Acer saccharum</i>)	Private	43	Fair; mature; divergent and asymmetric towards southeast; native species; to be removed
20	Sugar maple (<i>Acer saccharum</i>)	Private	33	Poor; mature; secondary stem removed at 1m; major stem wound 4-5m on north; native species; to be removed
21	Bur oak (<i>Quercus macrocarpa</i>)	Private	56	Very good; mature; single dominant upright stem with living crown held in upper 2/3 height (above canopy); native species; to be preserved and protected

22	Sugar maple (<i>Acer saccharum</i>)	Private	30	Good; mature; upright form; native species; to be removed
23	Sugar maple (<i>Acer saccharum</i>)	Private	25	Good; mature; upright form; native species; to be removed

Picture 4. Trees #18-22 (right to left) at 1037 Carp Road

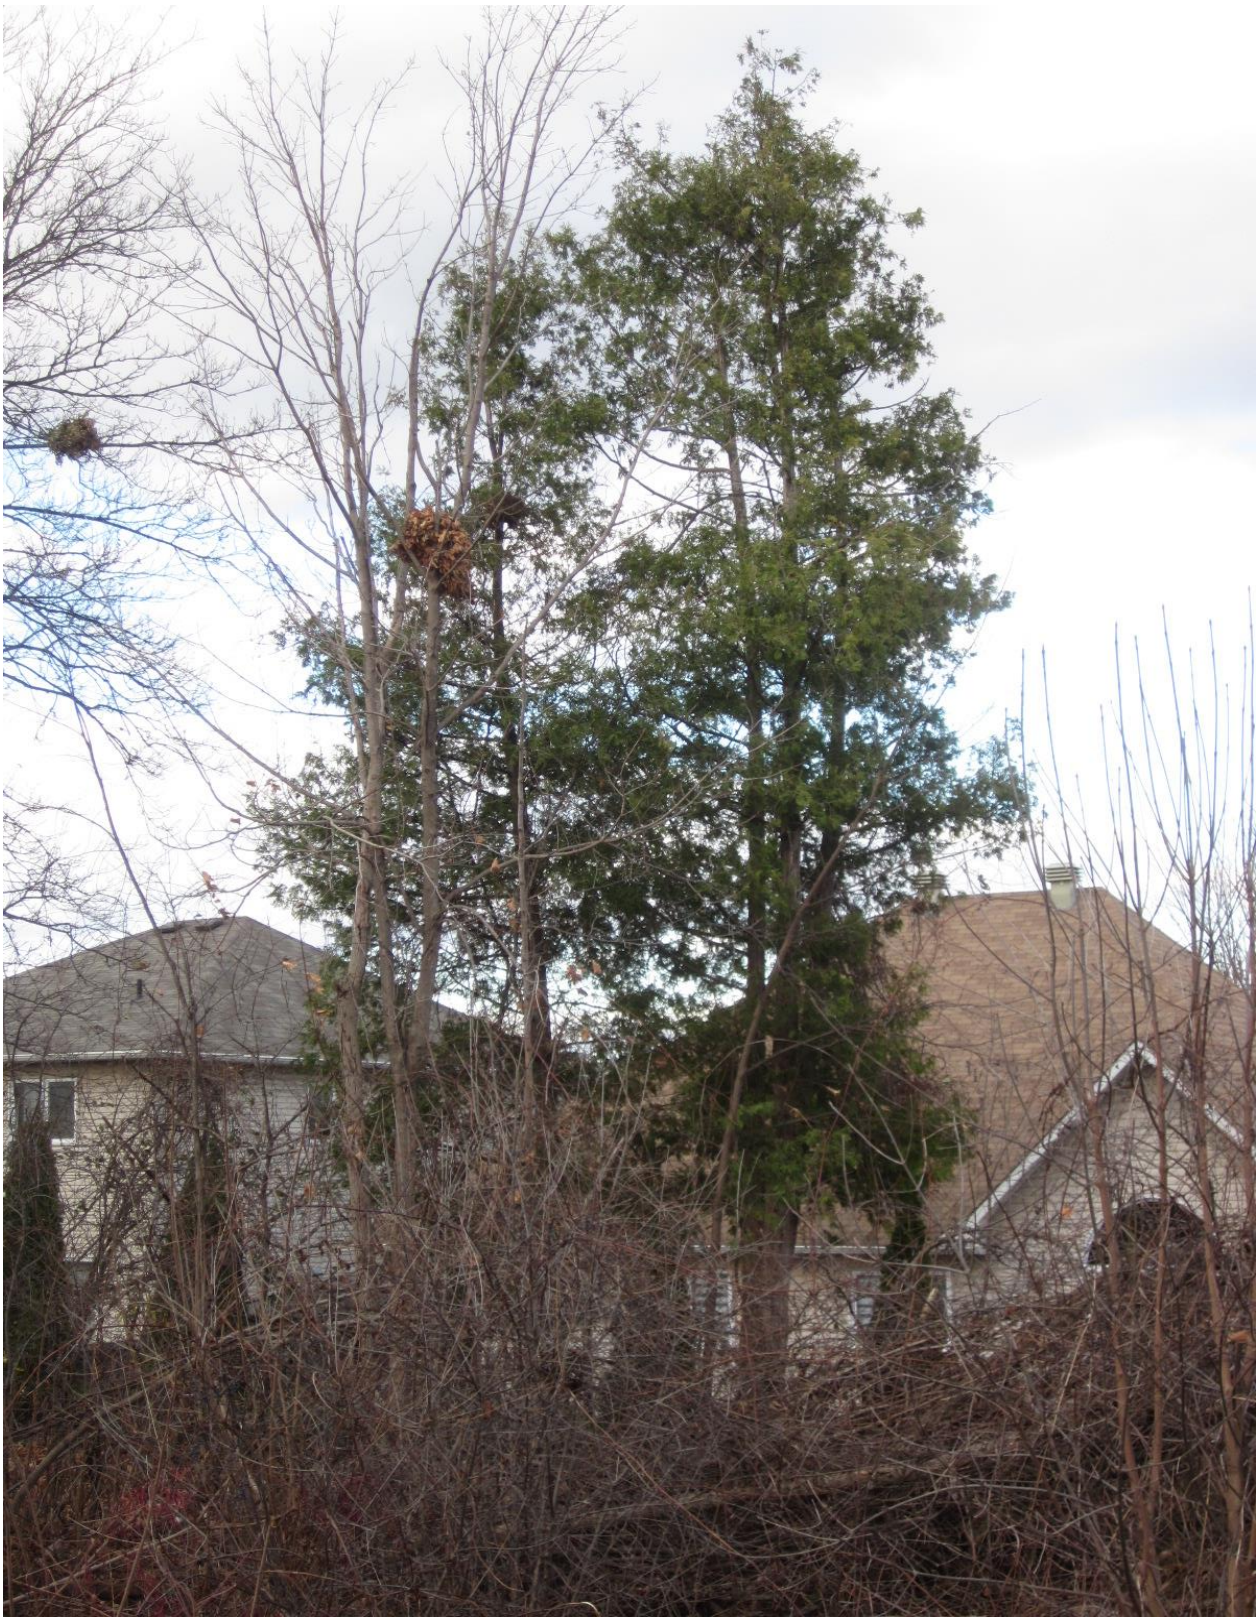
Tree grouping #B: Overstory of three white cedars (18, 19 and 20cm) and one sugar maple (14). Much wind throw damage to surrounding trees. Possibly shared with private property to the northeast. Trees on the subject property will be removed as a result of the grade change necessary for a proposed depressed storage area.

Picture 5. Tree grouping B at 1037 Carp Road

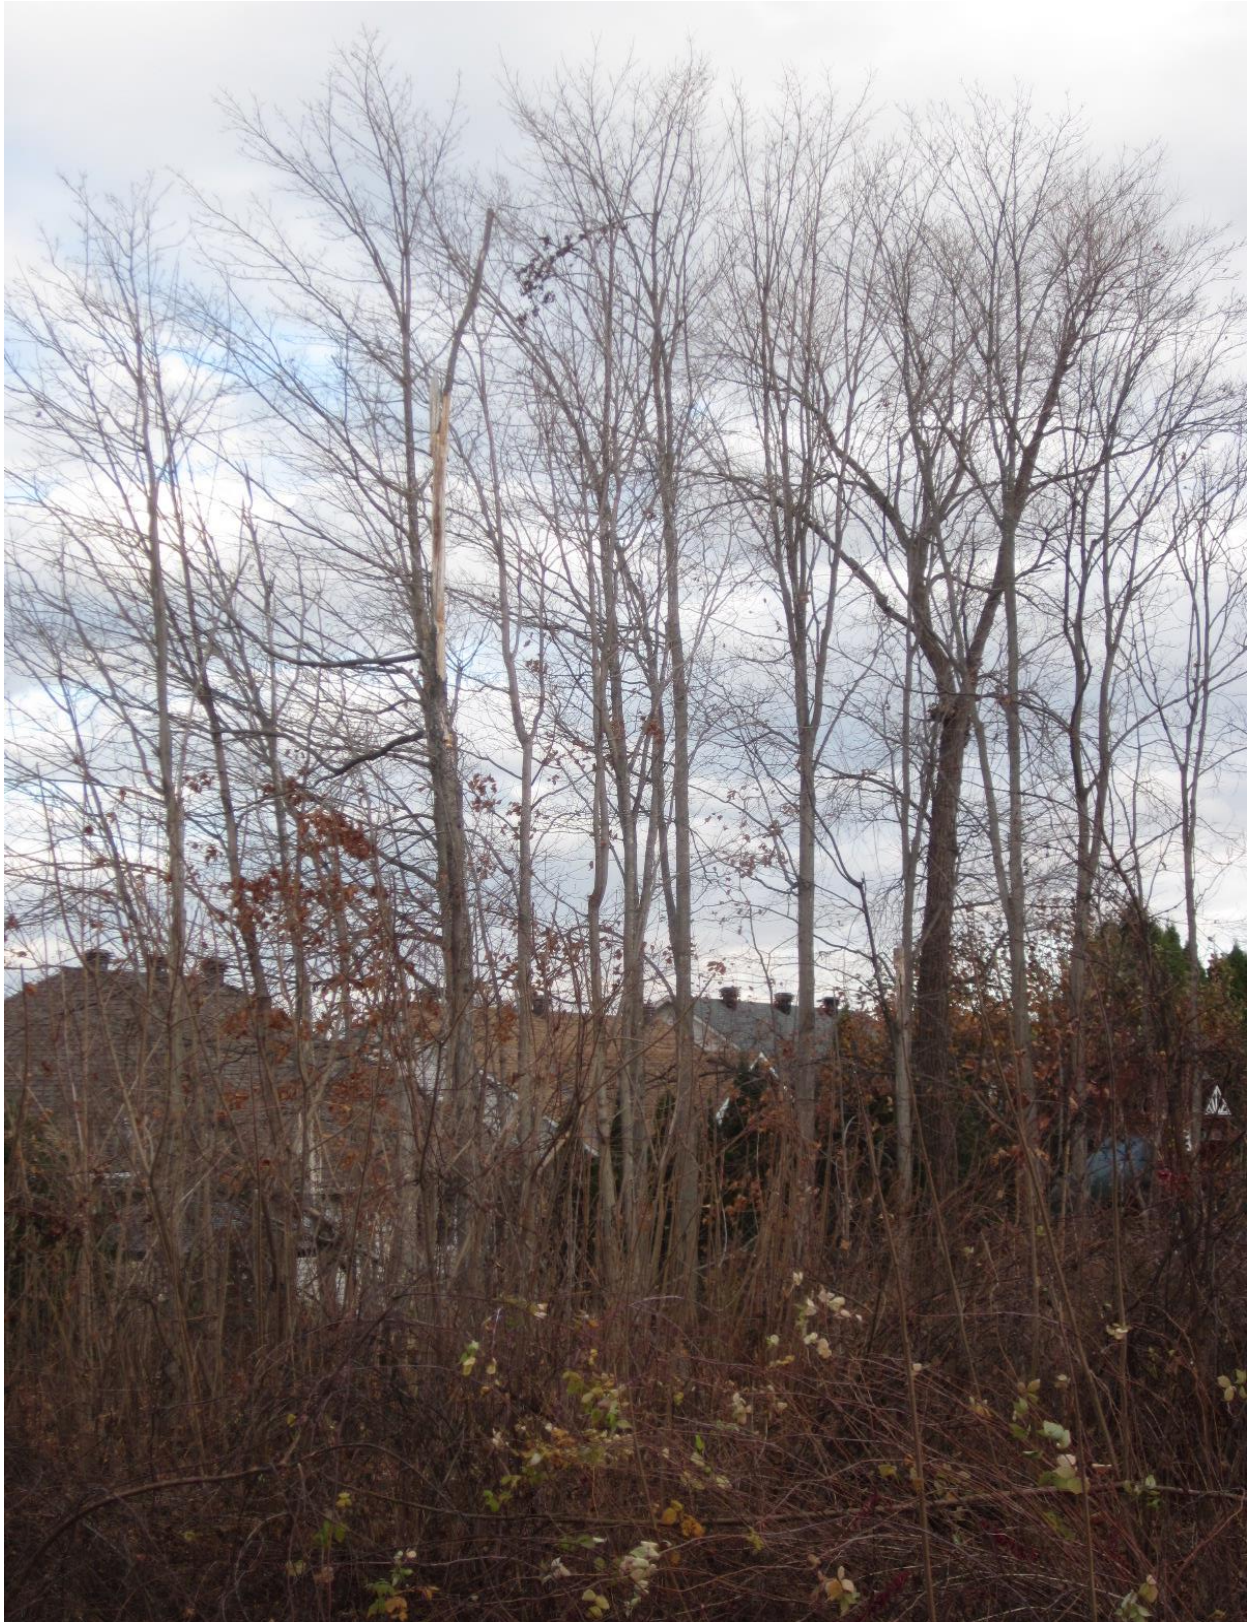
Tree grouping #D: A grouping of remnant trees dominated by 24 sugar maples which average less than 10cm in diameter. Several of these trees appear to be shared with the private properties to the northeast. Trees on the subject property will be removed as a result of the grade change necessary for a proposed depressed storage area.

Picture 6. Tree grouping D at 1037 Carp Road
