**Subject: Tree Conservation Report (TCR)**

**Proposed commercial development at 2585 – 2600 Bank Street**

**DST Job No.: TSSO-034880**

**RE: TREE CONSERVATION REPORT FOR 2584, 2600 BANK STREET, OTTAWA**

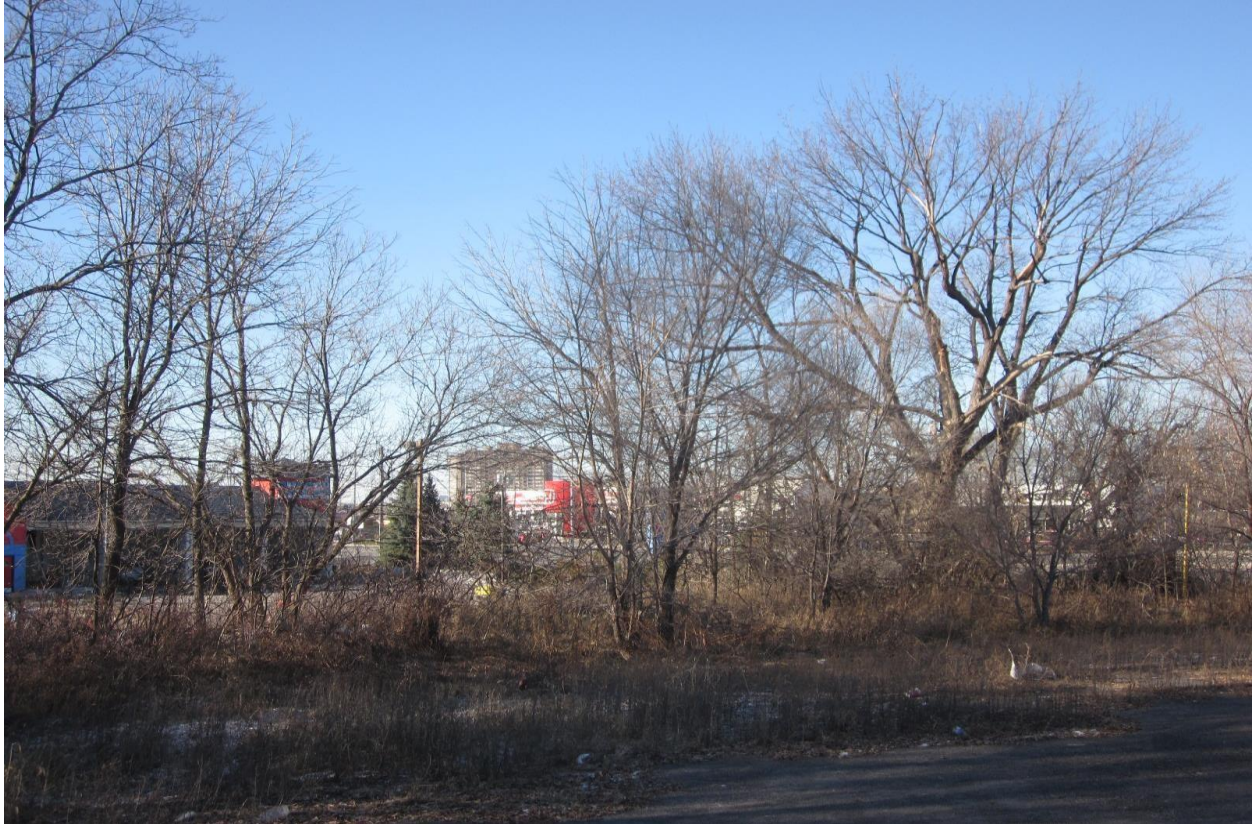
| Tree No. | Tree Species | Condition (VP→E) | DBH <sup>1</sup> (cm) | Age Class & Tree Condition Notes |
|---|---|---|---|---|
| 1 | Silver maple | Fair | 60 avg. | Mature; multi-stemmed from grade; broad, open grown crown; native species |

Picture 1. Tree #1, silver maple (far right) and seeded Siberian elm, Manitoba maple and black walnut at 2584 Bank.

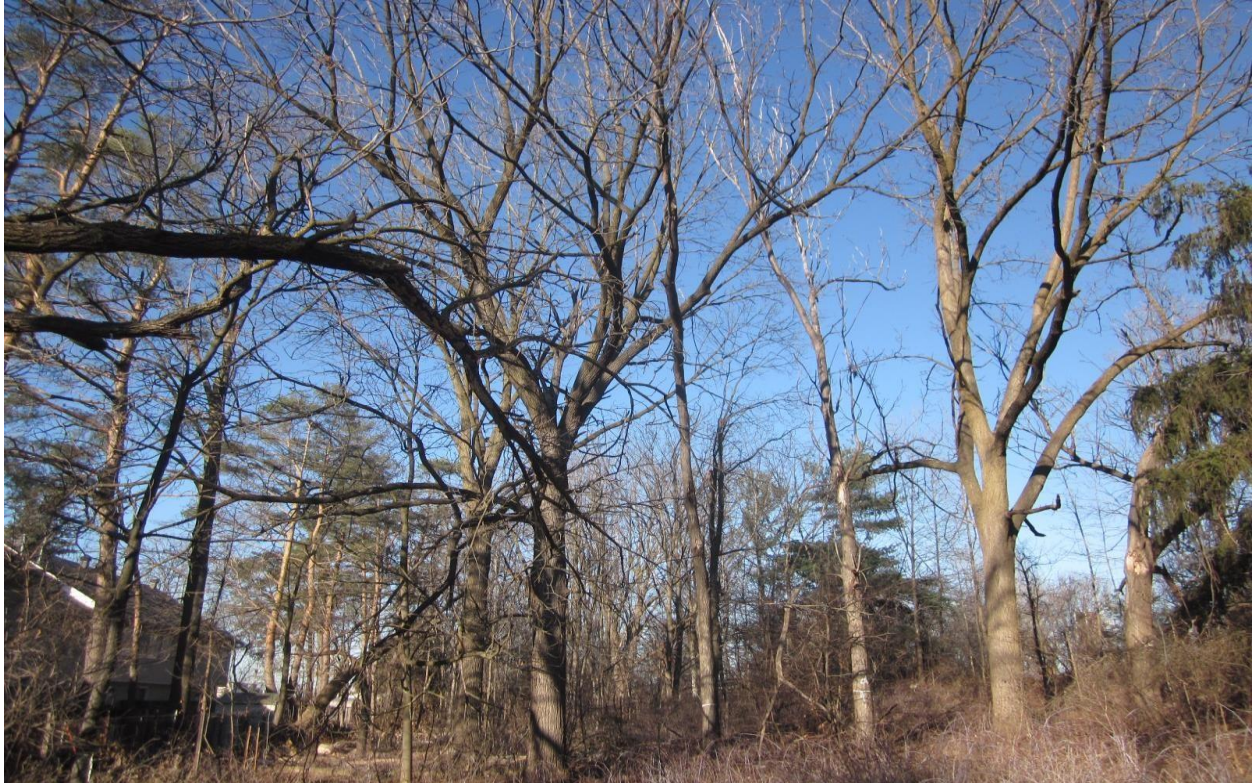
| 5 | Grouping of black walnut and butternut | Good to fair | 40 avg. | Mature to overmature; no discernable planting pattern - likely originated from seed spread by squirrels; butternut is a hybrid |

Picture 2. Grouping #5, mature black walnut and butternut (foreground), at 2584 Bank Street.

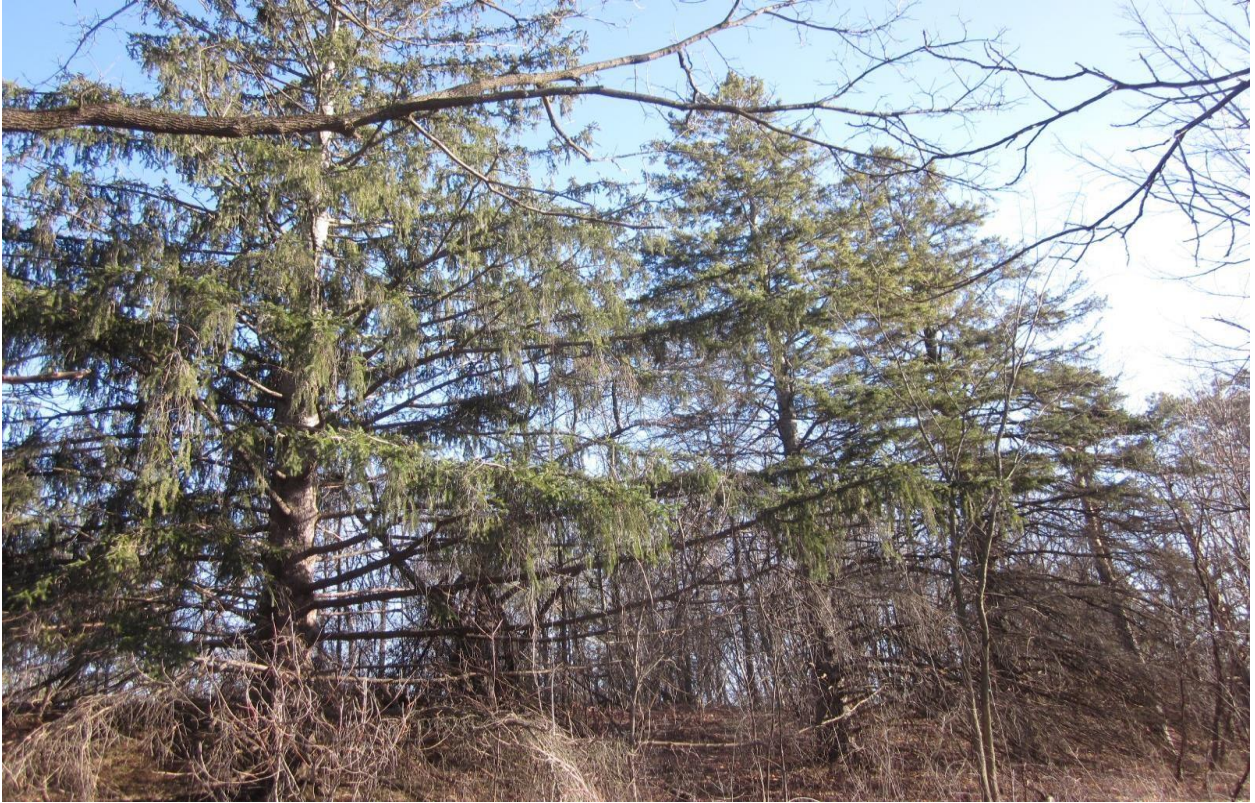
| 7 | Mixed coniferous hedgerow | Fair | | Mature to overmature line of one Norway spruce, two white spruce ( <i>Picea glauca</i> ), one Scots pine and one red pine |

Picture 3. Hedgerow #7, over mature Norway spruce and Scots pine, at 2584 Bank Street.

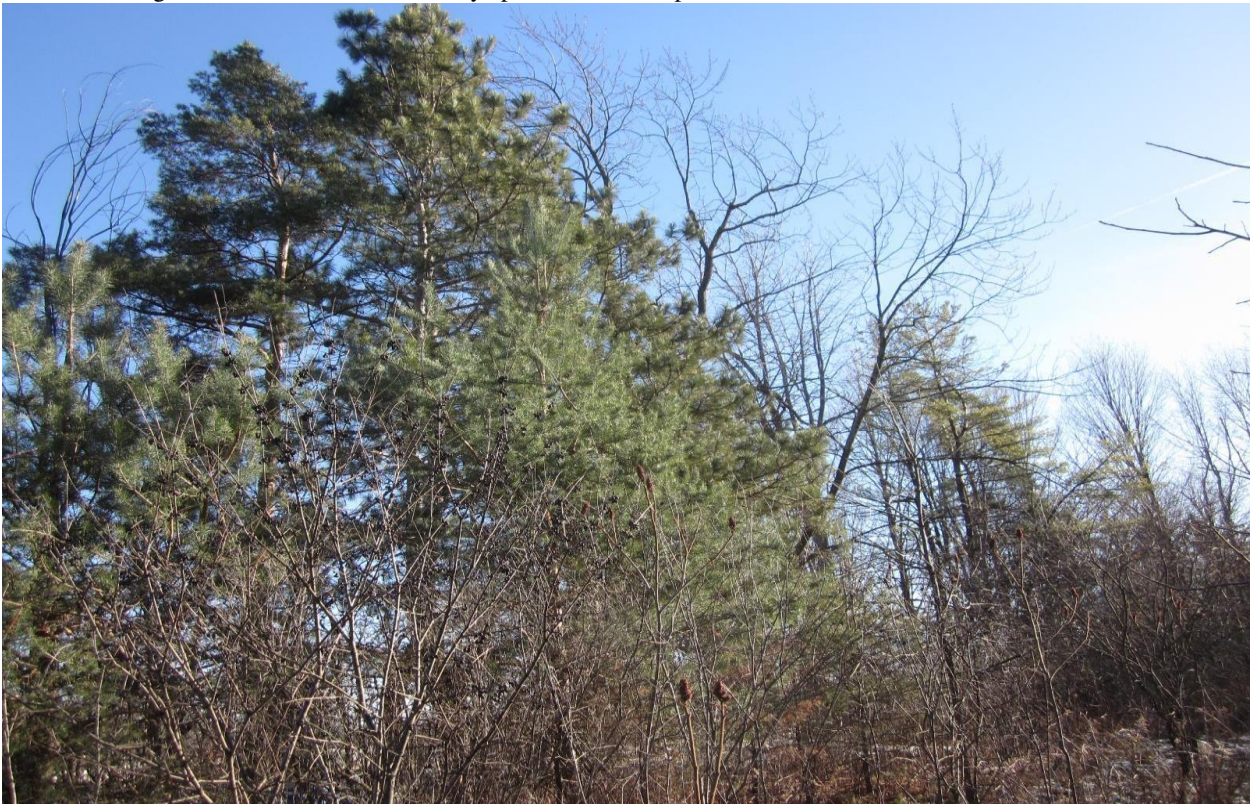
| 8 | Mixedwood hedgerow | Very poor to fair | 40-90 | Mature to overmature line of two white pine, two black walnut, four Scots pine, three red pine and one sugar maple |

Picture 4. Hedgerow #8, mature red, white and Scots pine and black walnut, at 2584 Bank Street.

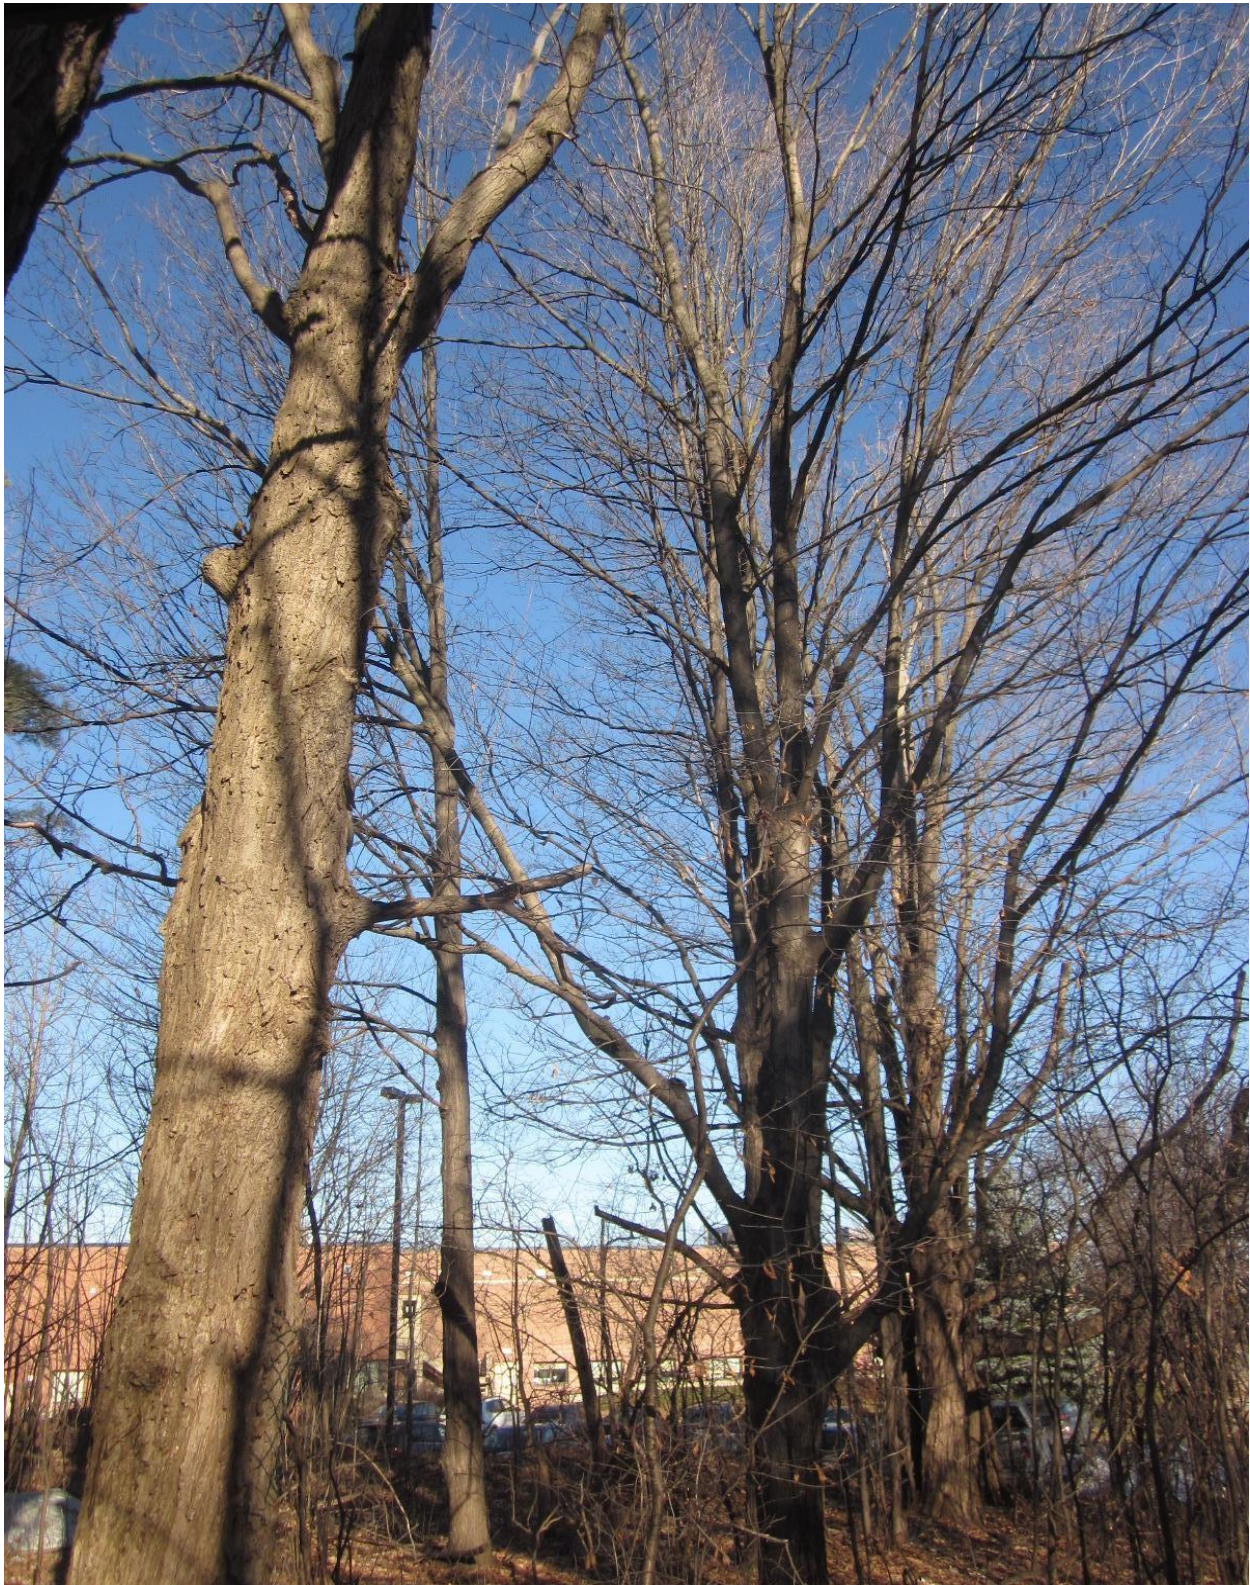
| 9 | Sugar maple | Poor to good | 30-60 | Mature to overmature; planted line of 10 trees (3 of which are on adjacent private property); larger trees in decline |

Picture 5. Tree line #9, mature and overmature sugar maples, at 2584 Bank Street

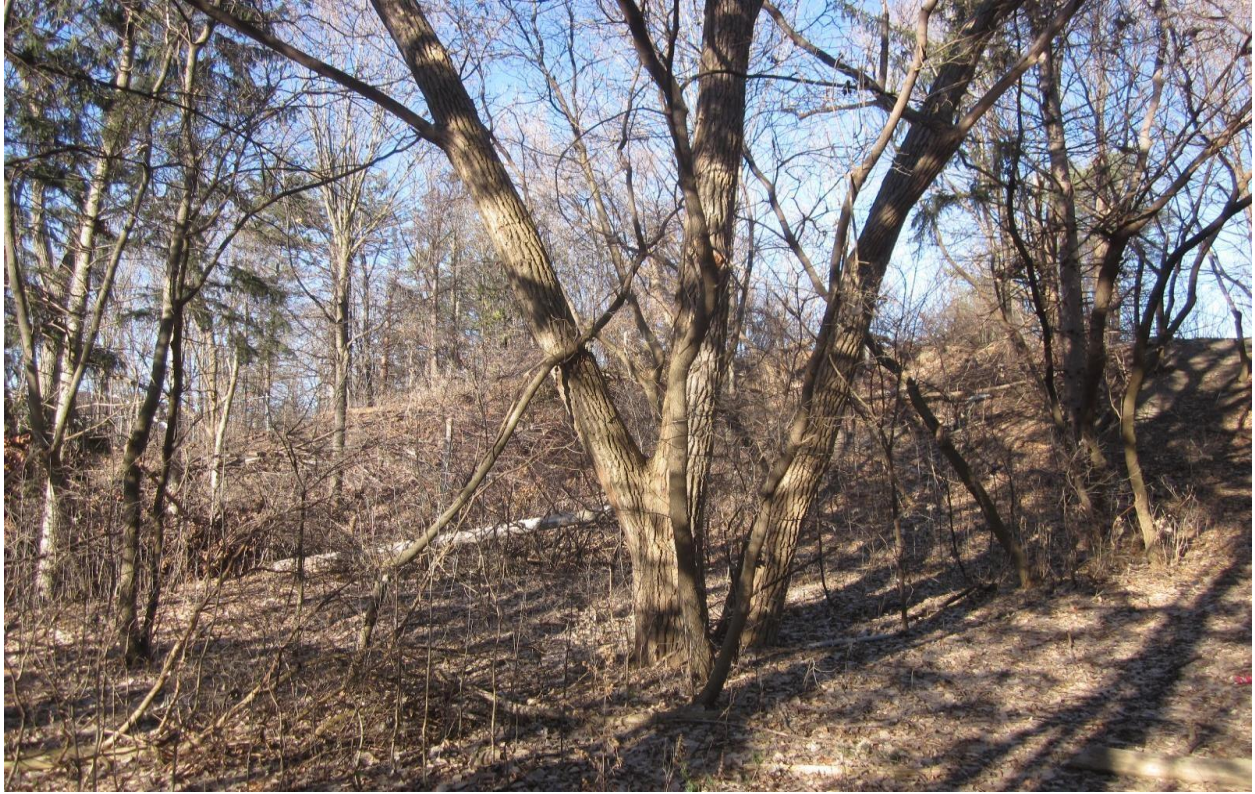
| 10 | Manitoba, Norway and sugar maple | Fair | 20 avg. | Mature to mature; primarily naturalized and introduced species (Manitoba and Norway maple) with some native sugar maple; all originated from seed; steeply sloped site |

Picture 6. Grouping #10, Manitoba and Norway maple growth on sloped portion of 2626 Bank Street

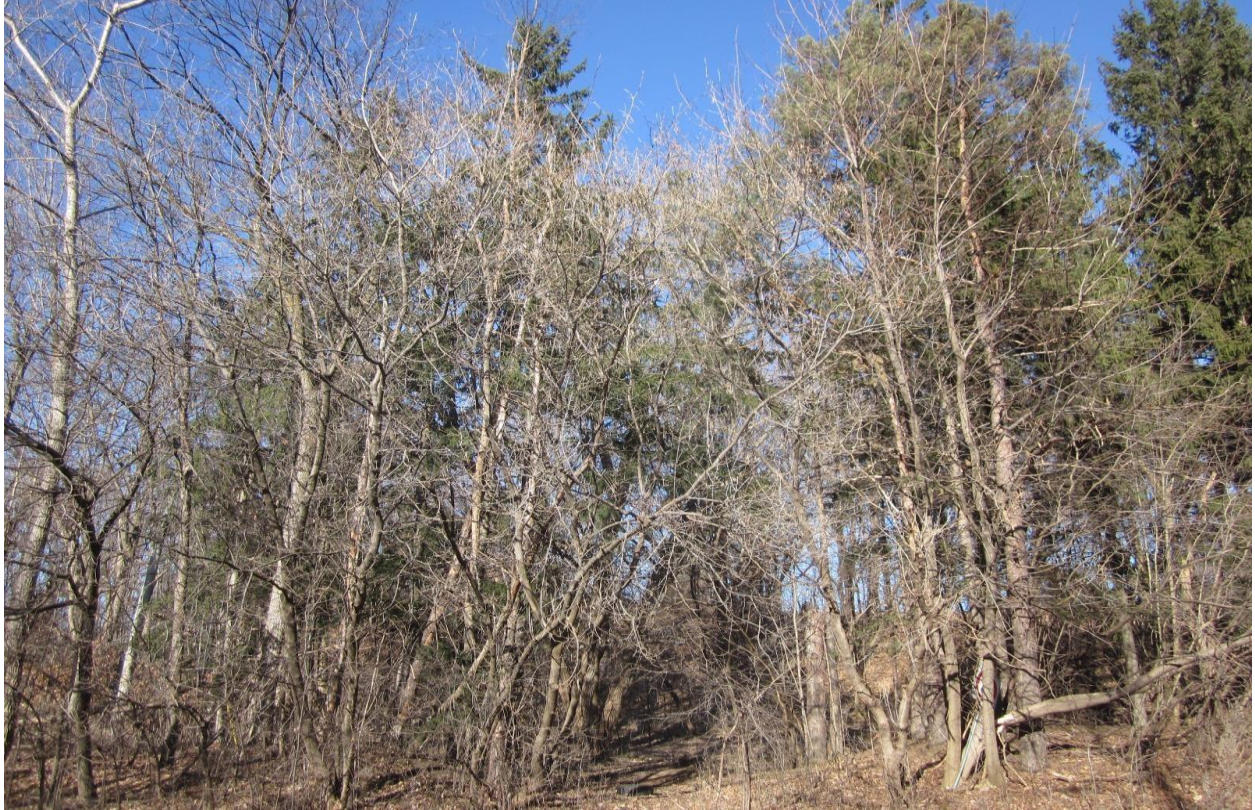
| 11 | Norway spruce and Scots pine | Fair | 40 avg | Mature; twenty four spruce and two pine planted on edge of old pit; scattered cottonwood ( <i>Populus deltoides</i> ) – up to +/- 80cm diameter |

Picture 7. Tree line #11, planted mature Norway spruce and Scots pines (background) and seeded Manitoba and Norway maples (foreground) on lower plateau at 2626 Bank Street
