URBAN FORESTRY & FOREST MANAGEMENT CONSULTING

June 21, 2023

**RE: TREE CONSERVATION REPORT FOR 1919 RIVERSIDE DRIVE, OTTAWA**

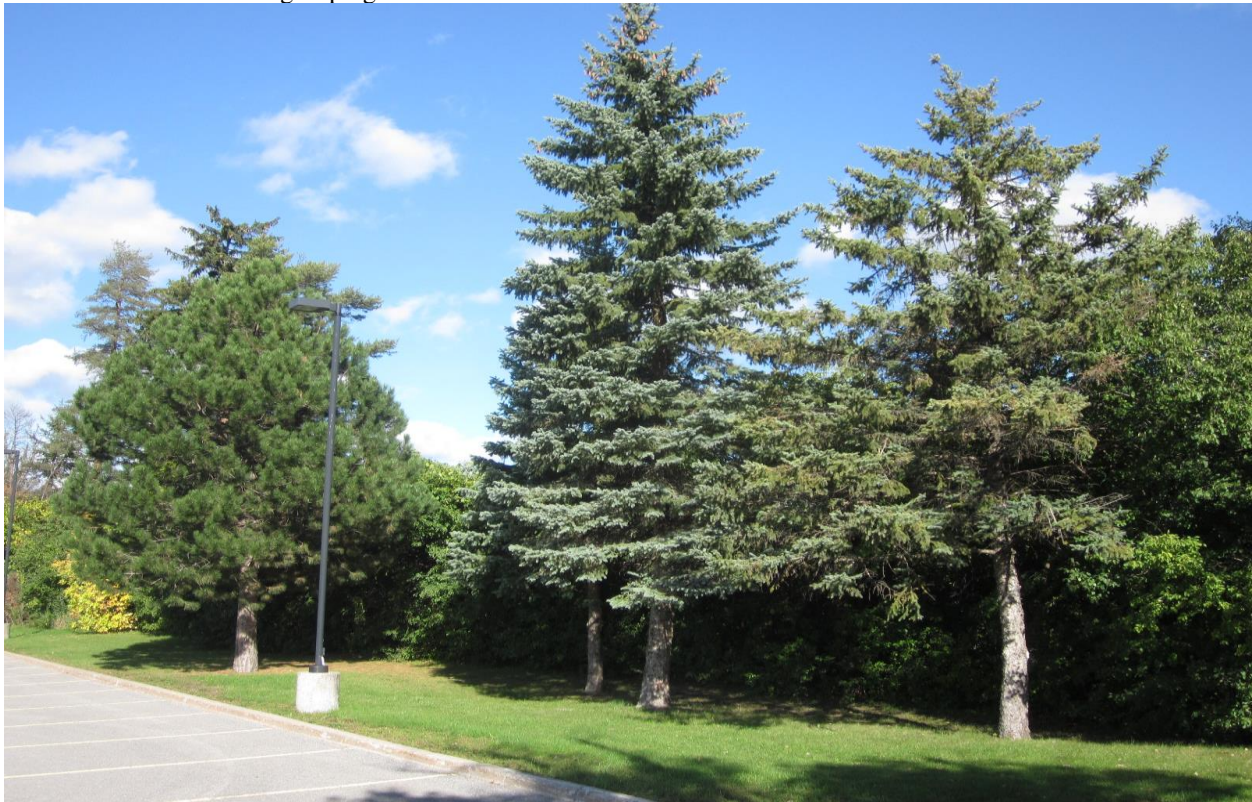
Picture 2. Trees #4-7 (right to left) at 1919 Riverside Drive

Tree No.	Tree species	Condition (VP→E)	DBH <sup>1</sup> (cm)	Age class, tree condition notes & <b>preservation status</b> (to be removed or preserved and protected)
1	Austrian pine ( <i>Pinus nigra</i> )	Fair	18.2	Mature; crown very asymmetric towards west; fair crown density, growth increment and needle colour; introduced species; <b>to be preserved and protected</b>
2	Austrian pine	Fair	29.2	Mature; crown asymmetric towards north; fair density, growth increment and needle colour; introduced species; <b>to be preserved and protected</b>
3	Bur oak ( <i>Quercus macrocarpa</i> )	Poor	90.3	Overmature; continuously topped for clearance from overhead Hydro lines; located within a restricted rooting zone – parking median; significant dieback; tree is in advanced decline; native species; <b>to be removed</b>
4	Colorado spruce ( <i>Picea pungens</i> )	Poor	28.8	Mature; lower crown asymmetric; poor crown density, growth increment and needle colour – tree is in advanced decline; introduced species; <b>to be removed</b>

5	Colorado spruce	Very good	36.4	Mature; lower crown asymmetric; very good density, increment and colour; introduced species; <b>to be removed</b>
6	Colorado spruce	Good	24.7	Mature; lower crown asymmetric; good density, increment and colour; introduced species; <b>to be removed</b>
7	Austrian pine	Very good	40.9	Mature; very good density, increment and colour; introduced species; <b>to be removed</b>
8	European larch ( <i>Larix decidua</i> )	Fair	19.1	Maturing; salt spray damage to west side of crown – extensive dieback; fair density, increment and colour; introduced species; <b>to be removed</b>
9	Honey-locust ( <i>Gleditsia triacanthos</i> )	Good	22.6	Maturing; central stem with competing lateral at 1.5m on south side; good crown density, leaf size and colour; introduced species; <b>to be removed</b>

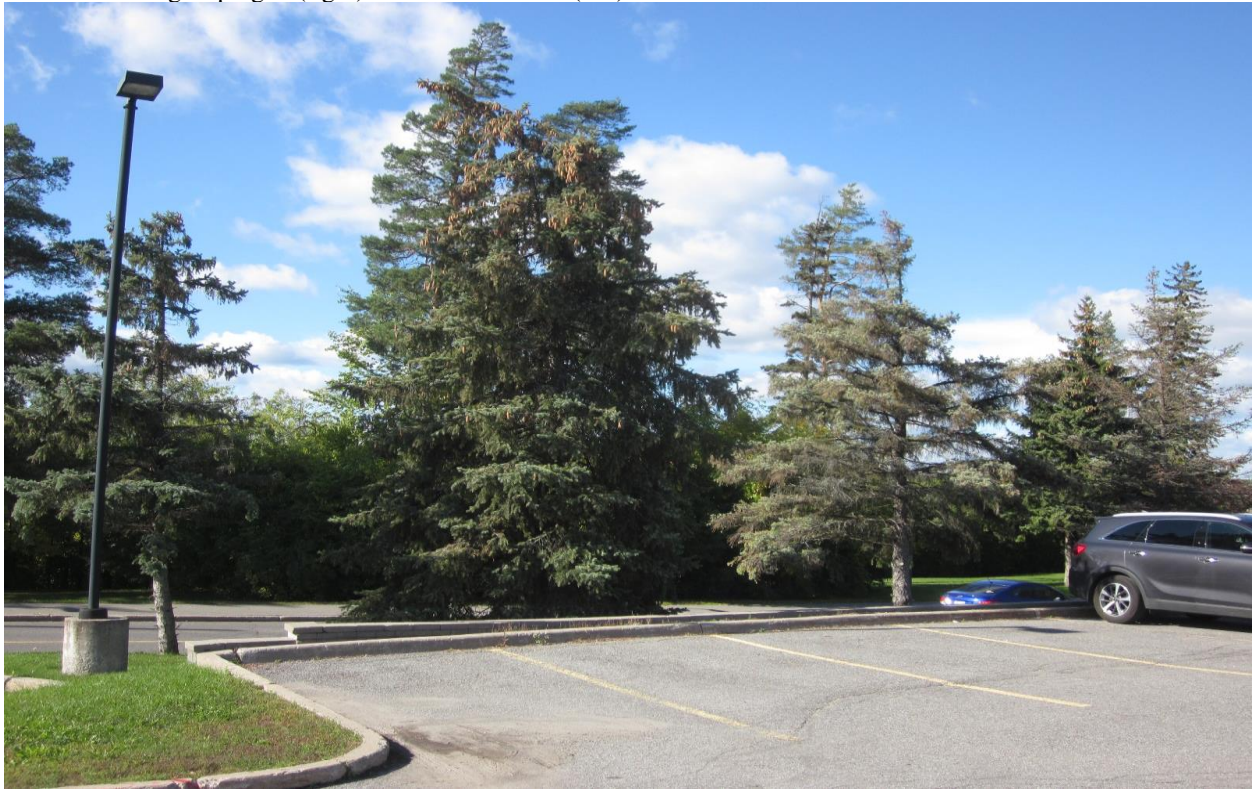
Picture 5. Trees #19-22 (right to left) at 1919 Riverside Drive

15	White spruce	Very poor	14.7	Maturing; divergent towards southeast; leader is dead; tree is in decline; poor density, increment and colour; native species; <b>to be removed</b>
16	Colorado spruce	Very good	24.1	Mature; good growth form; very good density, increment and colour; introduced species; <b>to be removed</b>
17	Little-leaf linden ( <i>Tilia cordata</i> )	Good	23.9	Maturing; co-dominant stems at 3m – moderately divergent; good crown density, leaf size and colour; introduced species; <b>to be removed</b>
18	Little-leaf linden	Good	27.1 (at 1m)	Maturing; multiple stems at 2-2.5m – broad crown; good crown density, leaf size and colour; embedded guy wire at 1.3m; introduced species; <b>to be removed</b>
19	Colorado spruce	Very poor	25.3	Maturing; holding less than 10% living foliage; tree is in advanced decline; embedded guy wire at 0.6m; introduced species; <b>to be removed</b>
20	Colorado spruce	Poor	23.6	Maturing; holding less than 50% living foliage; tree is in decline; heavy basal damage; introduced species; <b>to be removed</b>

Tree No.	Tree species	Condition (VP→E)	DBH <sup>1</sup> (cm)	Age class, tree condition notes & <b>preservation status</b> (to be removed or preserved and protected)
21	Colorado spruce	Fair	24.9	Maturing; fair density, increment and colour; leader strongly divergent towards southeast; introduced species; <b>to be removed</b>
22	Colorado spruce	Fair	17.9	Maturing; fair density, increment and colour; scattered dead branches; introduced species; <b>to be removed</b>
23	Scots pine ( <i>Pinus sylvestris</i> )	Very poor	35.1	Mature; holding less than 10% living foliage; tree is in advanced decline – only 4 lowest branches alive; located within a restricted rooting zone – parking median; introduced invasive species; <b>to be removed</b>
24	Scots pine	Poor	58.4	Mature; very poor density, poor increment and colour; tree is in advanced decline; located within a restricted rooting zone – parking median; introduced invasive species; <b>to be removed</b>
