URBAN FORESTRY & FOREST MANAGEMENT CONSULTING

September 30, 2021

RE: TREE CONSERVATION REPORT FOR 1919 RIVERSIDE DRIVE, OTTAWA

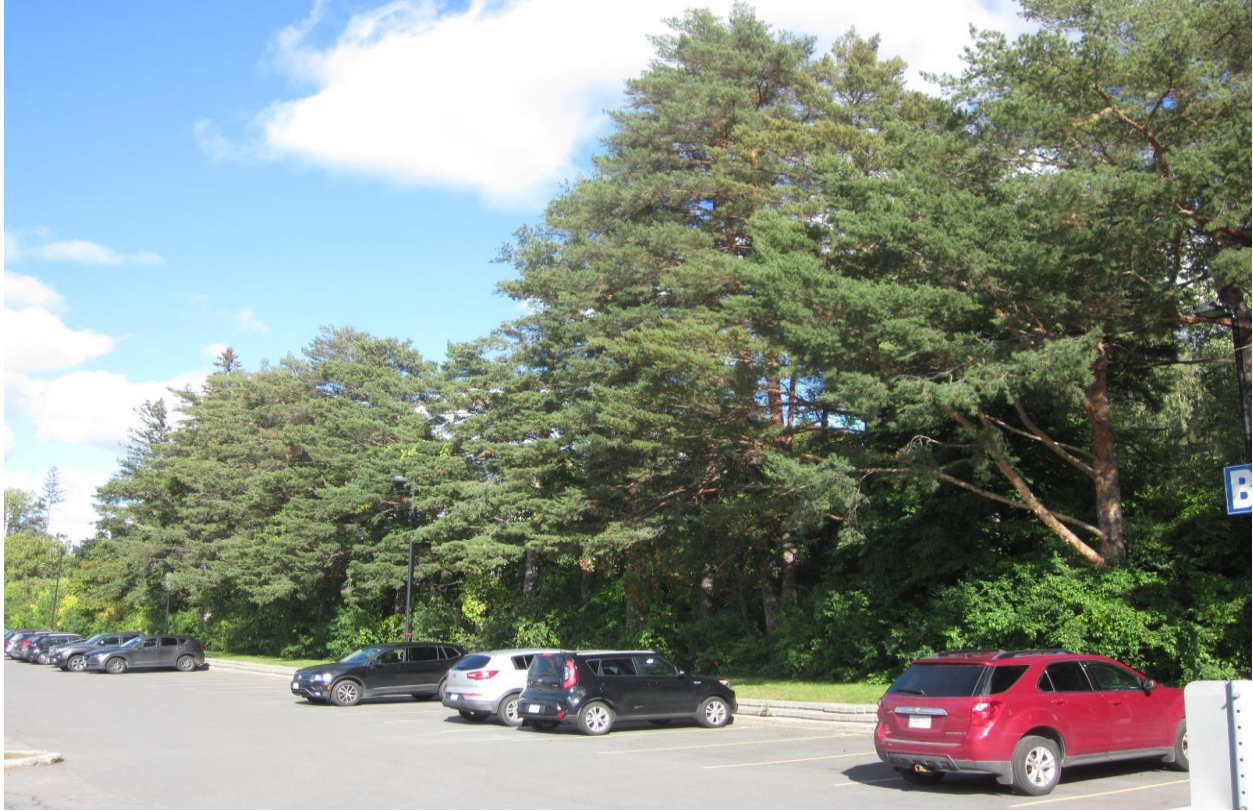
Tree grouping A: A line of twenty six mature Scots pine and five mature white spruce. All of these trees would have been planted. Generally they are in good condition – upright with good crown densities, growth increments and needle colour. Their crowns are held high above the understory and are often asymmetric towards the northwest due to intercompetition between trees. The understory is primarily introduced invasive buckthorn (*Rhamnus* spp.) and Norway maple (*Acer platanoides*) with scattered mountain-ash (*Sorbus* spp.), hawthorn (*Crataegus* spp.), bur oak and ash (*Fraxinus* spp.) – all of which are native species. All ash remaining on the property are either now dead or heavily infested with emerald ash borer (*Agilus planipennis*).

Picture 1. Tree grouping A at 1919 Riverside Drive

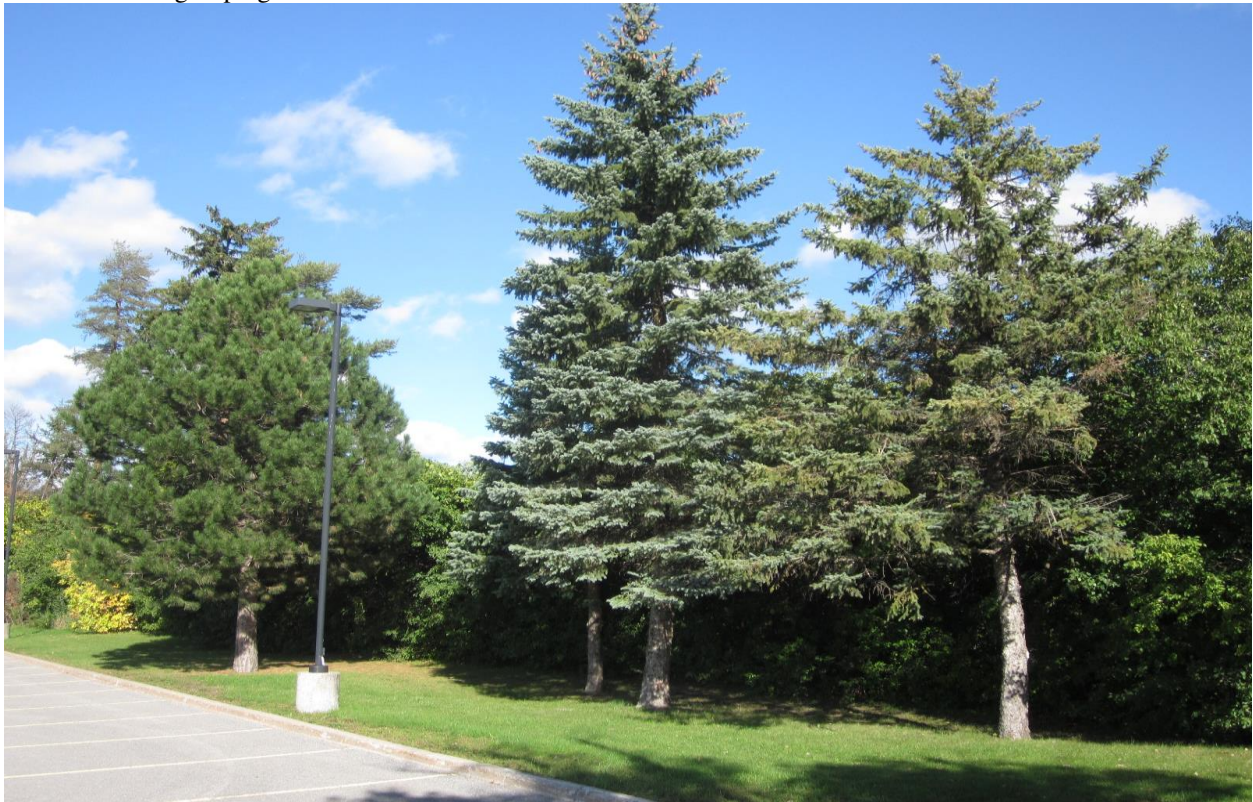
Tree No.	Tree species	Condition (VP→E)	DBH ¹ (cm)	Age class, tree condition notes & preservation status (to be removed or preserved and protected)
1	Austrian pine (<i>Pinus nigra</i>)	Fair	18.2	Mature; crown very asymmetric towards west; fair crown density, growth increment and needle colour; introduced species; to be removed
2	Austrian pine	Fair	29.2	Mature; crown asymmetric towards north; fair density, growth increment and needle colour; introduced species; to be removed
3	Bur oak (<i>Quercus macrocarpa</i>)	Poor	90.3	Overmature; continuously topped for clearance from overhead Hydro lines; located within a restricted rooting zone – parking median; significant dieback; tree is in advanced decline; native species; to be removed
4	Colorado spruce (<i>Picea pungens</i>)	Poor	28.8	Mature; lower crown asymmetric; poor crown density, growth increment and needle colour – tree is in advanced decline; introduced species; to be removed

5	Colorado spruce	Very good	36.4	Mature; lower crown asymmetric; very good density, increment and colour; introduced species; to be removed
6	Colorado spruce	Good	24.7	Mature; lower crown asymmetric; good density, increment and colour; introduced species; to be removed
7	Austrian pine	Very good	40.9	Mature; very good density, increment and colour; introduced species; to be removed
8	European larch (<i>Larix decidua</i>)	Fair	19.1	Maturing; salt spray damage to west side of crown – extensive dieback; fair density, increment and colour; introduced species; to be removed
9	Honey-locust (<i>Gleditsia triacanthos</i>)	Good	22.6	Maturing; central stem with competing lateral at 1.5m on south side; good crown density, leaf size and colour; introduced species; to be removed
10	Honey-locust	Good	19.5	Maturing; multiple competing stems at 2m – broad crown; good crown density, leaf size and colour; introduced species; to be removed

Picture 2. Trees #4-7 (right to left) at 1919 Riverside Drive

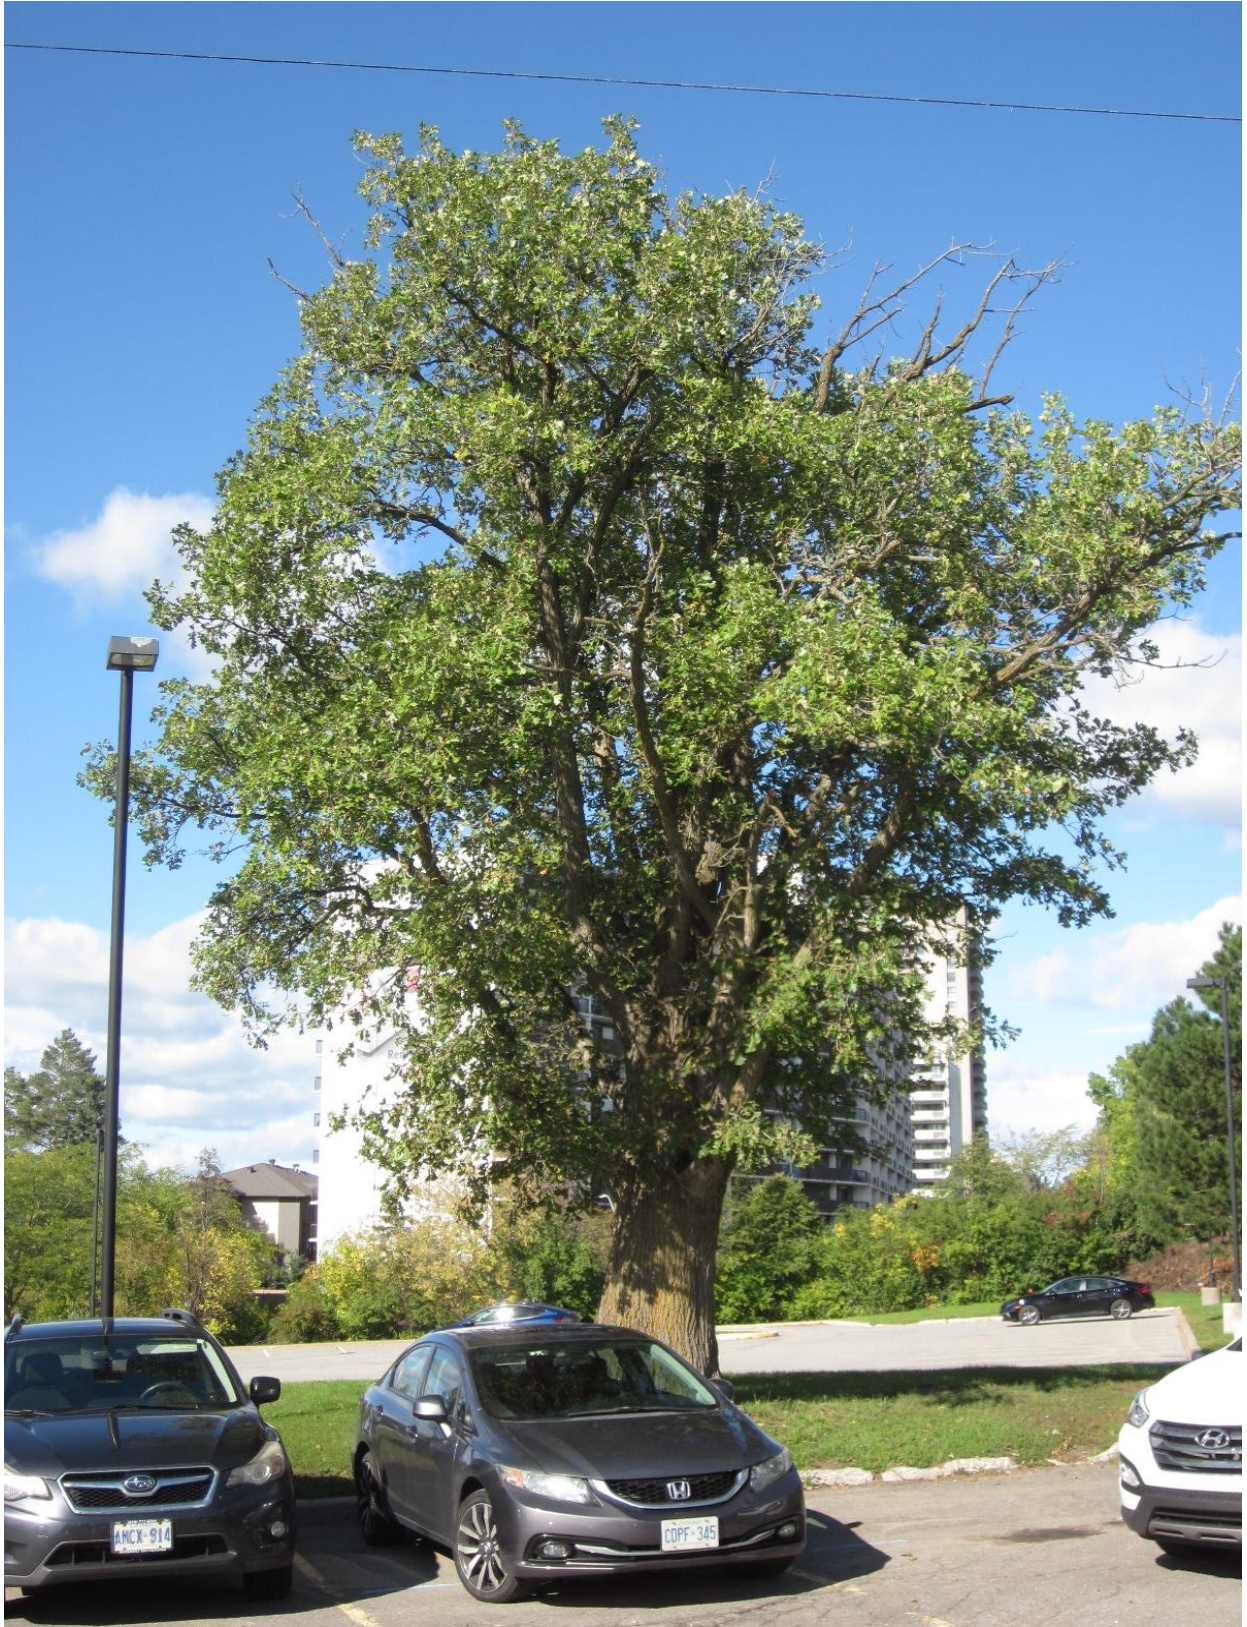
Picture 3. Tree #3 at 1919 Riverside Drive

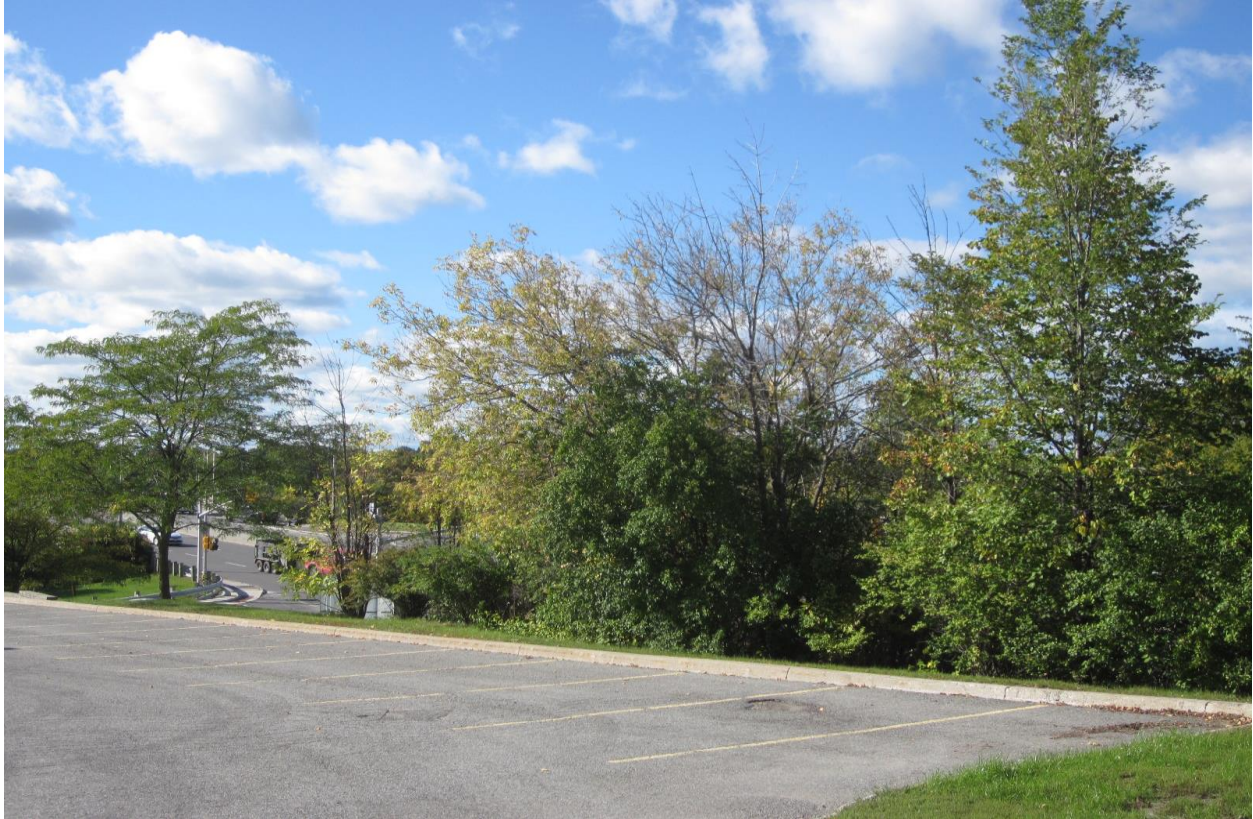
Tree grouping D: Three planted Scots pine and two American elms (*Ulmus americana*). The pines are mature, upright in form and hold their living crowns high above the buckthorn in the understory. They are in good condition, with good crown densities, growth increments and needle colour. The elms show no outward signs of Dutch elm disease (*Ophiostoma novo-ulmi*).

Picture 4. Tree grouping D (right) and trees #8 and 9 (left) at 1919 Riverside Drive

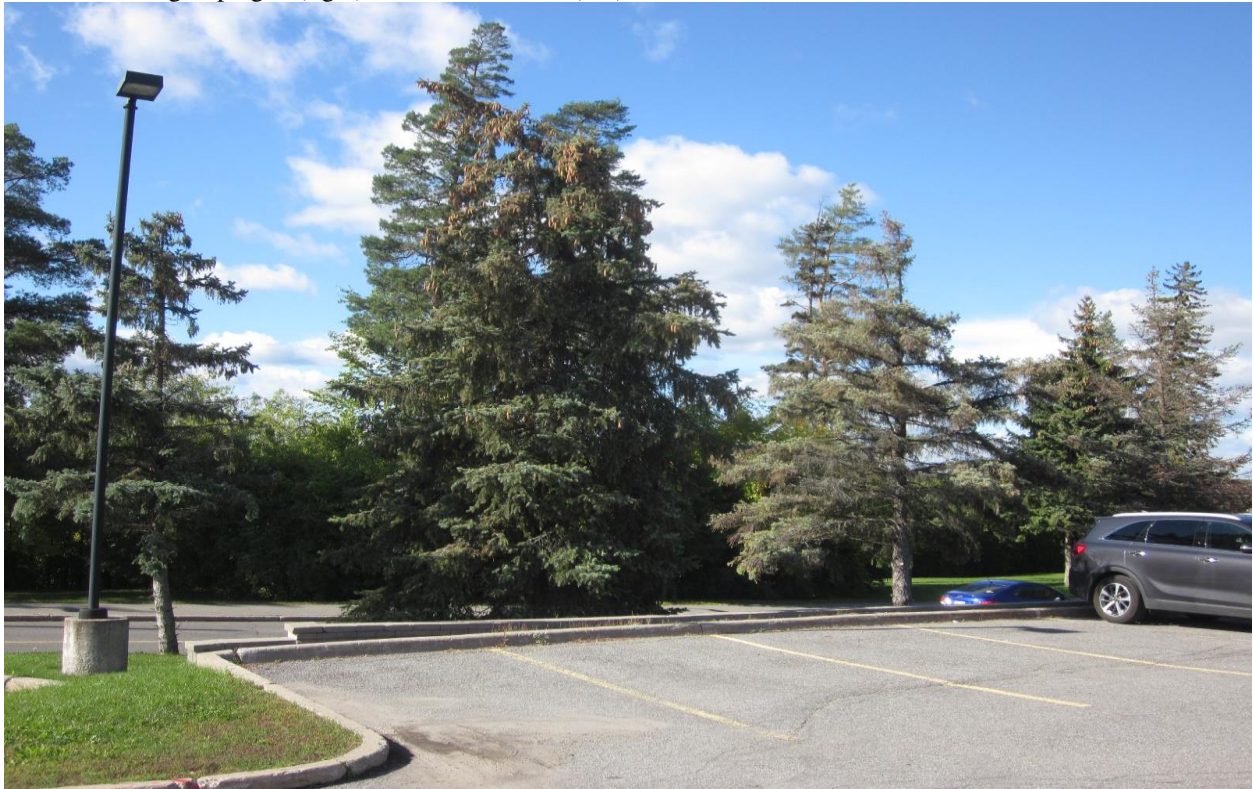
17	Little-leaf linden (<i>Tilia cordata</i>)	Good	23.9	Maturing; co-dominant stems at 3m – moderately divergent; good crown density, leaf size and colour; introduced species; to be removed
18	Little-leaf linden	Good	27.1 (at 1m)	Maturing; multiple stems at 2-2.5m – broad crown; good crown density, leaf size and colour; embedded guy wire at 1.3m; introduced species; to be removed
19	Colorado spruce	Very poor	25.3	Maturing; holding less than 10% living foliage; tree is in advanced decline; embedded guy wire at 0.6m; introduced species; to be removed
20	Colorado spruce	Poor	23.6	Maturing; holding less than 50% living foliage; tree is in decline; heavy basal damage; introduced species; to be removed
21	Colorado spruce	Fair	24.9	Maturing; fair density, increment and colour; leader strongly divergent towards southeast; introduced species; to be removed
22	Colorado spruce	Fair	17.9	Maturing; fair density, increment and colour; scattered dead branches; introduced species; to be removed

Picture 5. Trees #19-22 (right to left) at 1919 Riverside Drive
