URBAN FORESTRY & FOREST MANAGEMENT CONSULTING

October 12, 2021

**RE: TREE CONSERVATION REPORT FOR ST. THOMAS THE APOSTLE (2345 ALTA VISTA DRIVE)  
AND ELLWOOD HOUSE (2270 BRAESIDE AVENUE), OTTAWA**

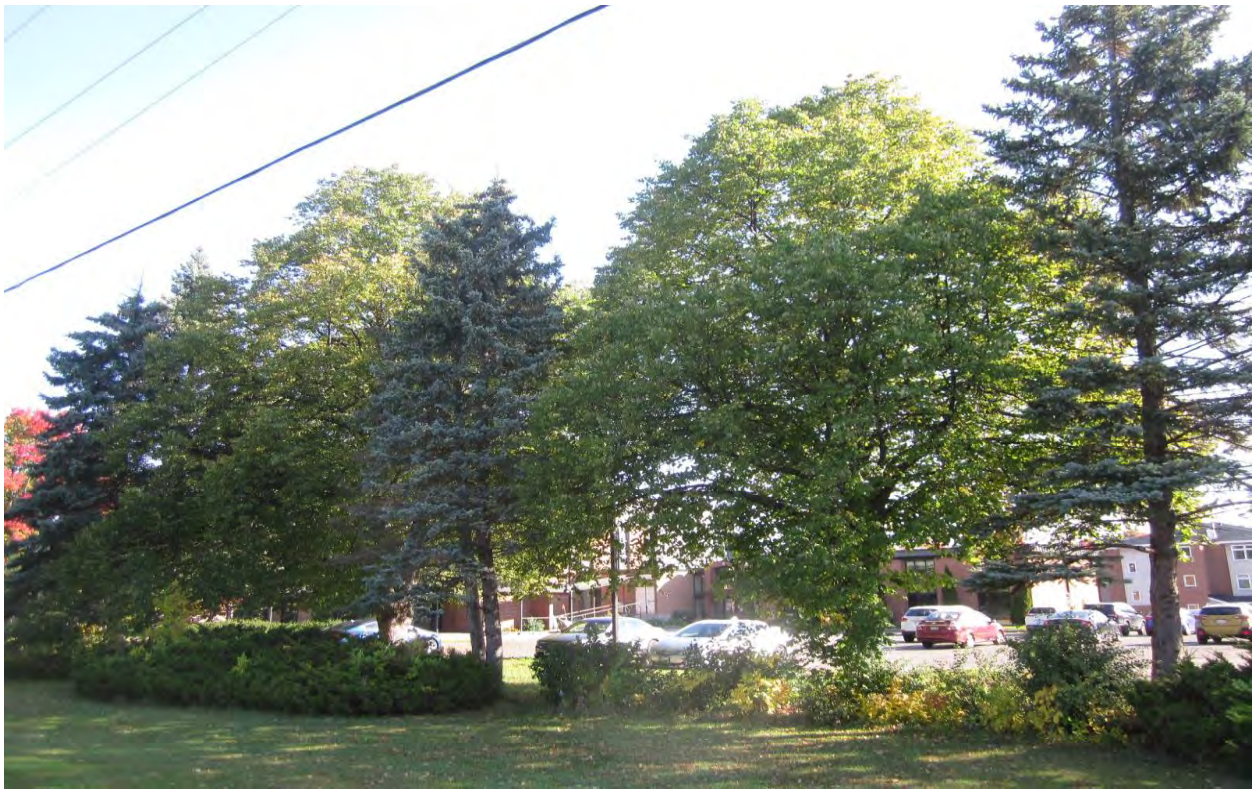
8	Colorado spruce ( <i>Picea pungens</i> )	Poor	29.0	Private	Mature; three competing leaders – all dead; poor crown density and growth increment, fair needle colour on recent growth; introduced species; <b>to be removed</b>
9	Colorado spruce	Fair	30.5	Private	Mature; upright form due to influence of adjacent trees; leader dead; poor density, fair increment and colour; introduced species; <b>to be removed</b>
10	Colorado spruce	Good	36.5	Private	Mature; leader alive and intact; lower crown shaded by tree #11; good density, increment and colour; introduced species; <b>to be removed</b>
11	Little-leaf linden ( <i>Tilia cordata</i> )	Good	61.7 (at 1m)	Private	Very mature; single dominant stem for most of height; suppressed laterals starting at 1.5m; very broad, dense crown with good leaf size; introduced species; <b>to be preserved and protected</b>
12	Colorado spruce	Good	28.6	Private	Mature; very asymmetric toward southwest due to influence of neighbouring trees; good density, increment and colour where exposed to direct sunlight; introduced species; <b>to be preserved and protected</b>

13	Colorado spruce	Poor	26.9	Private	Mature; leader missing; growth suppressed by adjacent trees – poor density, increment and colour; introduced species; <b>to be preserved and protected</b>
14	Little-leaf linden	Good	69.7 (at 1m)	Private	Very mature; competing stems 1.5m – mildly divergent; northwest stem dominant; very broad, dense crown with good leaf size; introduced species; <b>to be preserved and protected</b>
15	Colorado spruce	Fair	34.3	Private	Mature; leader dead; crown asymmetric towards west; good density, increment and colour where exposed to direct sunlight; introduced species; <b>to be preserved and protected</b>
16	Colorado spruce	Good	40.2	Private	Mature; crown asymmetric towards northwest; good density, increment and colour where exposed to direct sunlight; introduced species; <b>to be preserved and protected</b>

Picture 2. Private trees # 9 through 14 (right to left) at 2345 Alta Vista Drive (looking northward)

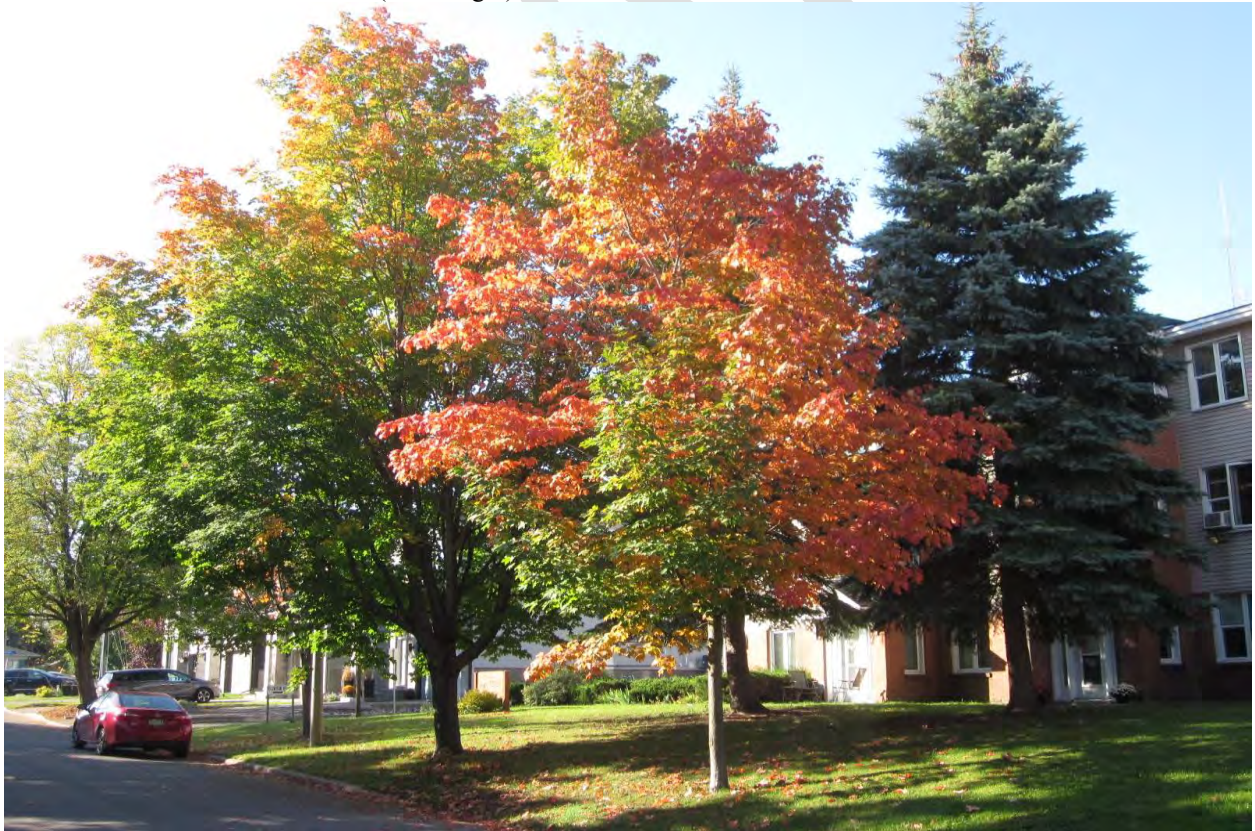
29	Sugar maple	Very poor	36.5	City	Mature; central stem with upright co-dominant leaders at 2.5m; suppressed laterals starting at 1.5m; in very advanced decline - holding less than 10% living foliage; major deadwood present; native variety; <b>to be preserved and protected</b> (though should be removed due to hazard potential)
30	Sugar maple	Fair	41.0	City	Mature; tri-dominant stems at 2m with competing laterals on northwest and northeast and a suppressed lateral on south – all at 1.5m from grade; broad, dense crown; good leaf size; native species; <b>to be preserved and protected</b>
31	Colorado spruce	Fair	40.3	Private	Mature; good form, density, increment and colour; lower crown shaded by tree #30; introduced species; <b>to be preserved and protected</b>
32	Colorado spruce	Very good	31.5	Private	Mature; good form, density, increment and colour; introduced species; <b>to be preserved and protected</b>

33	Sugar maple	Very good	16.5	City	Maturing; central dominant stem with suppressed laterals at 4m on east; native species; <b>to be preserved and protected</b>
34	Sugar maple	Good	49.7	City	Mature; central stem with co-dominant leaders at 5.5m; competing laterals at 2m on east and 2.25 and 4m on west; multiple suppressed laterals – very broad, dense crown; native species; <b>to be preserved and protected</b>
35	White cedar	Fair	22 avg.	Private	Mature hedge of 4 multi-stemmed clumps; all stems previously topped; fair density, increment and colour; native species; <b>to be removed</b>
36	Little-leaf linden	Good	55.5	City	Mature; central stem with competing laterals at 2m on southwest and southeast; co-dominant leaders at 4m; broad, dense crown with good leaf size; introduced species; <b>to be removed</b>
37	White cedar	Good	10 avg.	Shared	Maturing hedge with approx. 20 stems; shaded by nearby trees – esp. #36; good density, increment and colour when exposed to direct sunlight, fair when not; native species; <b>to be preserved and protected</b>

Picture 8. City trees #30 and 33 and private tree #32 (left to right) at 2270 Braeside Avenue
