TREE CONSERVATION REPORT

630 Montreal Road, Ottawa, Ontario.

MP Project No.: CCO-21-4432

August 11, 2021

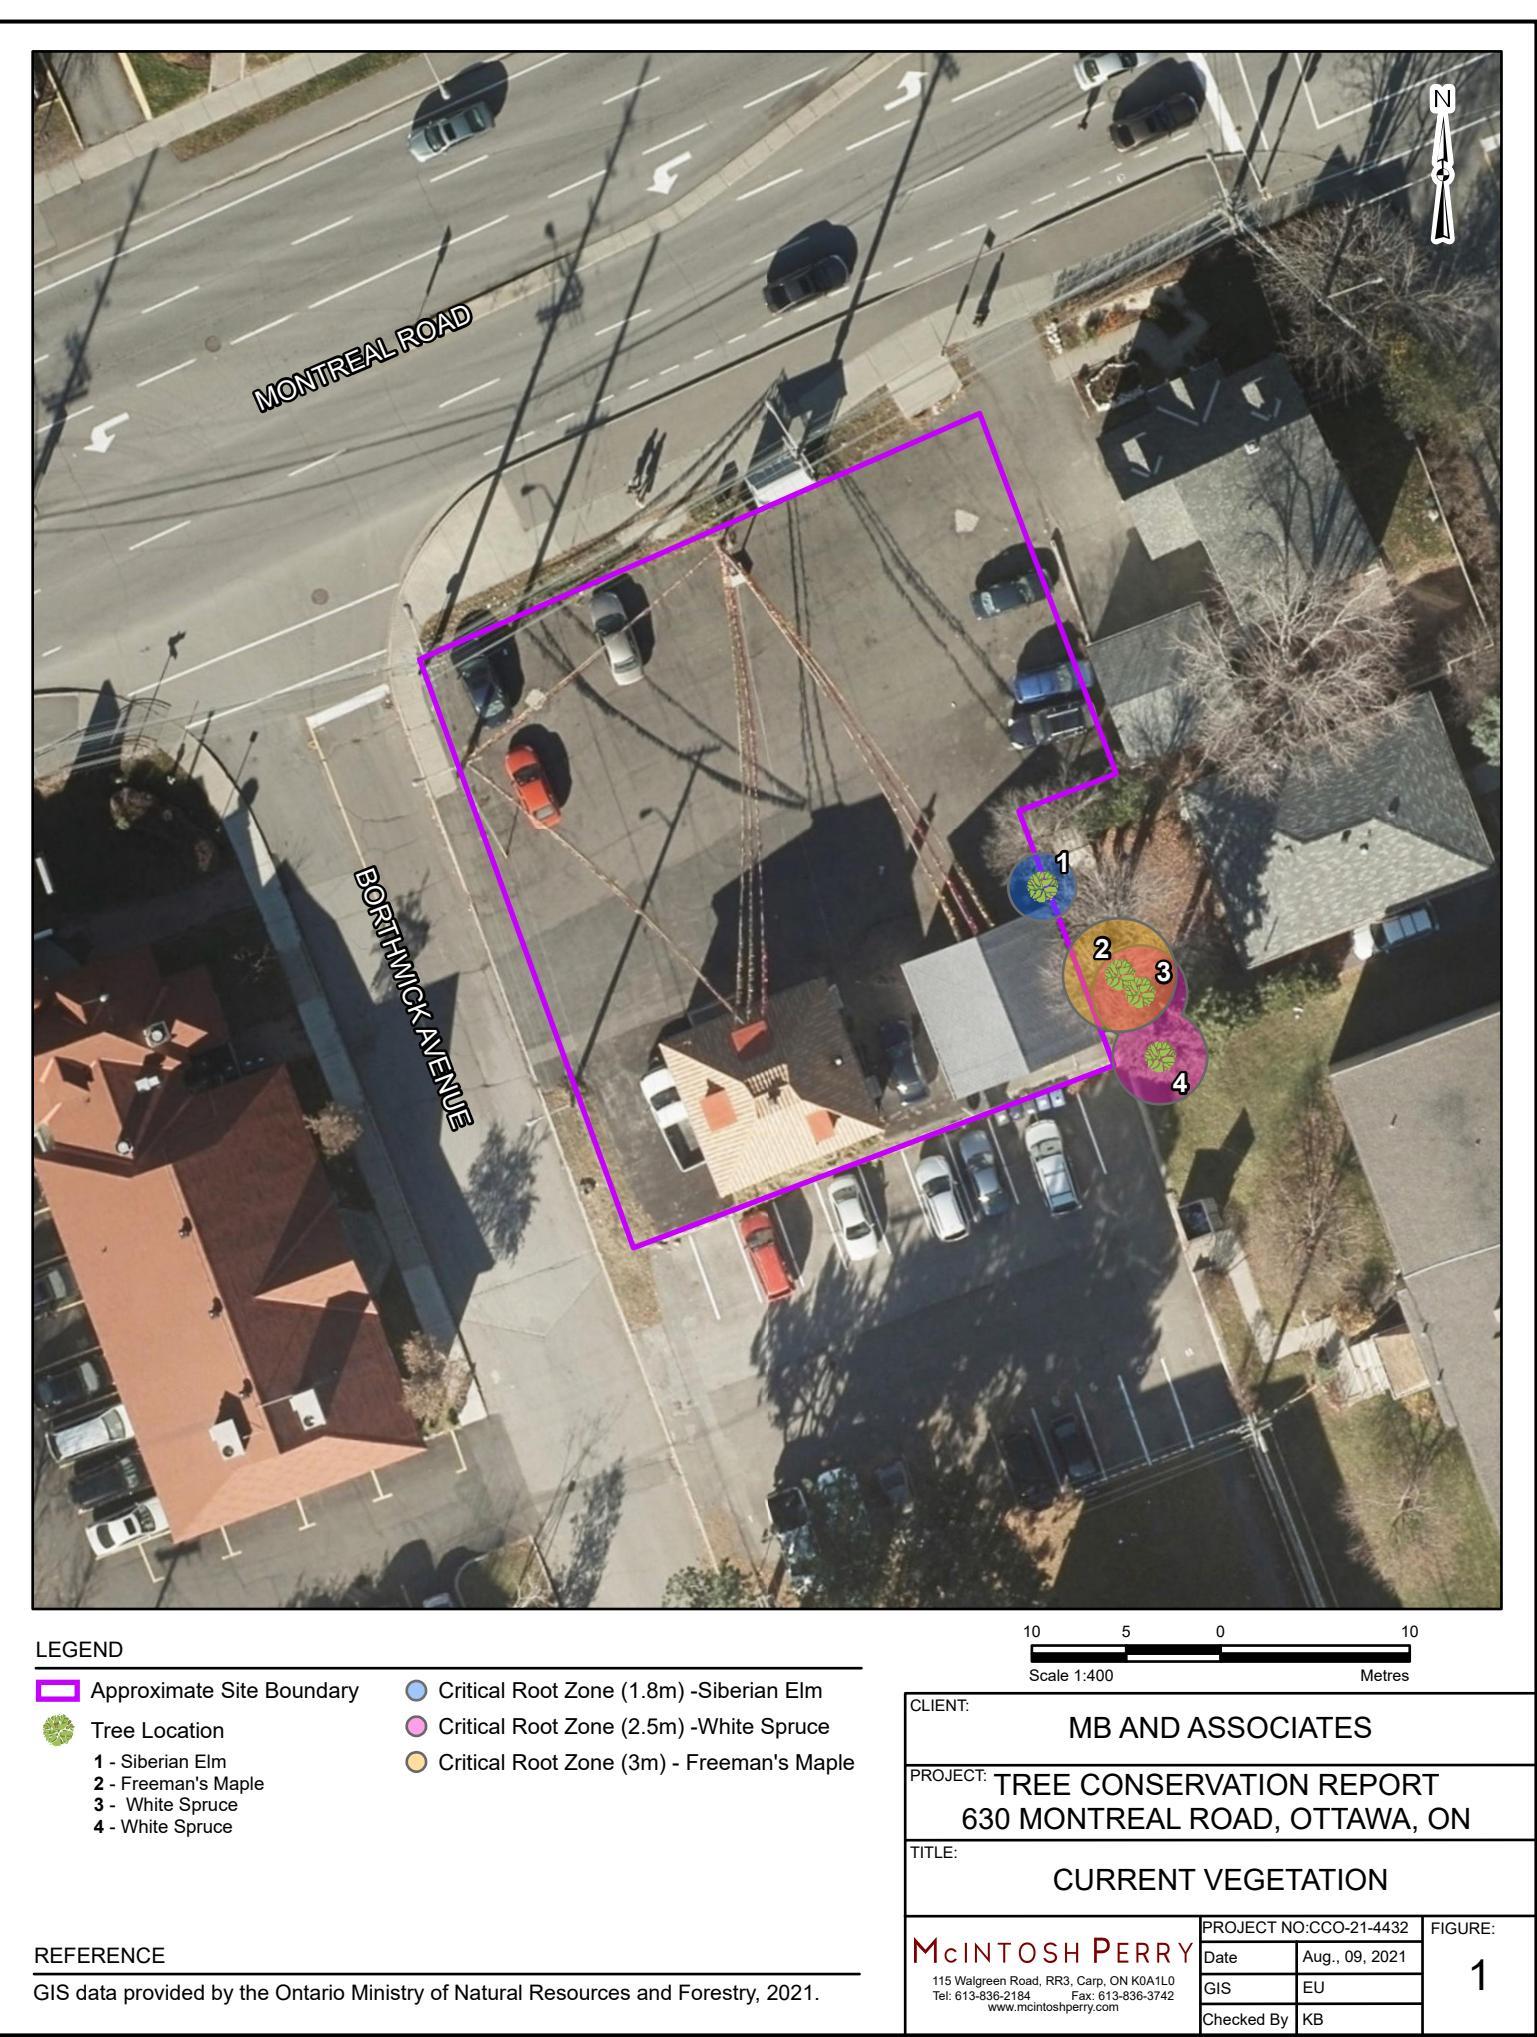
The tree inventory conducted for the subject property resulted in findings that there are no trees located within the property boundary; however, four (4) trees were identified and documented off-site that may be impacted by the proposed development (**Figure 1**). **Table 1** outlines the inventoried trees that are directly adjacent to the subject property.

The health status of the inventoried trees varied slightly, with Fair (2), Good (1), and Poor (1) ratings accounting for the inventoried trees. No dead trees were observed within the study area during the inventory and assessment. The study area is highly developed in nature, with few trees or natural vegetation found throughout the area.

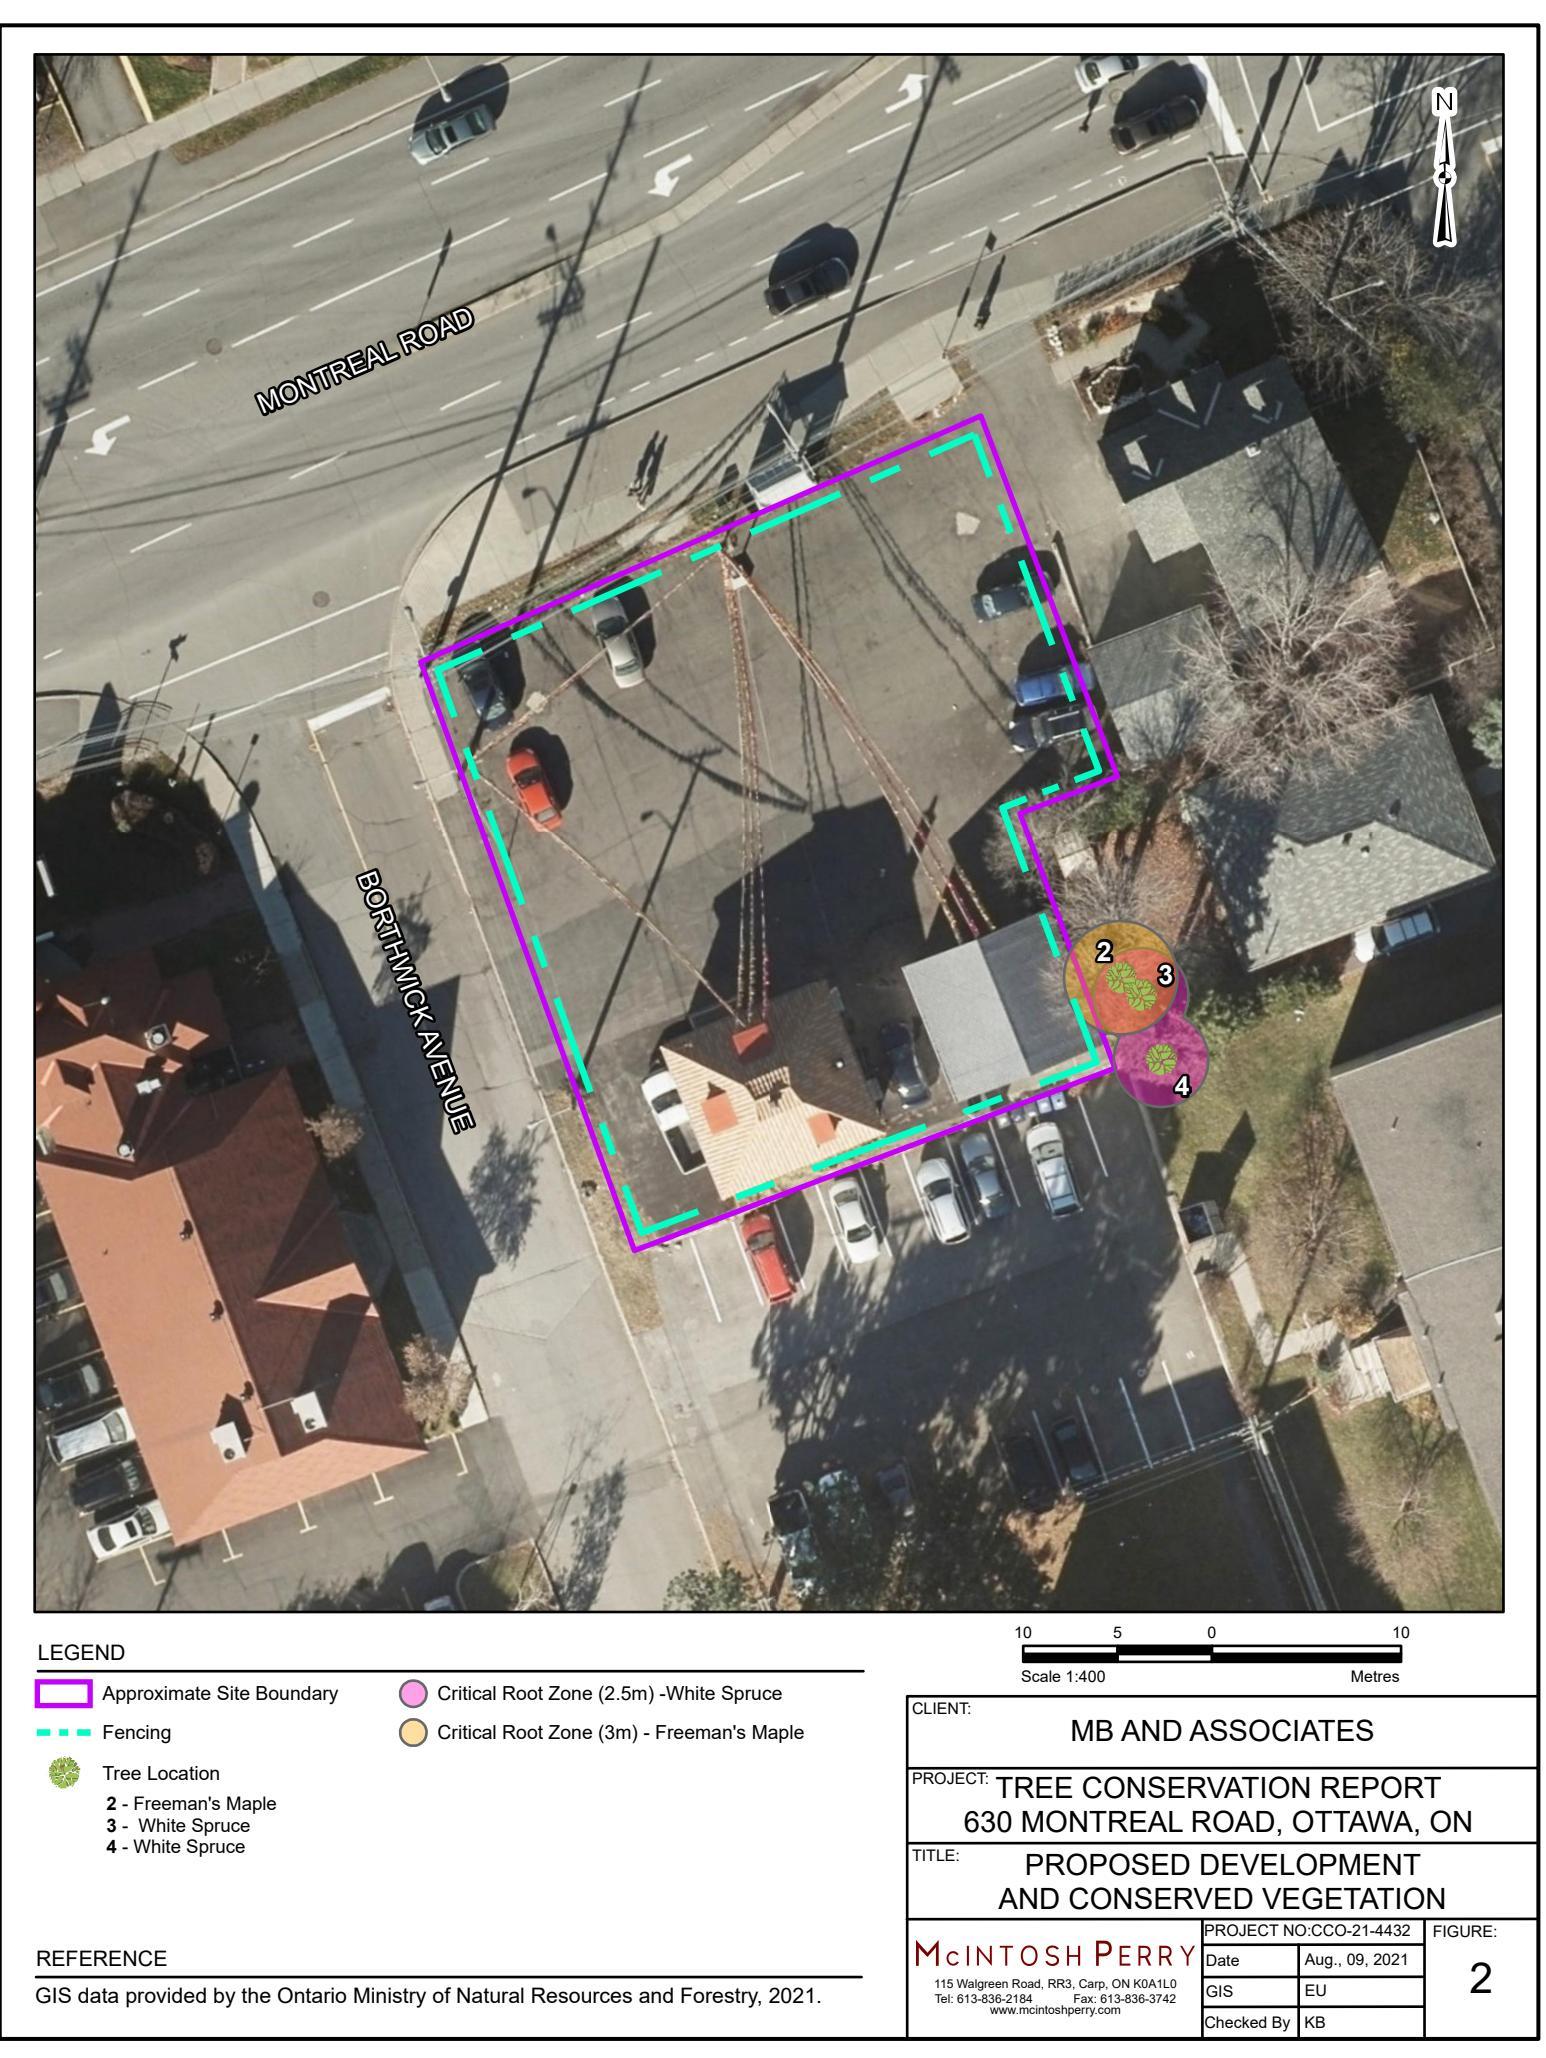
The proposed development will align closely to the original footprint of the subject property, resulting in a low impact to trees within the study area. There are no trees within the subject property; however, a single Siberian Elm, located off-site, directly adjacent to the subject property will be required to be removed (**Figure 2**). Siberian Elm is a non-native, invasive species. As this individual has grown, a portion of the tree has become intertwined with the boundary fence and the tree is in poor condition (see **Appendix A**).

The remaining trees (i.e. trees 2, 3, and 4) should be monitored over time. Care should be taken when removing the asphalt and existing fence and buildings on-site to avoid impacting these individual's critical root zones.

To ensure protection of the root system of trees to be retained, temporary tree protection fencing should be erected at the critical root zone of trees located inside or adjacent to the construction area. Temporary fencing is proposed surrounding the perimeter of the subject property (**Figure 2**) and will sufficiently protect the retained trees that are adjacent to the subject property.

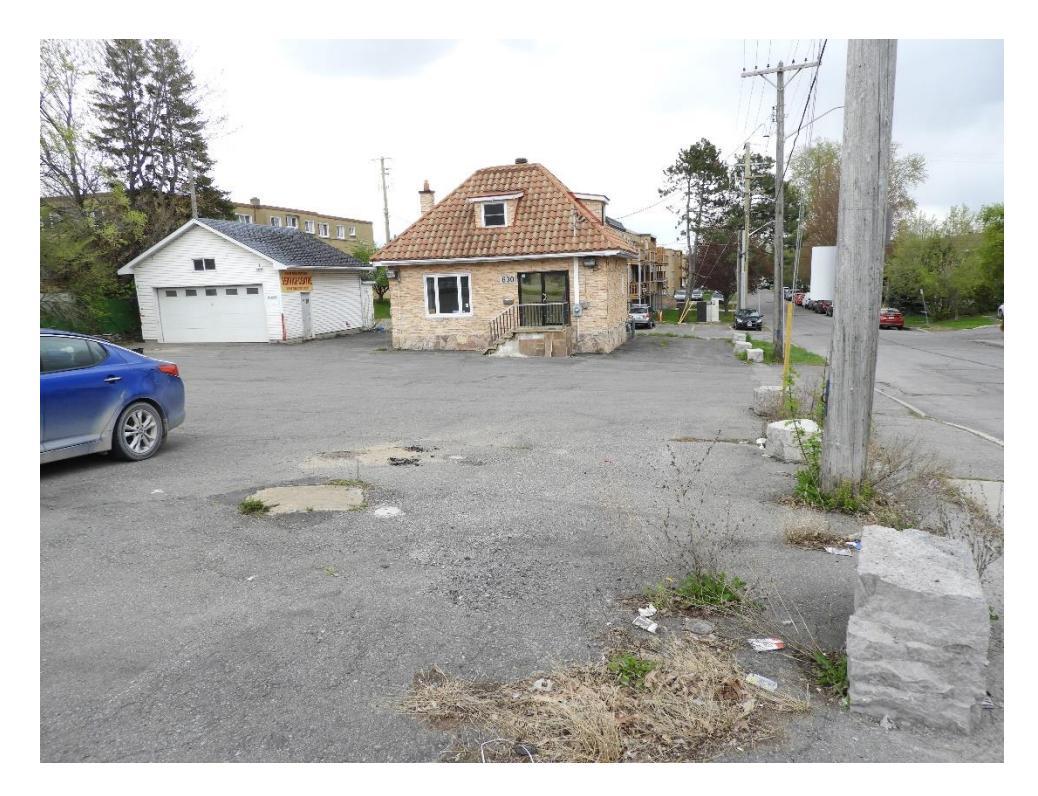
Photo 1: View of the subject property from the northwest corner facing south. May 7, 2021.

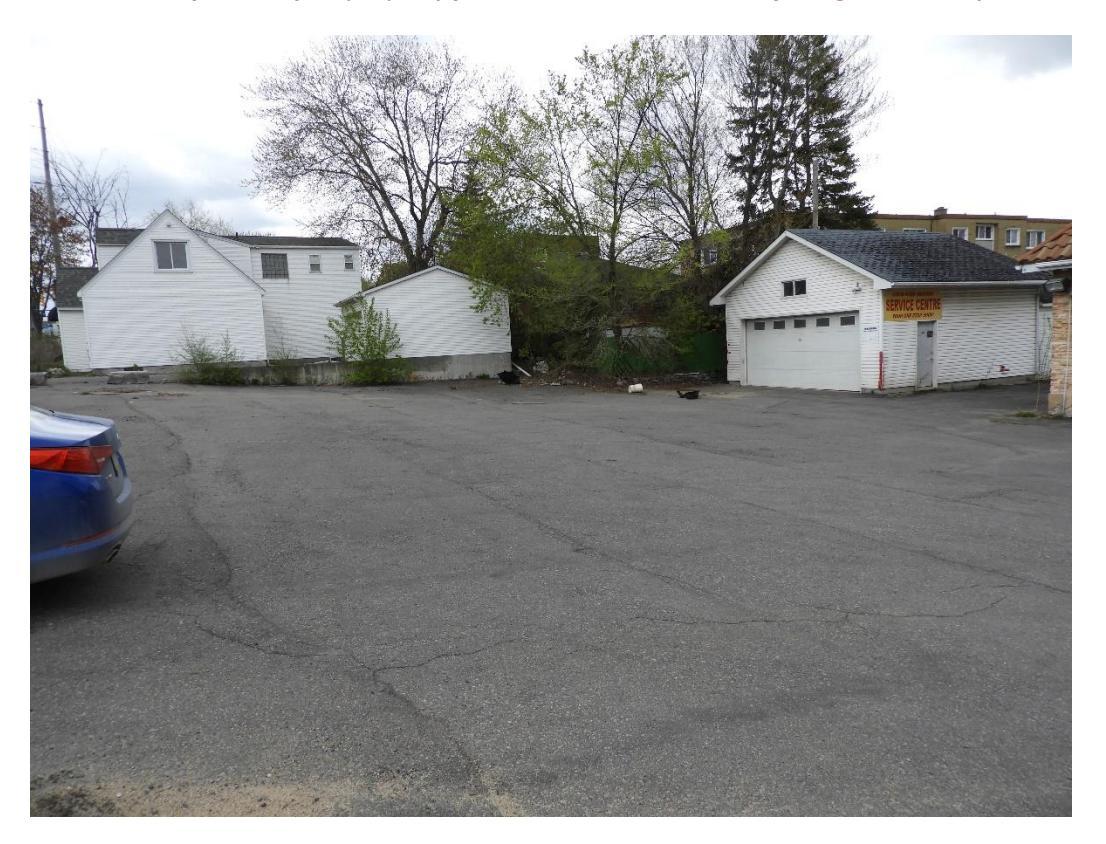
Photo 2: View of the subject property from the northwest corner facing southeast. May 7, 2021.

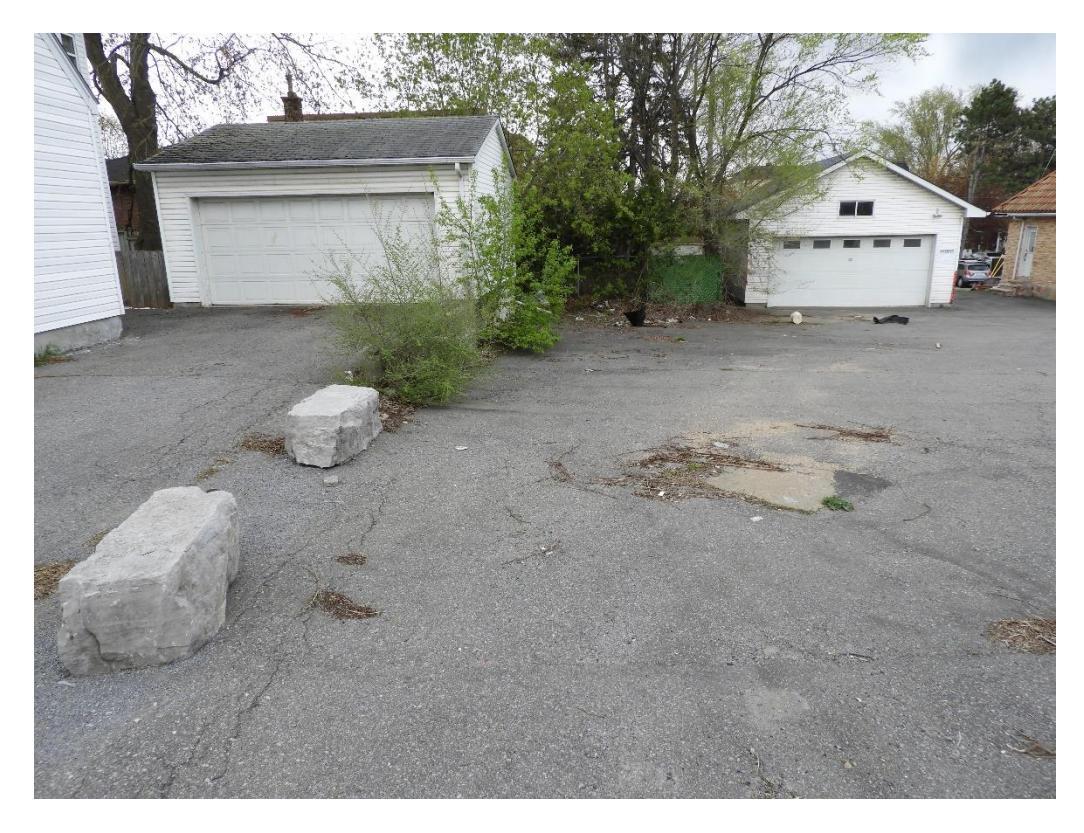
Photo 3: View of the subject property from the northeast corner facing south. May 7, 2021.

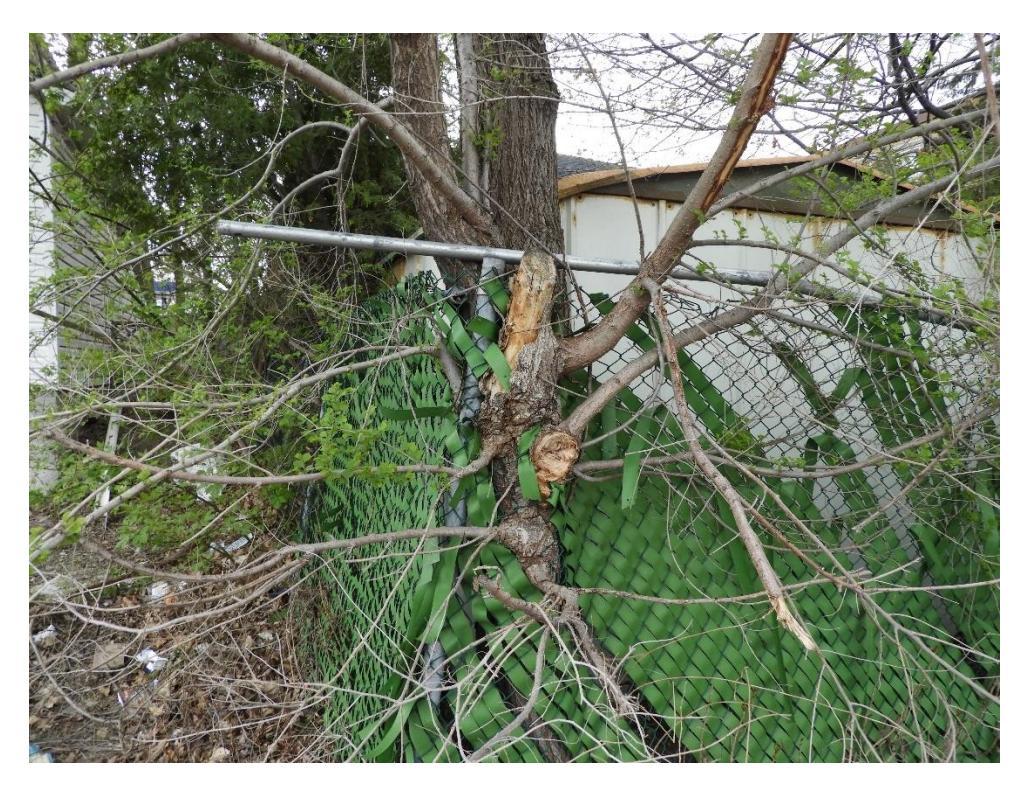
Photo 4: View of the Siberian Elm proposed for removal. May 7, 2021.

A single Siberian Elm (tree No. 1) is proposed for removal and is <30cm DBH; as such no compensation plantings or cash-in-lieu is proposed or required as per the City of Ottawa's Tree By-law (2020-340).

This individual tree is located off-site, directly adjacent to the subject property. In accordance with the City of Ottawa's Tree By-law (2020-340) written permission will be required from the landowner prior to approval for removal.
