# TREE CONSERVATION REPORT

Project No.: CCO-21-4432

630 MONTREAL ROAD, OTTAWA, ONTARIO

March 28, 2025

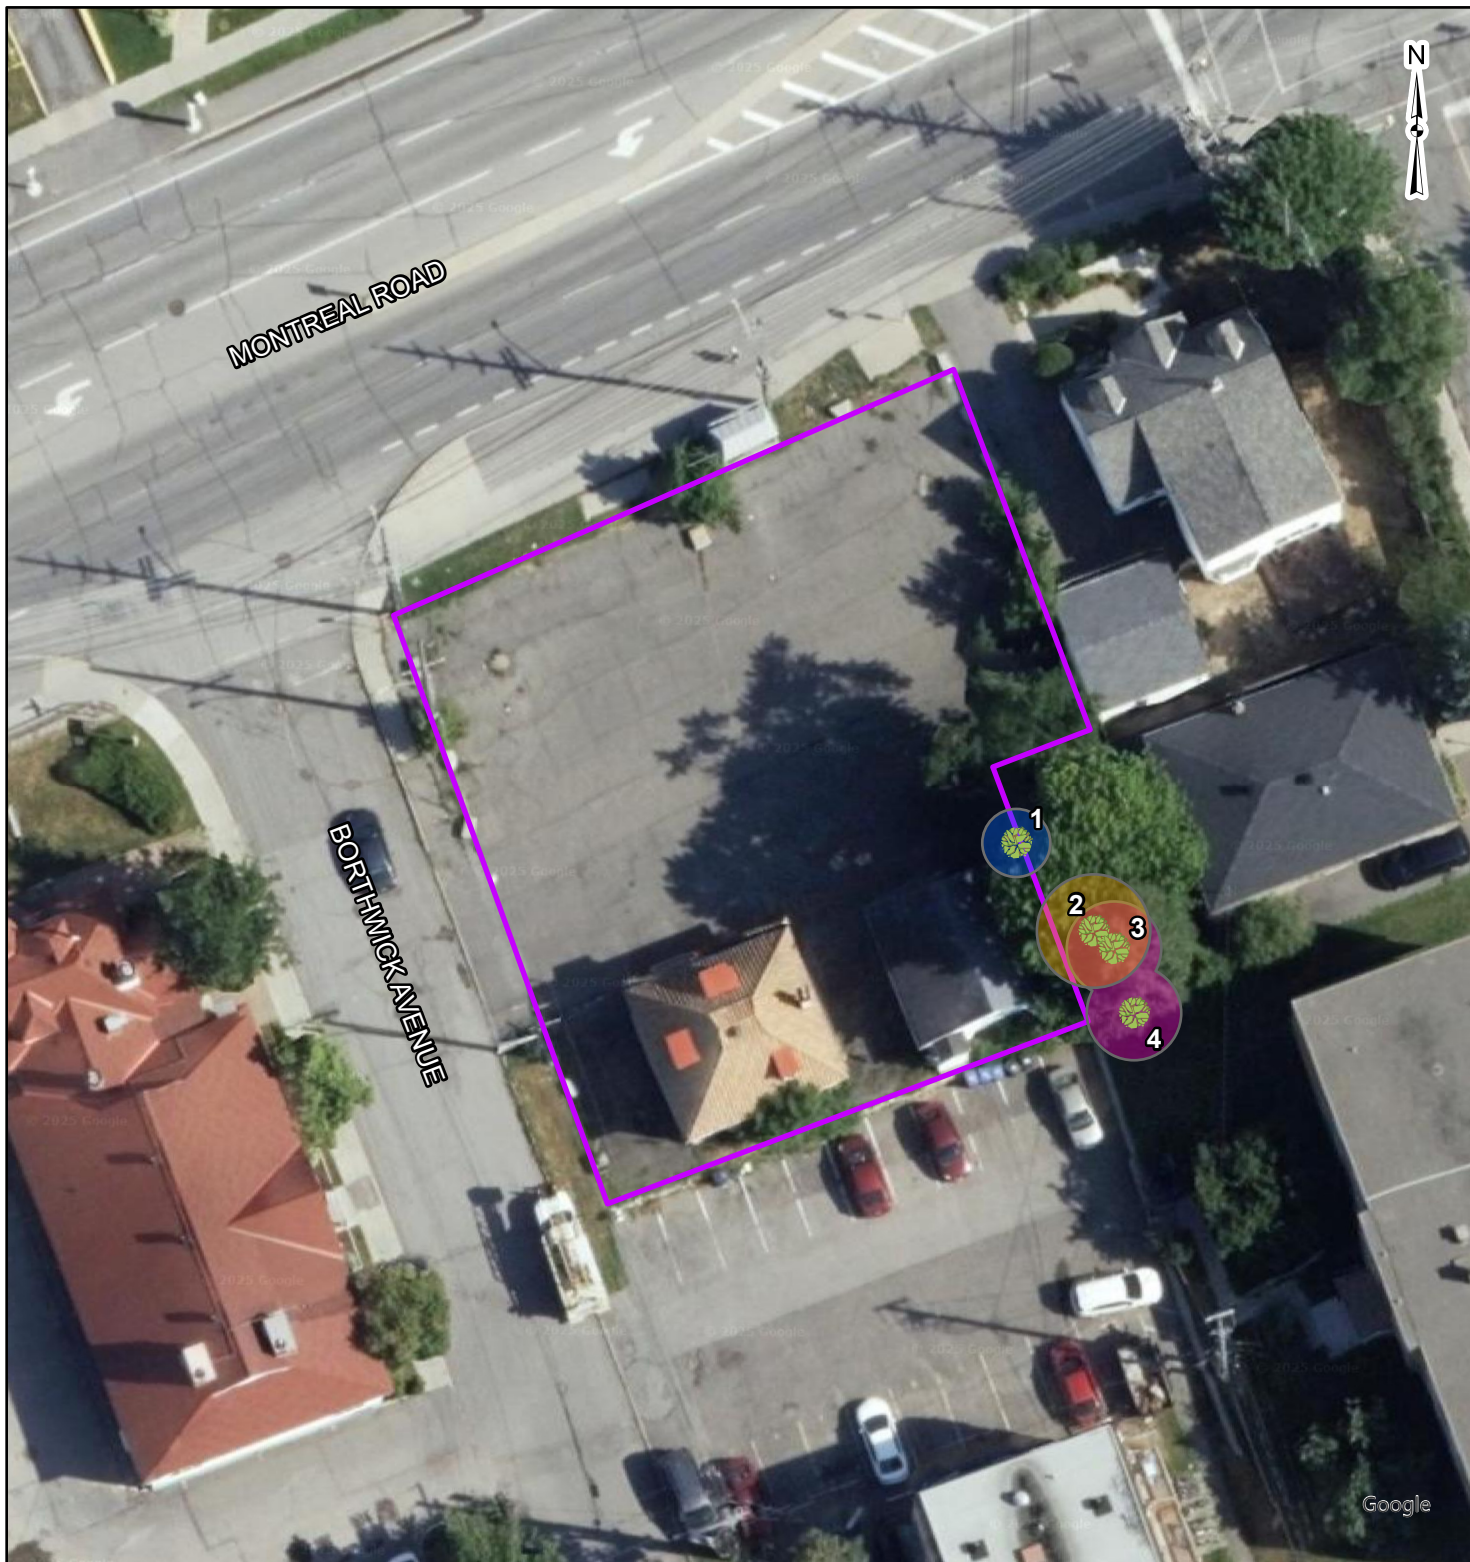
| TITLE: | | CURRENT VEGETATION | |

The tree inventory conducted for the subject property resulted in findings that there are no trees located within the property boundary; however, four (4) trees were identified and documented off-site that may be impacted by the proposed development (**Figure 1**).

The health status of the inventoried trees varied slightly, with Fair (2), Good (1), and Poor (1) ratings accounting for the inventoried trees. No dead trees were observed within the study area during the inventory and assessment. The study area is highly developed in nature, with few trees or natural vegetation found throughout the area.

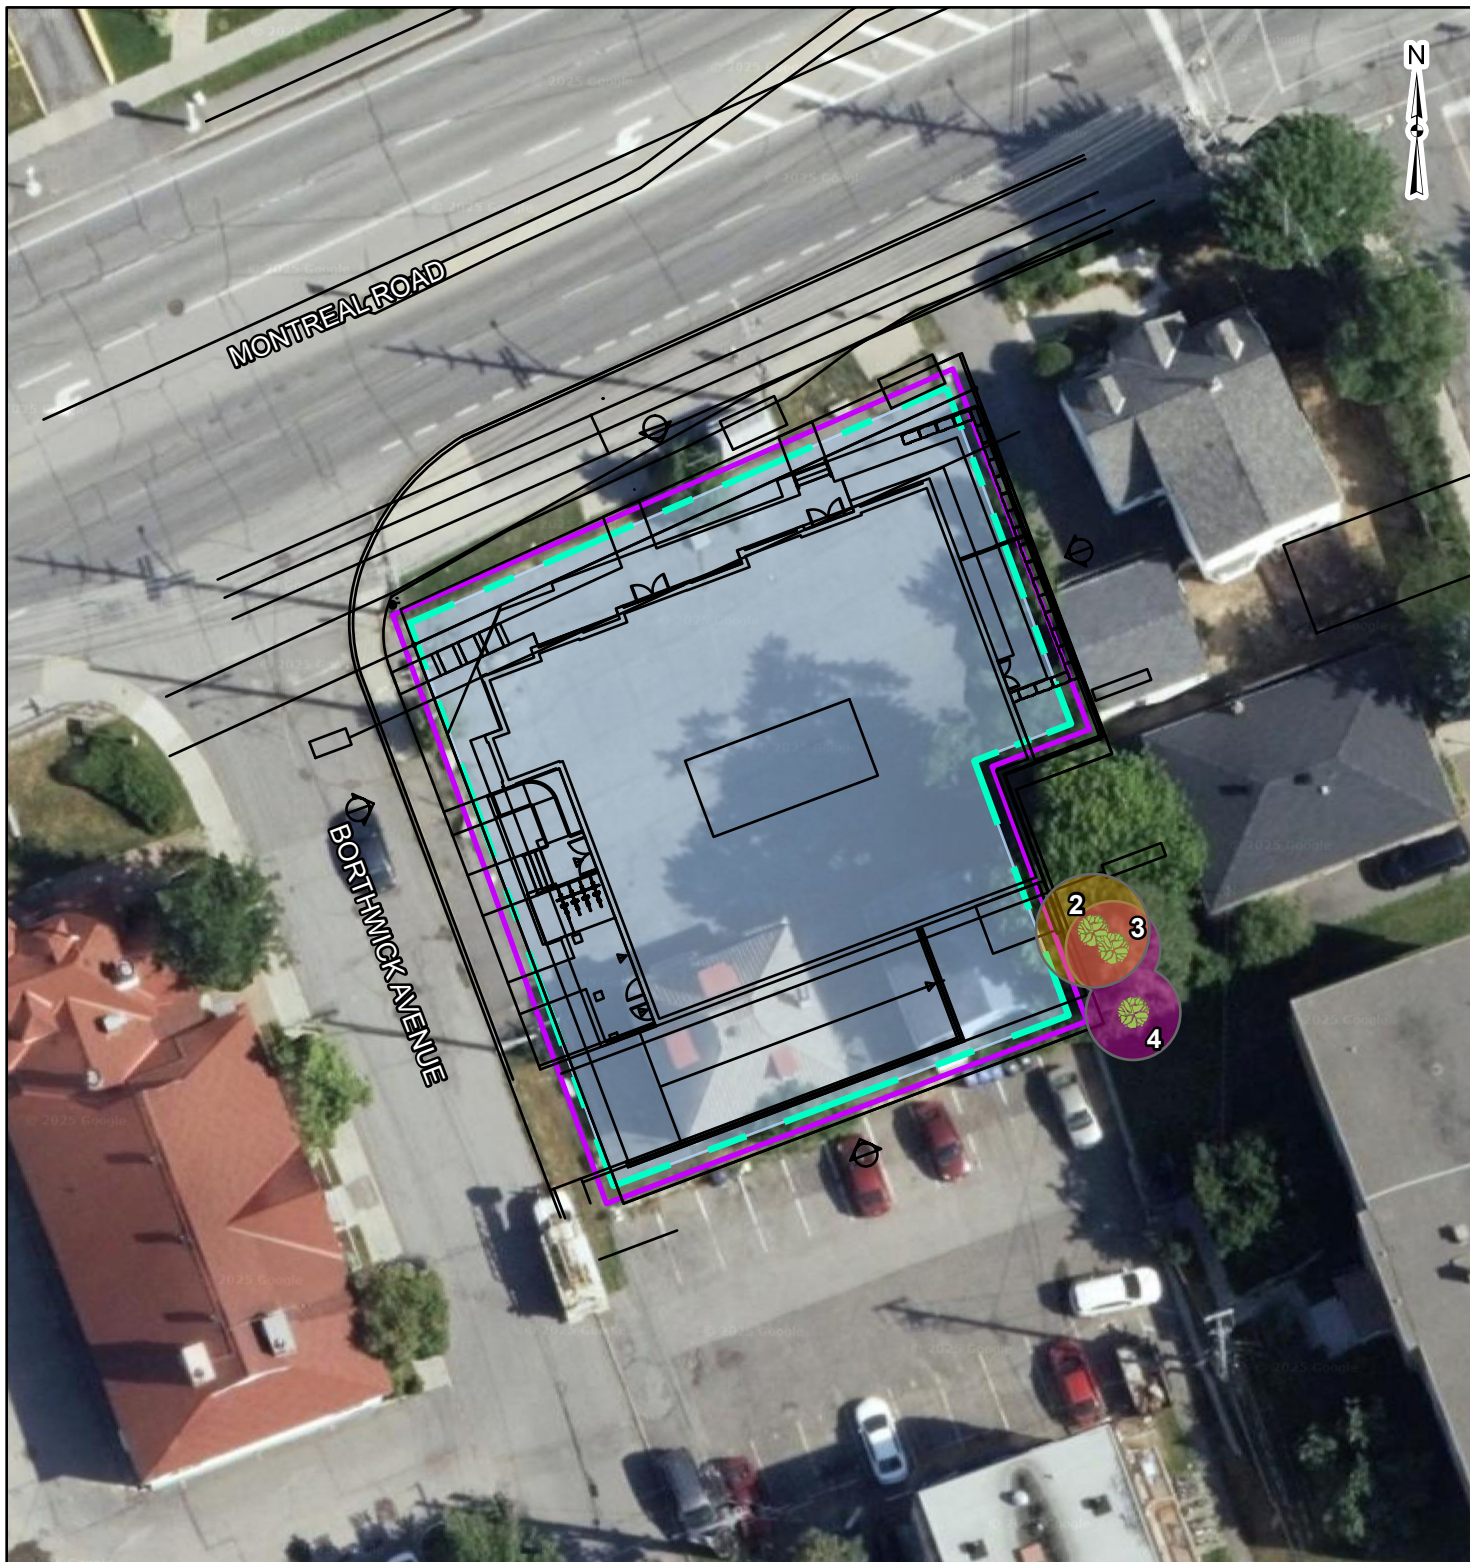
| TITLE: | | PROPOSED DEVELOPMENT<br>AND CONSERVED VEGETATION | |

The proposed development will align closely to the original footprint of the subject property, resulting in a low impact to trees within the study area. There are no trees within the subject property; however, a single Siberian Elm, located off-site, directly adjacent to the subject property will be required to be removed (*Refer to Figure 2*). Siberian Elm is a non-native, invasive species. As this individual has grown, a portion of the tree has become intertwined with the boundary fence and the tree is in poor condition (see **APPENDIX A**).

The remaining trees (i.e. trees 2, 3, and 4) should be monitored over time. A qualified professional, such as an arborist or equally qualified individual, shall be obtained by the contractor to monitor the health of the adjacent property trees during construction.

Care should be taken when removing the asphalt and existing fence and buildings on-site to avoid impacting these individual's critical root zones. Pavement overlapping with the CRZ of tree 2 will be done without the use of machinery.

To ensure protection of the root system of trees to be retained, temporary tree protection fencing should be erected at the critical root zone of trees located inside or adjacent to the construction area. Temporary fencing is proposed surrounding the perimeter of the subject property **Figure 2** and will sufficiently protect the retained trees that are adjacent to the subject property.

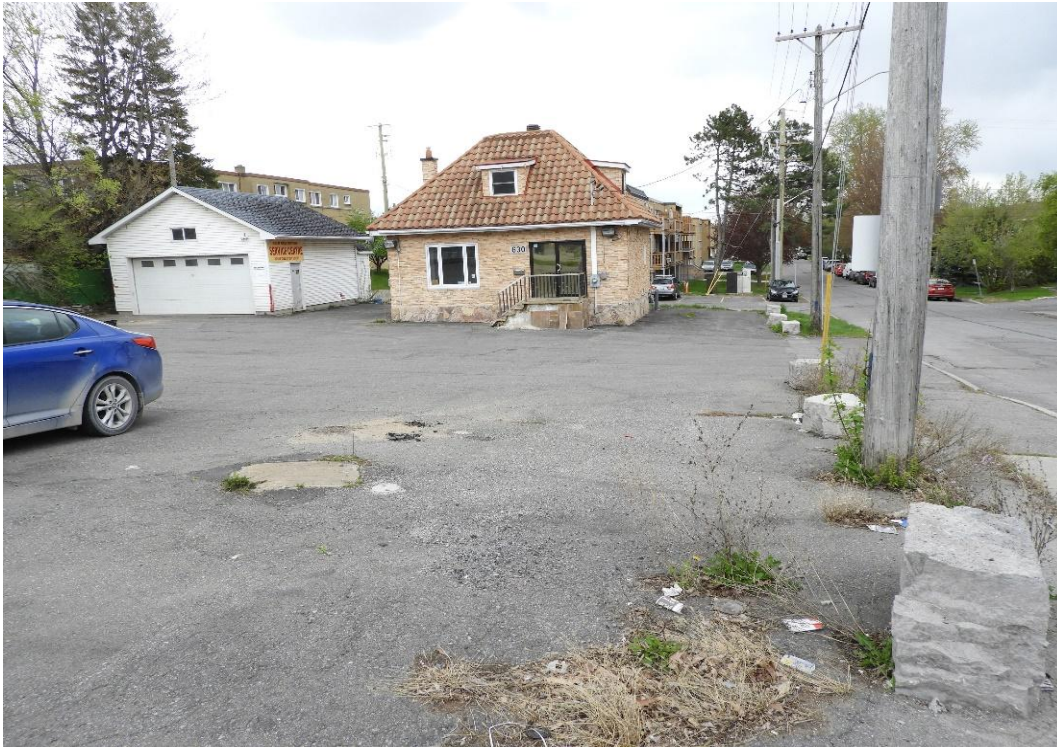
*Photo 1: View of the Subject Property from the Northwest Corner Facing South. (May 7, 2021)*

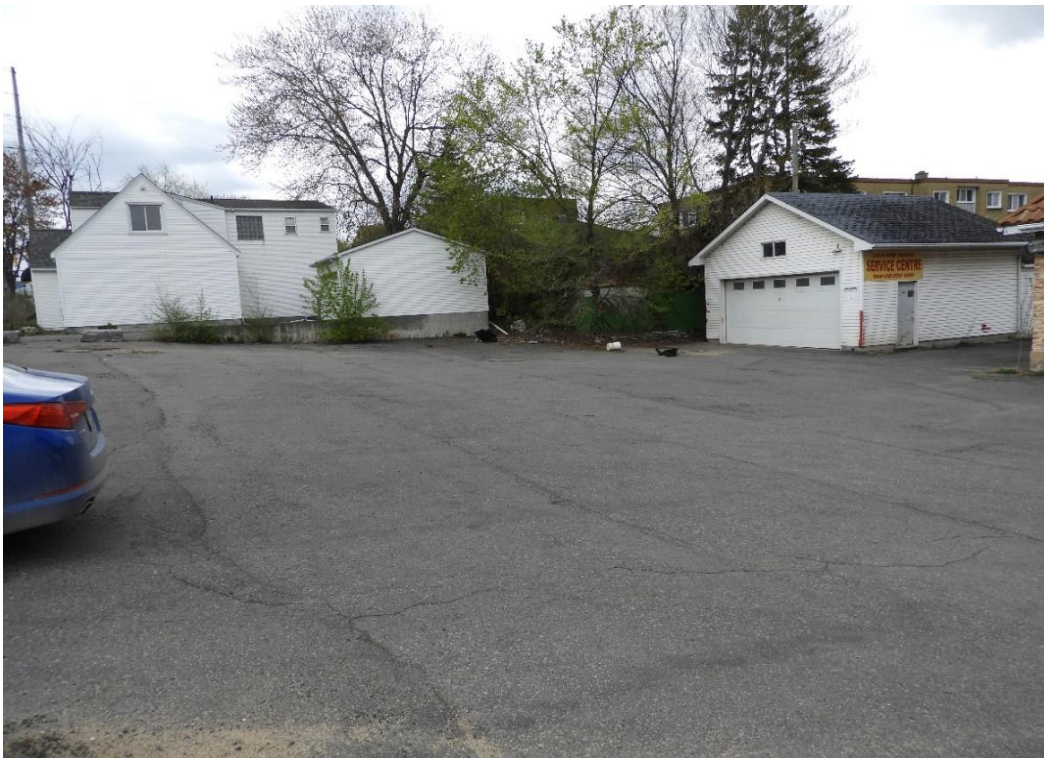
*Photo 2: View of the Subject Property from the Northwest Corner Facing Southeast. (May 7, 2021)*

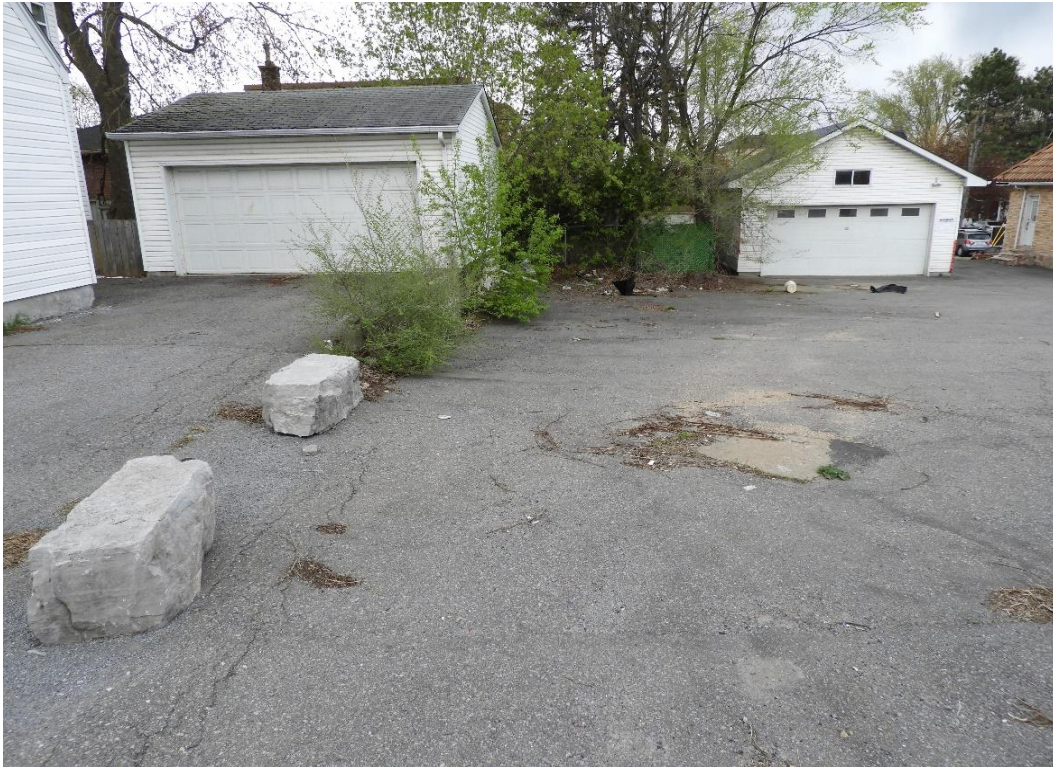
*Photo 3: View of the Subject Property from the Northeast Corner Facing South. (May 7, 2021)*

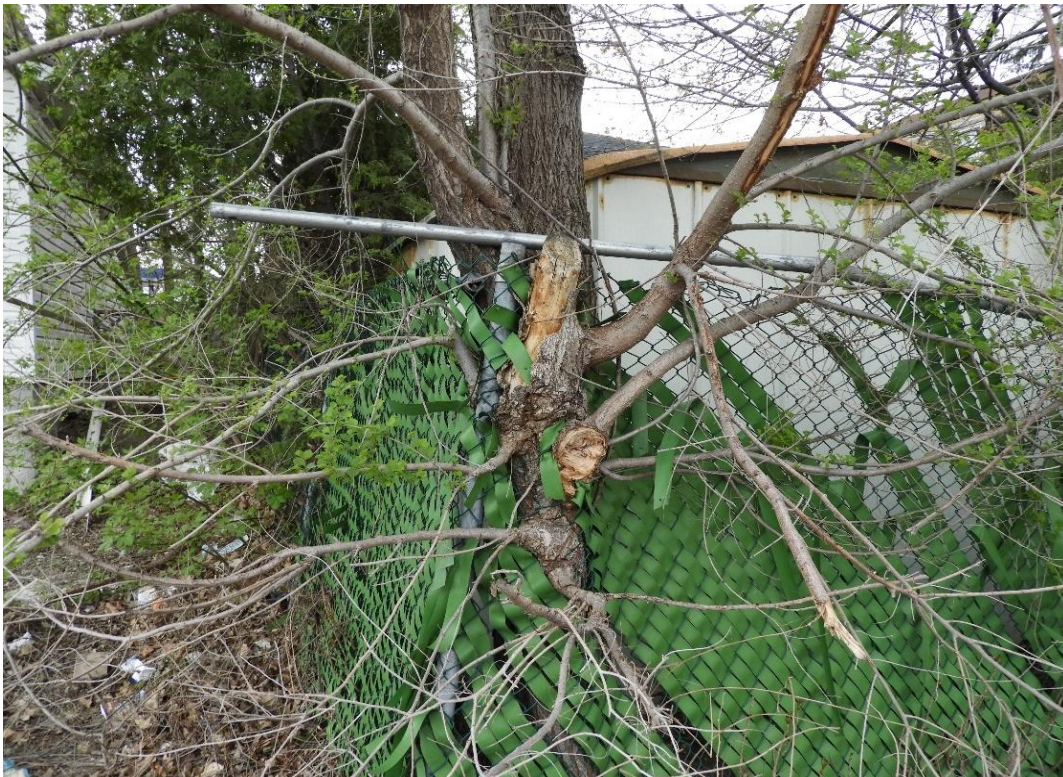
*Photo 4: View of the Siberian Elm Proposed for Removal. (May 7, 2021)*

A single Siberian Elm (tree No. 1) is proposed for removal and is <30cm DBH; as such no compensation plantings or cash-in-lieu is proposed or required as per the City of Ottawa's Tree By-law (2020-340).

This individual tree is located off-site, directly adjacent to the subject property. In accordance with the City of Ottawa's Tree By-law (2020-340) written permission will be required from the landowner prior to approval for removal.
