URBAN FORESTRY & FOREST MANAGEMENT CONSULTING

November 12, 2021

RE: TREE CONSERVATION REPORT FOR 2 ROBINSON AVENUE, OTTAWA

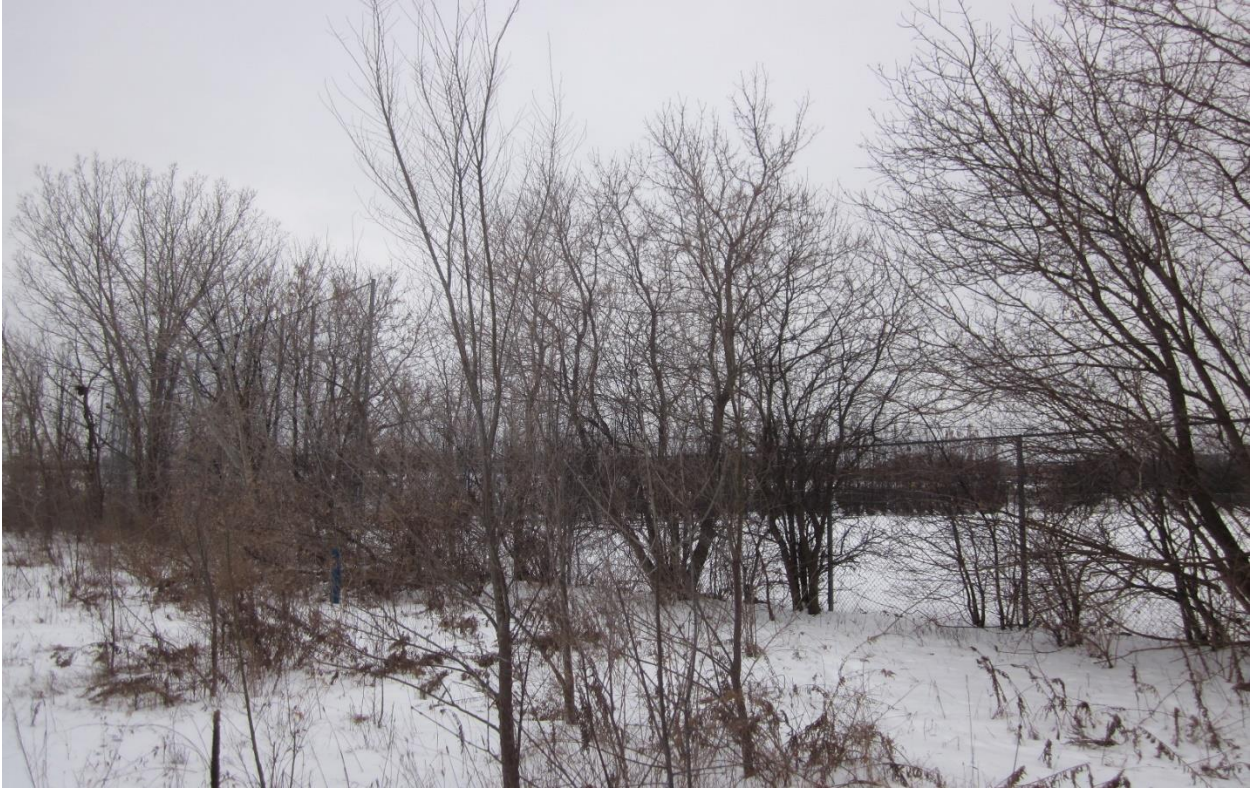
Picture 3. Seeded Siberian elms and Manitoba maples at 2 Robinson Avenue

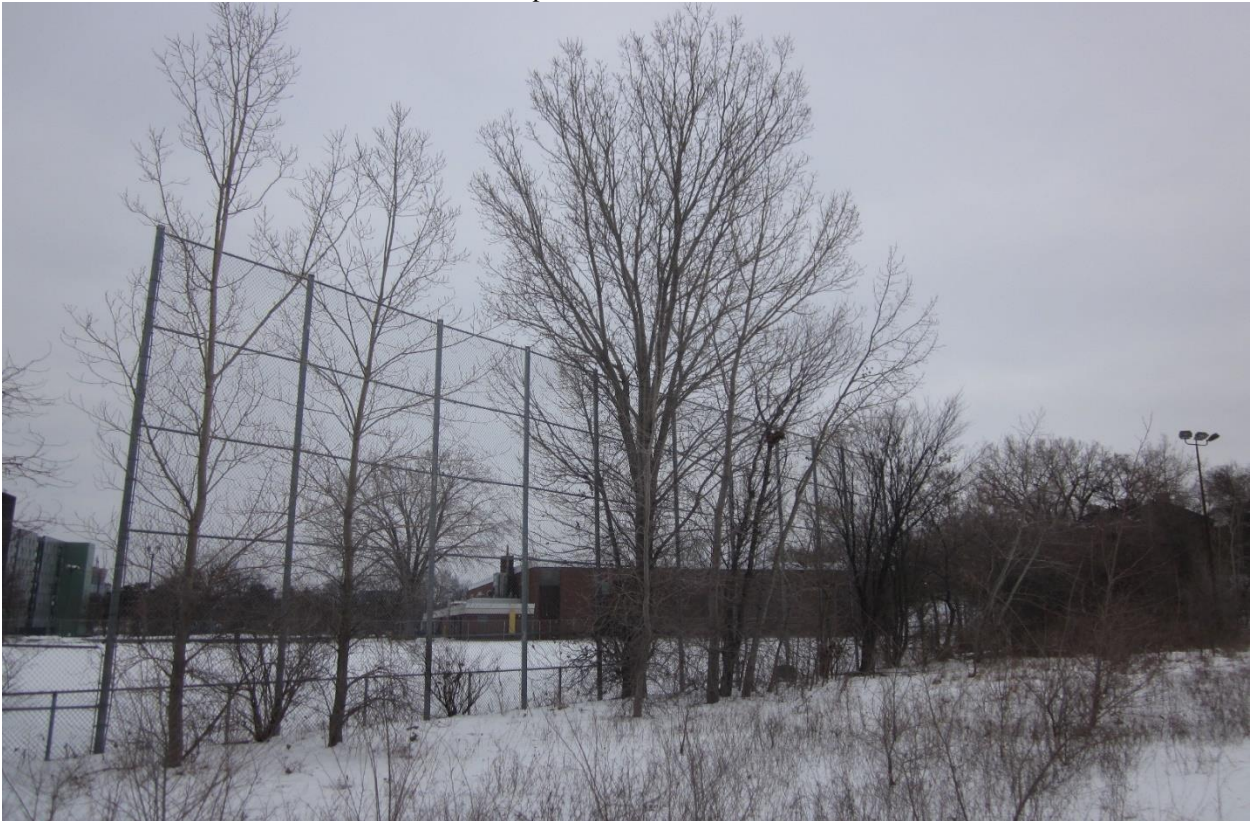
Picture 4. Poplars along western property line of 2 Robinson Avenue

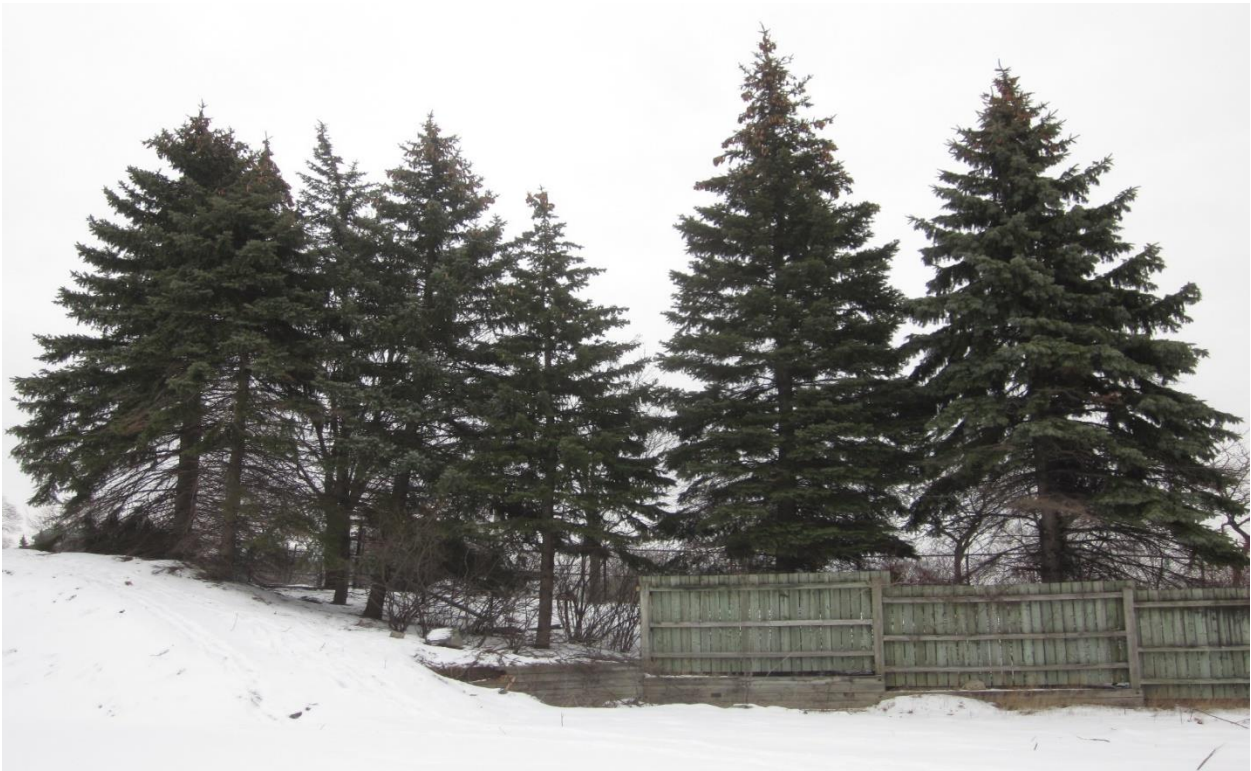
Picture 5. Planted grouping of Colorado spruce at 2 Robinson Avenue

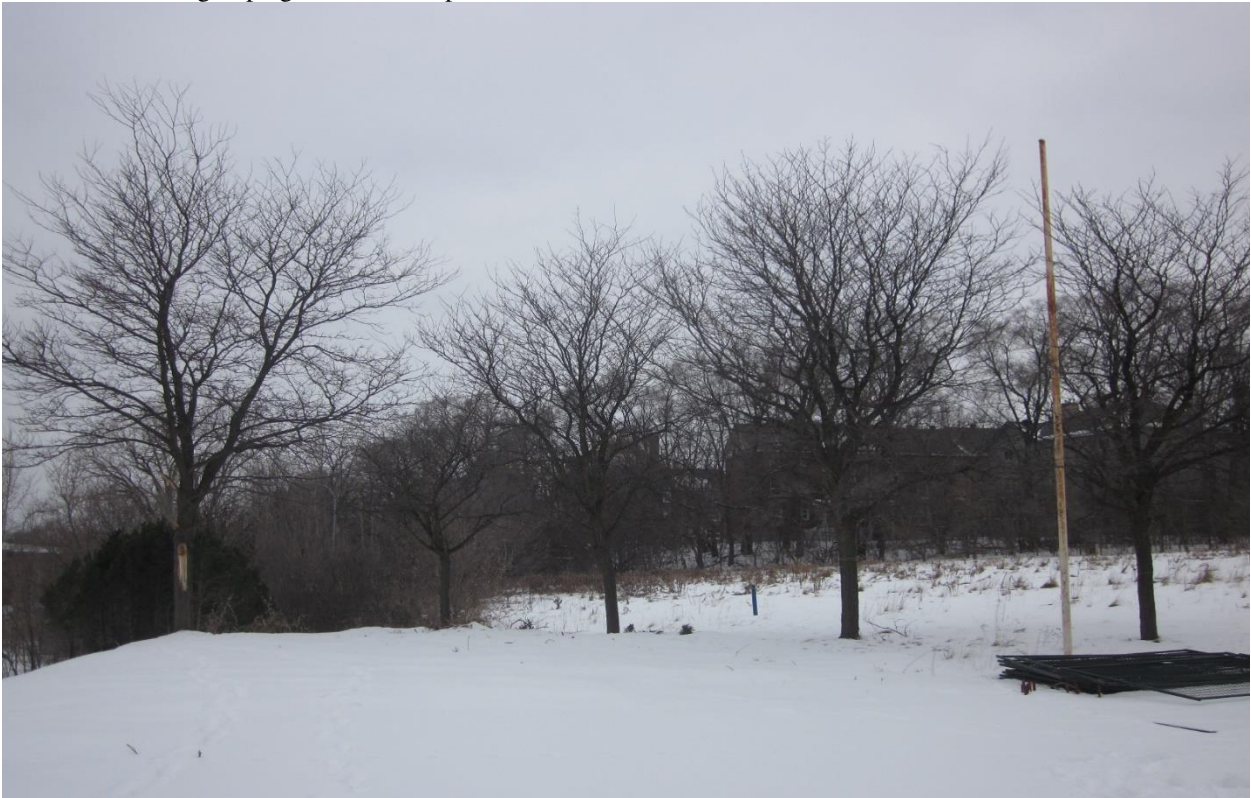
Picture 6. Line of planted honey-locust at 2 Robinson Avenue
