TREE CONSERVATION REPORT V2.0

109-115 Dalhousie

Tree Conservation Report submitted as Partial
Requirements for a Site Plan Control Application,
February 16, 2022

Dendron Forestry Services

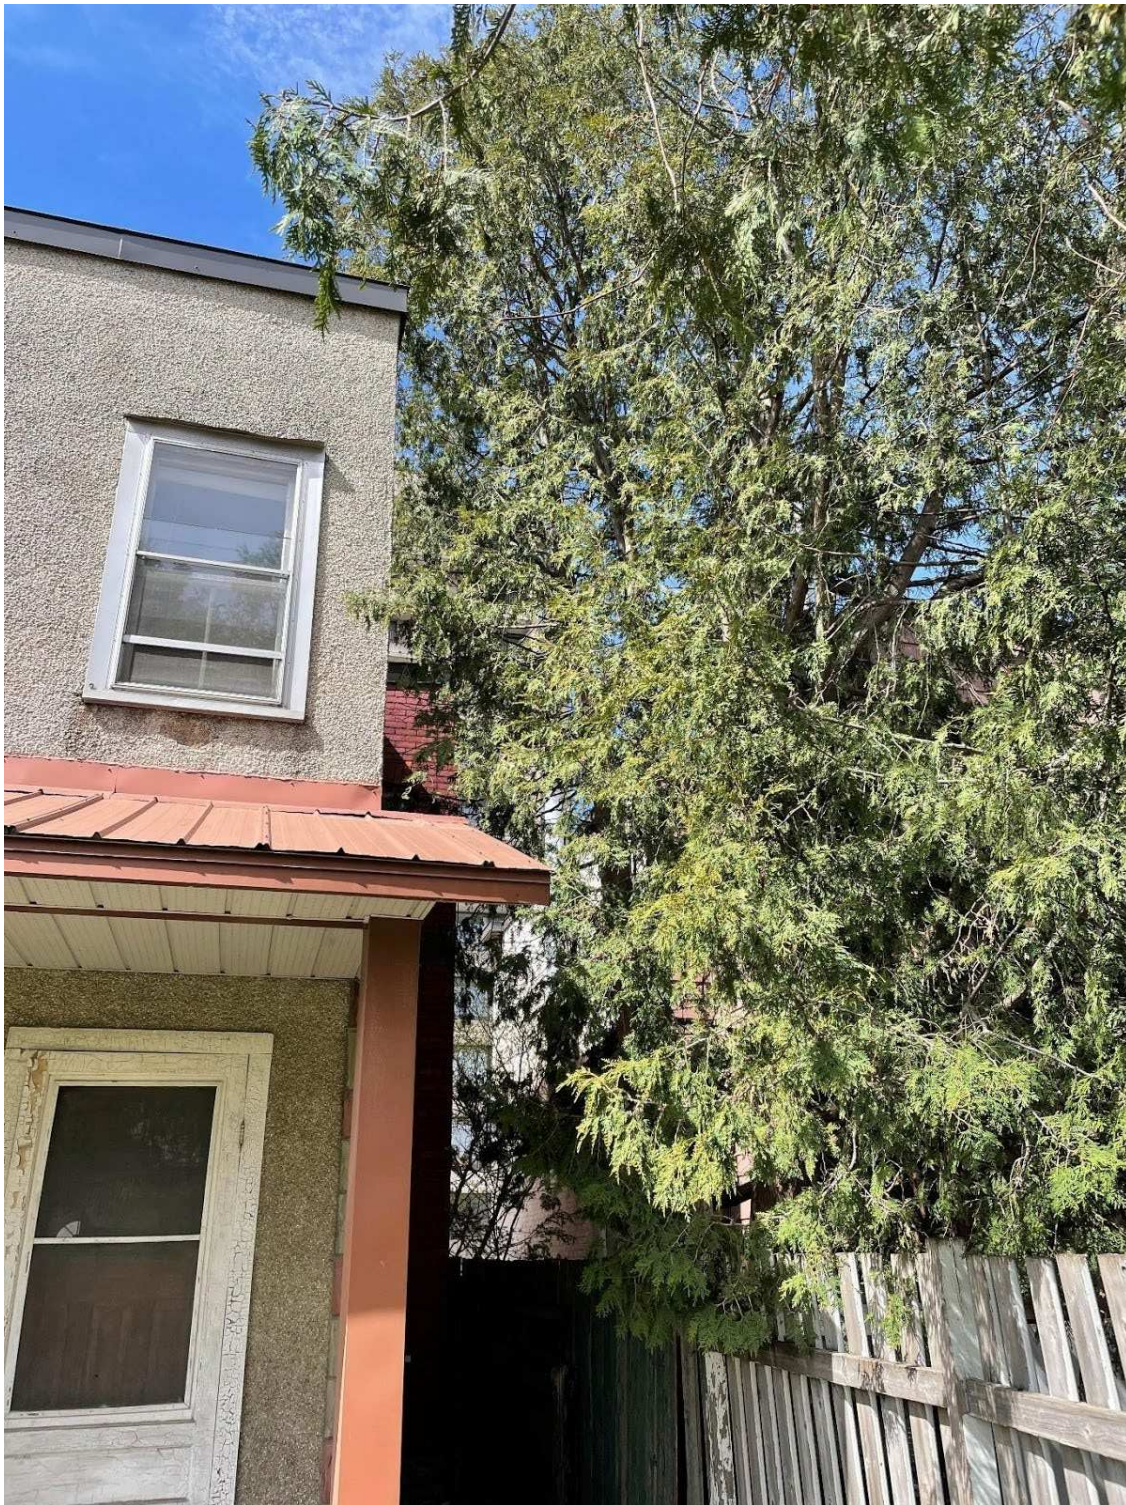
Tree 1, an eastern white cedar, located on adjacent property is in good health. However, the proposed development will involve severing some of the roots, possibly impacting the structural integrity of the tree. If the excavation in this area cannot be limited to at least 1 m from the edge of the tree, then removal is recommended. The two trunks are situated 25 and 40 cm from the current fence. If the tree is retained, an onsite inspection by an arborist to assess stability during excavation is recommended. Alternatively, the roots can be severed prior to excavation by an arborist using an airspade, at which time, an assessment on potential stability can be made. Pruning of the crown is also required to

Figure 1: Tree 1, eastern white cedar on adjacent property to be retained

accommodate the scaffolding while the new building is under construction. If excavation cannot be reduced to 1 m from the tree trunk, then removal is the recommended option. Since this tree is entirely on adjacent property, permission from the neighbour would be required for removal.

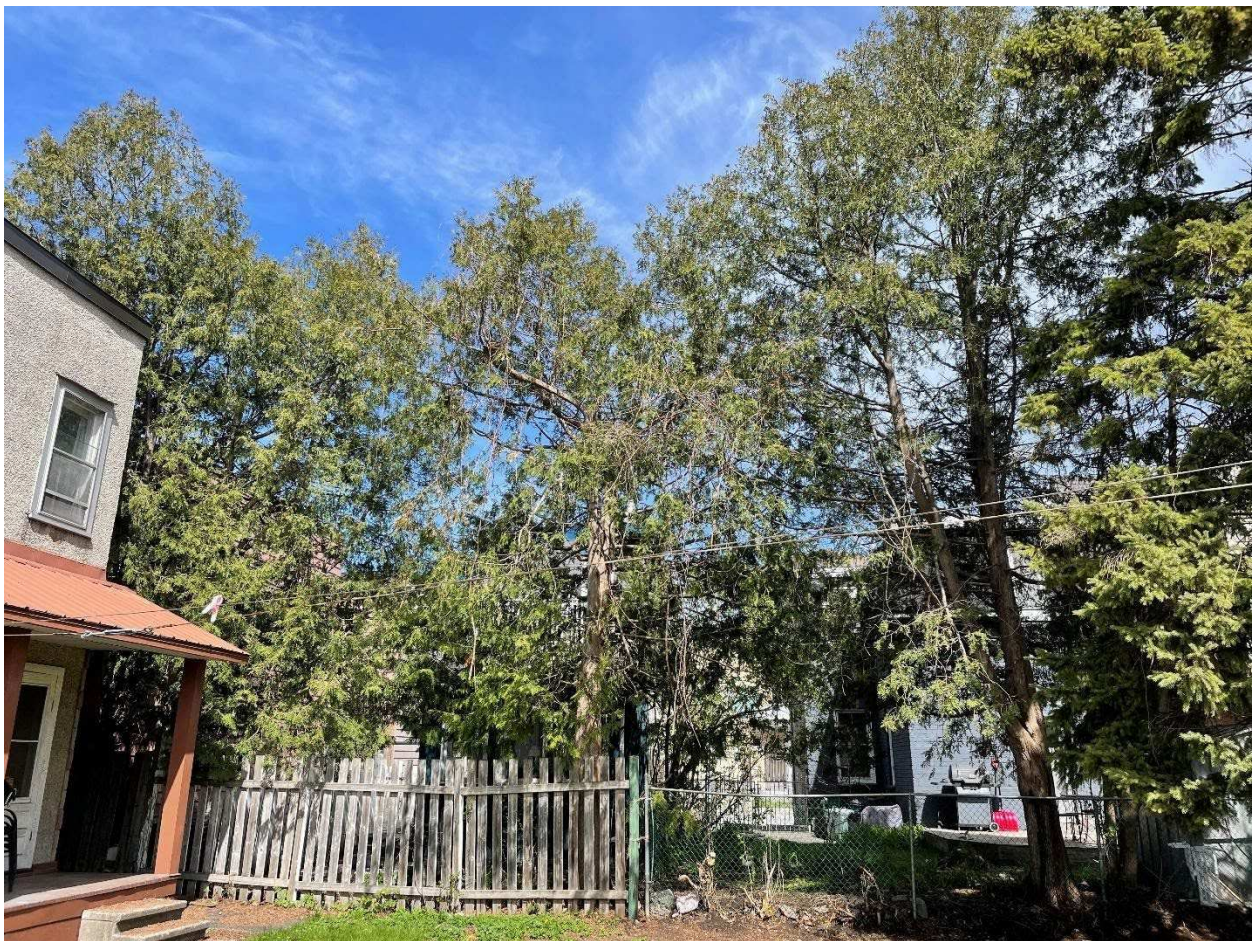
Tree 2 is in fair health due to the loss of its tops and will be within the area of excavation – removal is recommended. Although tree 3 is slightly further away, there will be some impact to the tree through severing of the roots from the excavation. The main stem of this tree has a large stem attached to the base of the trunk that is at risk of failure. The preferred option by the client is to retain this tree, but it should be monitored through construction for signs of failure. Some of the smaller stems close to this tree may be retained, but they are being suppressed by tree 4, and combined with the stress of the excavation, are not ideal candidates for retention.

Figure 2: Trees 1 (left), 2 (middle), 3 (right), all eastern white cedar
