May 29, 2023

RE: TREE CONSERVATION REPORT FOR 3447 OLD ALMONTE ROAD, OTTAWA (CORKERY COMMUNITY CENTRE)

Table 1. Species, diameter, condition and status of trees at 3447 Old Almonte Road

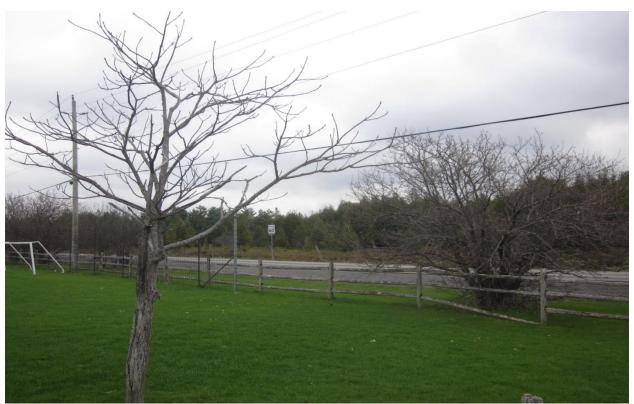
Picture 1. Trees #1 and 2 (right to left), apple and planted butternut trees at 3447 Old Almonte Road

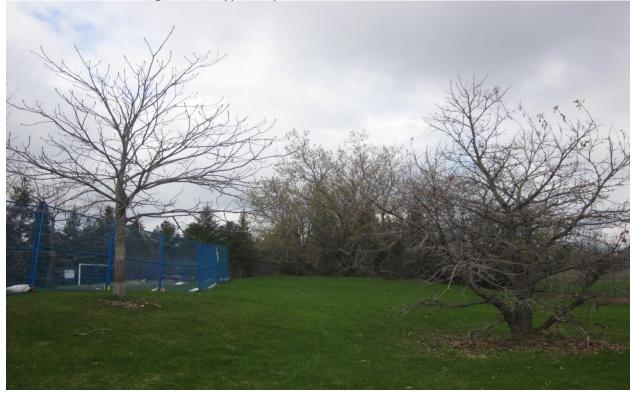
Picture 2. Trees #5 and 6 (right to left), oak and planted butternut trees at 3447 Old Almonte Road

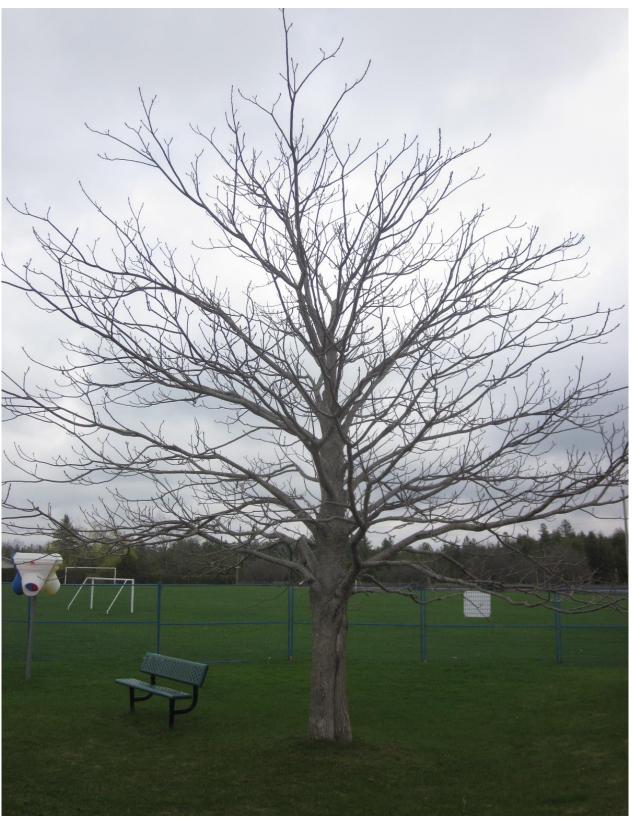
Picture 3. Tree #4, planted butternut at 3447 Old Almonte Road

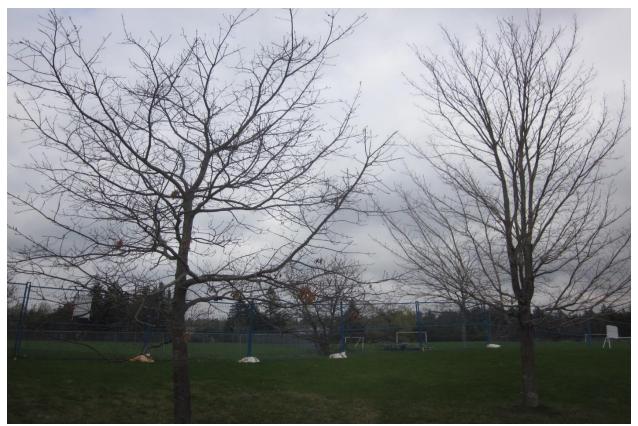
Picture 4. Trees #7 and 8 (right to left), maple and oak trees at 3447 Old Almonte Road

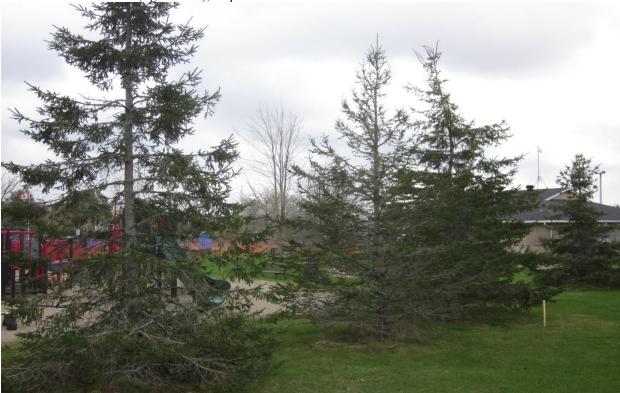
Picture 5. Trees #9-13, line of white spruce at 3447 Old Almonte Road

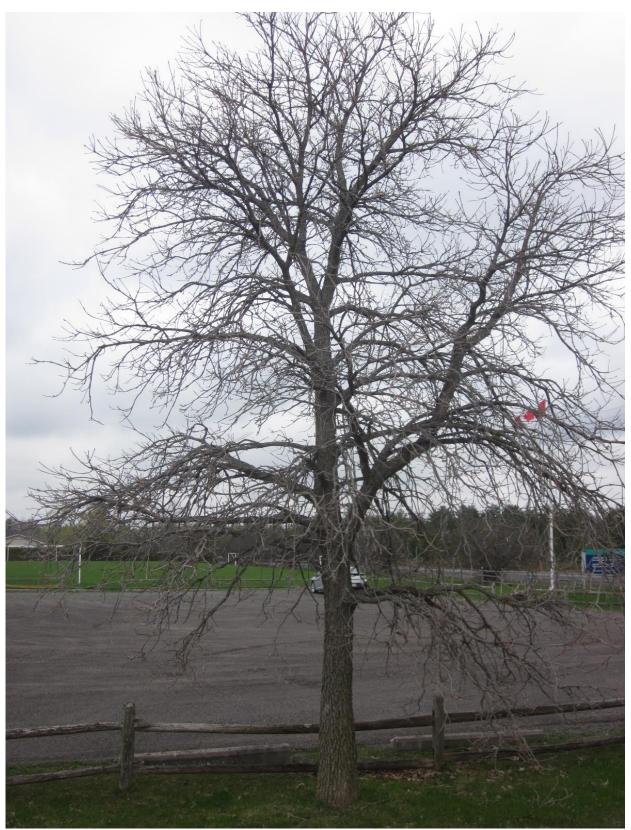
Picture 6. Tree #15, bur oak at 3447 Old Almonte Road
