May 18, 2022

RE: TREE CONSERVATION REPORT FOR 1209 ST. LAURENT BOULEVARD, OTTAWA

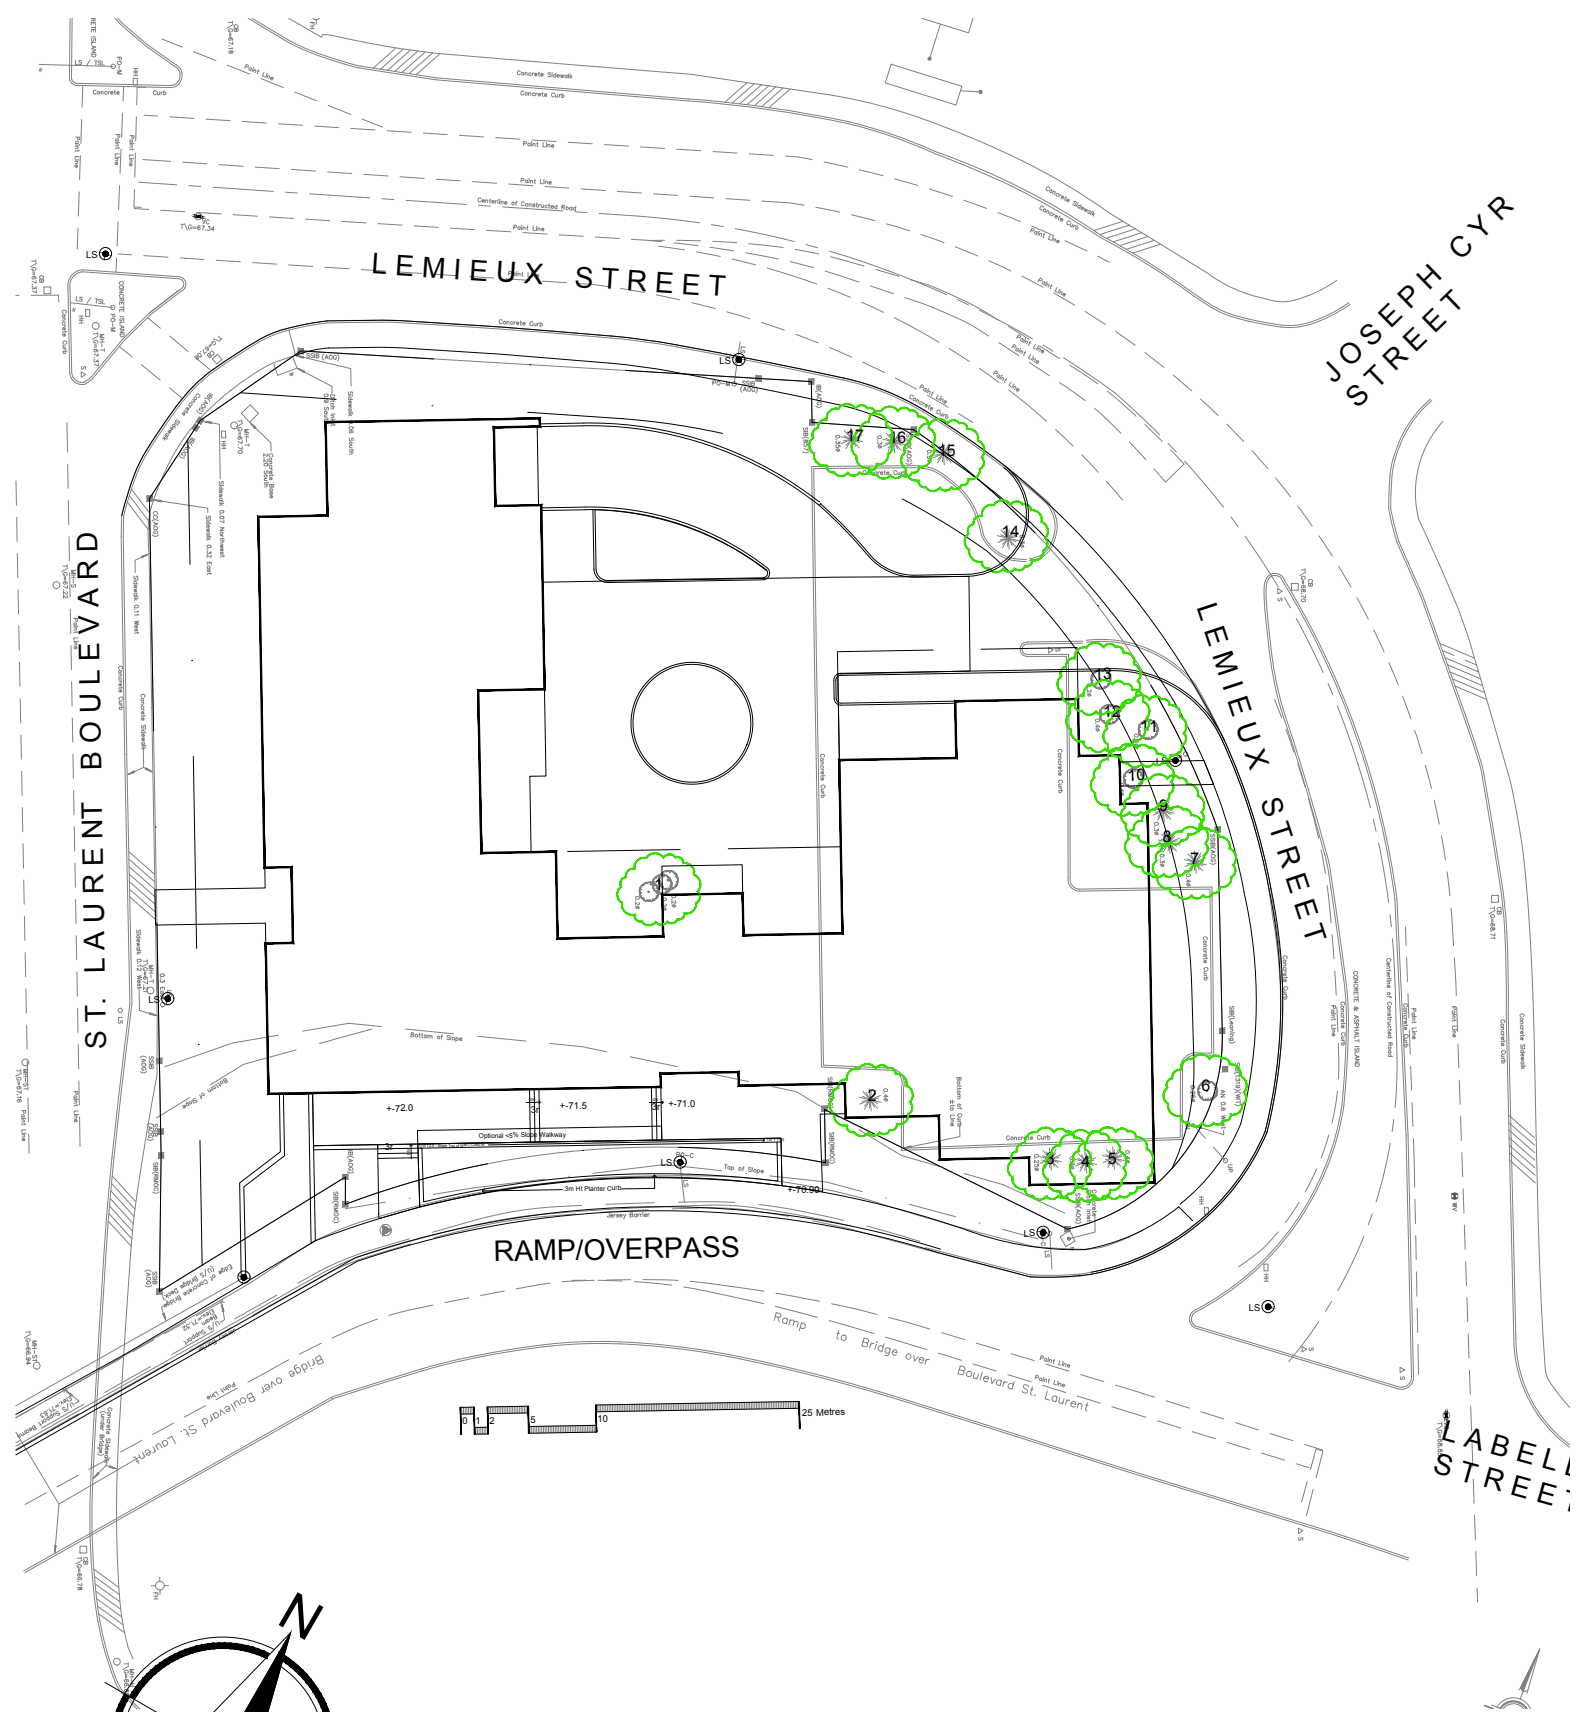
**MULTI UNIT 30 STOREY RESIDENTIAL
DEVELOPMENT**
1209 ST LAURENT BOULEVARD

Table 1 on pages 2 and 3 of this report details the species, condition, size (diameter) and status of the individual trees on the subject property. Each of these trees is referenced by the numbers plotted on the tree conservation plan included on page 5 of this report.

1. Erect a fence at the critical root zone (CRZ¹) of trees;
2. Do not place any material or equipment within the CRZ of the tree;
3. Do not attach any signs, notices or posters to any tree;
4. Do not raise or lower the existing grade within the CRZ without approval;
5. Tunnel or bore when digging within the CRZ of a tree;
6. Do not damage the root system, trunk or branches of any tree;
7. Ensure that exhaust fumes from all equipment are NOT directed towards any tree's crown.

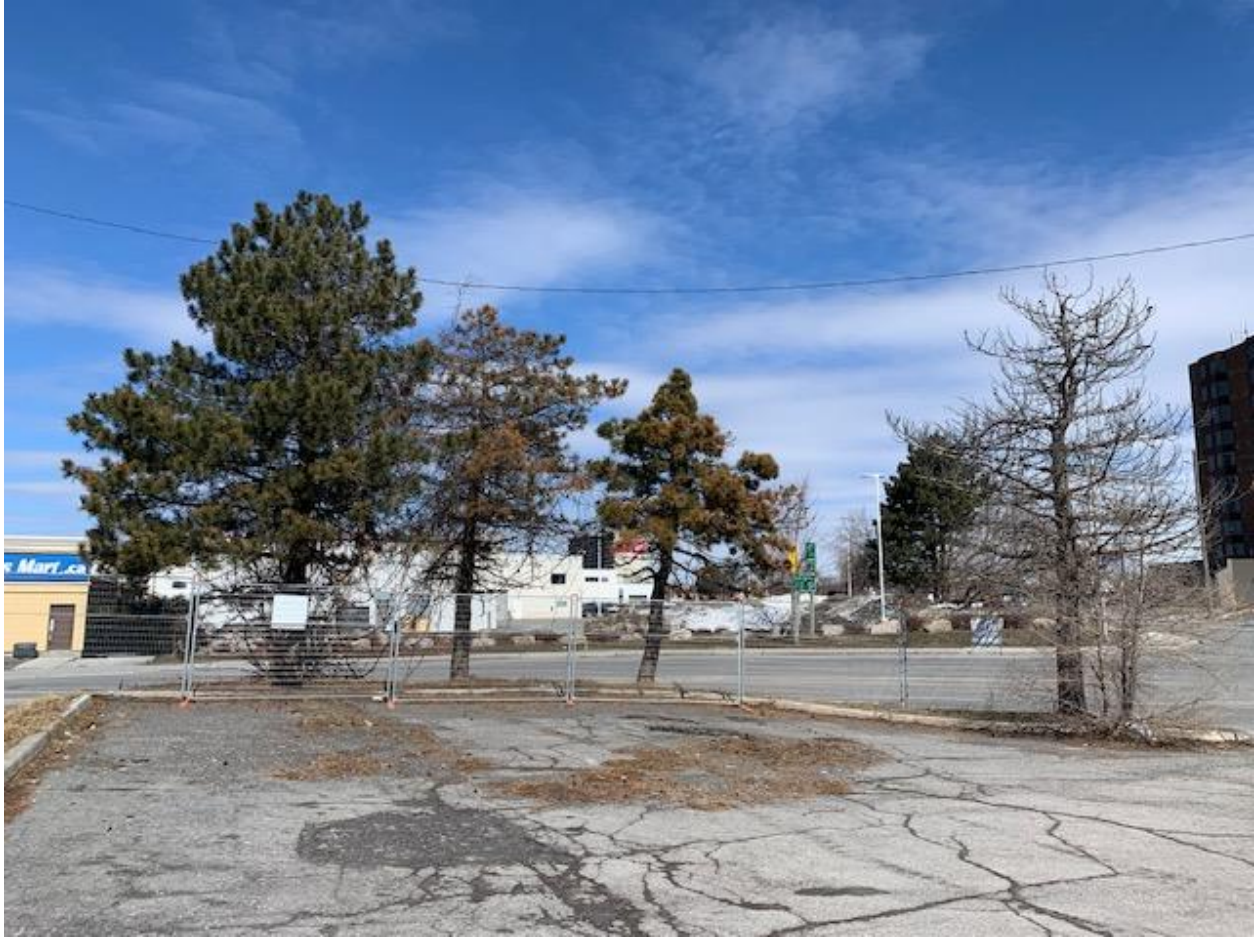
13	Norway maple (<i>Acer platanoides</i>)	22	-	Dead; mature; broken in two; to be removed (dead)
14	Austrian pine (<i>Pinus nigra</i>)	33	-	Dead; mature; seeded Siberian elm (<i>Ulmus pumila</i>) growing at base; to be removed (dead)
15	Austrian pine (<i>Pinus nigra</i>)/ Moderate-Good	26	-	Poor; mature; stunted growth form; poor crown density, growth increment and needle colour; introduced species; to be removed (poor condition)
16	Austrian pine (<i>Pinus nigra</i>)/ Moderate-Good	29	-	Poor; mature; stunted growth form; heavy vine (<i>Vitis</i> spp.) growth into crown; very poor crown density, growth increment and needle colour; introduced species; to be removed (poor condition)
17	Austrian pine (<i>Pinus nigra</i>)/ Moderate-Good	34	3.4	Fair; mature; crown asymmetric due to influence of nearby trees; vine (<i>Vitis</i> spp.) growth into crown; fair crown density and needle colour, good growth increment; hydro line runs through crown apex; introduced species; to be preserved and protected

Picture 4. Trees #14-17 (right to left) at 1209 St. Laurent Boulevard
