May 17, 2022

**RE: TREE CONSERVATION REPORT FOR 3150 WOODROFFE AVENUE, OTTAWA**

DRAWING: Tree Conservation Plan

PROJECT: 3150 WOODROFFE CITY OF OTTAWA

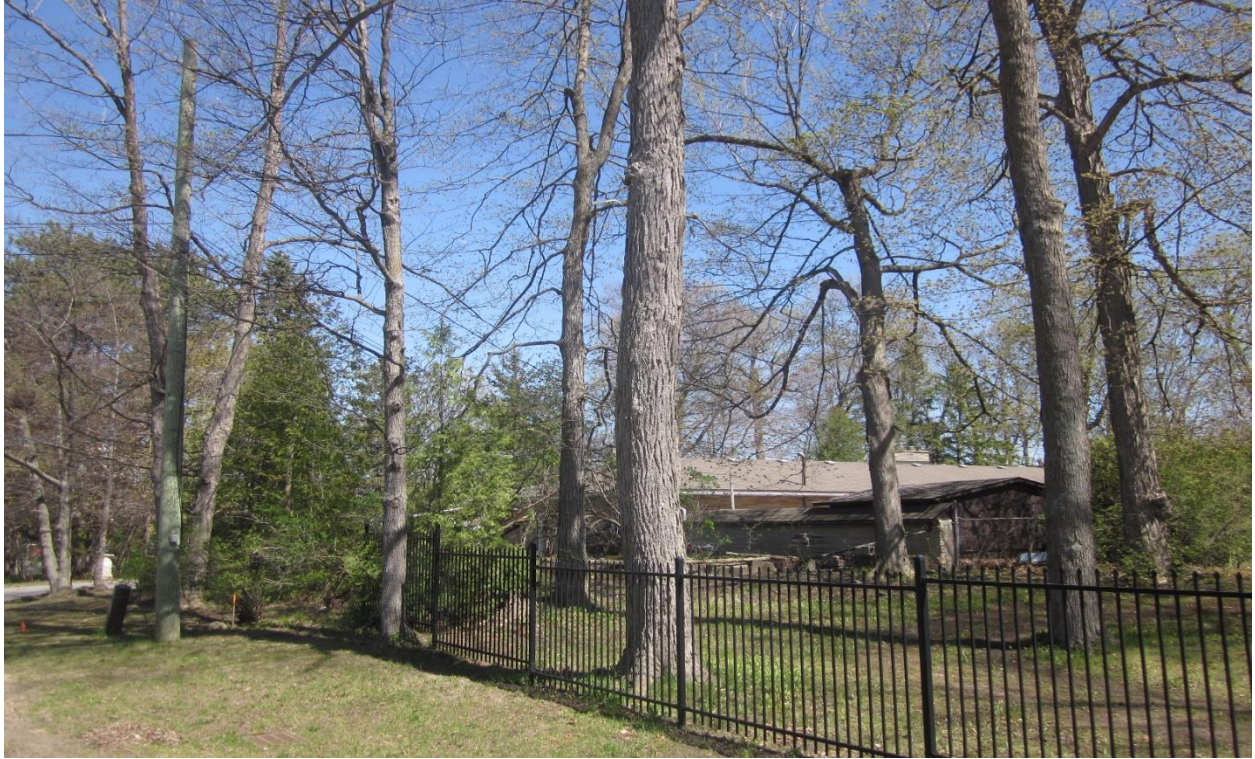
Picture 1. Tree #2 to 8 (left to right), adjacent to 3150 Woodroffe Avenue

Tree No.	Tree species /Tolerance to Construction <sup>1</sup>	DBH <sup>2</sup> / CRZ <sup>3</sup>	Owner-ship <sup>4</sup>	Condition, age class, tree condition notes; species origin & <b>preservation status</b> (to be removed or preserved and protected)
1	Beech ( <i>Fagus grandifolia</i> )/ Poor	10-25cm / 1-2.5m	City	Fair; maturing; four stems from grade – all root or stool shoots from previous parent tree; native species; <b>to be preserved and protected</b>
2	Sugar maple ( <i>Acer saccharum</i> )/ Poor-Moderate	34.8 & 37.8 cm / 7.3m	Shared with City	Fair; mature; double stemmed at 0.3m from grade; stems moderately divergent; early dieback in north stem (closest to road), poor wound closure – two small cavities; native species; <b>to be preserved and protected</b>
3	Sugar maple ( <i>Acer saccharum</i> )/ Poor-Moderate	+/-40 cm / +/-4m	Neighbour	Good; mature; upright form with symmetric crown; co-dominant leaders at 10m; living crown held to within 4m of grade; native species; <b>to be preserved and protected</b>

4	Eastern white cedar ( <i>Thuja occidentalis</i> )/ Good	+/-10cm / +/-1m	Neighbour	Fair; maturing; suppressed by surrounding trees - fair crown density, annual growth increment and needle colour; native species; <b>to be preserved and protected</b>
5	Sugar maple ( <i>Acer saccharum</i> )/ Poor-Moderate	+/-60cm / +/-6m	Neighbour	Fair; mature; dominant main stem with three competing leaders at 12m; crown asymmetric towards north; living crown held high (8m from grade) due to intercompetition for sunlight; native species; <b>to be preserved and protected</b>
6	Sugar maple ( <i>Acer saccharum</i> )/ Poor-Moderate	+/-30cm / +/-3m	Neighbour	Fair; mature; upright dominant main stem with dog's leg at 14m; living crown held high (10m from grade) due to intercompetition for sunlight; native species; <b>to be preserved and protected</b>
7	Sugar maple ( <i>Acer saccharum</i> )/ Poor-Moderate	+/-50cm / +/-5m	Neighbour	Fair; mature; central stem with strongly divergent leaders at 10m; crown asymmetric towards east due to influence of surrounding trees; native species; <b>to be preserved and protected</b>

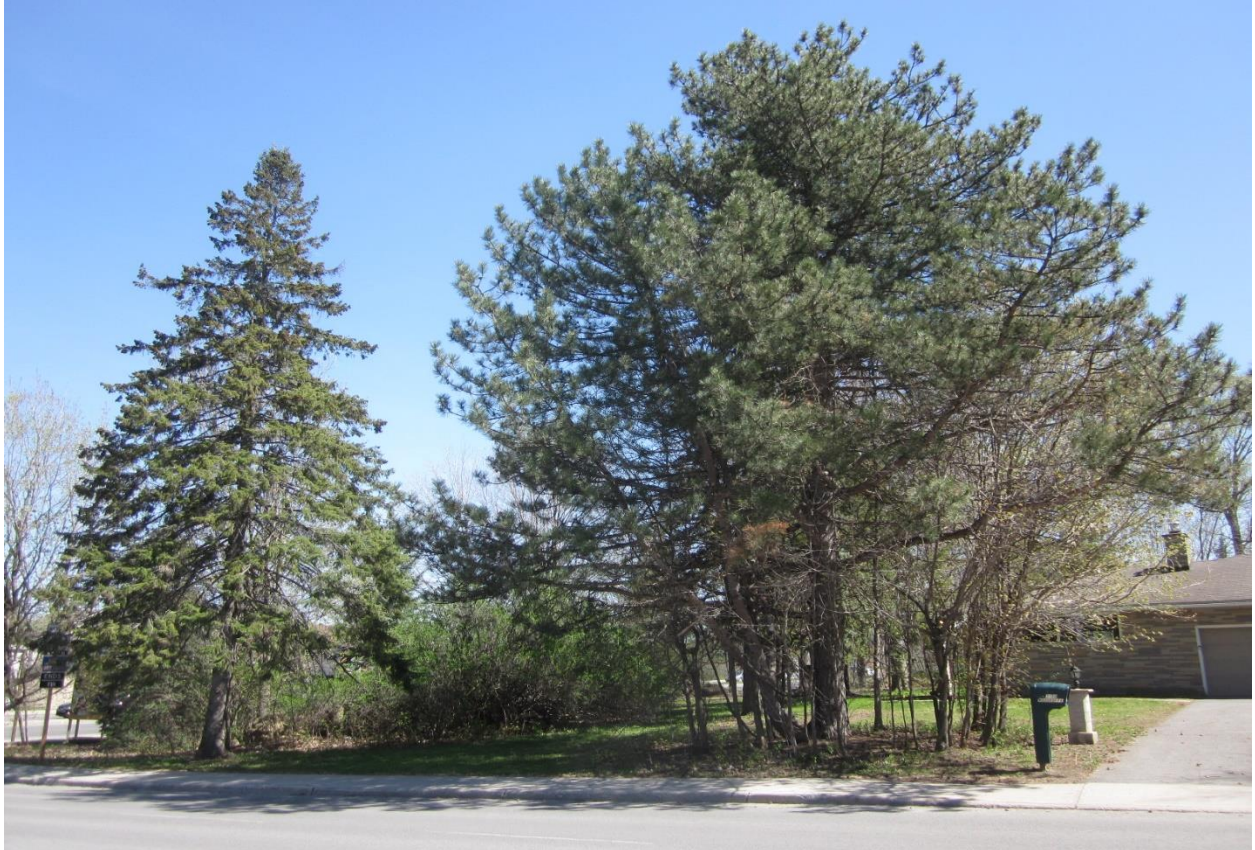
Picture 2. Trees #46 (left) and 48 (right) at 3150 Woodroffe Avenue

47	White spruce ( <i>Picea glauca</i> )/ Moderate-Good	53.3cm /5.3m	City	Fair; mature; single upright main stem and leader; scattered dead branches due to <i>Cytospora kunzei</i> ; fair crown density, annual growth increment and needle colour; native species; <b>to be preserved and protected</b>
48	Austrian pine ( <i>Pinus nigra</i> )/ Moderate-Good	67.1cm /6.7m	Private	Fair; very mature; co-dominant stems at 3.5m; suppressed basal lateral stems on north and east; fair crown density, annual growth increment and needle colour in upper crown, lower crown poor due to competition with multiple seeded Norway maple ( <i>Acer platanoides</i> ) and a single bur oak ( <i>Quercus macrocarpa</i> ); introduced species; <b>to be removed</b> (will not survive root loss related to nearby parking and pedestrian pathway)

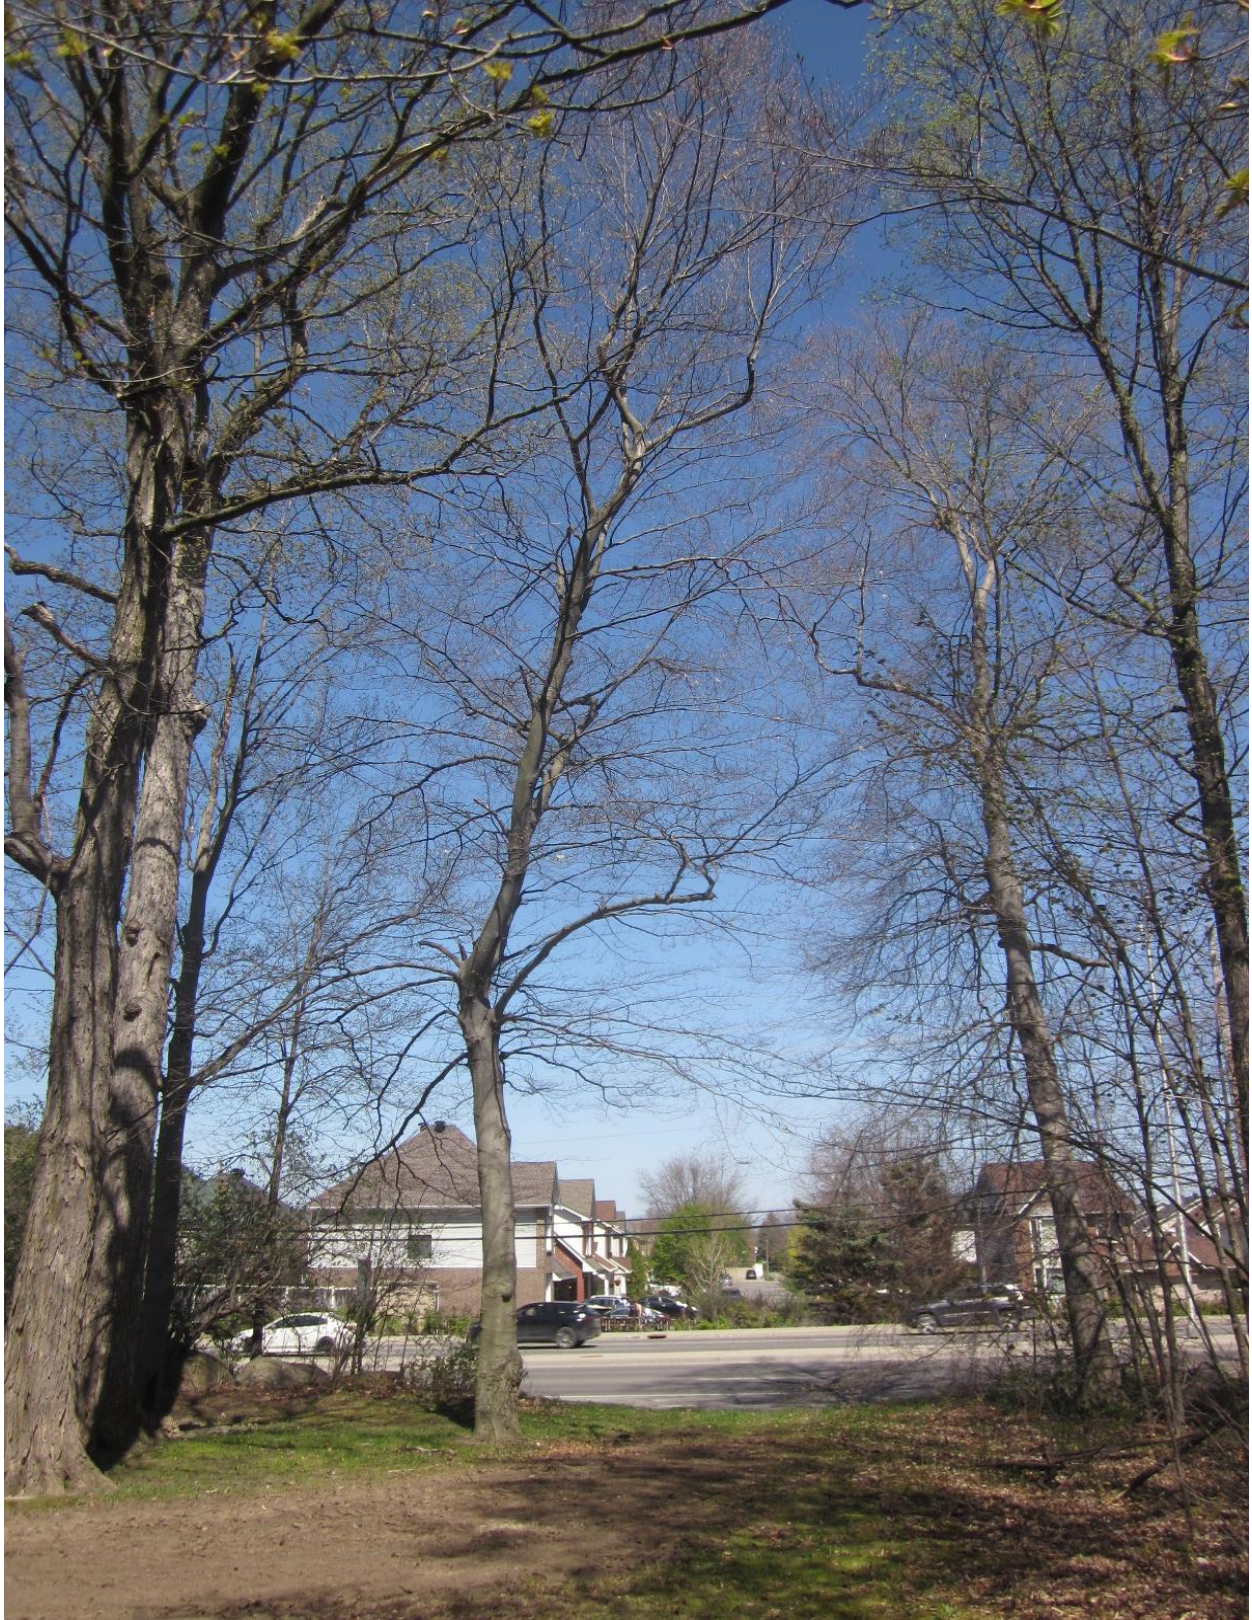
Picture 3. Trees #14 and 15 (right), 18 (centre) and 19 and 20 (left) at 3150 Woodroffe Avenue

15	Beech ( <i>Fagus grandifolia</i> )/ Poor	56.1cm /5.6m	Private	Fair; mature; moderately divergent and strongly asymmetric towards east; good wound response (vigour); minor cavities in upper crown; good rot collar; native species; <b>to be preserved and protected</b>

19	Sugar maple ( <i>Acer saccharum</i> ) / Poor-Moderate	80.6cm /8.1m	Private	Fair; very mature; upright main stem and crown held high (12m) due to intercompetition between trees for sunlight; co-dominant leaders with two suppressed laterals at 16m; recent root damage; good root collar; native species; <b>to be removed</b> (will not survive root loss)
20	Sugar maple ( <i>Acer saccharum</i> ) / Poor-Moderate	69.0cm /6.9m	Private	Fair; mature; single dominant stem with dog's leg at 16m; suppressed laterals at 6m on northwest and 10m on north; moderately divergent and strongly asymmetric towards southwest; good root collar; recent root damage; native species; <b>to be removed</b> (conflicts with parking)
21	White spruce ( <i>Picea glauca</i> ) / Moderate-Good	32.8cm /3.3m	Private	Fair; mature; upright main stem and leader; crown asymmetric towards southwest due to influence of tree #22; good crown density, annual growth increment and needle colour; recent root damage; native species; <b>to be removed</b> (will not survive root loss)

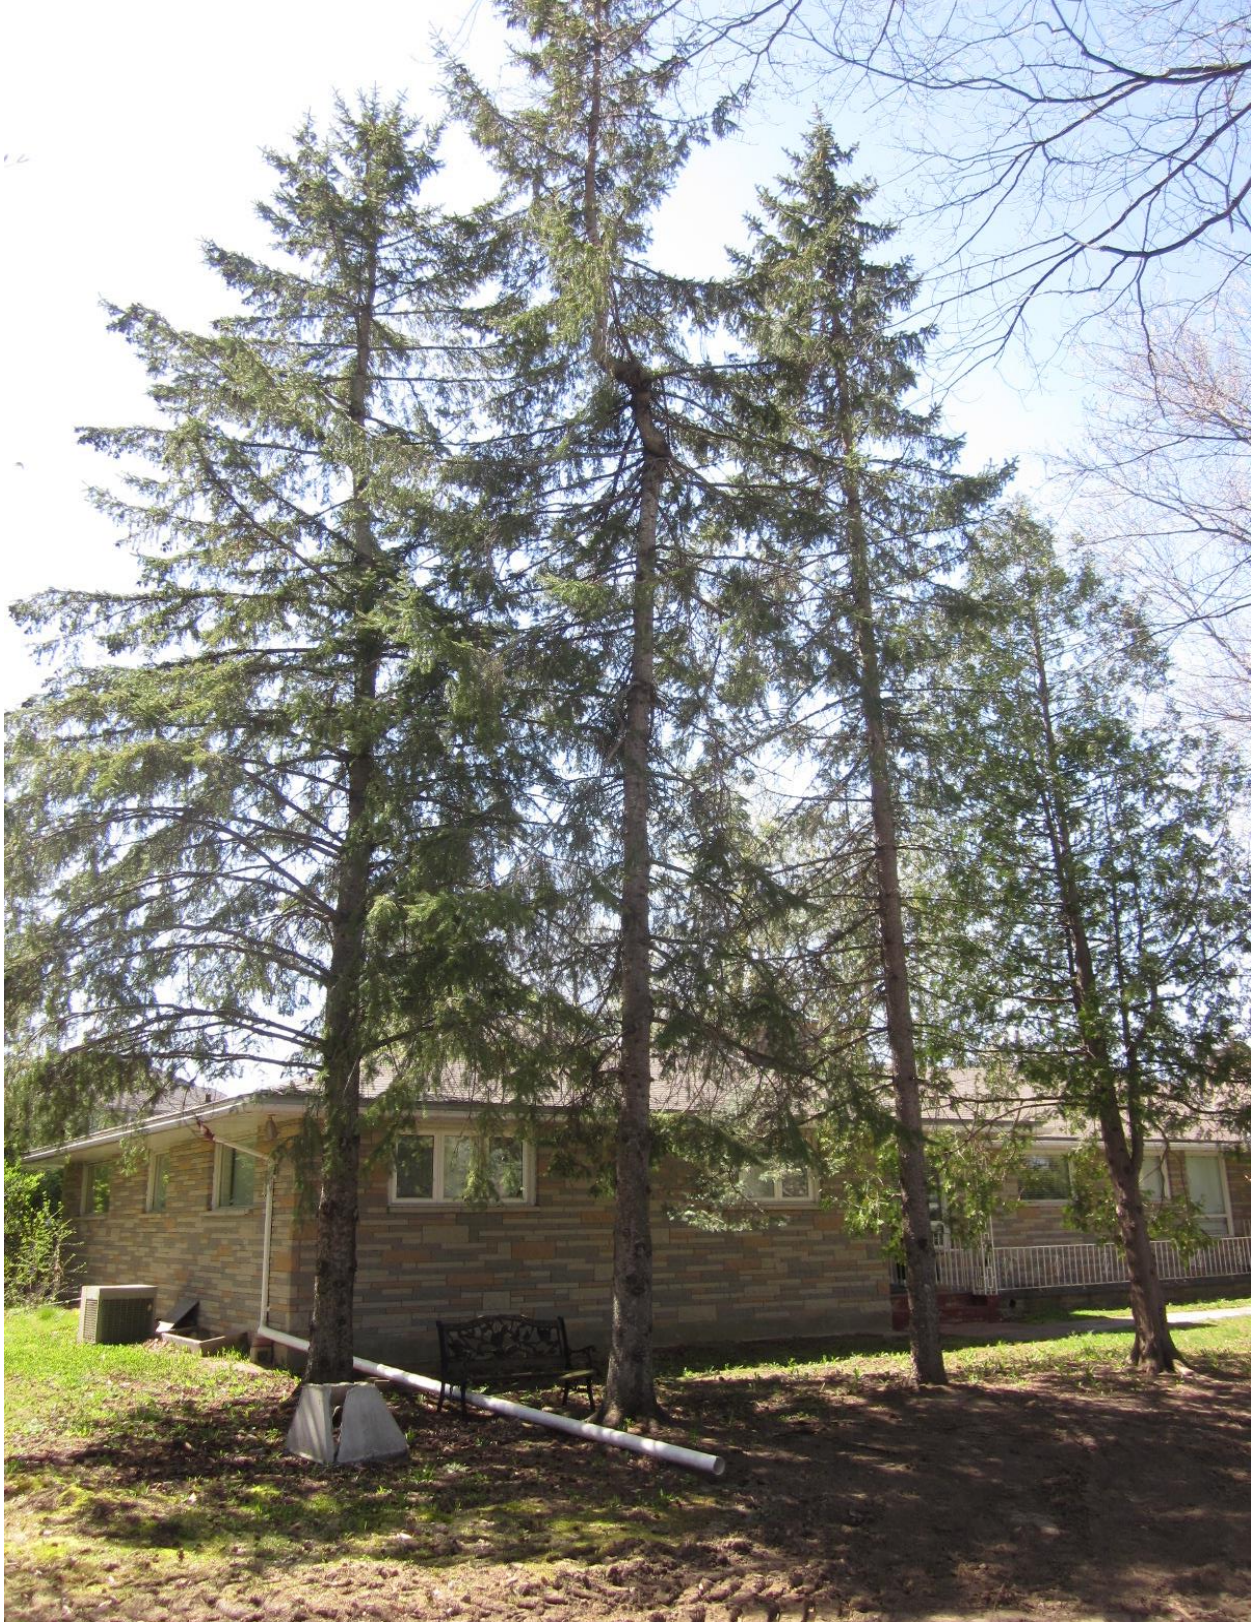
Picture 4. Trees #21 to 24 (left to right) at 3150 Woodroffe Avenue

22	White spruce ( <i>Picea glauca</i> ) / Moderate-Good	30.8cm /3.1m	Private	Fair, mature; poor form – series of dog's legs in main stem; single dominant leader; fair crown density, annual growth increment and needle colour; native species; <b>to be preserved and protected</b>

Tree No.	Tree species /Tolerance to Construction <sup>1</sup>	DBH <sup>2</sup> / CRZ <sup>3</sup>	Ownership <sup>4</sup>	Condition, age class, tree condition notes; species origin & <b>preservation status</b> (to be removed or preserved and protected)
23	Colorado spruce ( <i>Picea pungens</i> )/ Moderate-Good	26.3cm /2.6m	Private	Fair; mature; upright main stem and leader; lower crown asymmetric due to influence of nearby trees; fair crown density, annual growth increment and needle colour; introduced species; <b>to be removed</b> (will not survive root loss)
24	Eastern white cedar ( <i>Thuja occidentalis</i> )/ Good	26.4cm /2.6m	Private	Fair; mature; co-dominant leaders with suppressed lateral at 2.5m on southwest; native species; <b>to be removed</b> (conflicts with pedestrian walkway)
25	Sugar maple ( <i>Acer saccharum</i> )/ Poor-Moderate	81.5cm /8.2m	Private	Fair; very mature; main stem mildly divergent towards west; crown moderately asymmetric towards west; tri-dominant leaders at 18m; recent root damage and broken branches; root collar partially obscured by raised grade; native species; <b>to be removed</b> (conflicts with parking)

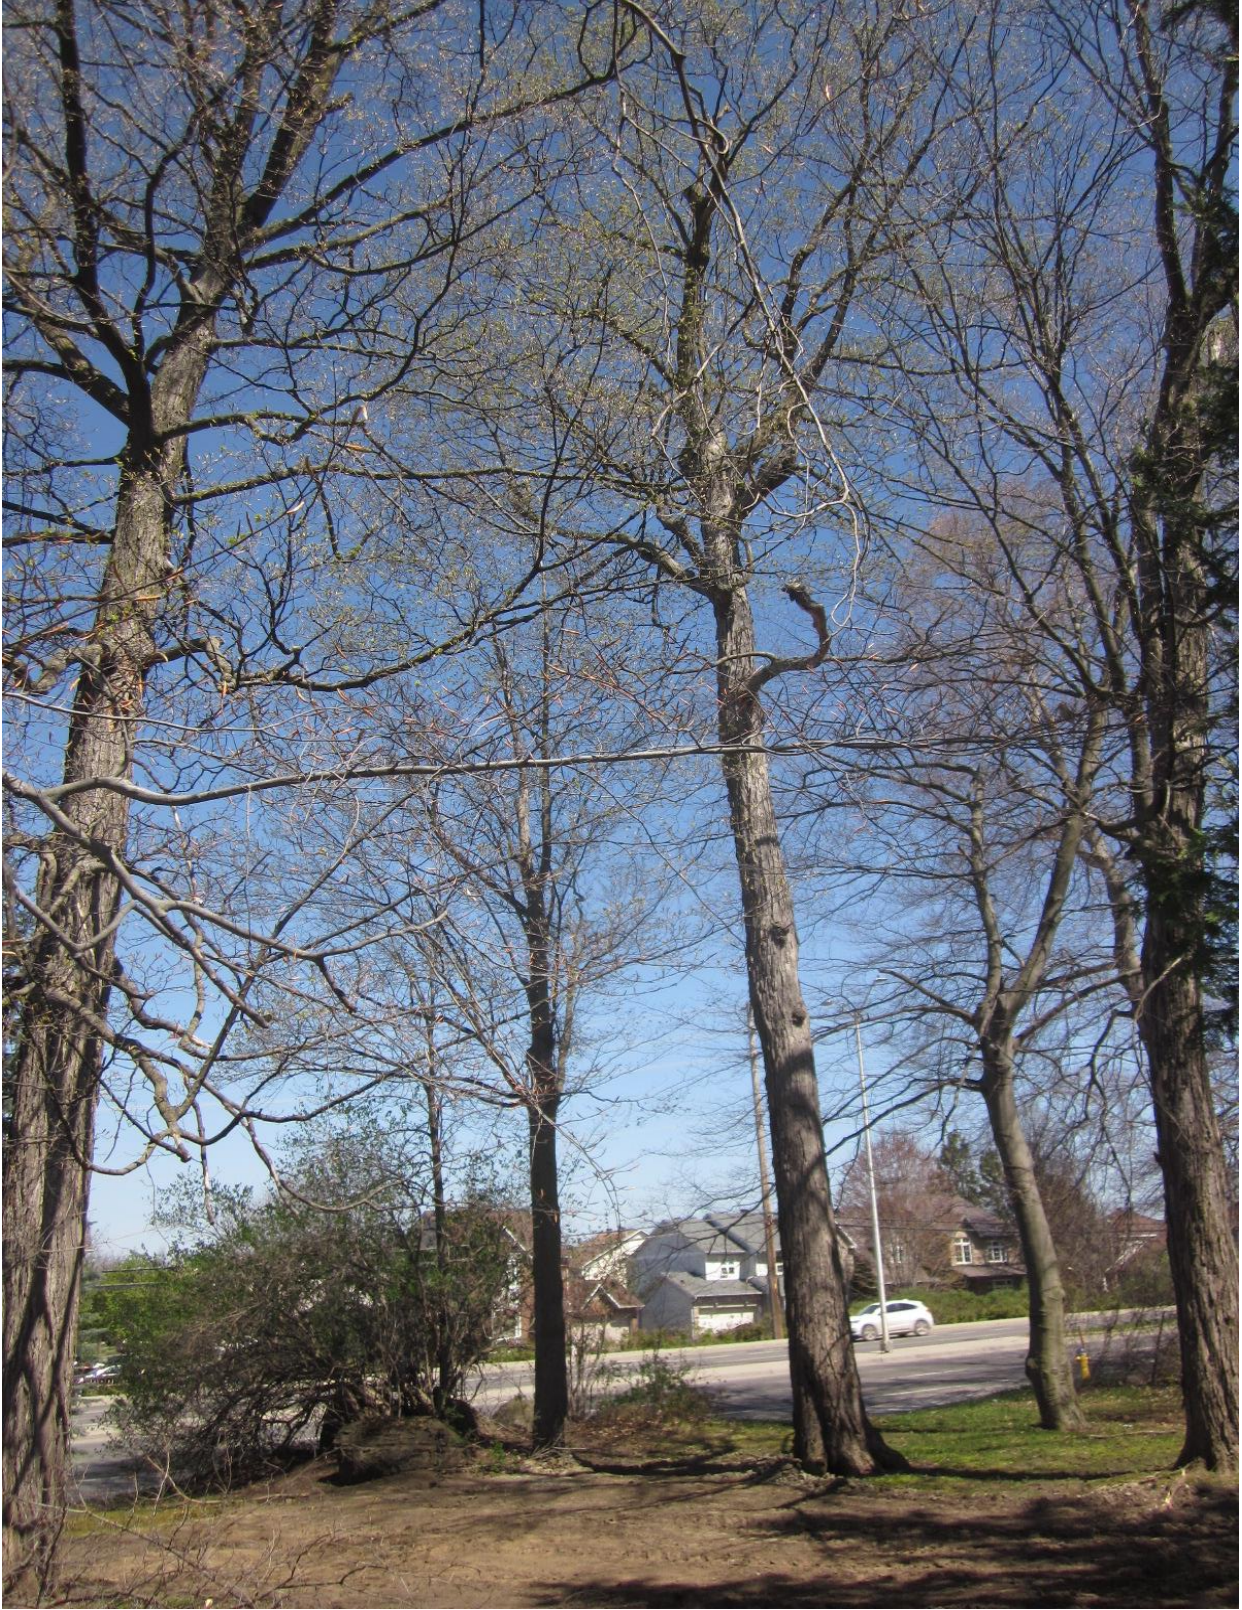
Picture 5. Trees #20-16 (right to left) and 25 (far left) at 3150 Woodroffe Avenue

Tree No.	Tree species /Tolerance to Construction <sup>1</sup>	DBH <sup>2</sup> / CRZ <sup>3</sup>	Owner-ship <sup>4</sup>	Condition, age class, tree condition notes; species origin & <b>preservation status</b> (to be removed or preserved and protected)
16	Bitternut hickory ( <i>Carya cordiformis</i> ) / Moderate	17.7cm /1.7m	Private	Good; maturing; moderately divergent and very asymmetric towards east due to influence of tree #15; native species; <b>to be preserved and protected</b>
17	Beech ( <i>Fagus grandifolia</i> ) / Poor	44.4cm /4.4m	Private	Poor; mature; mildly divergent and very asymmetric towards east due to influence of nearby trees; co-dominant stems at 10m – one fully dead; major basal wound on southwest without decay; root collar obscured by raised grade; native species; <b>to be preserved and protected</b>
18	Beech ( <i>Fagus grandifolia</i> ) / Poor	48.1cm /4.8m	Private	Fair; mature; poor form - divergent co-dominant stems at 7m – dominant towards south, suppressed towards east; good annual increment; native species; <b>to be preserved and protected</b>

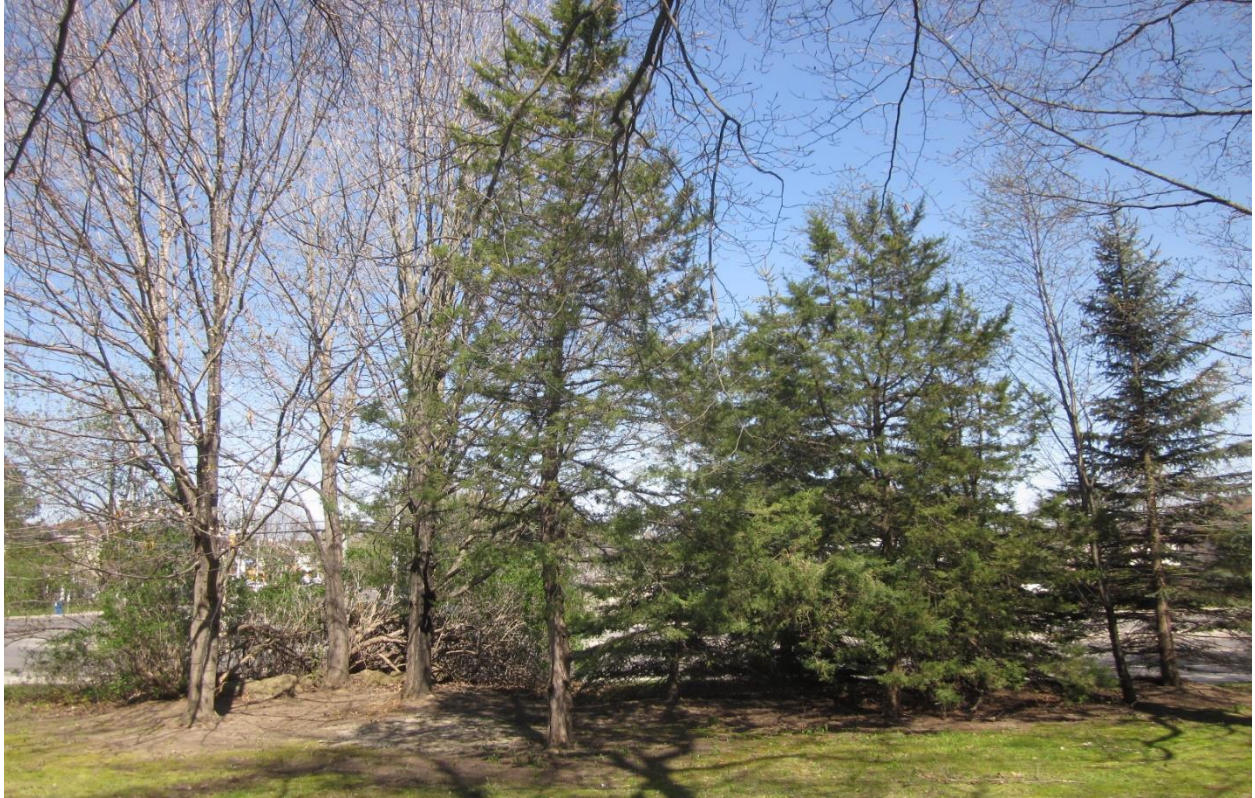
Picture 6. Trees #28-34 (right to left) at 3150 Woodroffe Avenue

33	Sugar maple ( <i>Acer saccharum</i> )/ Poor-Moderate	32.9cm /3.3m	Private	Fair; mature; moderately divergent and strongly asymmetric towards northeast due to influence of trees #32 and 34; good root collar; native species; <b>to be preserved and protected</b>
34	Sugar maple ( <i>Acer saccharum</i> )/ Poor-Moderate	35.5cm /3.6m	Private	Good; mature; central stem with three competing laterals at 3m; major wound from lost co-dominant stem at 3m on east; crown very asymmetric towards northwest due influence of trees #32 and 33; <b>to be removed</b> (conflicts with parking)
35	White spruce ( <i>Picea glauca</i> )/ Moderate-Good	46.0cm /4.6m	Private	Good; mature; upright main stem and leader; crown generally symmetric; good crown density, annual growth increment and needle colour; multiple exposed surface roots; native species; <b>to be removed</b> (conflicts with parking)
36	White spruce ( <i>Picea glauca</i> )/ Moderate-Good	31.8cm /3.2m	Private	Good; mature; upright main stem and leader; crown generally symmetric; good crown density, annual growth increment and needle colour; multiple exposed surface roots within area of root plate; native species; <b>to be removed</b> (conflicts with laneway)

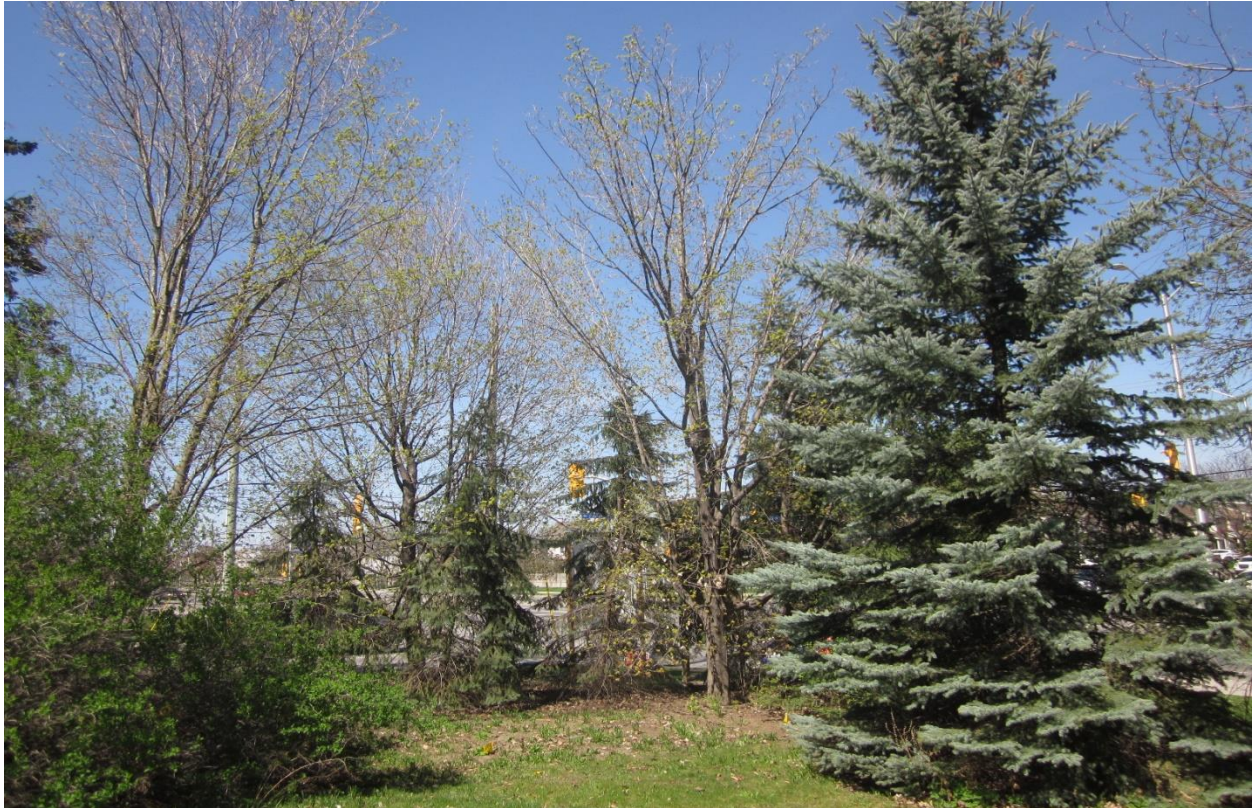
Picture 7. Trees #38-44 (right to left) at 3150 Woodroffe Avenue

40	Balsam fir ( <i>Abies balsamea</i> )/ Moderate-Good	15.6cm /1.6m	Private	Poor; maturing; crown very asymmetric due to influence of tree #39; leader suffering abrasion damage; fair crown density, annual growth increment and needle colour; native species; <b>to be preserved and protected</b>
41	Colorado spruce ( <i>Picea pungens</i> )/ Moderate-Good	15.1cm /1.5m	Private	Poor; maturing; crown very asymmetric due to influence of tree #39; good crown density, annual growth increment and needle colour; introduced species; <b>to be preserved and protected</b>
42	Colorado spruce ( <i>Picea pungens</i> )/ Moderate-Good	12.3cm /1.2m	Private	Poor; maturing; crown very asymmetric due to influence of tree #39; sweep at 2m from previously lost leader; good crown density, annual growth increment and needle colour; introduced species; <b>to be preserved and protected</b>
43	Colorado spruce ( <i>Picea pungens</i> )/ Moderate-Good	12.7cm /1.3m	Private	Poor; maturing; crown very asymmetric due to influence of tree #44; sweep at 2m from previously lost leader; good crown density, annual growth increment and needle colour; introduced species; <b>to be preserved and protected</b>

Tree No.	Tree species /Tolerance to Construction <sup>1</sup>	DBH <sup>2</sup> / CRZ <sup>3</sup>	Ownership <sup>4</sup>	Condition, age class, tree condition notes; species origin & <b>preservation status</b> (to be removed or preserved and protected)
44	Sugar maple ( <i>Acer saccharum</i> )/ Poor-Moderate	38.6cm (at 0.5m)/ 3.9m	Private	Fair; mature; central stem with competing lateral at 1m on east; co-dominant leaders at 2.5m – both bisect at 3.5m with inclusion ridges at unions; native species; <b>to be preserved and protected</b>
45	Sugar maple ( <i>Acer saccharum</i> )/ Poor-Moderate	35.5cm /3.6m	Private	Fair; mature; central stem with co-dominant leaders at 5.5m – both bisect within 2m of primary union; suppressed and competing laterals starting at 1.5m - broad, dense crown; native species; <b>to be preserved and protected</b>
46	Ash ( <i>Fraxinus</i> spp.)	-	Private	Dead due to emerald ash borer ( <i>Agrilus planipennis</i> ); broken at 1m; <b>to be removed</b>

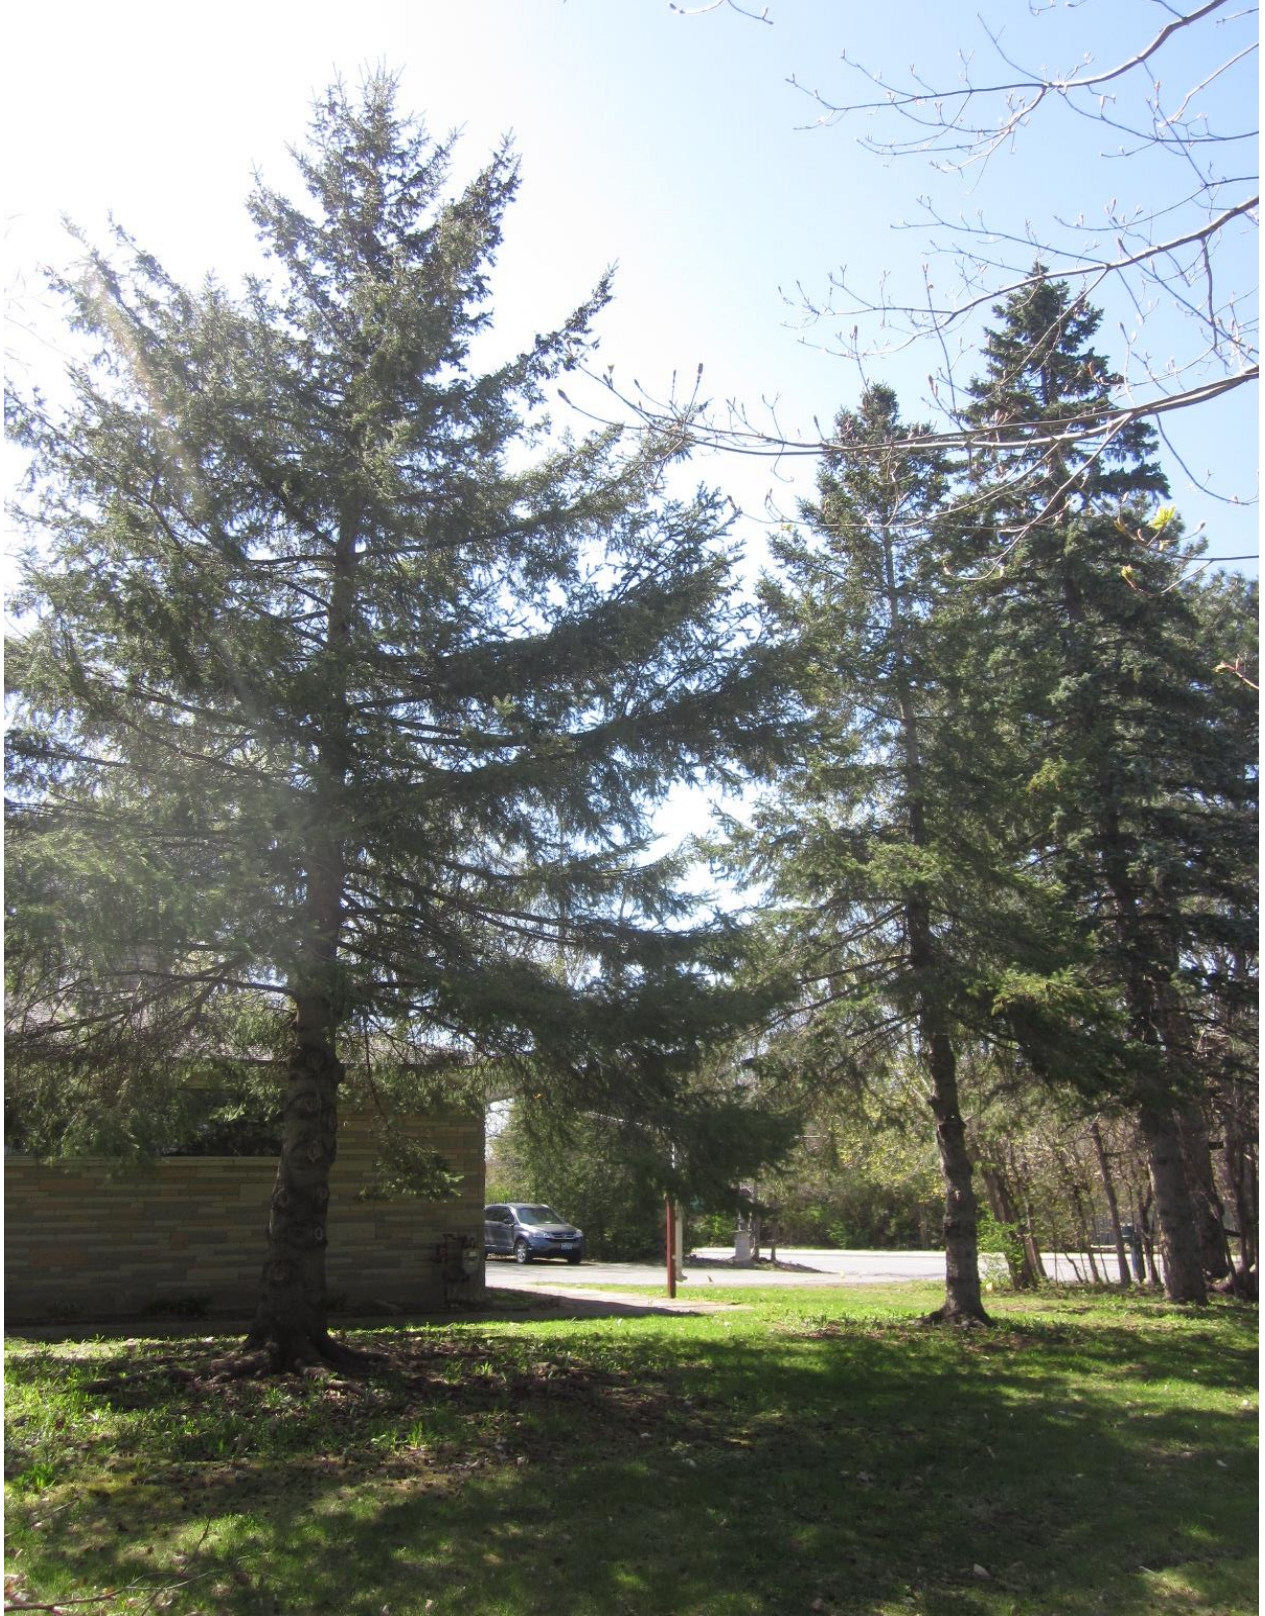
Picture 8. Trees #35, 36 and 37 (left to right) at 3150 Woodroffe Avenue

Tree No.	Tree species /Tolerance to Construction <sup>1</sup>	DBH <sup>2</sup> / CRZ <sup>3</sup>	Owner-ship <sup>4</sup>	Condition, age class, tree condition notes; species origin & <b>preservation status</b> (to be removed or preserved and protected)
37	Colorado spruce ( <i>Picea pungens</i> )/ Moderate-Good	47.1cm /4.7m	Private	Good; mature; single upright main stem and leader; crown generally symmetric; lower crown thin due to influence of tree #48; good crown density, annual growth increment and needle colour elsewhere; introduced species; <b>to be removed</b> (conflicts with parking)
38	Colorado spruce ( <i>Picea pungens</i> )/ Moderate-Good	22.3cm /2.2m	Private	Very good; maturing; generally symmetric crown; good crown density, annual growth increment and needle colour elsewhere; introduced species; <b>to be preserved and protected</b>
39	Sugar maple ( <i>Acer saccharum</i> )/ Poor-Moderate	29.1cm /2.9m	Private	Good; maturing; co-dominant stems at 2.5m with competing lateral at 2m on east; native species; <b>to be preserved and protected</b>
