project
BROOKFIELD RESIDENCE APARTMENT BUILDING
770 BROOKFIELD ROAD, OTTAWA

drawing title
Phase 2 - TREE CONSERVATION REPORT

project 1964-02
drawing no. **TCR1**

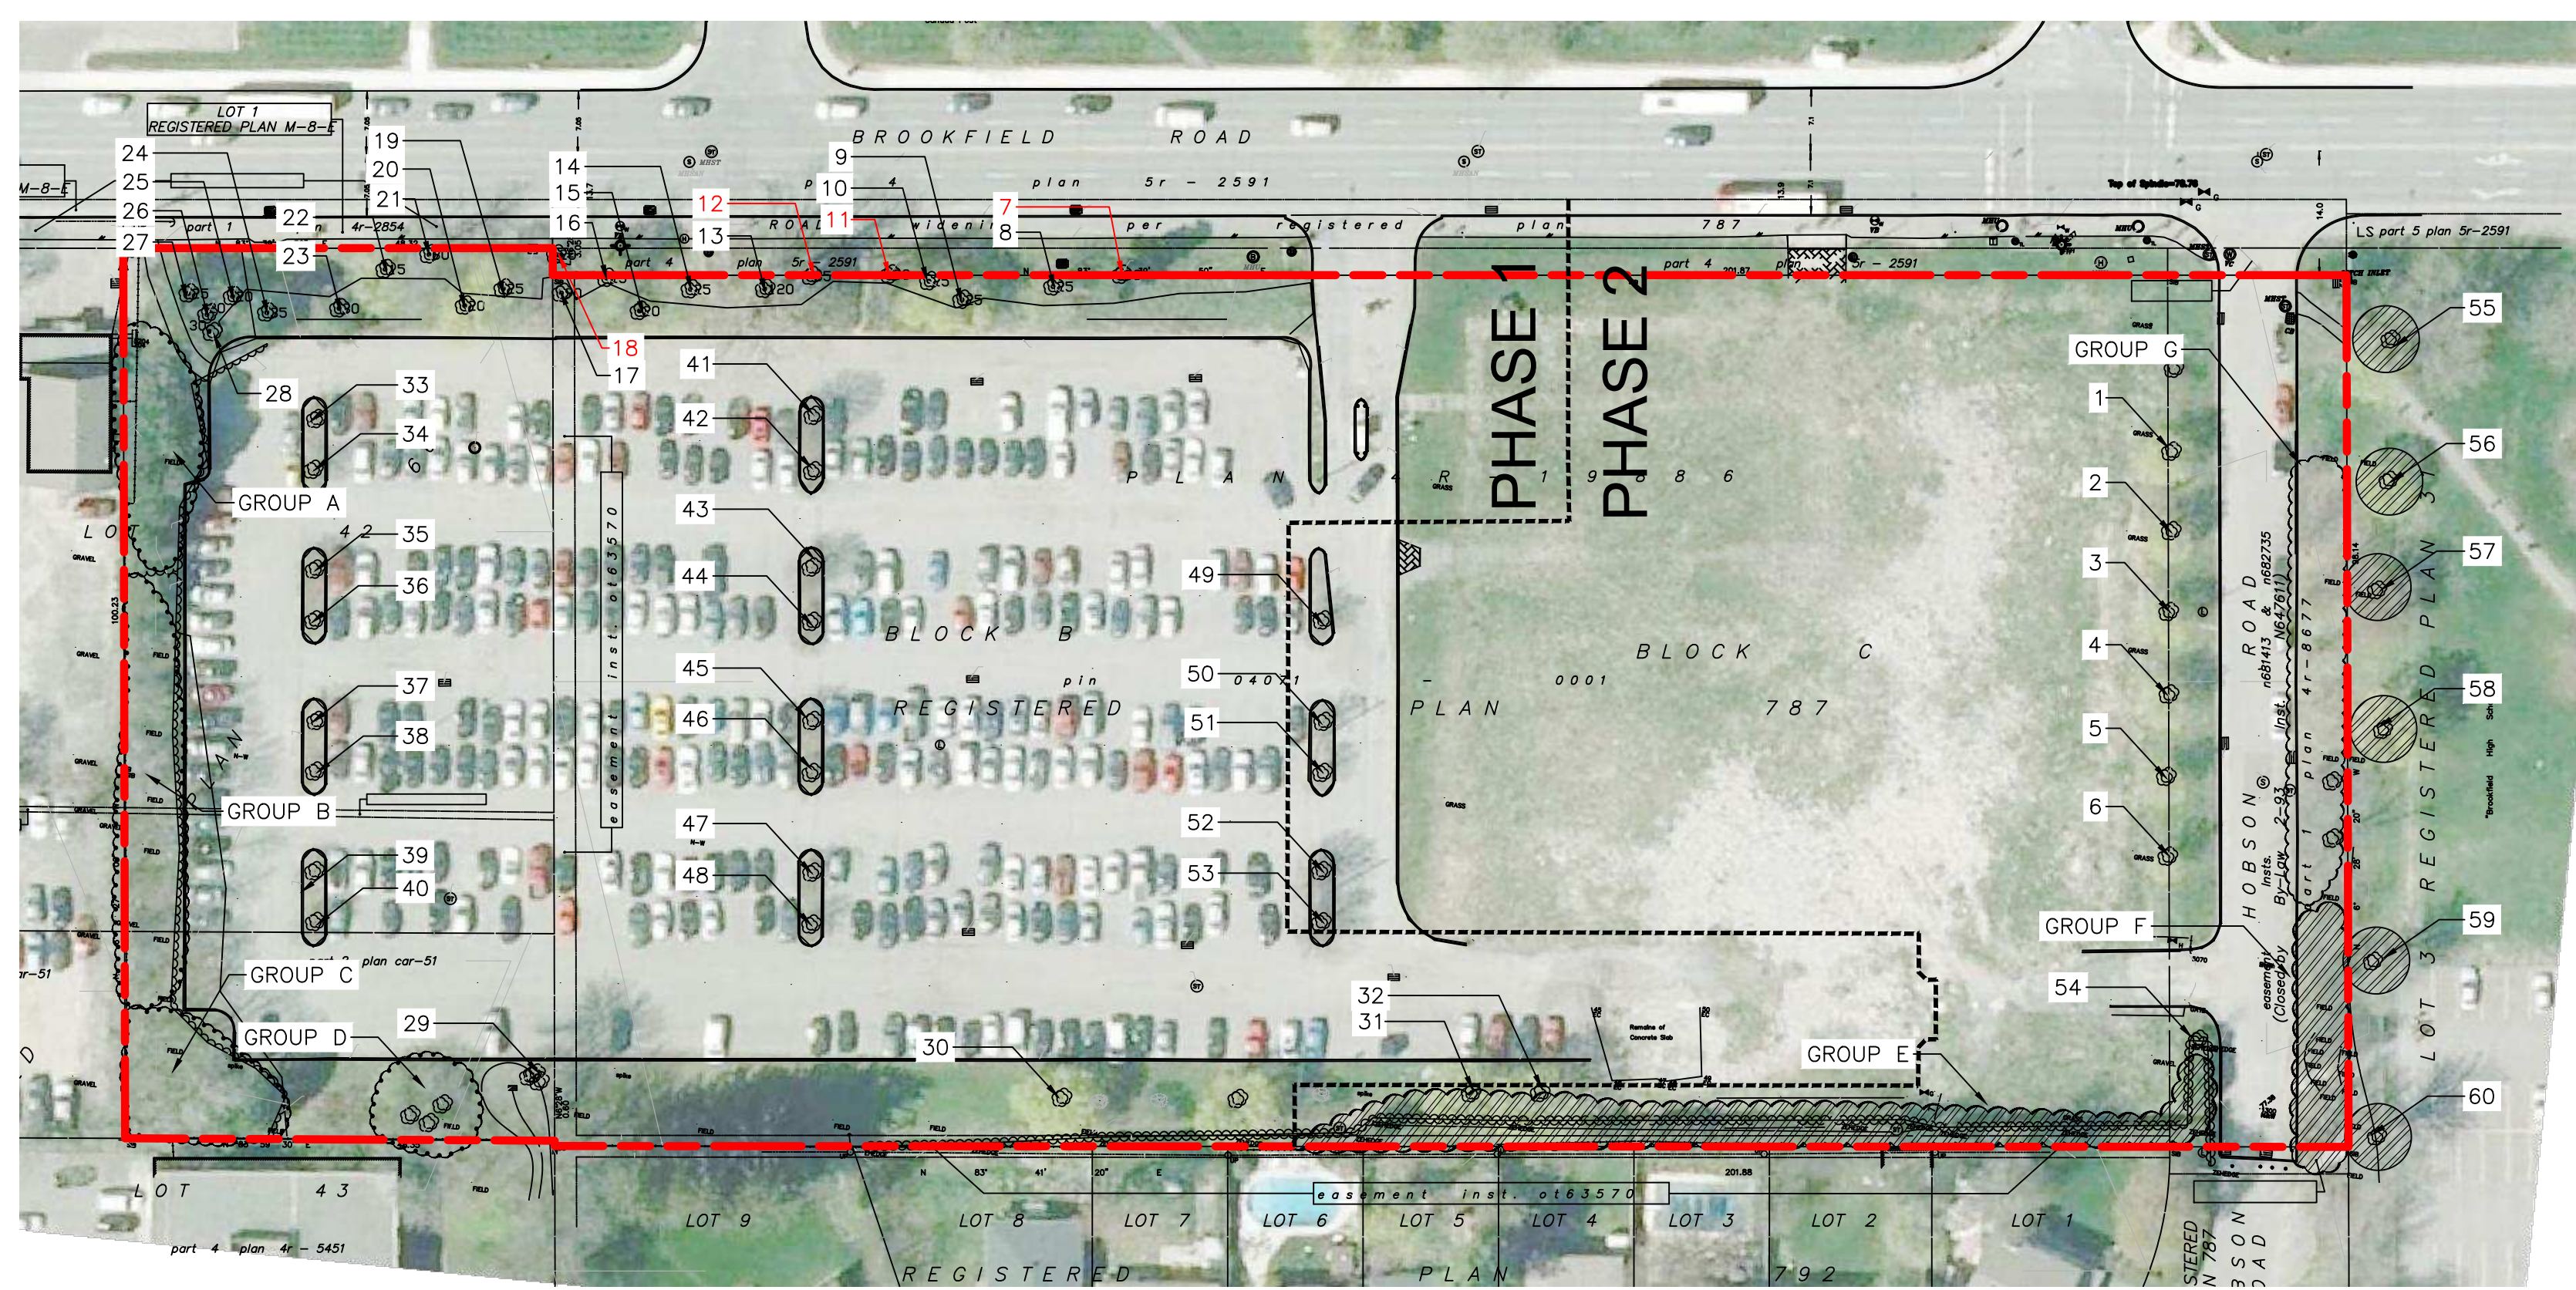
TREE CONSERVATION MAP 1 – AERIAL PHOTOGRAPHY:

TREE #	BOTANICAL NAME	COMMON NAME	CALIPER (cm)	CONDITION	HIGH QUALITY TREE	RARE TREE	COMMENTS	TO BE PRESERVED
1	Acer platanoides	Norway Maple	32	Good	No	No	Tree in good condition.	NO
2	Acer platanoides	Norway Maple	33	Good	No	No	Tree in good condition.	NO
3	Acer platanoides	Norway Maple	26	Good	No	No	Tree in good condition.	NO
4	Acer platanoides	Norway Maple	28	Good	No	No	Tree in good condition. Some crossed branches.	NO
5	Acer platanoides	Norway Maple	25	Good	No	No	Tree in good condition.	NO
6	Acer platanoides	Norway Maple	24	Good	No	No	Tree in good condition. Some minor damage at base.	NO
7	Picea pungens	Colorado Blue Spruce	32	Good	No	No	Tree is well formed and vigorous.	NO
8	Acer platanoides	Norway Maple	32	Good	No	No	Tree in good condition. There are some very minor dead branches in the canopy.	NO
9	Acer platanoides	Norway Maple	30	Good	No	No	Tree in good condition. There is minor die back in the interior canopy.	NO

10	Acer platanoides	Norway Maple	25	Good	No	No	Tree in good condition.	NO
11	Picea pungens	Colorado Blue Spruce	26	Poor	No	No	There is substantial die back through out the canopy of this tree and at the terminus of many branches. The canopy of this tree is thinning.	NO
12	Picea pungens	Colorado Blue Spruce	27	Poor	No	No	There is substantial die back through out the canopy of this tree and at the terminus of many branches. The canopy of this tree is thinning.	NO
13	Populus deltoides	Eastern Cottonwood	120	Poor	No	No	Tree poor condition as there is high volume of dead wood through out the canopy of this tree. Many of the dead limbs are of substantial size.	NO
14	Acer platanoides	Norway Maple	31	Good	No	No	Tree in good condition.	NO
15	Acer platanoides	Norway Maple	31	Good / Mod	No	No	Tree in good to moderate condition. Some die back to lower branches.	NO
16	Acer platanoides	Norway Maple	32	Good	No	No	Tree in good condition.	NO

17	Fraxinus pennsylvanica	Green Ash	49	Dead	No	No	Tree is dead, evidence of emerald ash borer (EAB).	NO
18	Fraxinus pennsylvanica	Green Ash	18	Dead	No	No	Tree is dead, evidence of EAB.	NO
19	Acer platanoides	Norway Maple	30	Good	No	No	Tree in good condition.	NO
20	Acer platanoides	Norway Maple	23	Moderate	No	No	Tree in good condition.	NO
21	Fraxinus pennsylvanica	Green Ash	41	Dead	No	No	Tree is dead, evidence of EAB.	NO
22	Acer platanoides	Norway Maple	28	Good	No	No	Tree in good condition.	NO

23	Pinus nigra	Austrian Pine	30	Good	No	No	Tree in good condition. Has a very slight lean	NO
24	Pinus nigra	Austrian Pine	38	Good	No	No	Tree is in good condition, co-dominant stem at 3.0m height.	NO
25	Pinus nigra	Austrian Pine	27	Good	No	No	Tree is in good condition	NO
26	Pinus nigra	Austrian Pine	30	Good	No	No	Tree is in good condition	NO
27	Pinus nigra	Austrian Pine	30	Good	No	No	Tree is in good condition	NO
28	Pinus nigra	Austrian Pine	40	Good	No	No	Tree is in good condition, some die back of lower branches.	NO
29	Fraxinus pennsylvanica	Green Ash	26	Dead	No	No	Tree is dead, evidence of EAB.	NO
30	Acer platanoides	Norway Maple	23	Moderate	No	No	Large split in main branch union	NO
31	Acer platanoides	Norway Maple	28	Good	No	No	Tree is in good condition	YES
32	Acer platanoides	Norway Maple	18	Poor	No	No	Tree has split at main branch union. Half of the tree is on the ground.	YES
33	Tilia cordata	Little Leaf Linden	22	Good	No	No	Tree in good condition. Has had the lower canopy branches trimmed.	NO

34	Tilia cordata	Little Leaf Linden	22	Good / Mod	No	No	Tree in good condition. Some die back in lower branches.	NO
35	Tilia cordata	Little Leaf Linden	22	Good	No	No	Tree in good condition. Has had the lower canopy branches trimmed.	NO
36	Tilia cordata	Little Leaf Linden	20	Moderate	No	No	Canopy is very thin with some damaged/dead branches.	NO
37	Tilia cordata	Little Leaf Linden	20	Good / Mod	No	No	Tree in good condition. Some die back in lower branches.	NO
38	Tilia cordata	Little Leaf Linden	20	Good	No	No	Tree in good condition. Has had the lower canopy branches trimmed.	NO
39	Tilia cordata	Little Leaf Linden	20	Good / Mod	No	No	Canopy is thin with some die back of lower branches.	NO
40	Tilia cordata	Little Leaf Linden	20	Good / Mod	No	No	A lower branch has dropped off and damaged trunk.	NO
41	Tilia cordata	Little Leaf Linden	28	Good	No	No	Tree in good condition. Has had the lower canopy branches trimmed.	NO

42	Tilia cordata	Little Leaf Linden	26	Moderate	No	No	Tree in good condition. Has had the lower canopy branches trimmed.	NO
43	Tilia cordata	Little Leaf Linden	24	Good	No	No	Tree in good condition. Has had the lower canopy branches trimmed.	NO
44	Tilia cordata	Little Leaf Linden	22	Good	No	No	Tree in good condition. Has had the lower canopy branches trimmed.	NO
45	Tilia cordata	Little Leaf Linden	20	Good / Mod	No	No	Canopy is thin with some die back of lower branches.	NO
46	Tilia cordata	Little Leaf Linden	20	Good	No	No	Tree in good condition. Has had the lower canopy branches trimmed.	NO
47	Tilia cordata	Little Leaf Linden	20	Good	No	No	Tree in good condition. Has had the lower canopy branches trimmed.	NO
48	Tilia cordata	Little Leaf Linden	20	Mod-Poor	No	No	Poor form. Die back of central leader.	NO
49	Tilia cordata	Little Leaf Linden	20	Good-Moderate	No	No	Tree in good condition. Has had the lower canopy branches trimmed.	NO

50	Tilia cordata	Little Leaf Linden	20	Good	No	No	Tree in good condition. Has had the lower canopy branches trimmed.	NO
51	Tilia cordata	Little Leaf Linden	19	Good / Mod	No	No	Tree is leaning slightly. Some die back of upper canopy.	NO
52	Tilia cordata	Little Leaf Linden	28	Good	No	No	Tree in good condition. Has had the lower canopy branches trimmed.	NO
53	Tilia cordata	Little Leaf Linden	28	Good / Mod	No	No	Damage at base of tree. Some die back in upper canopy.	NO
54	Ulmus pumila	Siberian Elm	18	Moderate	No	No	Tree crowded by cedar hedge, thin canopy.	NO
55	Acer saccharum	Sugar Maple	35	Moderate	No	No	30% canopy die back on outer branches.	Yes
56	Acer platanoides	Norway Maple	35	Good	No	No	Tree in good condition.	Yes
57	Acer saccharum	Sugar Maple	45	Good	No	No	Tree in good condition.	Yes
58	Acer saccharum	Sugar Maple	50	Good	No	No	Tree in good condition.	Yes
59	Ulmus pumila	Siberian Elm	80	Good / Mod	No	No	Tree in good condition. Some black spot on leaves, 15% canopy dieback.	Yes

60	Ulmus pumila	Siberian Elm	100	Good / Mod	No	No	Tree in good condition. Some black spot on leaves.	Yes

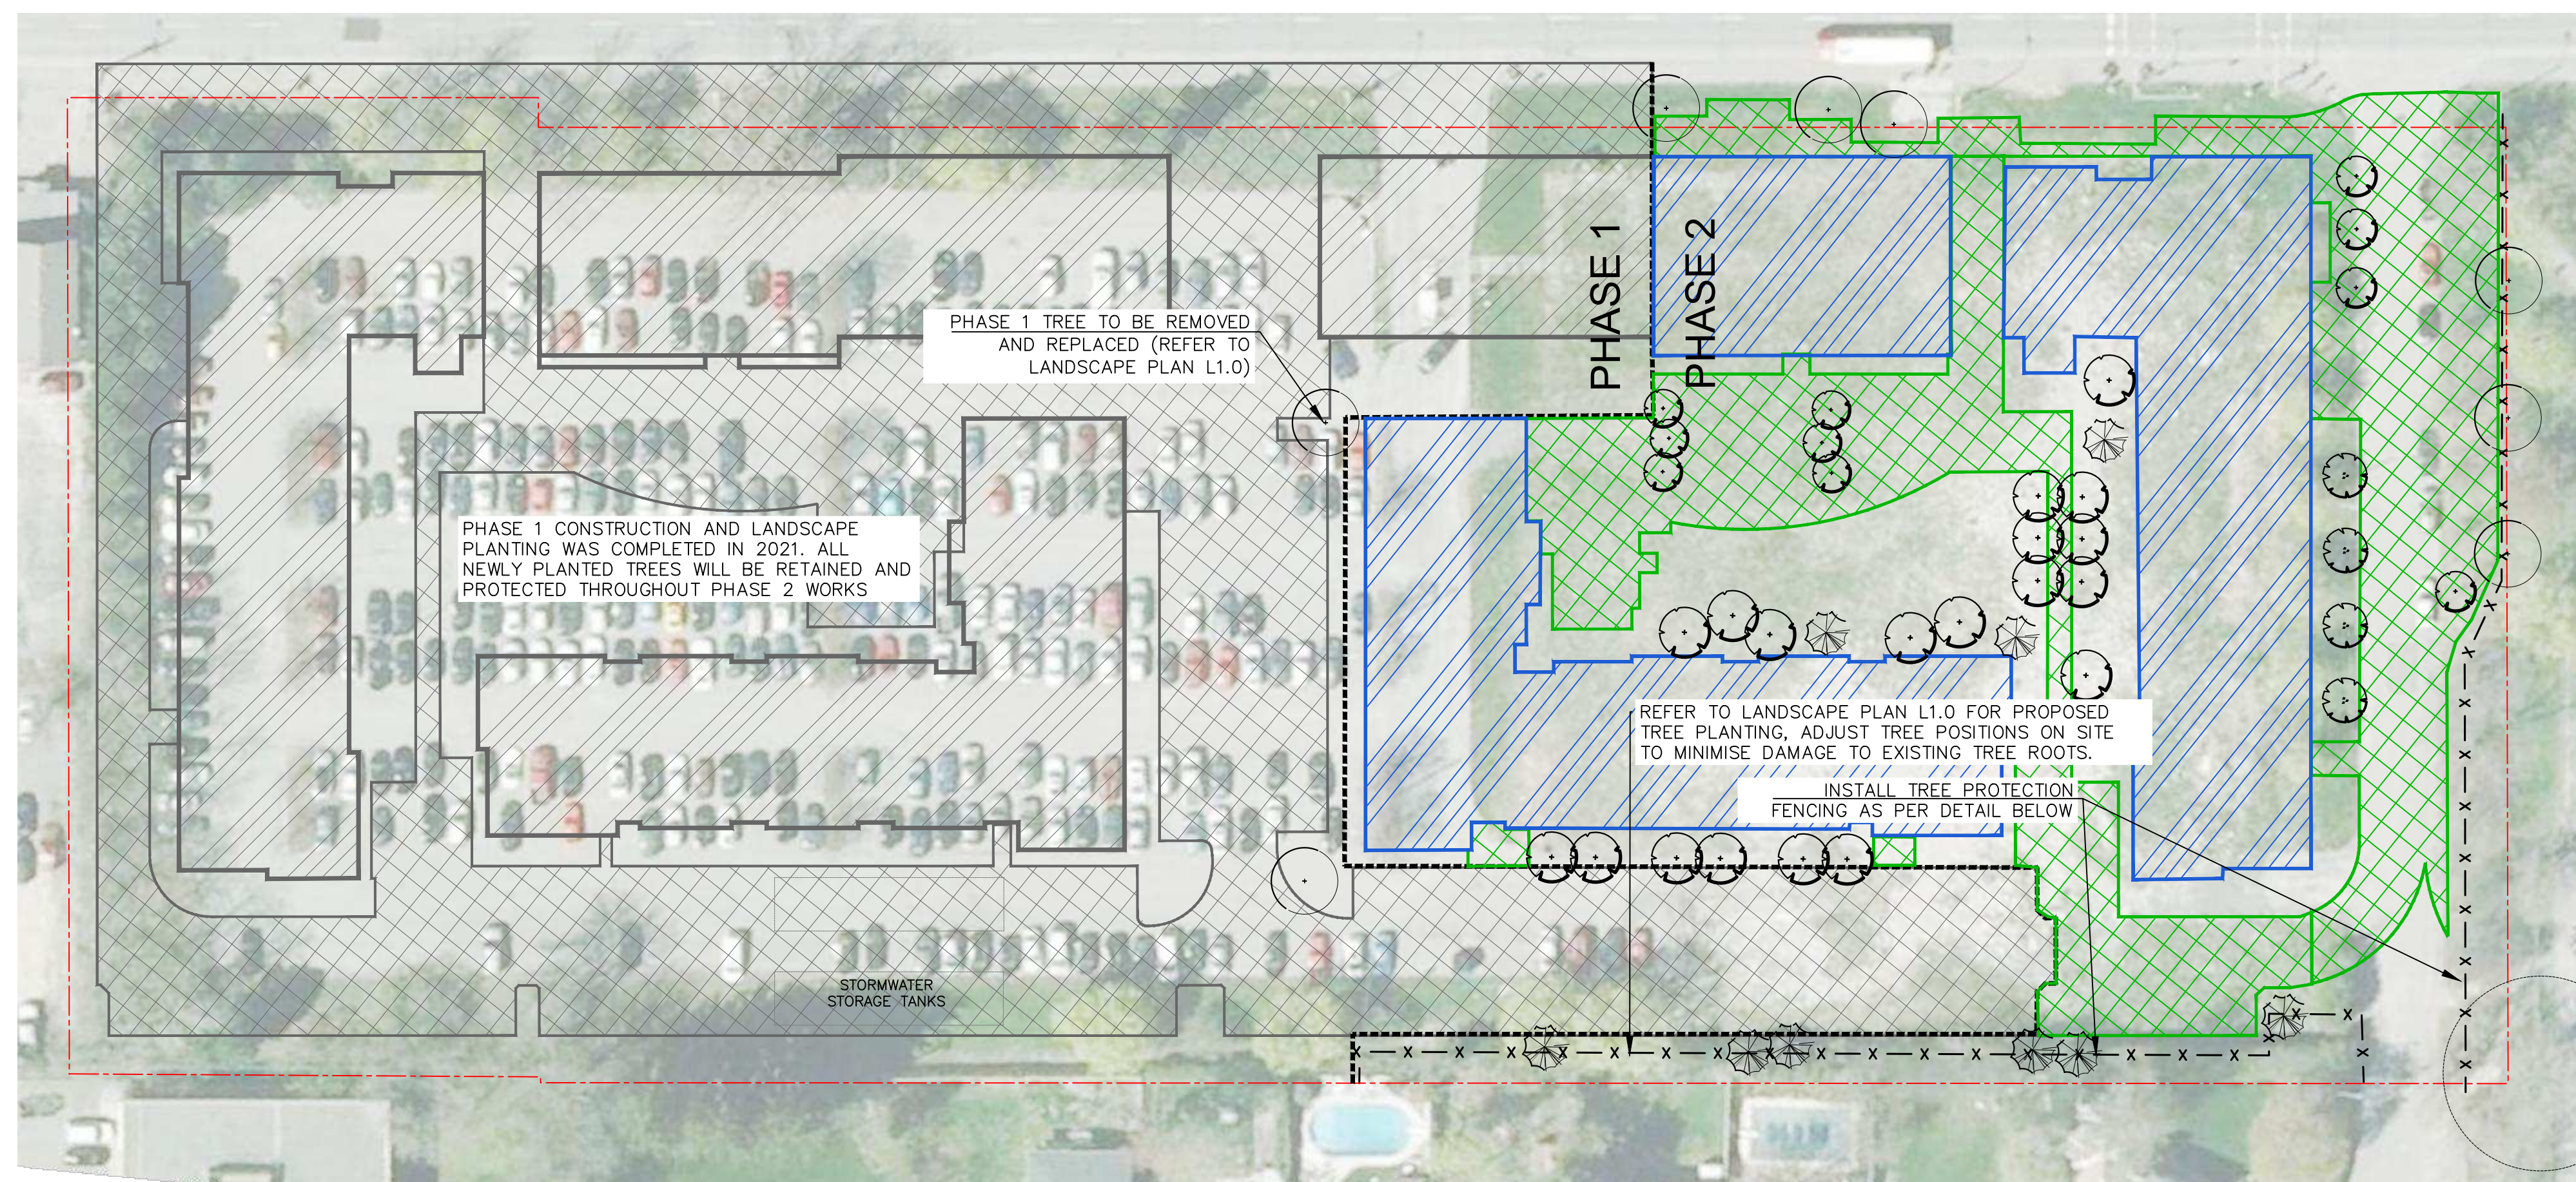
TREE CONSERVATION MAP 2 – PROPOSED DEVELOPMENT:

THIS GROUP CONSISTS OF PRIMARILY FRAXINUS PENNSYLVANICA (GREEN ASH) (THERE ARE 32) WHICH ARE ALL DEAD AND SHOW EVIDENCE OF THE EMERALD ASH BORER. THERE ARE ALSO TWO (2) ELAEAGNUS ANGSTIFOLIA (REMOVED DURING PHASE 1) THAT ARE IN MODERATE CONDITION. THEY HAVE DBHS RANGING FROM 10-18 CM. THERE ARE TWO (2) ULMUS PUMILA (SIBERIAN ELMS) THAT ARE IN MODERATE CONDITION WITH SOME MINOR DEAD BRANCHING IN THE CANOPY. THEIR DBH IS BETWEEN 14-22.

THIS GROUP IS THE MOST DIVERSE IN THE HEDGE ROW. THERE ARE SEVEN (7) REMOVED DURING PHASE 1 (SIBERIAN ELMS). FOUR (4) OF THE REMOVED TREES ARE IN SEVERE DECLINE. THE REMAINING THREE ARE IN MODERATE TO POOR CONDITION AND RANGE FROM 24-28 CM DBH. THERE ARE FOUR (4) FRAXINUS PENNSYLVANICA THAT ARE DEAD AND SHOW EVIDENCE OF EAB. THEY RANGE FROM

16-24 DBH. THREE (3) PINUS NIGRA (AUSTRIAN PINES) ARE ALSO LOCATED IN THIS GROUP. THEY ARE IN GOOD CONDITION AND RANGE FROM 14-32 DBH. THERE IS A LONE ACER (REMOVED DURING PHASE 1) (A MAPLE) THAT IS IN POOR CONDITION AND HAS A DBH OF 13 CM.

THIS GROUP IS LOCATED ALONG THE SOUTHERN EDGE OF THE PARKING LOT. IT IS COMPRISED OF ACER NEGUNDO (MANITOBA MAPLE) AND ELAEAGNUS ANGSTIFOLIA. ALL TREES IN THIS GROUP ARE POORLY FORMED AND LEA (REMOVED DURING PHASE 1) RANGES IN SIZE FROM 12-22CM DBH.

THIS GROUP IS LOCATED ON A BANK ALONG THE EASTERN EDGE OF HOBSON ROAD. IT IS COMPRISED OF FORTY EIGHT (48) ULMUS SP. (ELM) IN MODERATE TO GOOD CONDITION AND DBH RANGE FROM 10 - 25CM. THERE IS ALSO A LARGE AMOUNT OF RHAMMUS CATHARTICA (COMMON BUCKTHORN) AND TWO (2) CRATAEGUS SP. (HAWTHORN).

THIS GROUP CONSISTS OF NINE (9) FRAXINUS SP. (ASH) THAT ARE ALL DEAD AND SHOW EVIDENCE OF EAB. TREES RANGE IN SIZE FROM 15-30CM DBH.

GROUP F TO BE RETAINED.

GROUP F TO BE RETAINED, APPROX 1.5m STRIP OF BUCKTHORN TO BE CLEARED FROM EDGE OF PAVEMENT TO ALLOW FOR NEW NATIVE SHRUB PLANTING ADJACENT TO PATH.

GROUP G TO BE REMOVED AS REQUIRED FOR CONSTRUCTION LIMITS.
