Tree Conservation Report 424 Churchill Avenue North Ottawa, Ontario

Prepared for GSI Properties
By Arcadis IBI Group
June 26, 2025

| IBI REFERENCE: | 139413 |

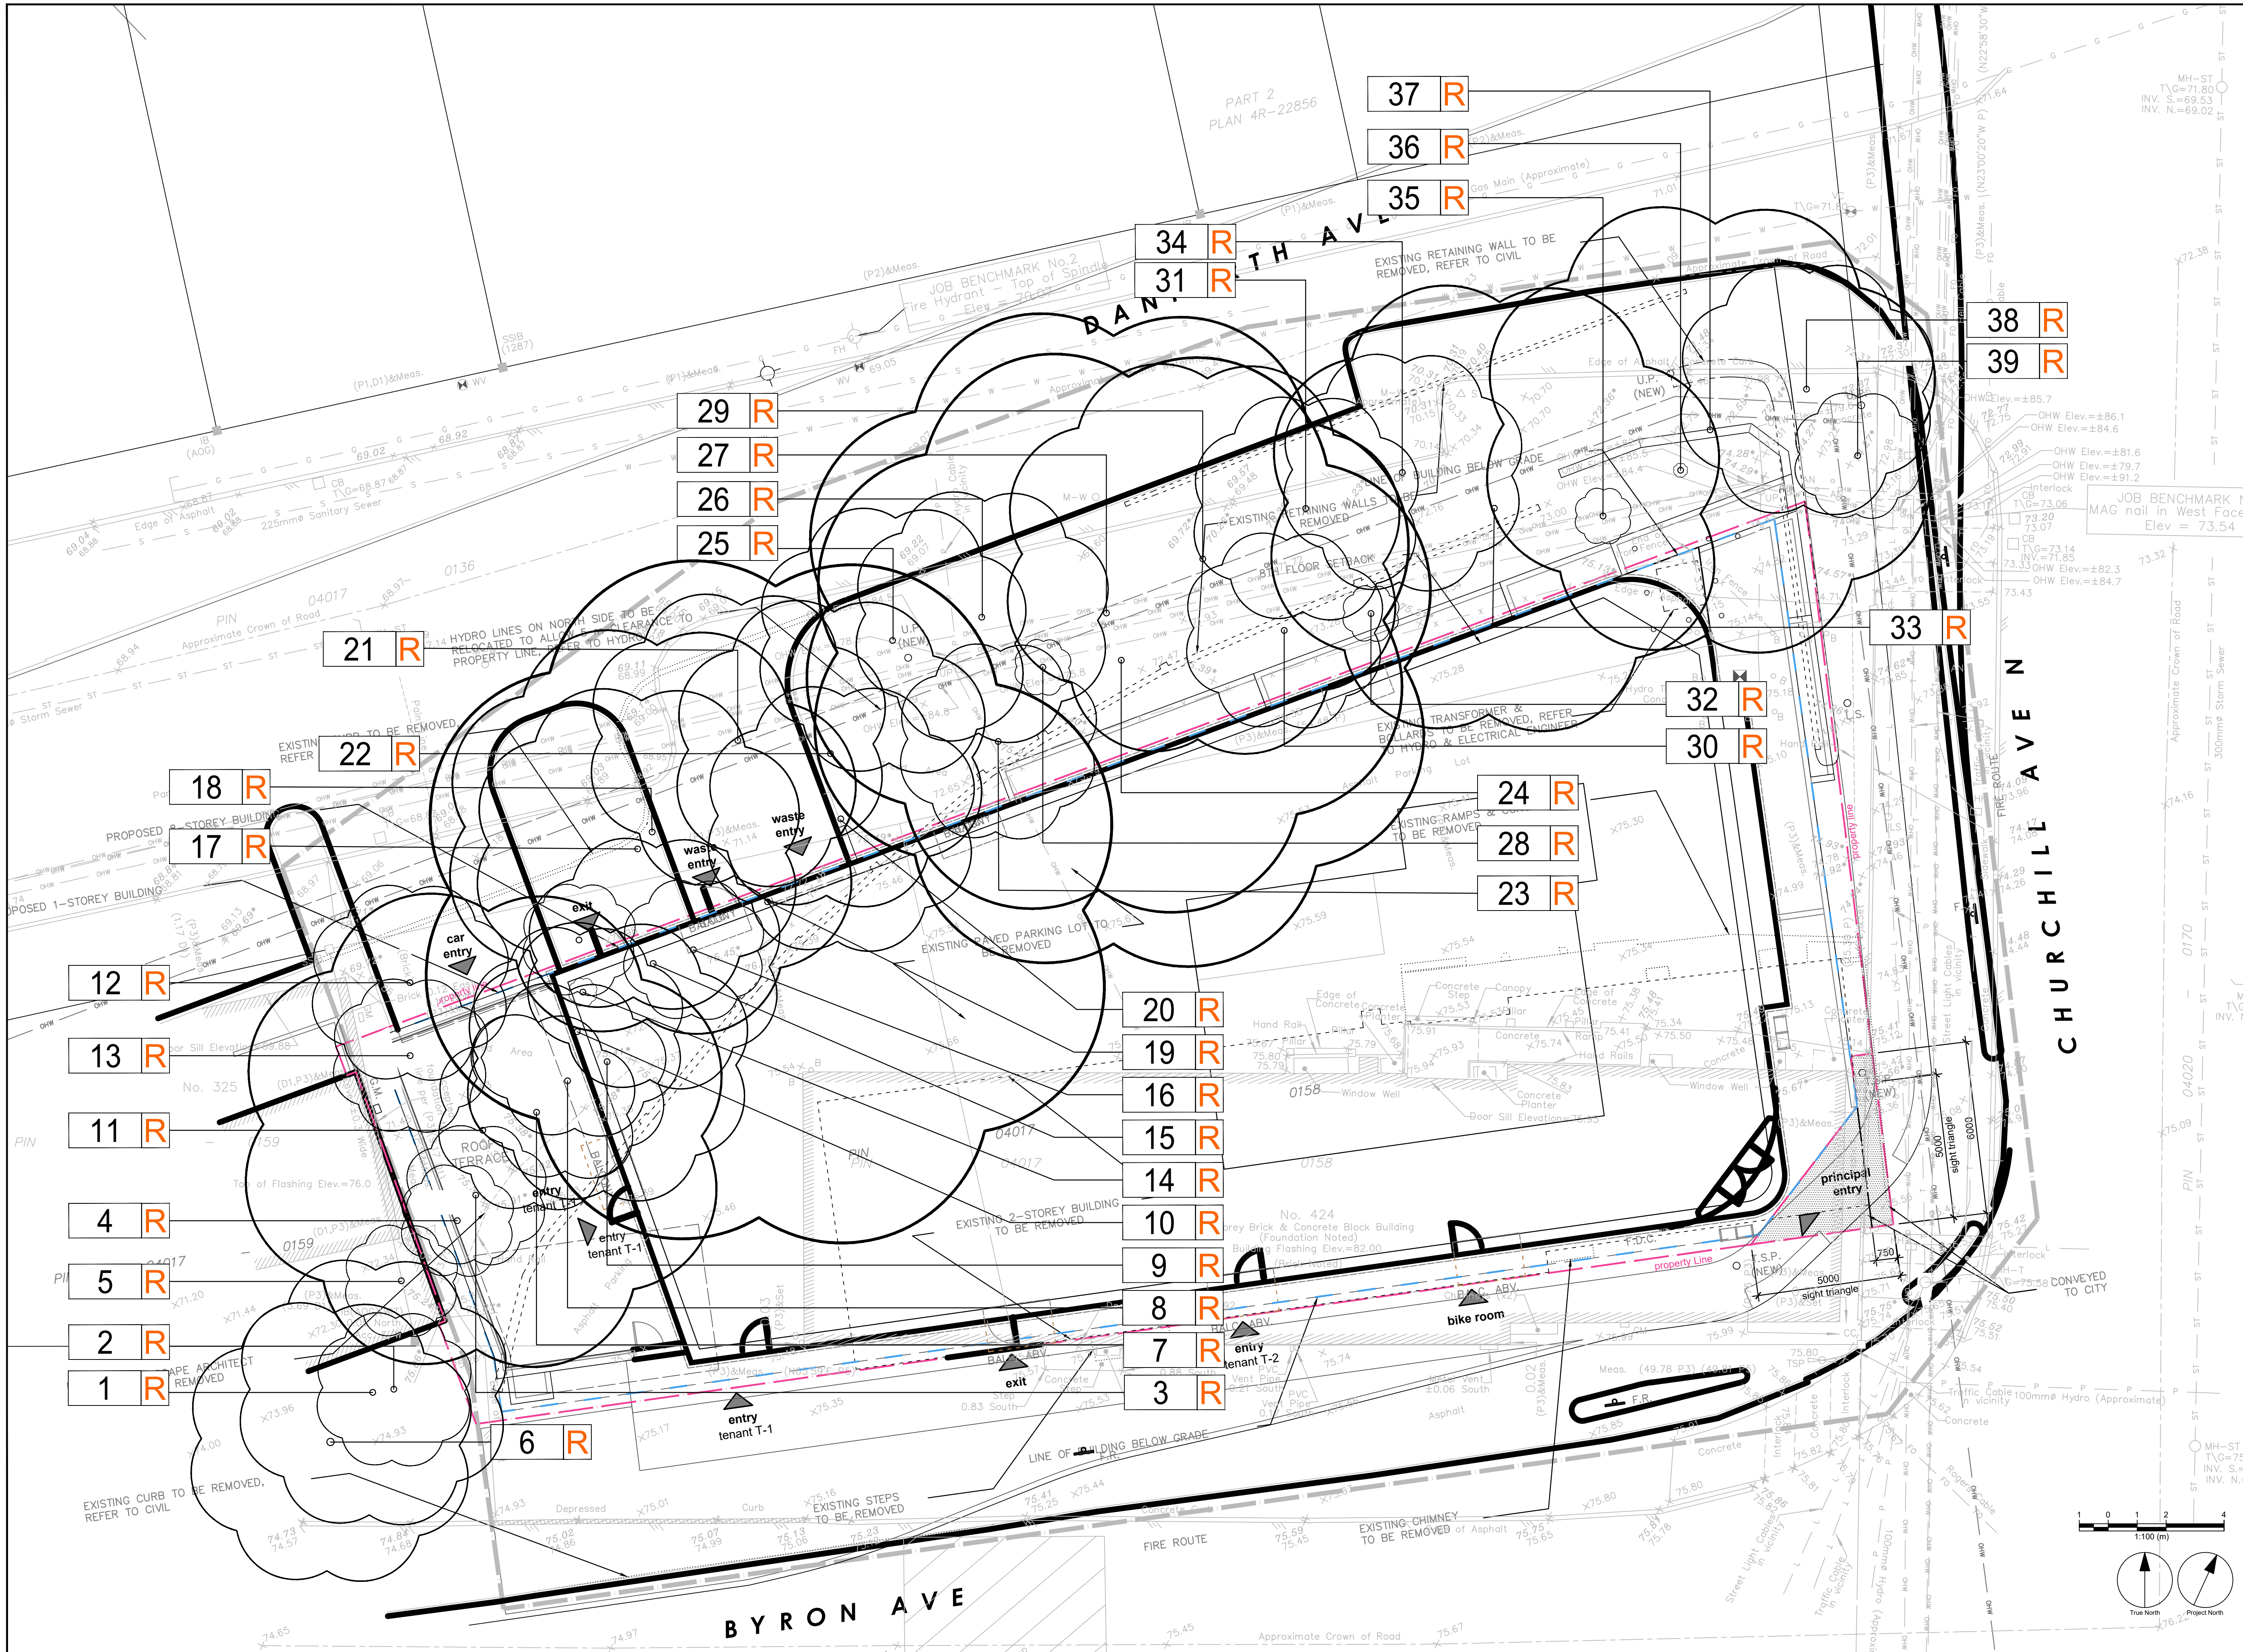
There are thirty-four (34) trees on the subject site that will need to be removed to facilitate the construction of the proposed building and development. There is one (1) dead tree within property that will also be removed within the proposed building area. There are four (4) trees on the adjacent property that will need to be removed to facilitate the construction of the proposed building and development.

- Thirty-nine (39) trees are recommended to be removed:
 - Thirty-four (34) live trees and one (1) dead tree on subject property
 - Four (4) live trees on adjacent property - Tree 1, Tree 2, Tree 5, and Tree 6

The limits of TPF have been indicated on the Tree Conservation Plan sheet TPP-1 and shall be considered to delineate the limits of work. All TPF shall conform to the City of Ottawa's current standards and Tree Protection Specification as shown on Detail 1-TPP2.
