Tree Conservation Report 424 Churchill Avenue North Ottawa, Ontario

CLIENT:	GSI Properties				
PROJECT NAME:	Tree Conservation Report 424 Churchill Avenue North Ottawa, Ontario				
REPORT TITLE:	Tree Conservation Report 424 Churchill Avenue North Ottawa, Ontario				
IBI REFERENCE: 139413					
VERSION:	1.0				
DIGITAL MASTER:	https://ibigroup.sharepoint.com/sites/Projects2/139413/Internal Documents/6.0_Technical/6.05_Landscape/03_Reports/LTR_424_Churchilll_2022-10-07_DRAFT.docx\2022-10-14\MG				
ORIGINATOR:	Tim McCormick				
REVIEWER:	Erin Hellinga				
AUTHORIZATION:	Tim McCormick				
CIRCULATION LIST:	Jemmy Taing (GSI Properties), Kris Benes (Open Plan Architects Inc.)				
HISTORY:

IBI GROUP DRAFT TREE CONSERVATION REPORT 424 CHURCHILL AVENUE NORTH OTTAWA, ONTARIO Submitted to GSI PROPERTIES

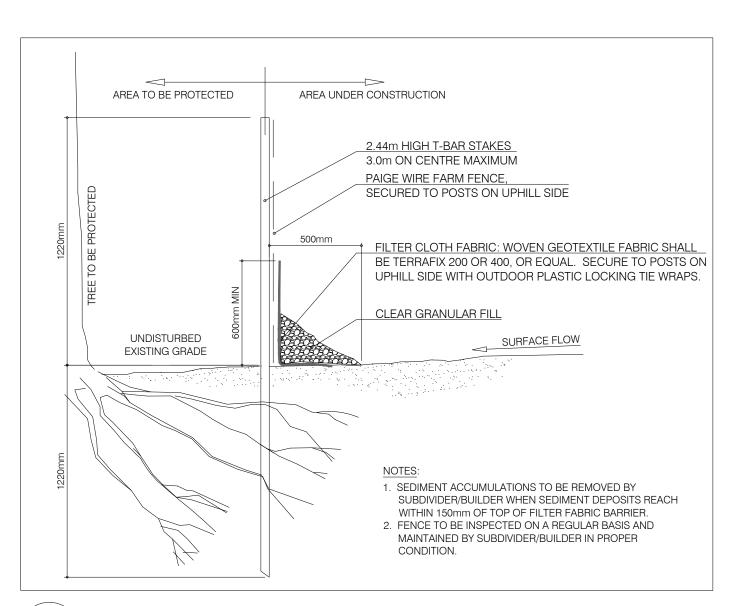
1 TREE PROTECTION SPECIFICATION

TO BE IMPLEMENTED FOR RETAINED TREES, BOTH ON SITE AND ON ADJACENT SITES, PRIOR TO ANY TREE REMOVAL OR SITE WORKS AND MAINTAINED FOR THE DURATION OF WORK ACTIVITIES ON SITE.

Tree Protection Fencing (TPF) is to be installed on site along the western property line to protect four (4) trees on the adjacent property (Appendix A). The limits of TPF have been indicated on the Tree Conservation Plan sheet TPP-1 and shall be considered to delineate the limits of work. All TPF shall conform to the City of Ottawa's current standards and Tree Protection Specification as shown on Detail 1-TPP2.
