**TREE CONSERVATION REPORT FOR
401 SMYTH ROAD,
CITY OF OTTAWA, ONTARIO**

Colville Consulting Inc.

Date: September 19th, 2023
File: C23080

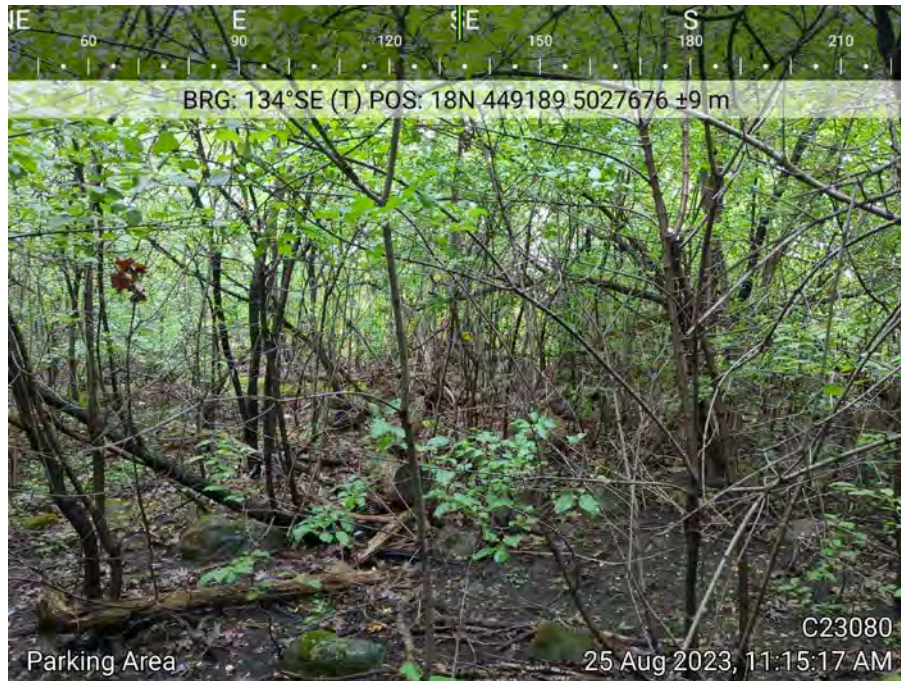
Of the trees to be removed, sixteen (16) are invasive common buckthorn. A significant amount of smaller common buckthorn was also observed within the hedgerows adjacent to Ring Road and within the thicket adjacent the woodland feature north of the proposed parking structure.

Photo 5: General condition of the buckthorn thicket on northside of parking area

- ◆ Tree hoarding for trees to be retained shall meet the City of Ottawa Tree Protection Specifications, as attached in Appendix F.
- ◆ Any Common Buckthorn or other invasive tree species observed during construction should be removed where feasible and areas replanted with native species where possible.

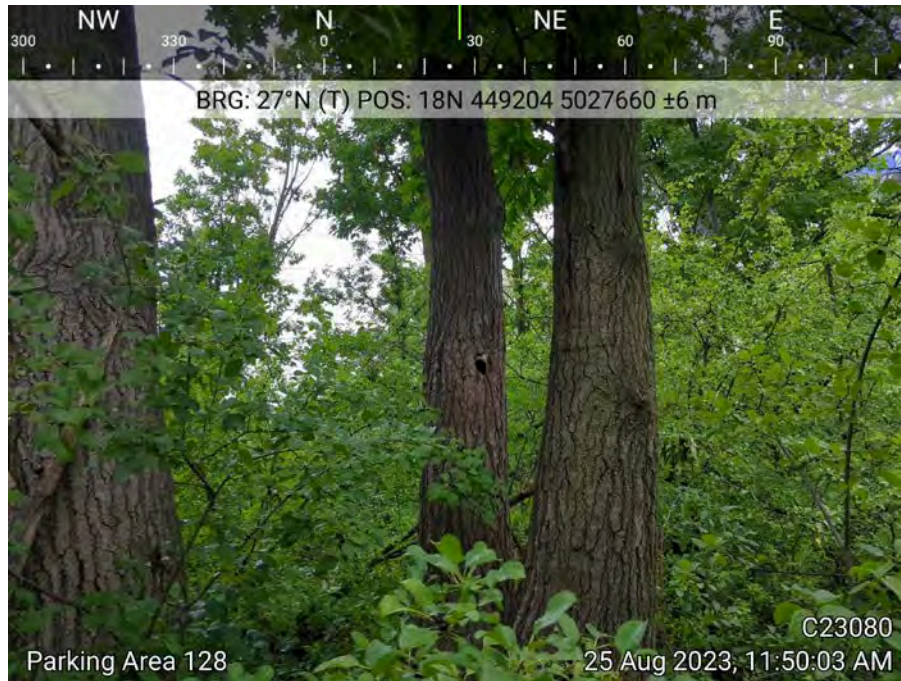
Photo 7: Northern Red Oaks in woodland feature, cavity visible mid stem.

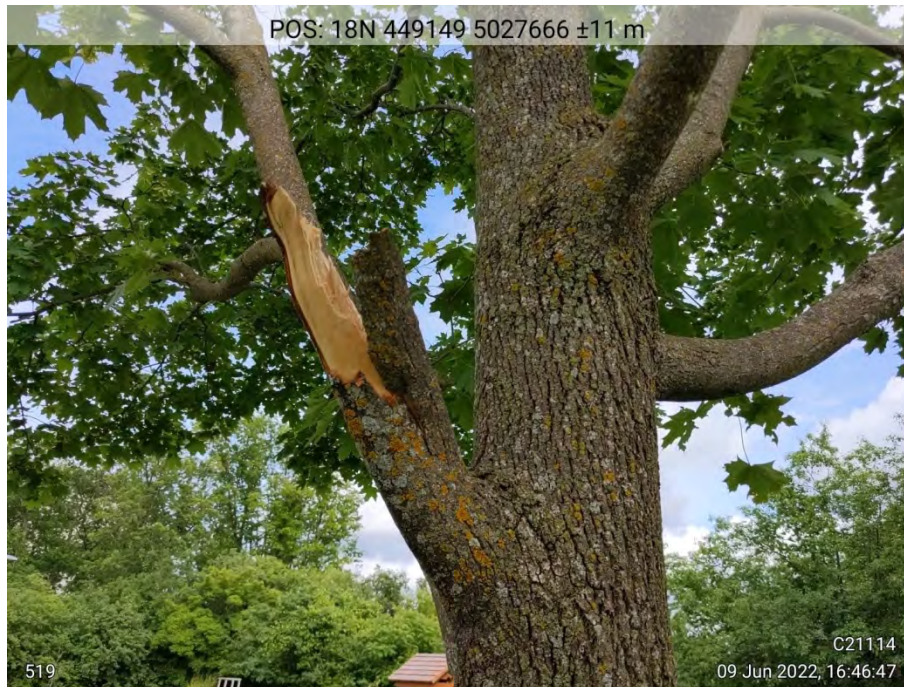
519	Norway Maple	<i>Acer platanoides</i>	Parking Structure	30	300	5	Good	Retain	Ripped lower limb	18T	5027666.60	449145.91
520	Norway Maple	<i>Acer platanoides</i>	Parking Structure	24	240	3	Fair	Retain	Union at 155cm, some dieback	18T	5027672.80	449139.65
521	Silver Maple	<i>Acer saccharinum</i>	Parking Structure	18	180	3	Good	Retain	Healed over frost crack	18T	5027667.52	449133.02
522	White Oak	<i>Quercus alba</i>	Parking Structure	54	540	7	Good	Retain	Some leaf wilt, good canopy.	18T	5027657.22	449145.77
523	Red Oak	<i>Quercus rubra</i>	Parking Structure	40	400	8	Good/Fair	Remove, grading	Buried root flare, 80% canopy, touching fence.	18T	5027646.62	449260.71
524	White Oak	<i>Quercus alba</i>	Parking Structure	28	280	4	Good	Remove, grading	90% canopy.	18T	5027590.18	449250.69
525	Red Oak	<i>Quercus rubra</i>	Parking Structure	42	420	6	Good	Retain	Good canopy condition, good taper.	18T	5027661.40	449204.91

Photo 13: Ripped limb damage on tree #519

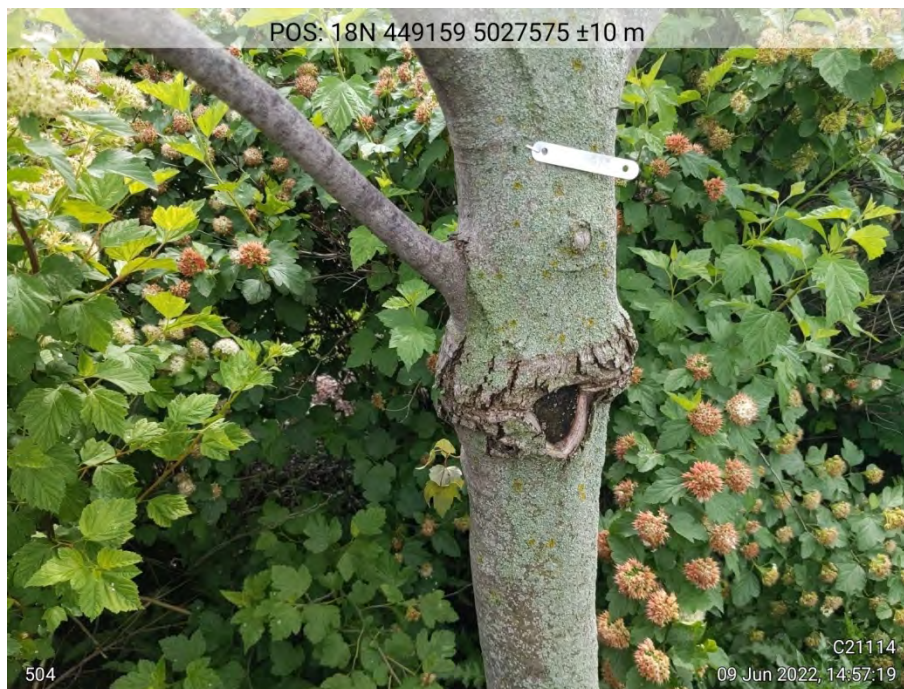
Photo 14: Trunk girdling on tree #504

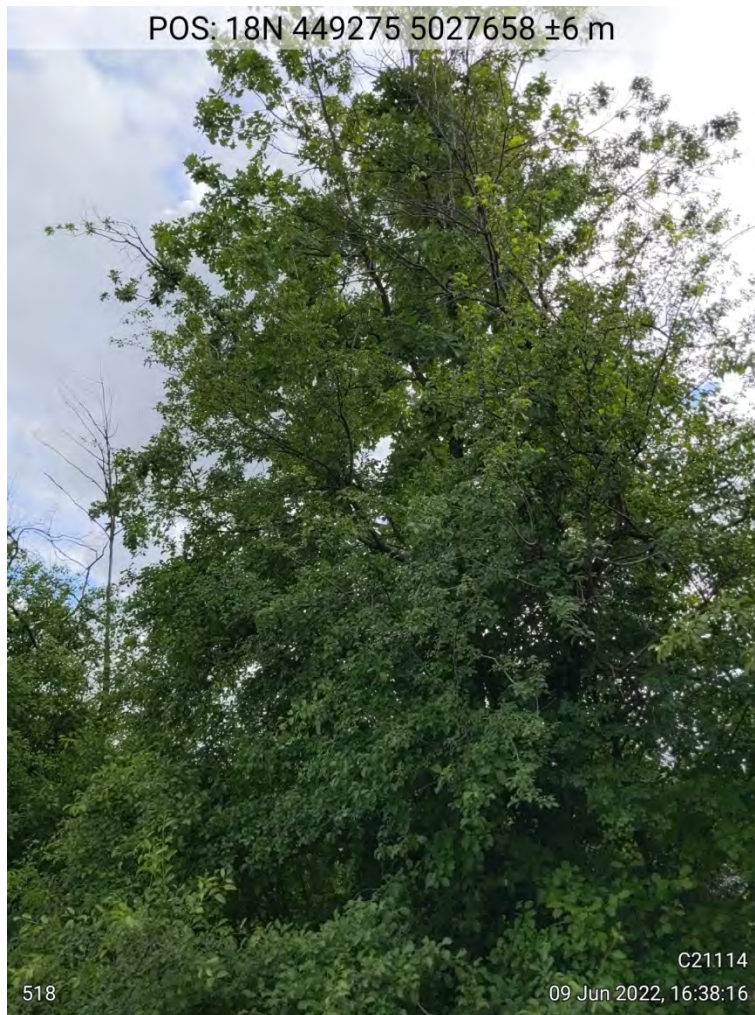
Photo 15 : White Oak #518 at northeast corner of parking lot, surrounded by Common Buckthorn.

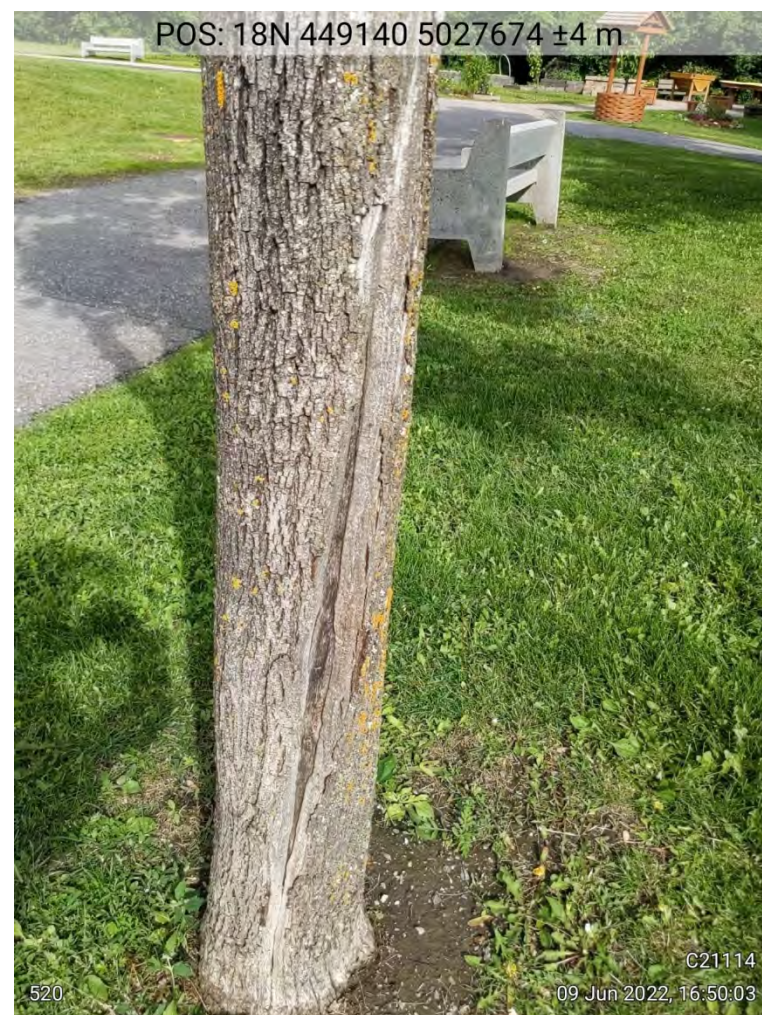
Photo 16: Frost crack on tree #520.

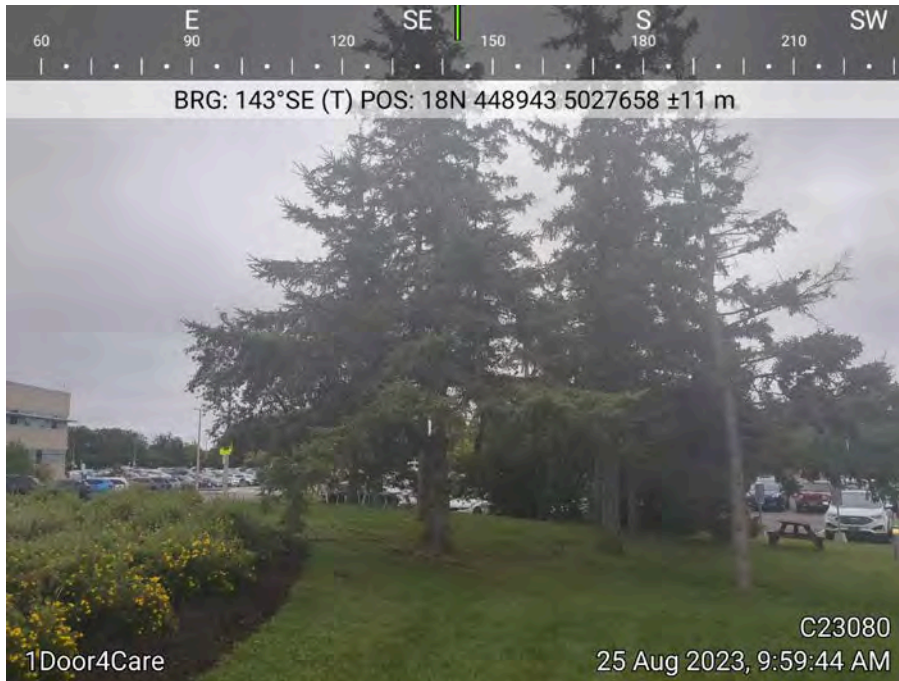
Photo 5: View of trees to be removed in footprint of new building.

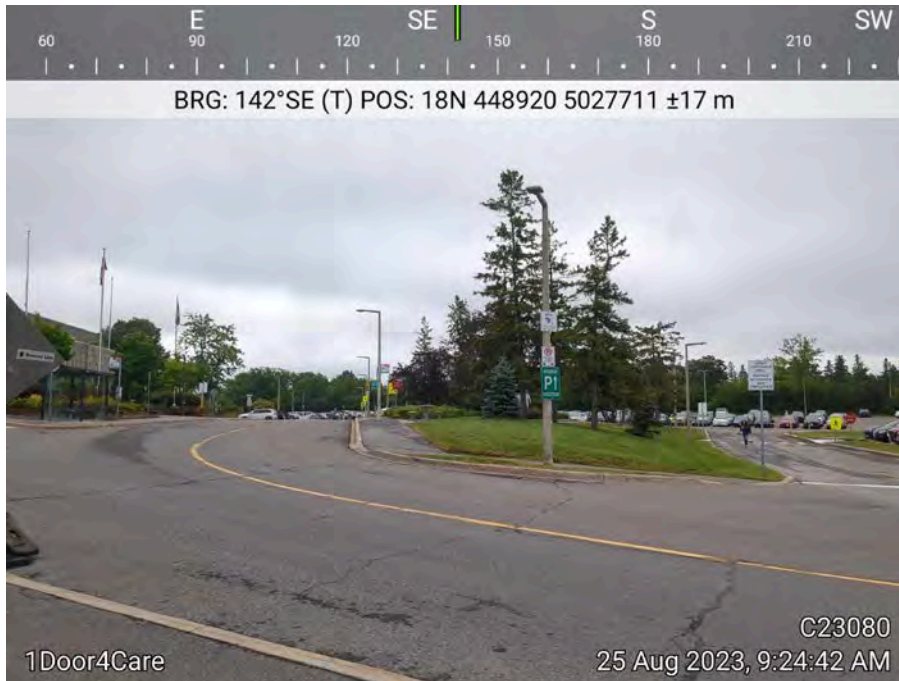
Photo 7: View of trees to be removed southwest of patient drop off door.

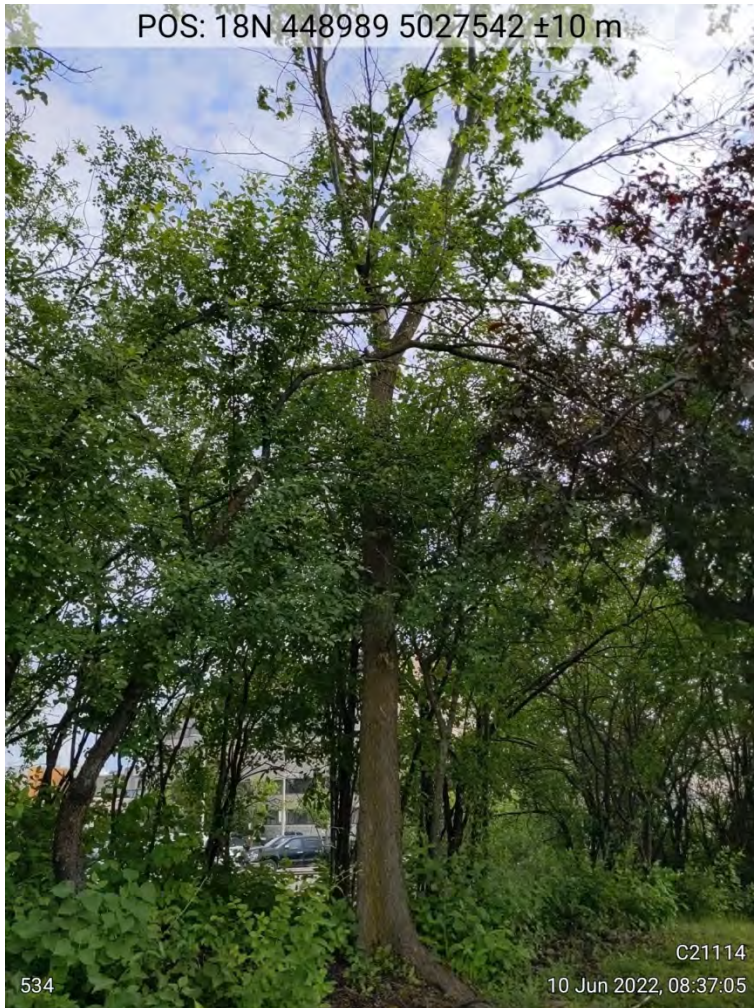
Photo 11: Tree #534 in poor/fair condition with significant canopy dieback.

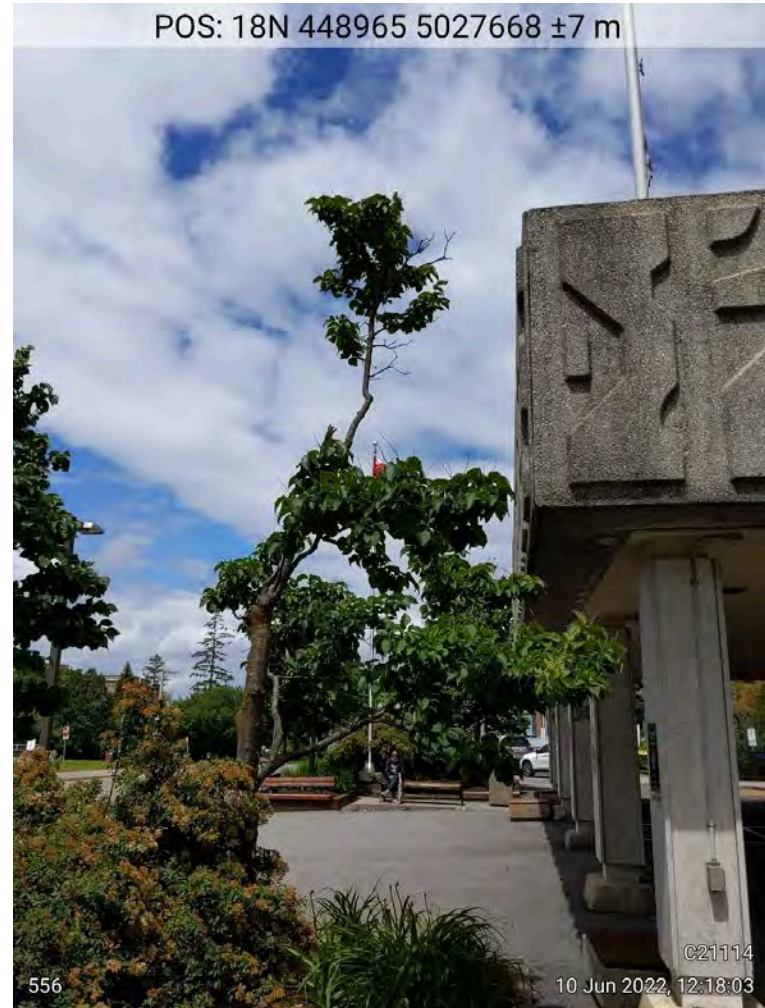
Photo 12: Tree #556 adjacent CHEO main entrance, fair condition with reduced canopy.

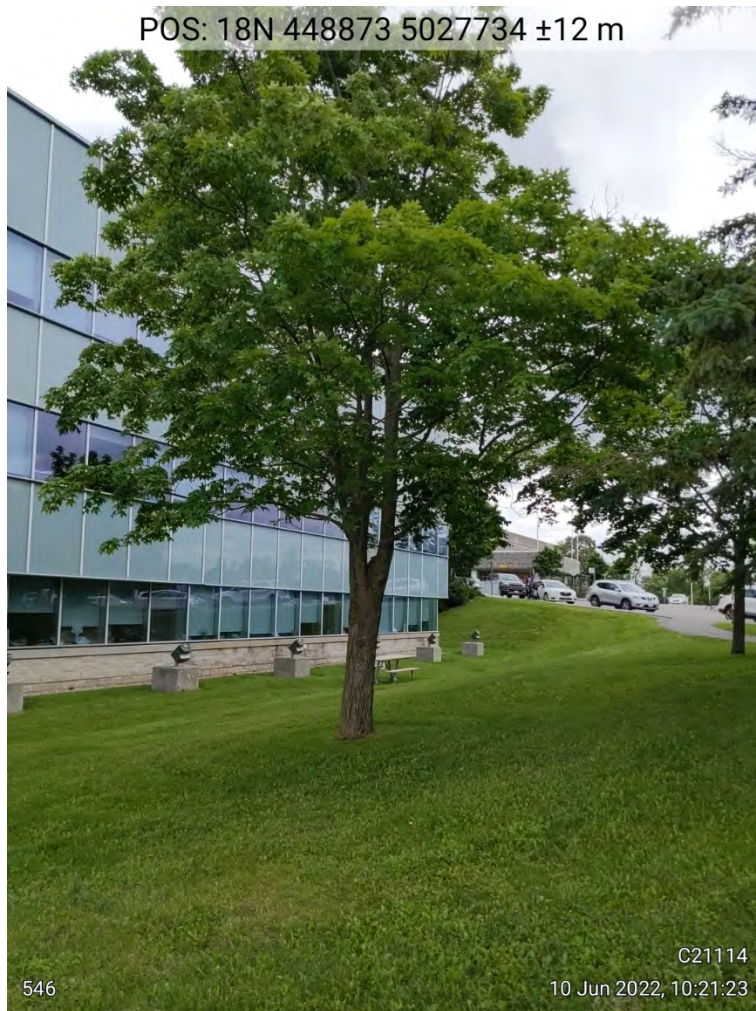
546	Sugar Maple	<i>Acer saccharum</i>	Treatment Facility	42	420	5	Good/Fair	Remove, construction	Union at 1.5m, codominant	18T	5027727.87	448885.80
547	White Spruce	<i>Picea glauca</i>	Treatment Facility	38	380	5	Good	Remove, construction	No sign of disease	18T	5027721.64	448884.34
548	Norway Maple	<i>Acer platanoides</i>	Treatment Facility	26	260	4	Good	Remove, construction	Good canopy, good taper.	18T	5027718.03	448891.44
549	Sugar Maple	<i>Acer saccharum</i>	Treatment Facility	34	340	4	Fair	Remove, construction	dieback in crown, broken branches removed.	18T	5027713.09	448883.92
551	White Spruce	<i>Picea glauca</i>	Treatment Facility	34	340	3	Fair	Remove, construction	Dieback in crown, good taper.	18T	5027707.69	448888.49
552	Norway Maple	<i>Acer platanoides</i>	Treatment Facility	46	460	3	Good	Remove, construction	Good canopy	18T	5027709.60	448895.52
553	Norway Maple	<i>Acer platanoides</i>	Treatment Facility	24	240	4	Good	Retain	On slope, adjacent existing CHEO	18T	5027705.62	448928.51

Photo 13: Tree #546, weak union at 1.5 metres.

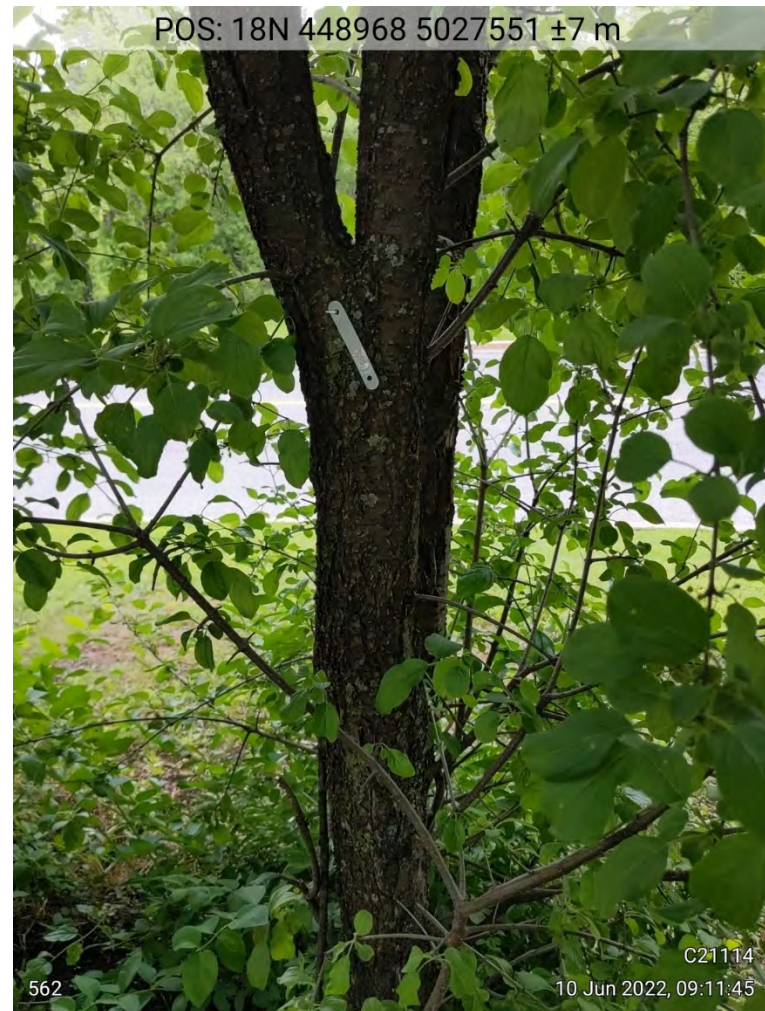
Photo 14: Tree #562, example of larger DBH Common Buckthorn present in hedgerows around parking area.
