URBAN FORESTRY & FOREST MANAGEMENT CONSULTING

December 16, 2022

# RE: TREE CONSERVATION REPORT FOR 3430 CARLING AVENUE, OTTAWA

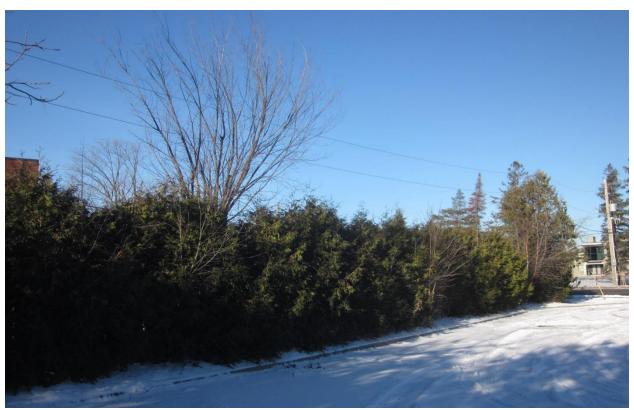
Table 1	Species, condition, size (diameter) and status of trees located on or shared with 3430 Carling Avenue					
Tree	Tree species	Condition	DBH <sup>1</sup>	Owner	Age class, tree condition notes & <b>preservation status</b> (to be removed or	
No.		$(VP \rightarrow E)$	(cm)	-ship	preserved and protected)	
1	Eastern white	Fair	15 &	Private	Mature individual tree within hedge; double-stemmed from grade; fair crown	
	cedar (Thuja		27		density, growth increment and needle colour; native species; <b>to be removed</b>	
	occidentalis)				(conflicts with underground parking)	
2	Eastern white	Fair	<10	Private	Immature hedge; fair crown density, growth increment and needle colour;	
	cedar (Thuja				competing ash (Fraxinus spp.), Siberian elm (Ulmus pumila) and linden (Tilia	
	occidentalis)				spp.) growth diminishing condition; <b>to be removed</b> (conflicts with underground	
					parking)	
3	White elm	Poor	17	Shared	Mature; central stem with five competing leaders at 2m from grade – topped in

Picture 1. Cedar hedge #2 at 3430 Carling Avenue (cedar tree #1 is on the far right and shared dead elm #3 on left)

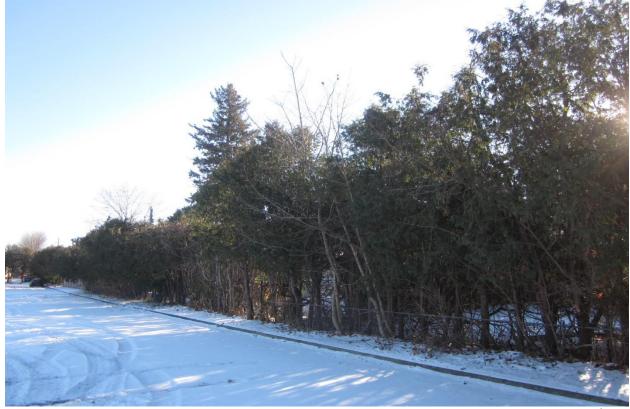
(Ulmus				past; dead due to Dutch elm disease (Ophiostoma novo-ulmi); native species; to	
	americana)				be removed (dead)	
4	Black walnut	Good	26 &	Shared	Mature; double-stemmed at 0.3m from grade; western stem topped at 3m due to	
	(Juglans nigra)		31		overhead Hydro lines; native species; to be preserved and protected	
5	Eastern white	Fair	15	Private	Maturing hedge; fair crown density, growth increment and needle colour; heavy	
	cedar (Thuja		avg.		vine (Vitas spp.) and Norway maple (Acer platanoides) growth diminishing	
	occidentalis)				condition; to be preserved and protected (except in selected areas of diminished	
					condition where solid fencing will be installed for snow storage/containment)	
6	Eastern white	Good	15	Private	Maturing hedge; good crown density, growth increment and needle colour; <b>to be</b>	
	cedar (Thuja		avg.		preserved and protected	
	occidentalis)					
7	Eastern white	Poor	<10	Private	Immature hedge; poor crown density, growth increment and needle colour; very

Picture 2. Cedar hedge #5 at 3430 Carling Avenue

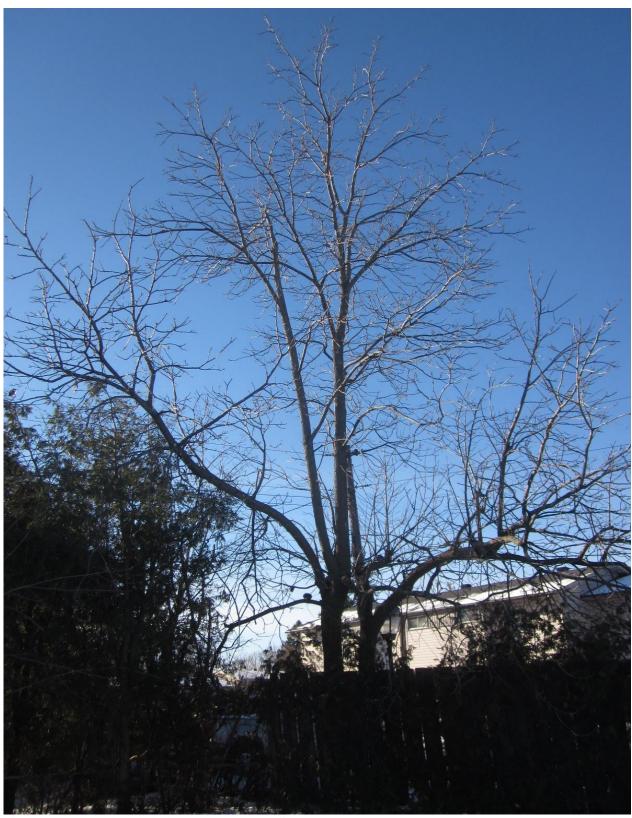
Picture 3. Tree #4, shared black walnut at 3430 Carling Avenue

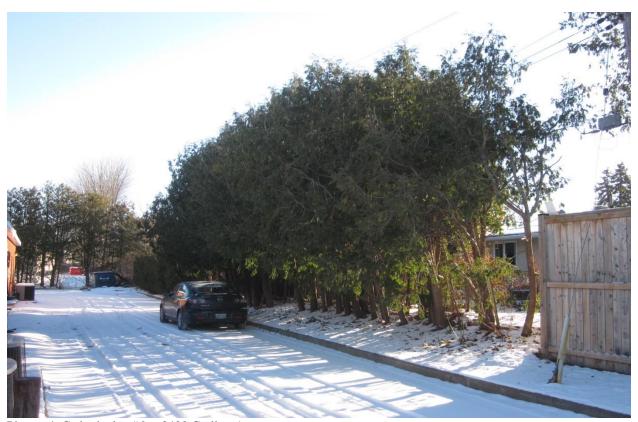
Picture 4. Cedar hedge #6 at 3430 Carling Avenue

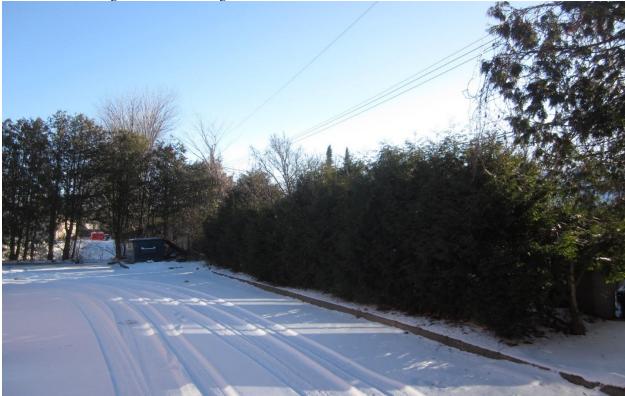
Picture 5. Cedar hedge #7 at 3430 Carling Avenue

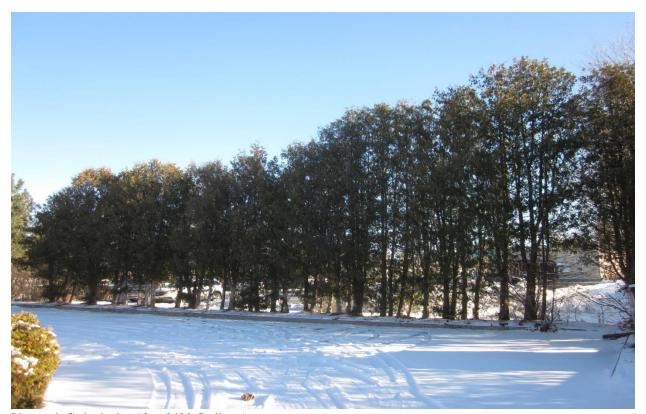
cedar (Thuja				heavy vine growth greatly diminishing condition; to be preserved and protected	
	occidentalis)					
8	Eastern white	Good	12	Private	Maturing hedge; good crown density, growth increment and needle colour; to be	
	cedar (Thuja		avg.		fully preserved and protected	
	occidentalis)					
9	Austrian pine	Poor	25	Private	Mature; poor crown density, growth increment and needle colour; heavily	
	(Pinus nigra)				divergent and asymmetric towards northeast; strong sweep in main stem at 4.5m;	
					introduced species; to be removed (conflicts with construction)

Picture 6. Cedar hedge #8 at 3430 Carling Avenue

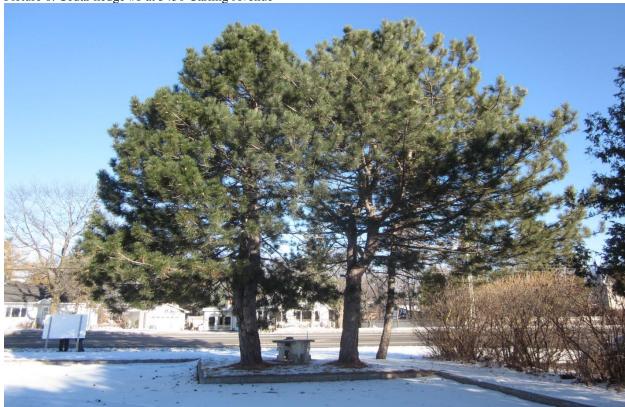
Tree	Tree species	Condition	DBH <sup>1</sup>	Owner	Age class, tree condition notes & <b>preservation status</b> (to be removed or
No.		$(VP \rightarrow E)$	(cm)	-ship	preserved and protected)
10	Austrian pine	Fair	46	Private	Mature; fair crown density, growth increment and needle colour; moderately
	(Pinus nigra)				divergent and asymmetric towards southeast; co-dominant stems at 3m; to be
					removed (conflicts with construction)
11	Austrian pine	Good	54 (at	Private	Mature; good crown density, growth increment and needle colour; moderately
	(Pinus nigra)		1m)		divergent and asymmetric towards southwest; co-dominant stems at 1.5m; to be
					removed (conflicts with construction)

Picture 7. Austrian pines #9 (right background), 10 and 11 (left to right) at 3430 Carling Avenue
