May 3, 2023

RE: TREE CONSERVATION REPORT FOR 2700 SWANSEA CRESCENT, OTTAWA

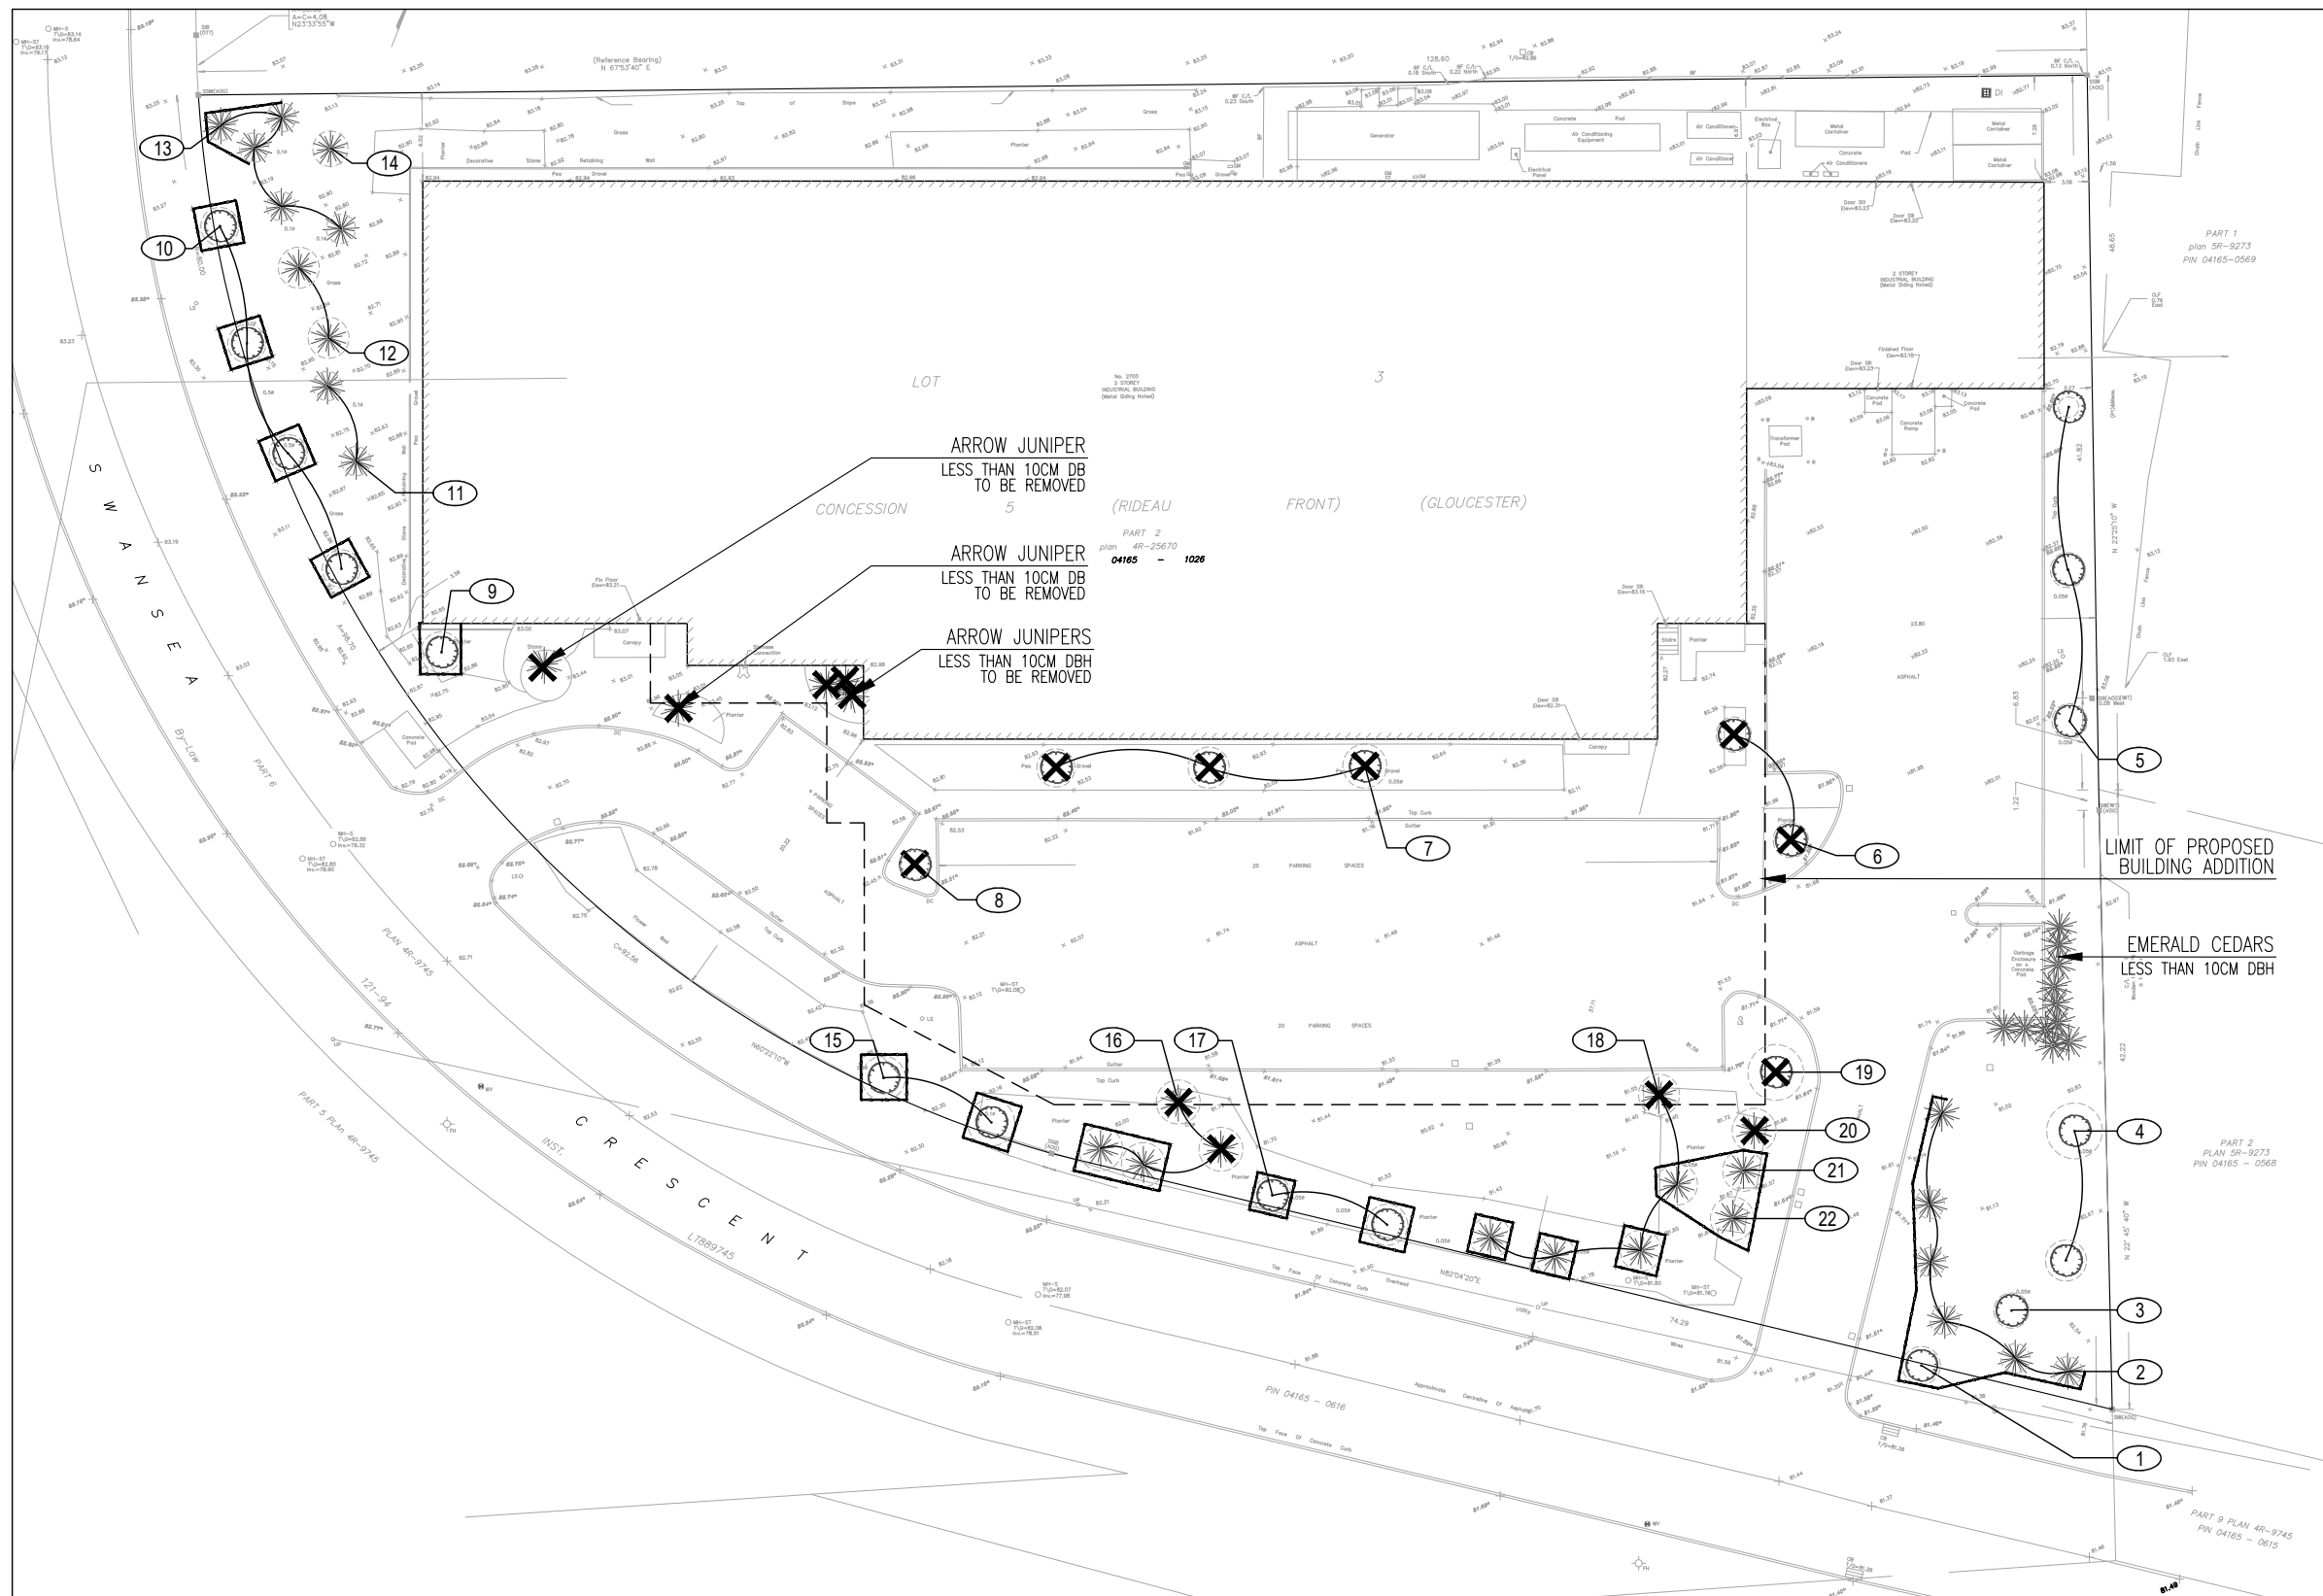
drawing **MAP # 1A - CURRENT VEGETATION**

REFER TO MAP # 1B FOR TREE PROTECTION DETAIL

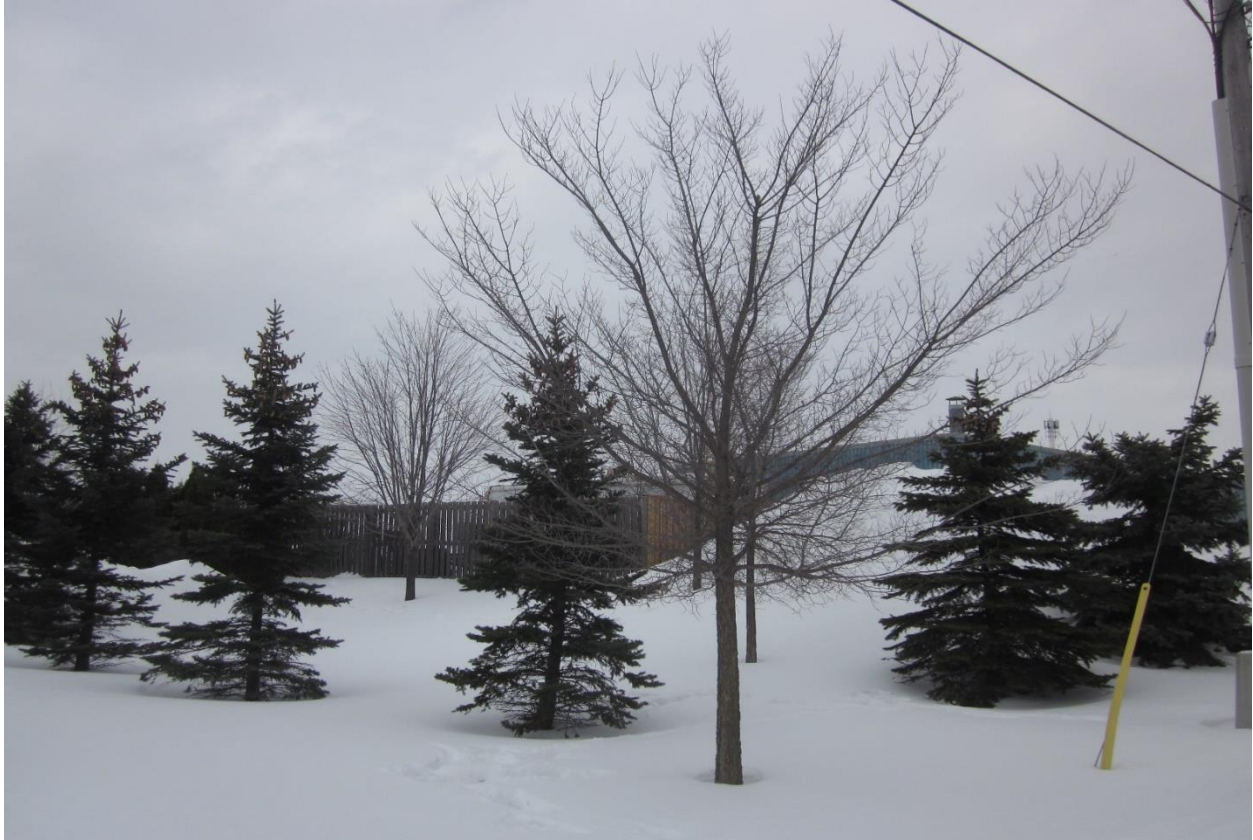
Picture 1. Trees/groupings #1-4 at 2700 Swansea Crescent

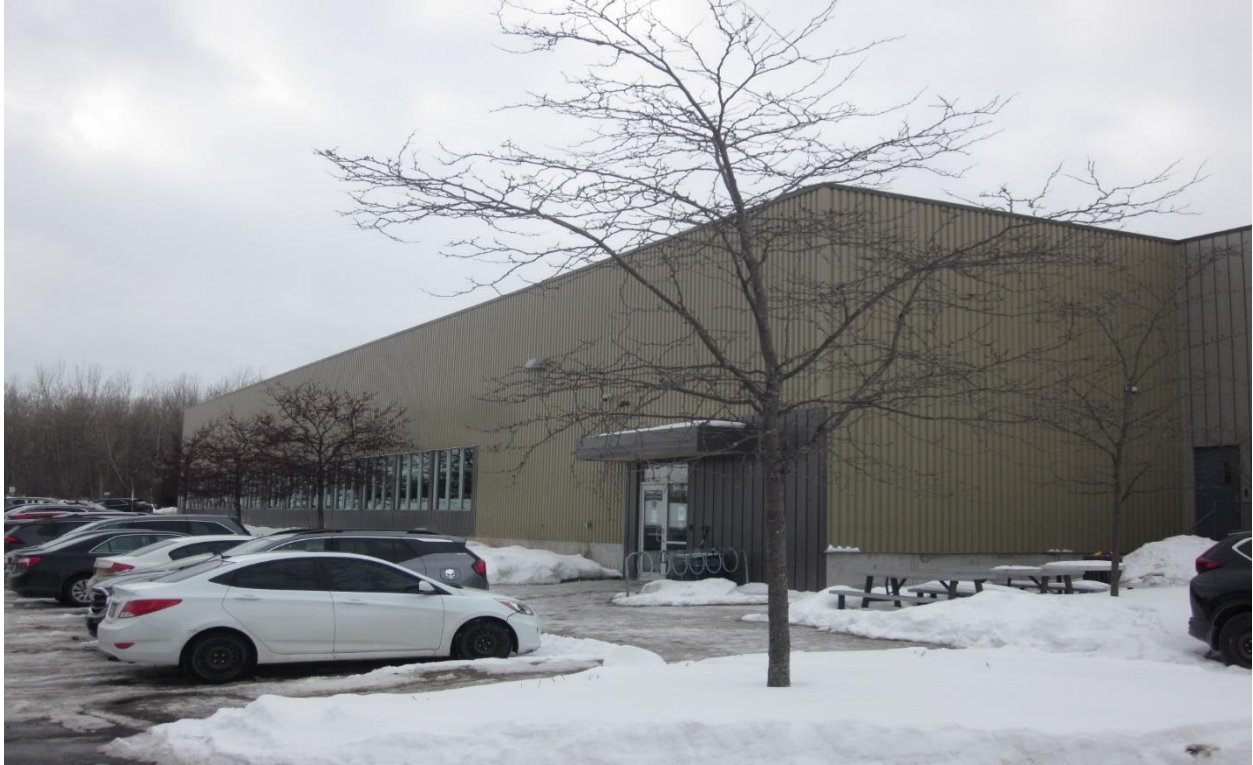
Picture 2. Tree groupings #6 and 7 at 2700 Swansea Crescent

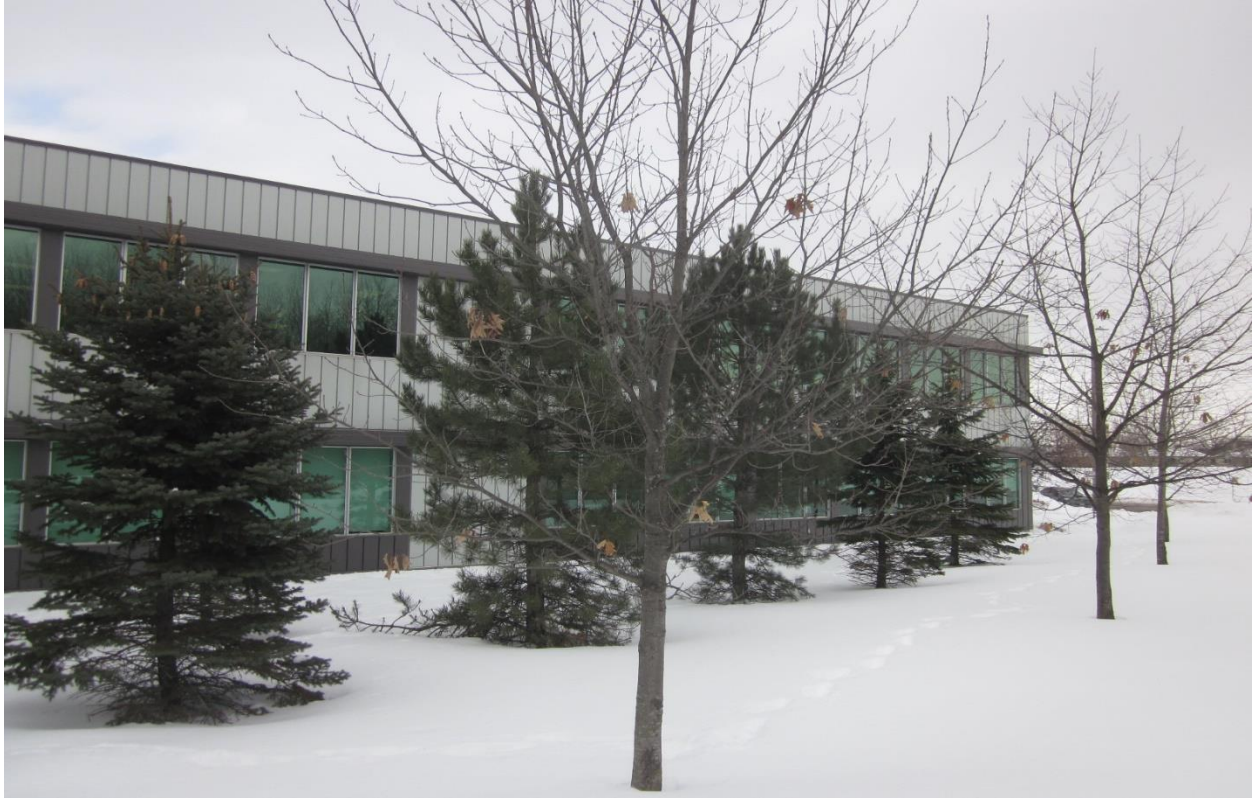
Picture 3. Tree groupings #10, 11 and 12 at 2700 Swansea Crescent

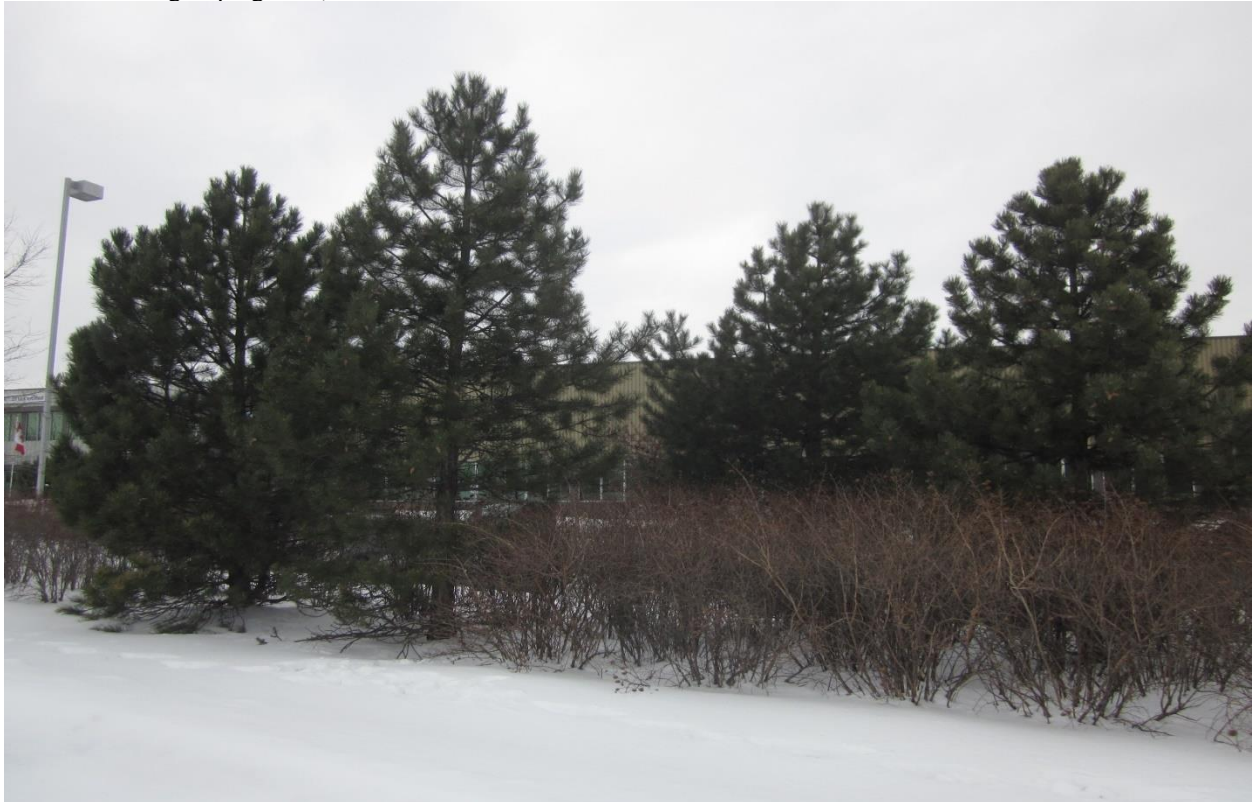
Picture 4. Tree groupings #16 at 2700 Swansea Crescent
