TREE CONSERVATION REPORT V2.0

30 Auriga Drive, Part 10

Tree Conservation Report submitted as Partial
Requirements for a Site Plan Control Application,
July 12, 2023

Dendron Forestry Services

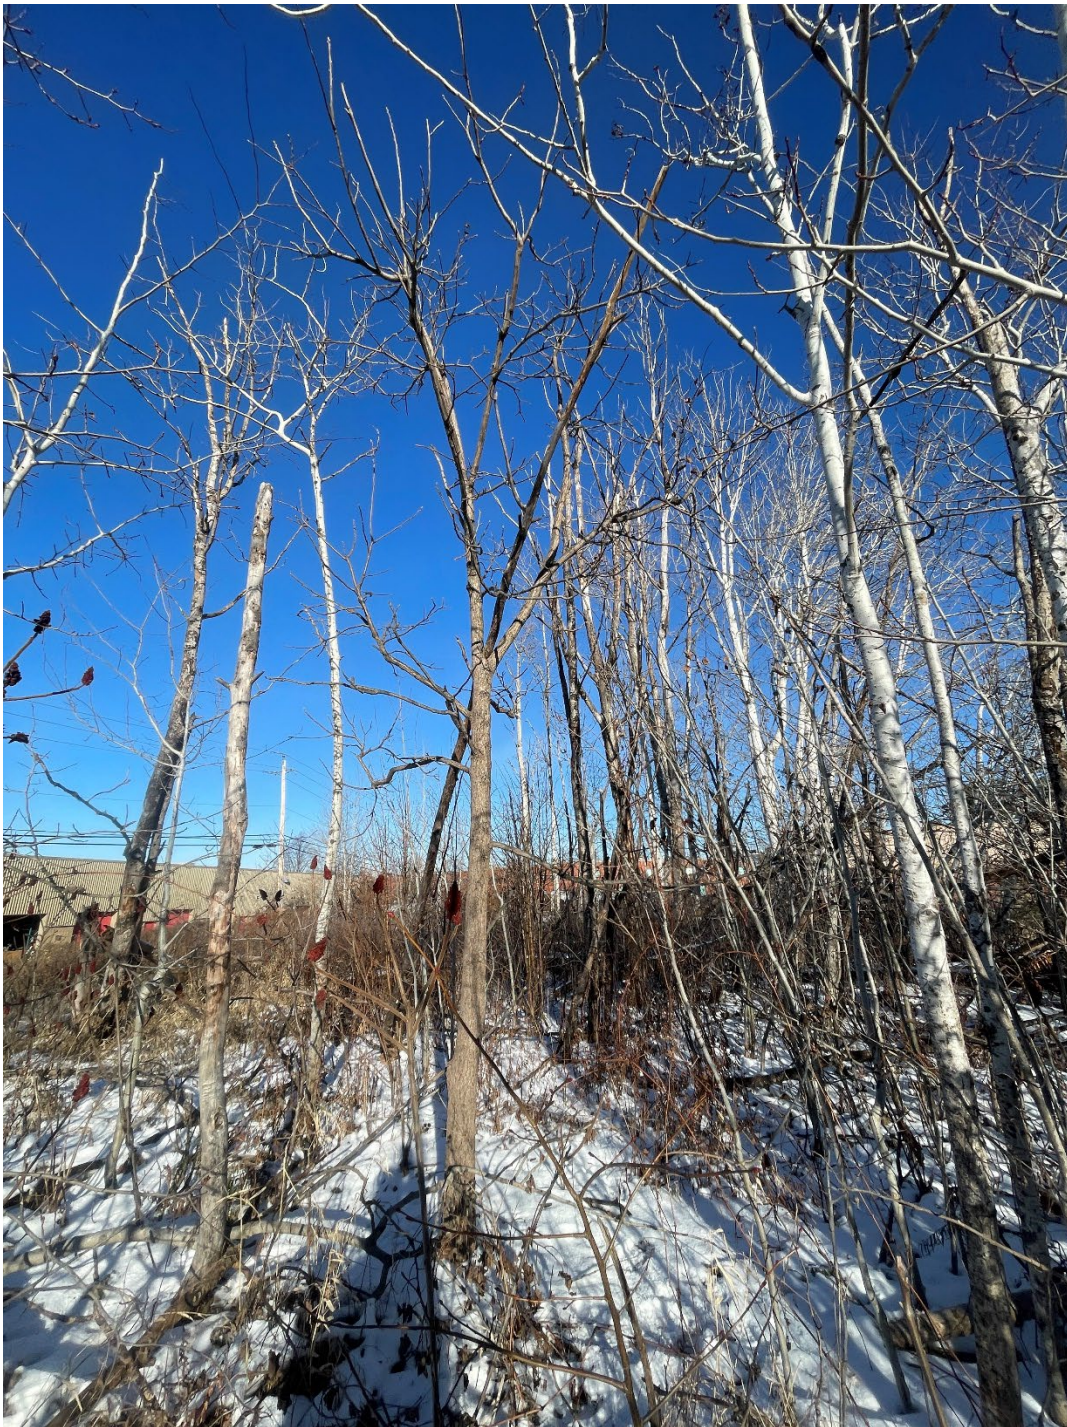
Trees began establishing in this area approximately 30 years ago and consist mainly of *Populus tremuloides* which range from approximately 10 – 30 cm in diameter. There is an abundance of regeneration of *Tilia americana* and *Fraxinus spp.* One 13 cm black walnut (*Juglans nigra*) was also identified in this section.

Figure 2: Polygon B, medium sized poplars in the northern section

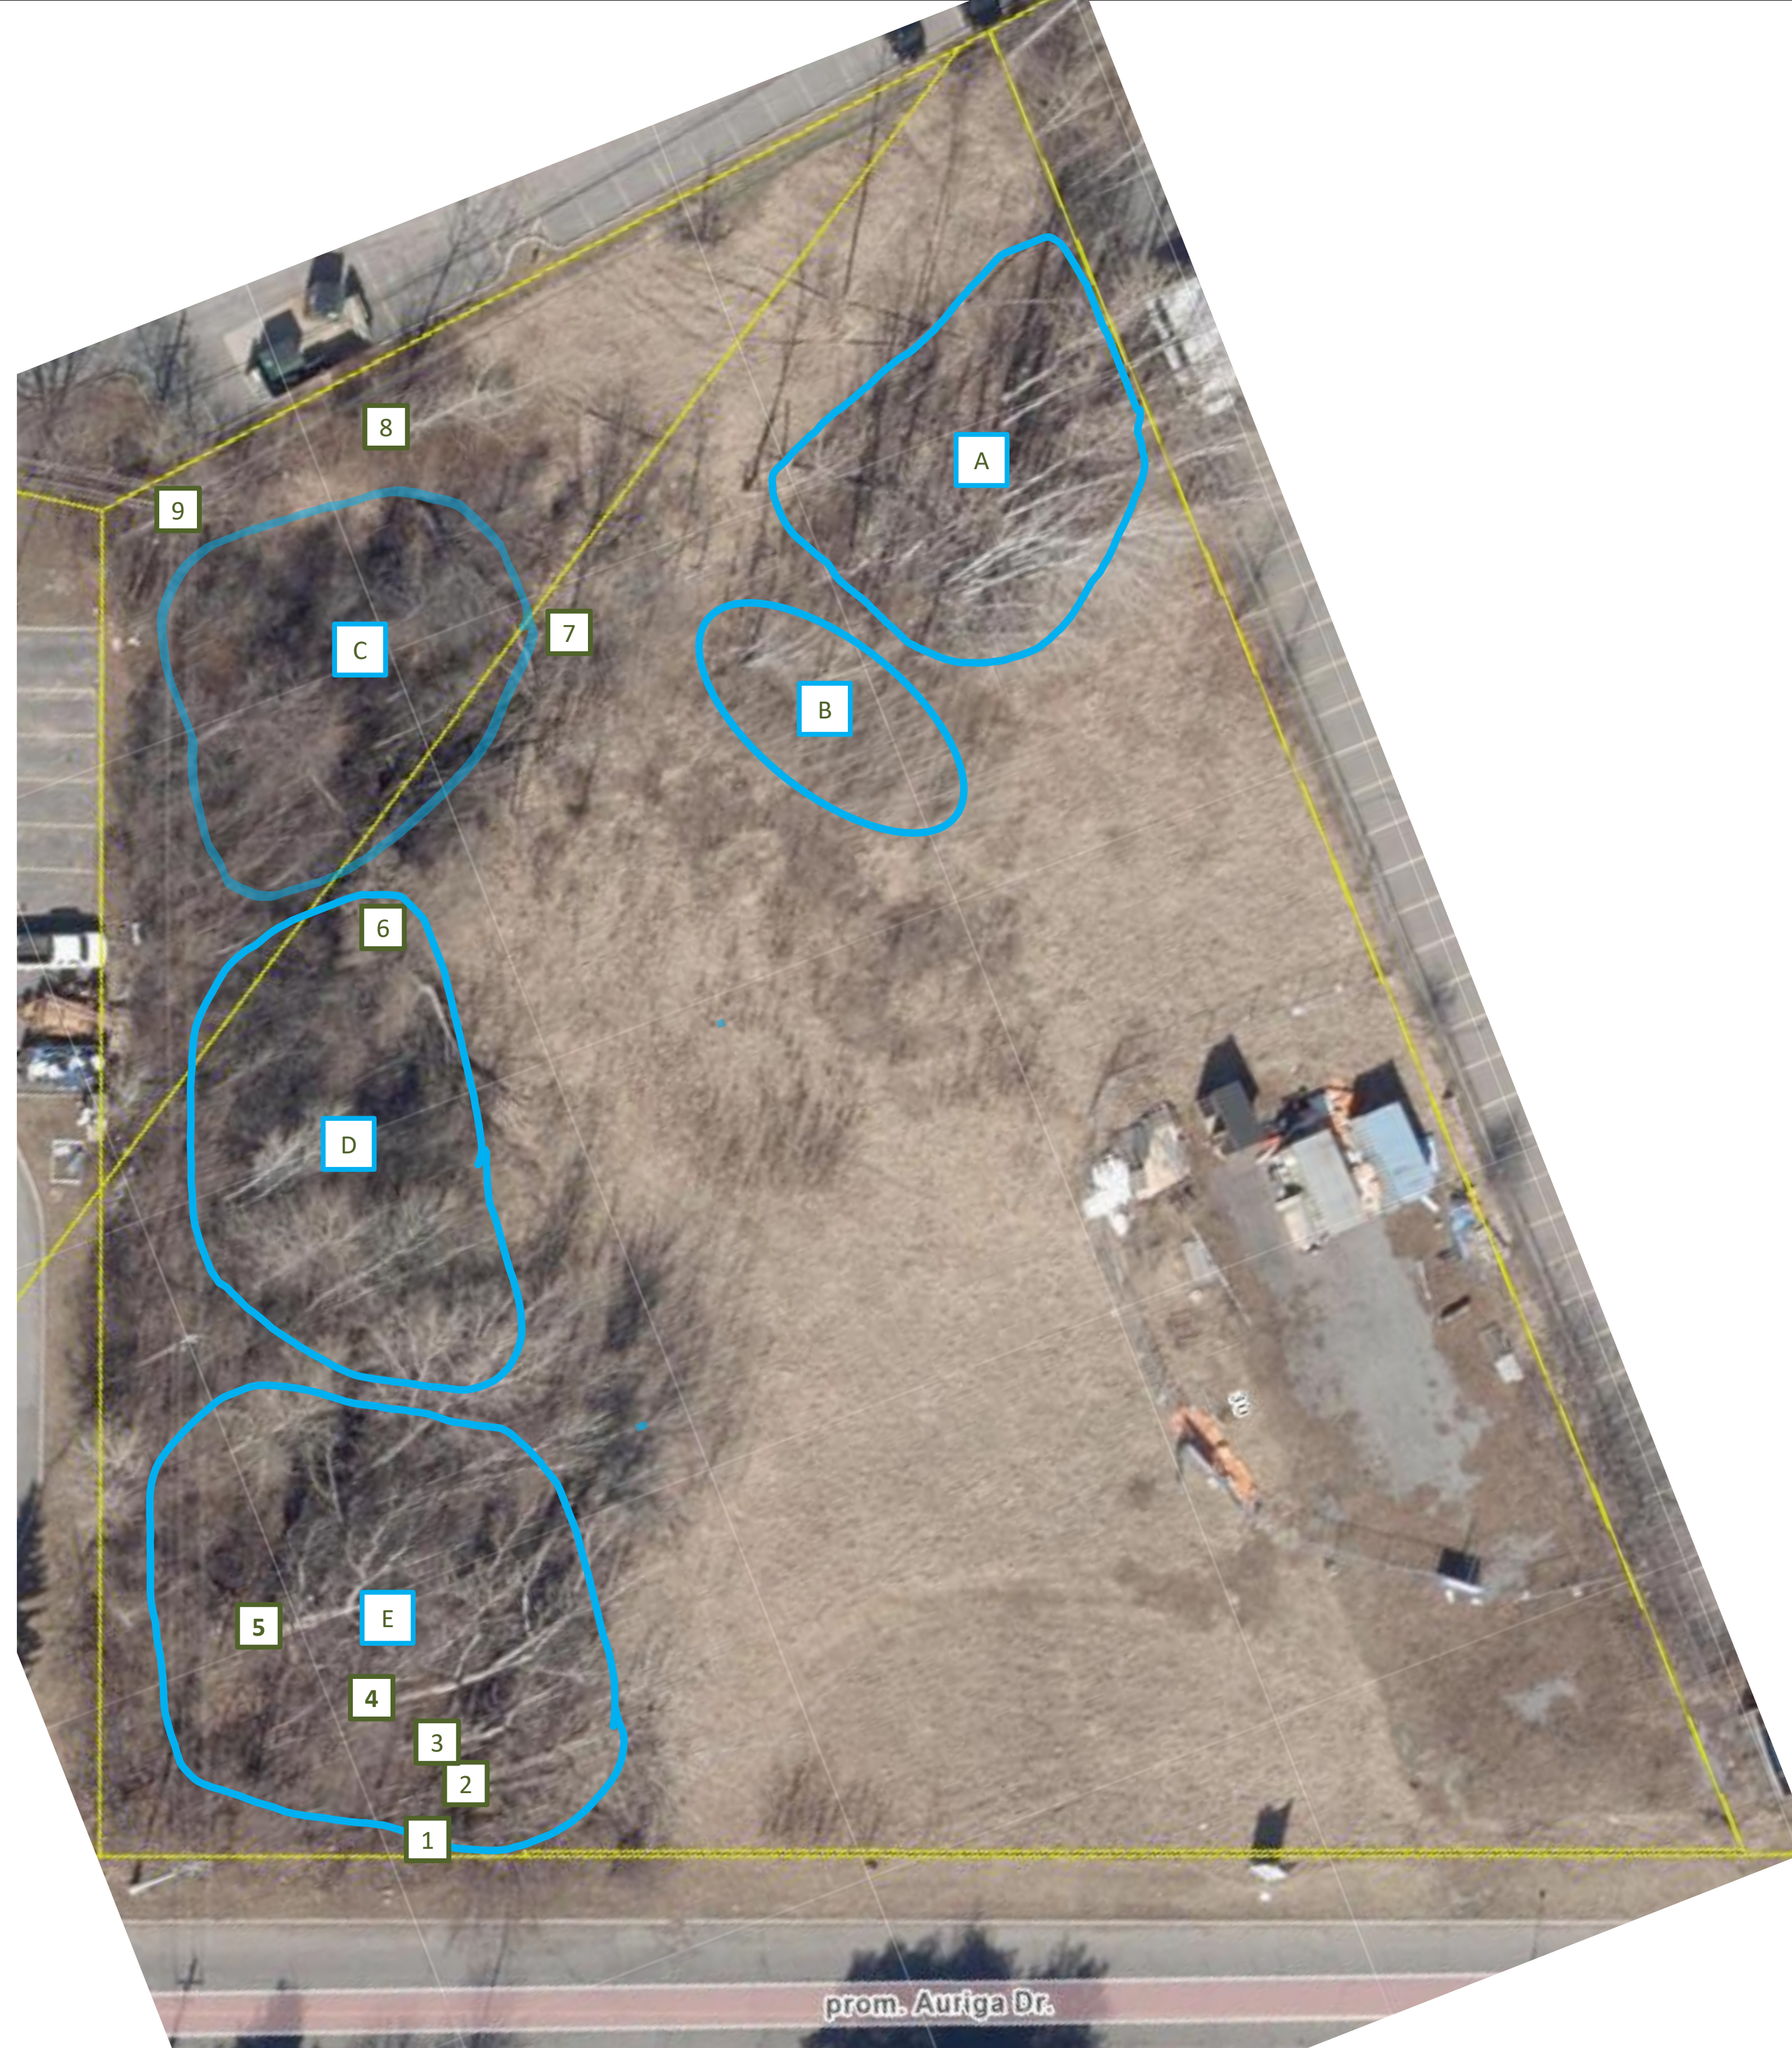
Tree Conservation Report Map #1 – Current Vegetation
 Tree layer prepared by Dendron Forestry Services
 Version 1.0, November 22, 2022
 For more information, please contact info@dendronforestry.ca

Using the 2021 imagery from GeoOttawa, the tree inventory has been parceled into five polygons with similar vegetation types as identified in the *Current Vegetation Map#1*. The boundaries of these polygons are approximate, and the vegetation is described generally as follows:

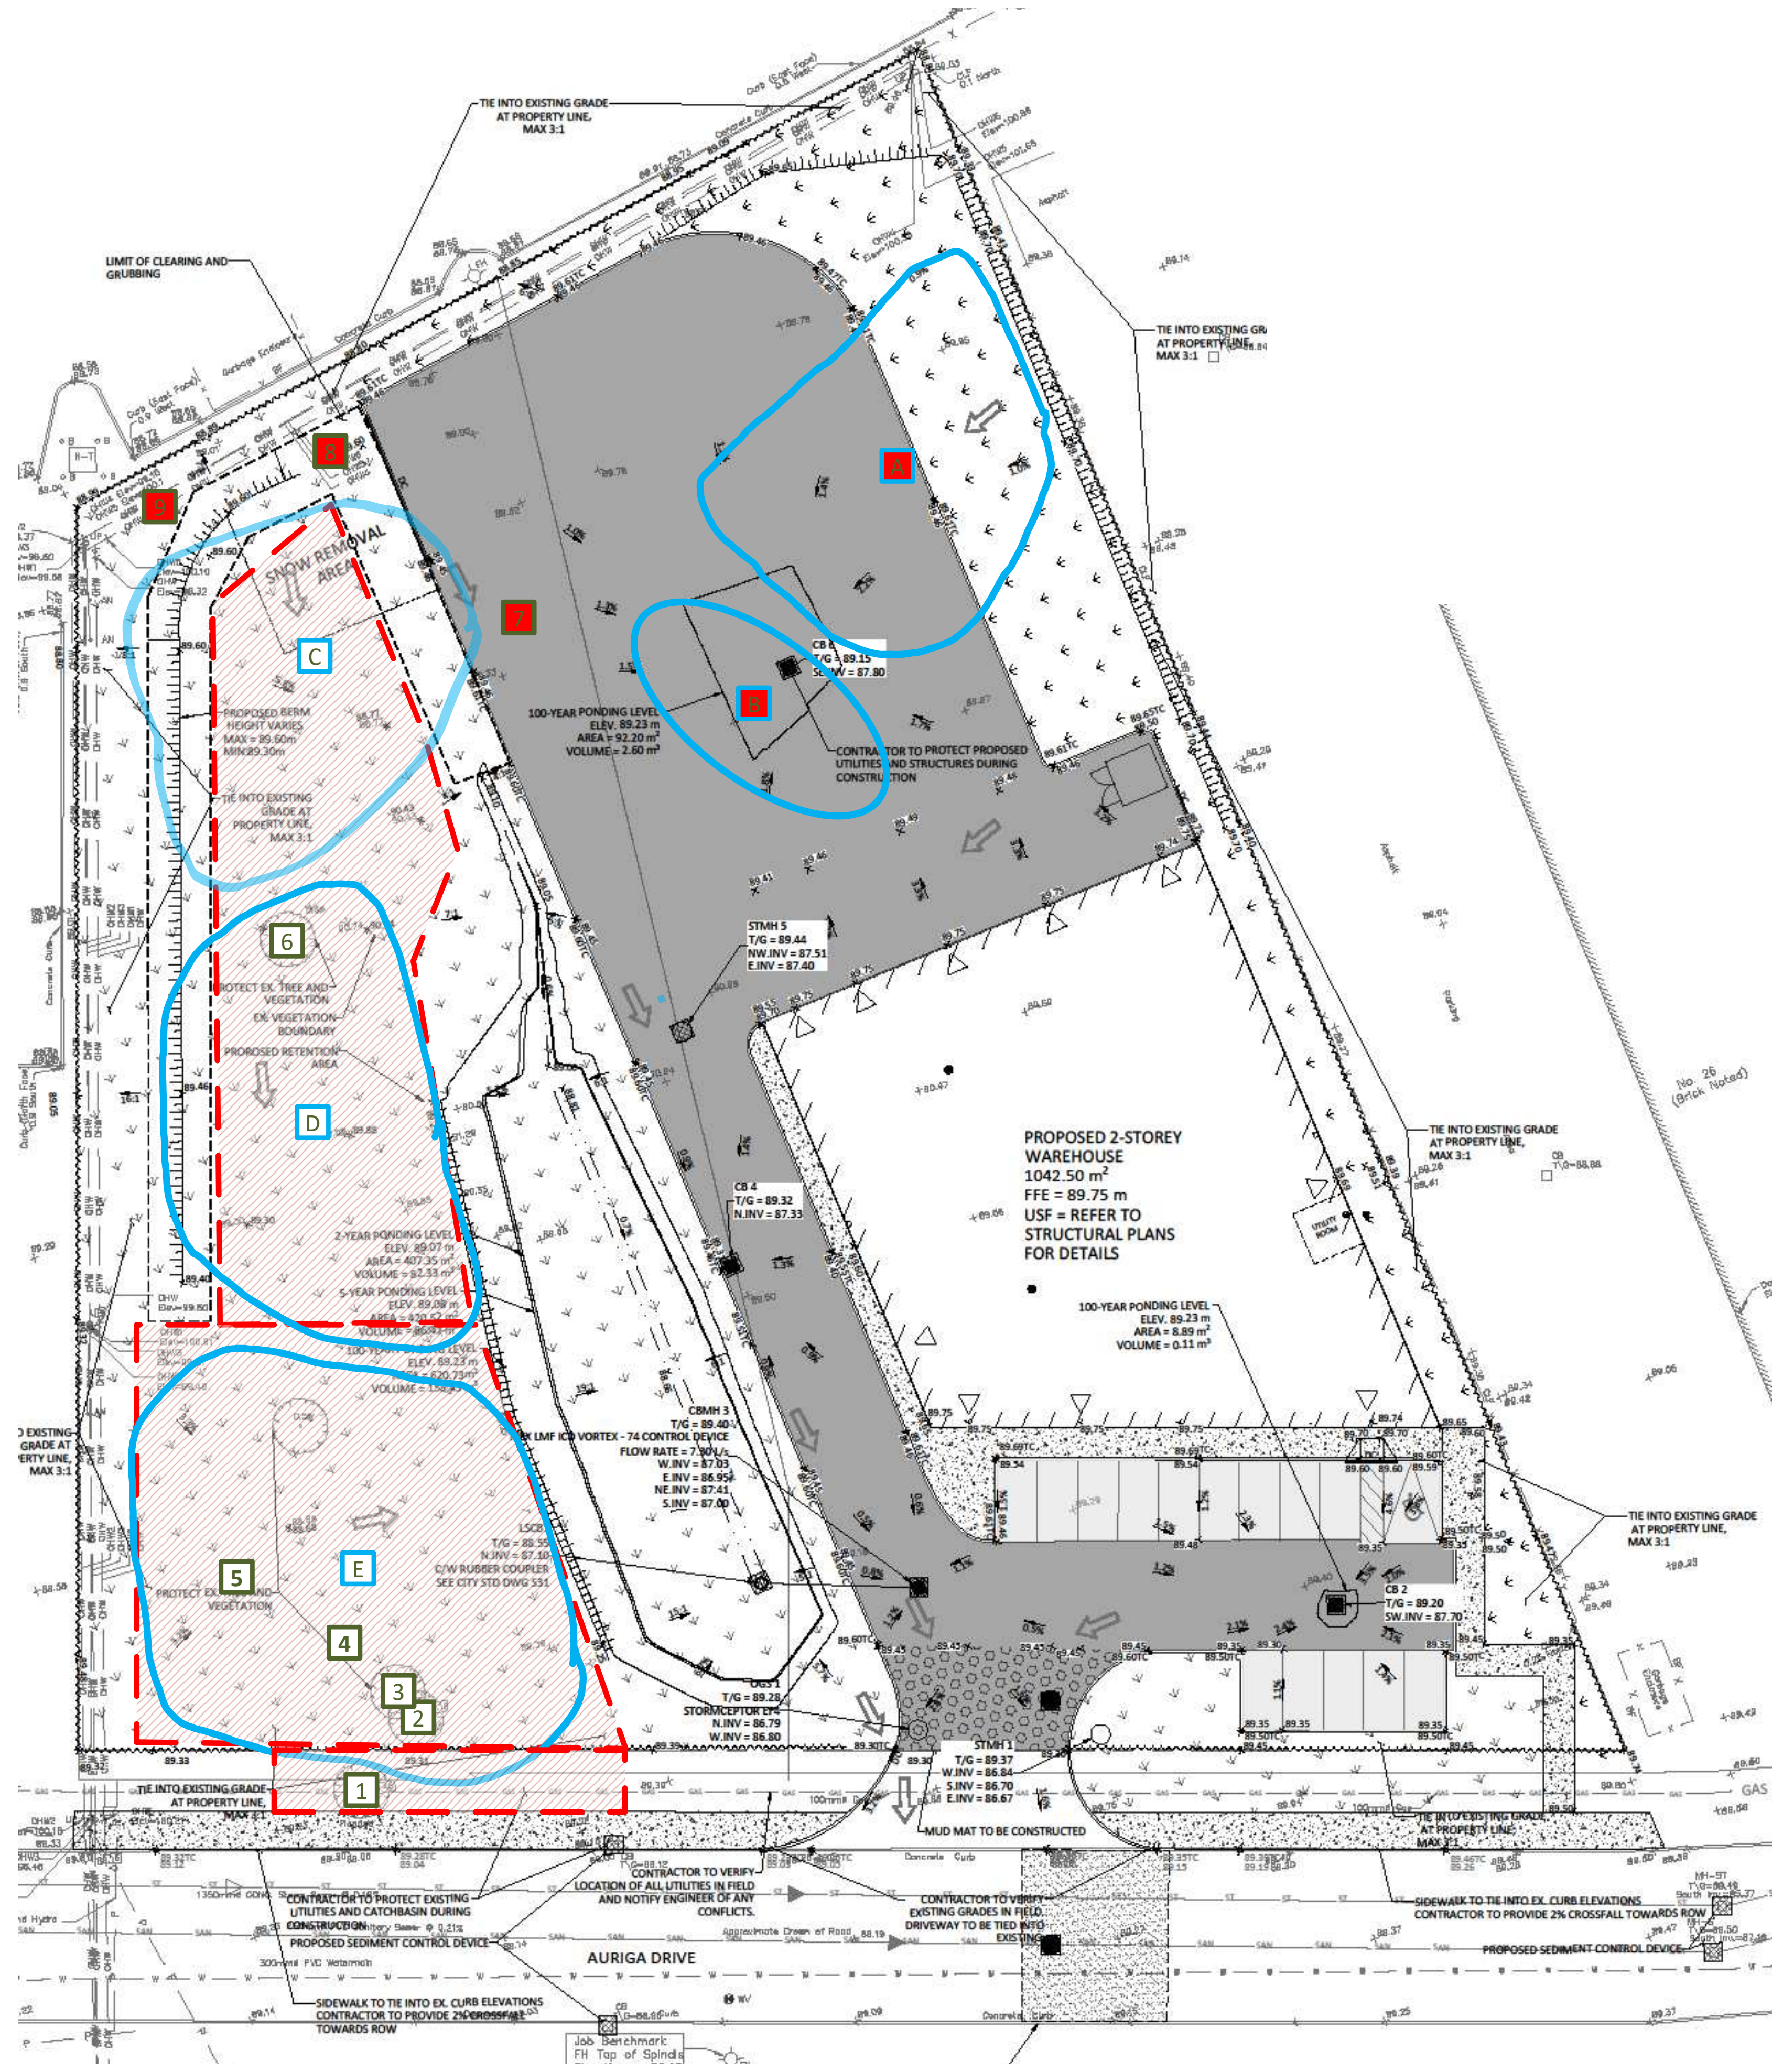
Tree Conservation Report Map #2 – Proposed Development and Conserved Vegetation
 Tree layer prepared by Dendron Forestry Services
 Version 3.0, July 12, 2023
 For more information, please contact info@dendronforestry.ca

The Proposed Development and Conserved Vegetation map (Map #2) shows the area that will be developed as part of Phase 1 with the tree layer from Map #1 transposed on top. The locations are approximate but are sufficient for the purposes of this Tree Conservation Report. The proposed development will involve paving the back section of the upper lot to accommodate the turnaround for trucks. As a result, all the trees in the northern section, including those in Polygons A, B, and tree 7 will require removal.

In an attempt to reduce tree loss, drainage on site has been controlled by use of a berm along the southern property edge, and a drainage pond immediately south of the proposed paved surface. While these measures will necessitate the **removal of Tree 8 and 9**, as well as some trees in **Polygon C and D**, it will allow a large area in the undeveloped southern portion of the property to keep existing grades. This maintaining of grade should allow for the trees in these areas to be retained. Map #2 has been updated to show a Tree Protection Area within which no tree removal should occur:

Prior to any site works, protective fencing should be installed around the TPA as indicated in this Map and maintained until all construction on site has been completed as per the City of Ottawa Tree Protection Specifications (March 2021). **Failure to install and maintain fencing as indicated in this report may result in fines from the city.**

The tree protection fencing must be 1.2 m in height and constructed of a rigid or framed material (e.g. modulus – steel, plywood hoarding, or snow fence on a 2"x4" wood frame) with posts 2.4 m apart such that the fence location cannot be altered.
