TREE CONSERVATION REPORT

30 Auriga Drive, Part 10

Tree Conservation Report submitted as Partial
Requirements for a Site Plan Control Application,
November 22, 2022

Dendron Forestry Services

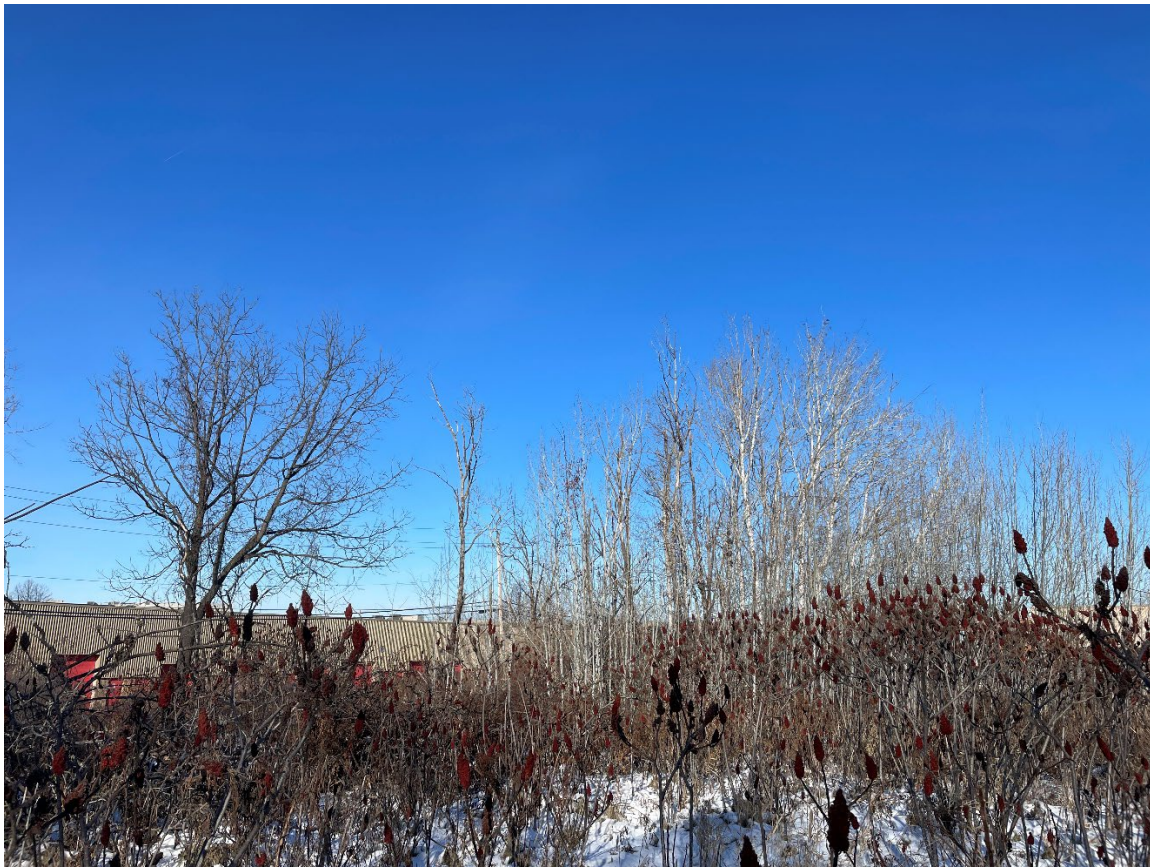
This area has only recently seeded in with trembling aspen (*Populus tremuloides*) which are 1-8 cm in diameter. Although small, this area is dense, and the trees are young and vigorous.

Figure 1: Taken from centre of property looking north. Small poplars in Polygon A on right, and black walnut (tree 7 on left)

The Proposed Development and Conserved Vegetation map shows the area that will be developed as part of Phase 1 with the tree layer from map#1 transposed on top. The locations are approximate but are sufficient for the purposes of this Tree Conservation Report. The proposed development will involve paving the back section of the upper lot to accommodate the turnaround for trucks. As a result, all the trees in the northern section, including those in Polygons A, B, and tree 7 will require removal.

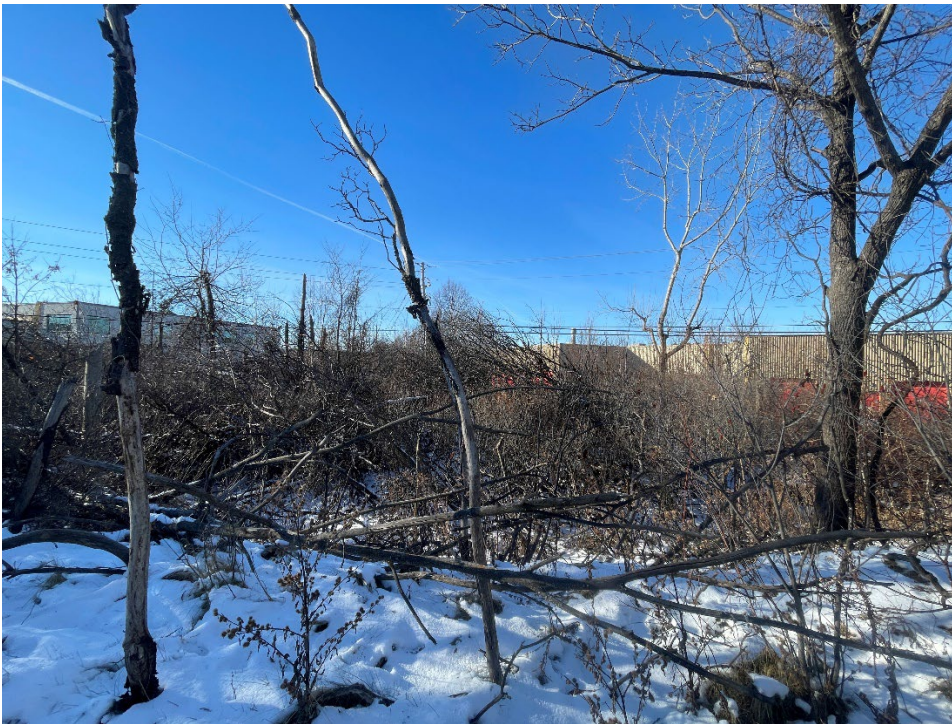
This area in the southwest corner is a depression and was impenetrable due to severe blowdown. Few standing trees exist in this section, and it is likely that part of this blowdown occurred during the Derecho storm that affected this area significantly in May 2022.

Figure 3: Polygon C - depression with blowdown

Since the area being developed from Phase 1 is located approximately 15-20 m from the treed area in the south, no tree mitigation or protection measures would be required. However, this area should be avoided during all construction of Phase 1, especially because some of the trees may be hazardous with large hanging branches.

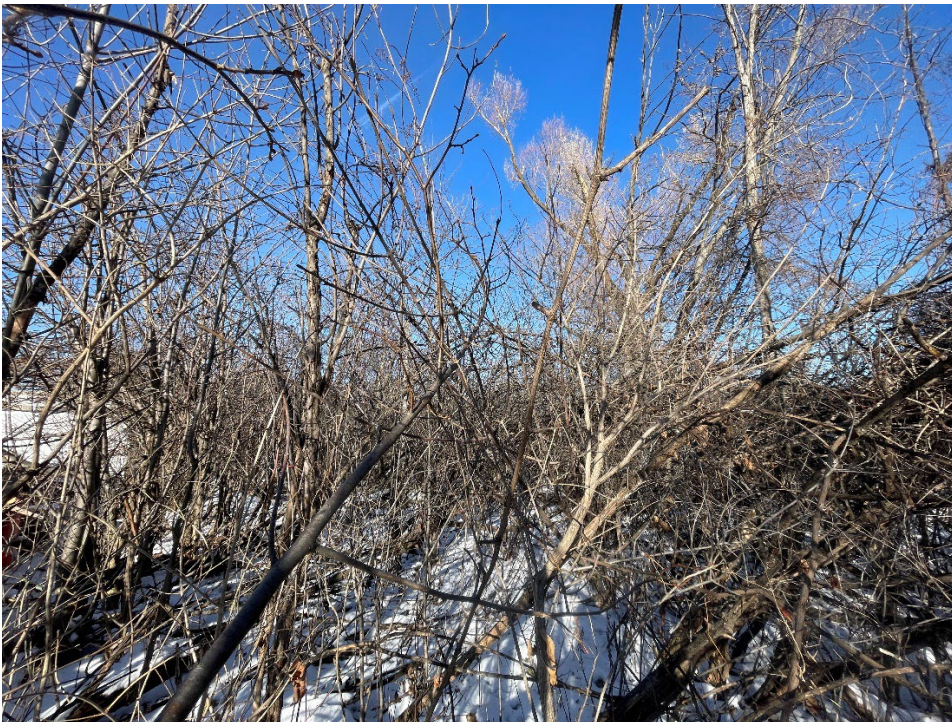
This section is mostly young trees including American elm (*Ulmus americana*), ash (*Fraxinus spp*), serviceberry (*Amelanchier spp*), trembling aspen (*Populus tremuloides*) and hawthorn (*Crataegus spp*). With the loss of the ash

canopy due to the emerald ash borer, the area has become a dense thicket, and there is a high abundance of vines (Virginia creeper and wild grape).

Figure 4: Example of dense thicket in Polygon D

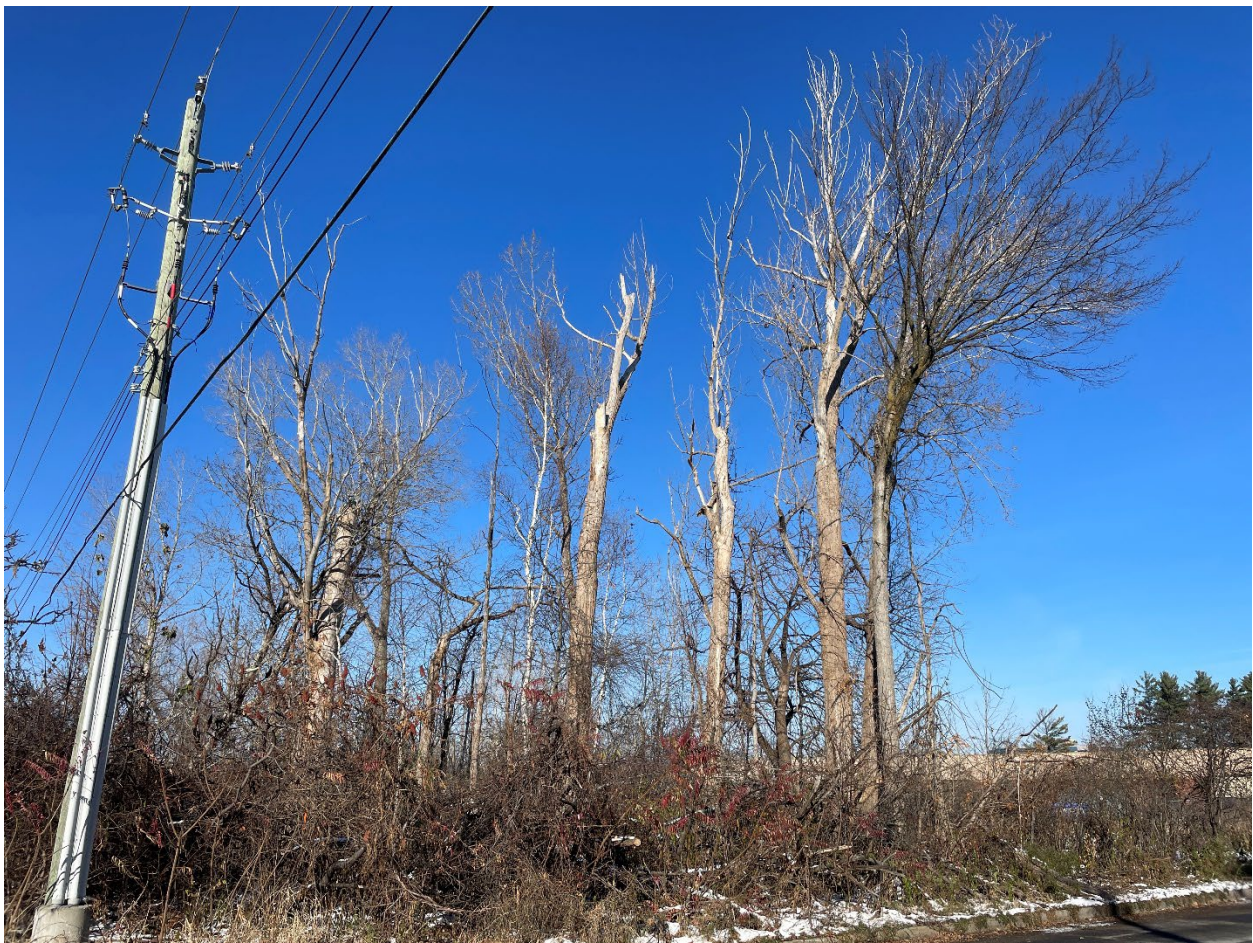
This area is part of the old hedgerow that separated two agriculture fields prior to 1991. Some of the trembling aspen trees are very large and are in decline. Smaller trees (10-30 cm) that are present in this section include white birch (*Betula papyrifera*), black cherry (*Prunus serotina*), basswood, and American elm. All of the trees are in either fair or poor condition. Many have lost larger branches during the recent Derecho storm.

Figure 5: Trees in the southern tip (polygon E) part of the old hedgerow. Elm tree (Tree #1) is on the right

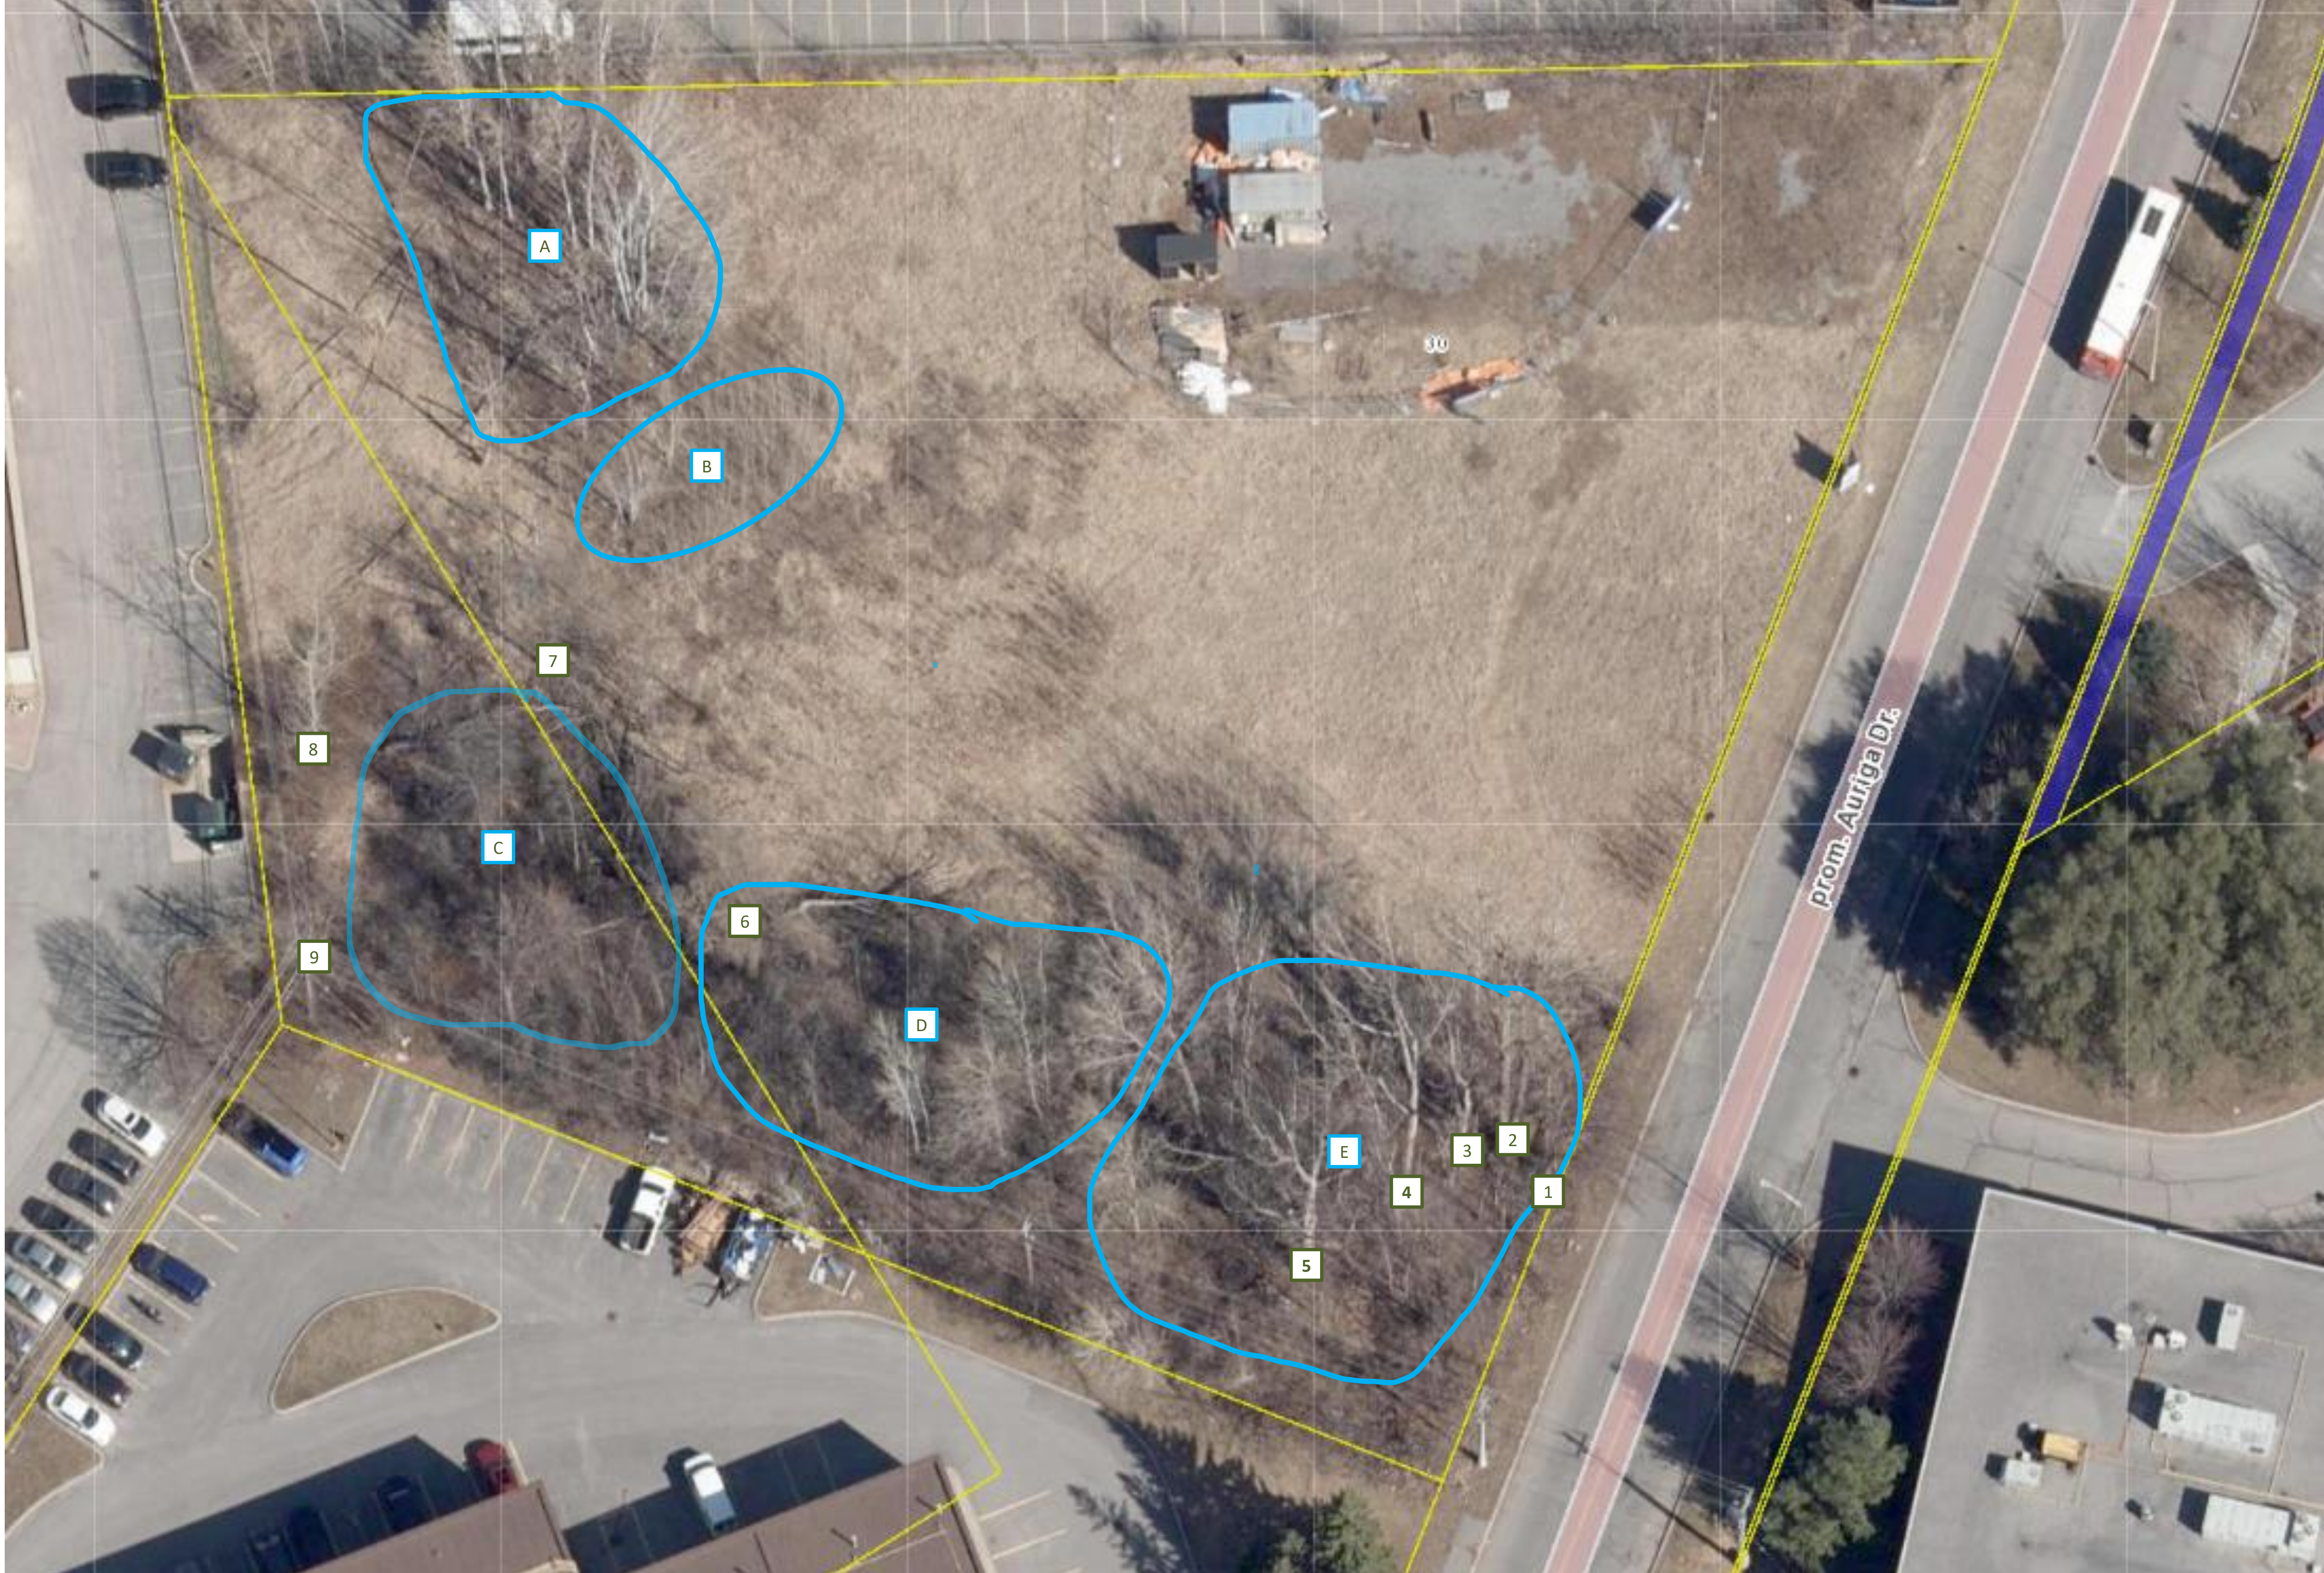
Tree Conservation Report Map#1 – Current Vegetation
 Tree layer prepared by Dendron Forestry Services
 Version 1.0, November 22, 2022
 For more information, please contact info@dendronforestry.ca

Using the 2021 imagery from GeoOttawa, the tree inventory has been parceled into five polygons with similar vegetation types as identified in the *Current Vegetation Map#1*. The boundaries of these polygons are approximate, and the vegetation is described generally as follows:
