Our File Ref.: 220536

Subject: Slope Stability Analysis – Proposed Automotive Dealership and Body Shop

5254 Bank Street Ottawa, Ontario

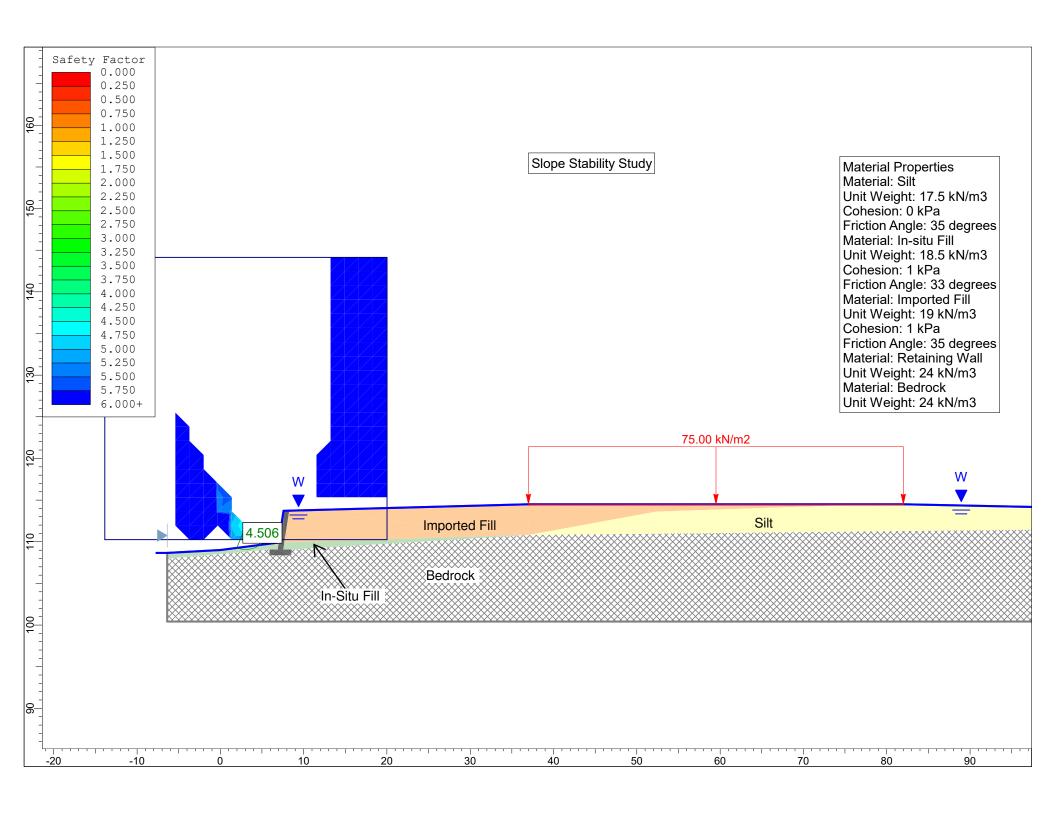
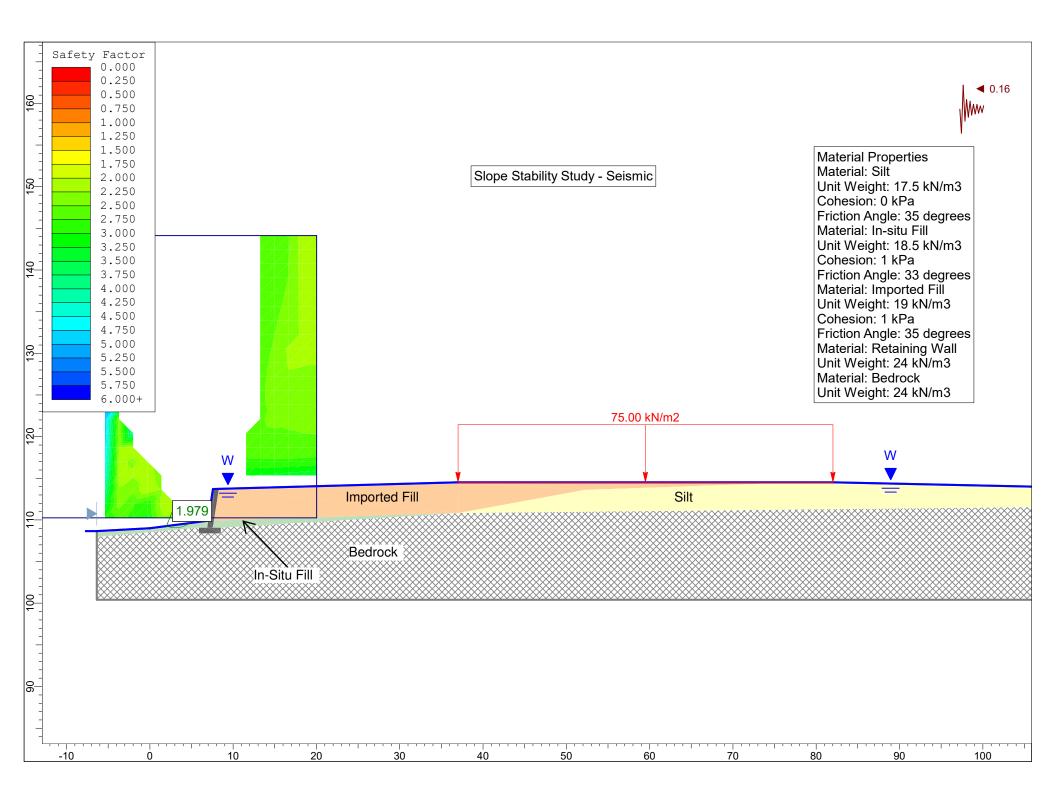
Encl. Slope Stability Analysis Results

The FoS against slope failure for the proposed slope profile was determined to be 4.51. A FoS of 1.50 or greater is considered to be safe with regards to slope stability.

The FoS in the seismic condition was determined to be 1.98. The minimum FoS with regards to seismic condition is 1.10.

These results indicate that the proposed construction will not negatively affect the slope, and it will remain stable in the long and short term, and in the event of any seismic activity.
