April 4, 2022

RE: TREE CONSERVATION INVENTORY FOR 5254 BANK STREET, OTTAWA

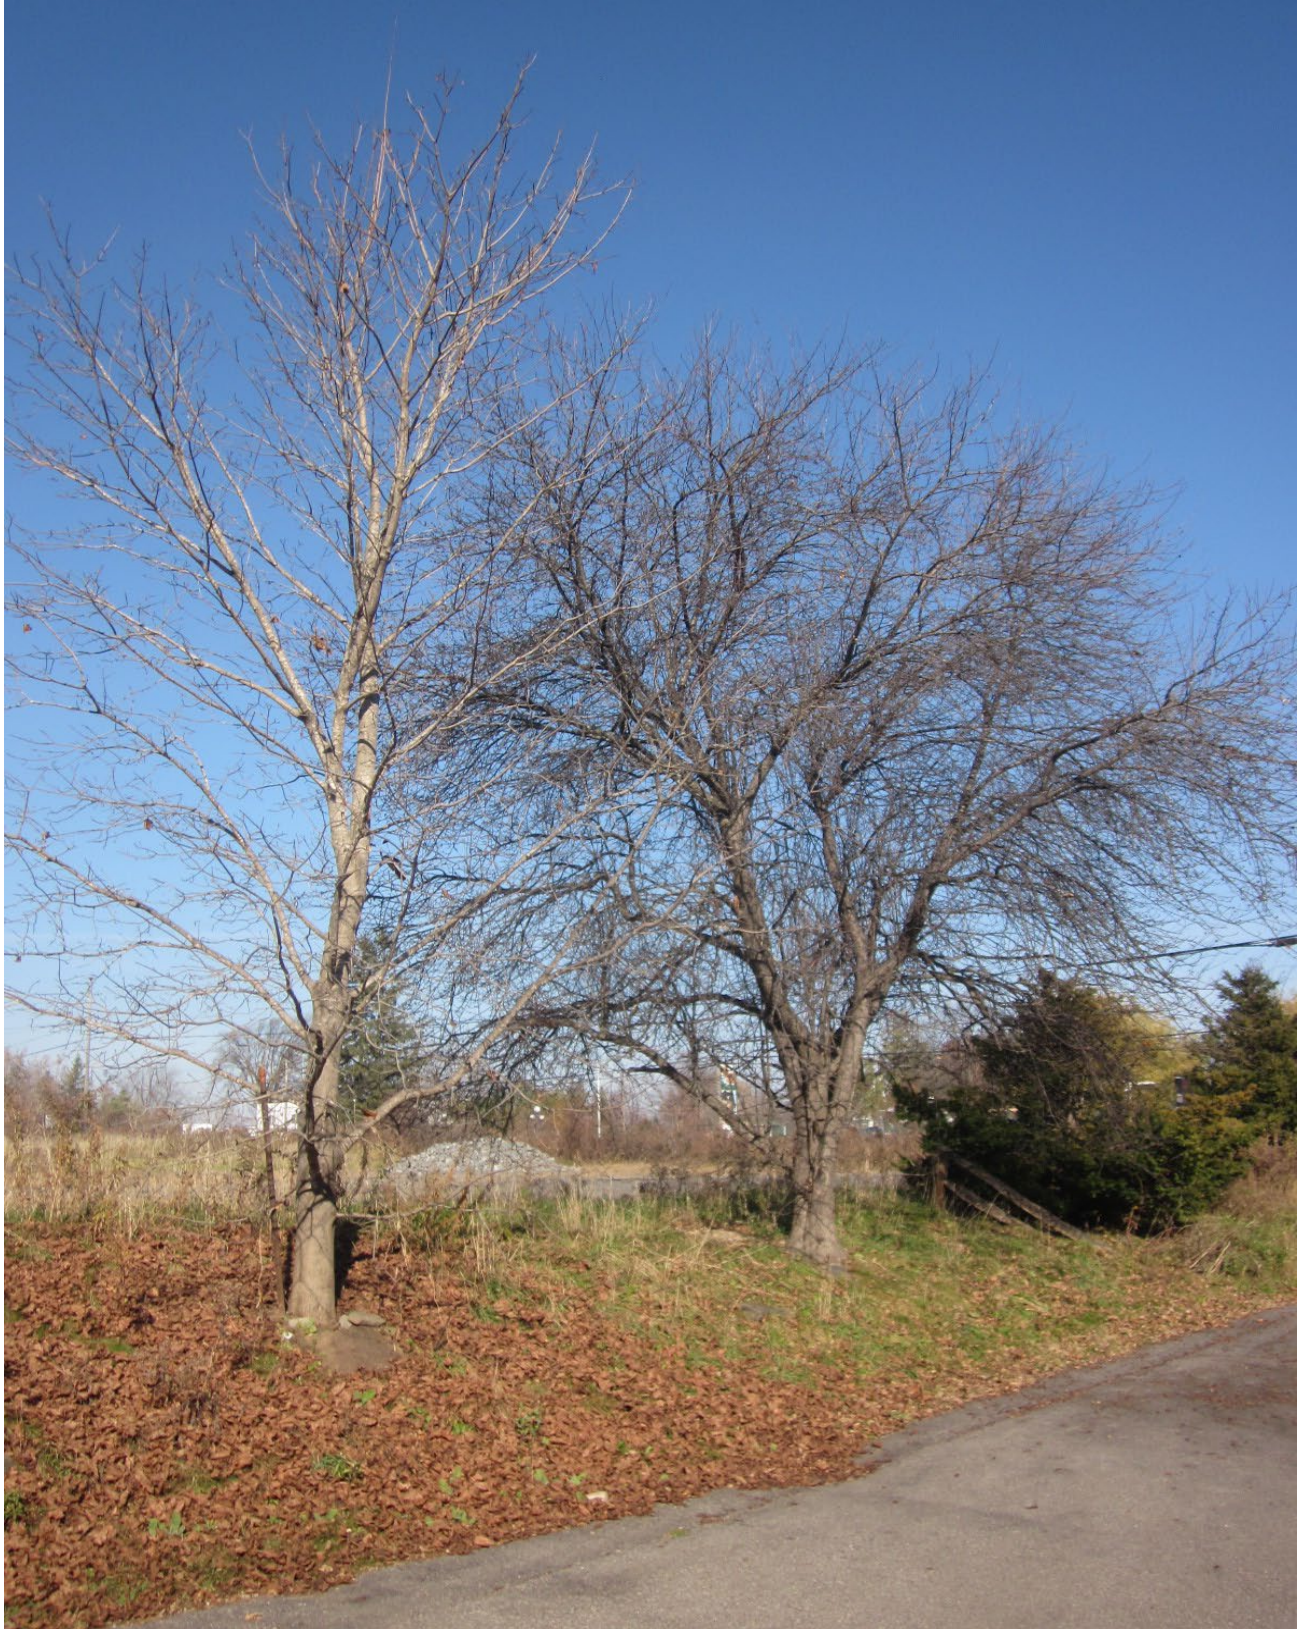
Picture 1. Trees #1 and 2 (right to left), shared crab apple and Norway maple located at 5254 Bank Street

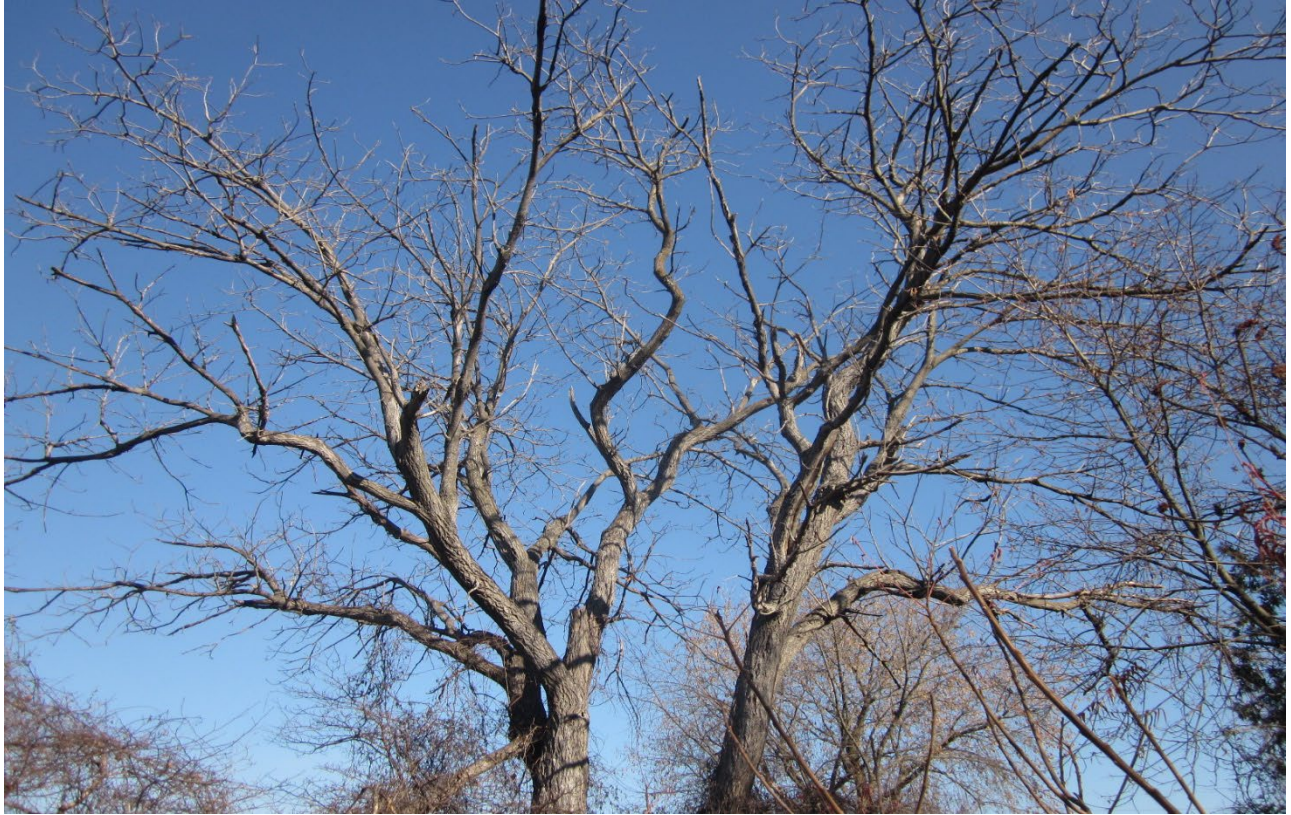
- 1) Endangered Species Act (2007): A mature butternut (*Juglans cinerea*) tree was identified on adjacent private property. This species of tree is listed as threatened under the Province of Ontario's Endangered Species Act (ESA, 2007) and so is protected from harm. This tree will be assessed following ESA protocol in spring 2024.
- 2) Migratory Bird Convention Act (1994): In the period between April and August of each year nest surveys are required to be performed by a suitably trained person no more than five (5) days before trees or other similar nesting habitat are to be removed.

Picture 3. Crown of butternut tree #4 adjacent to 5254 Bank Street

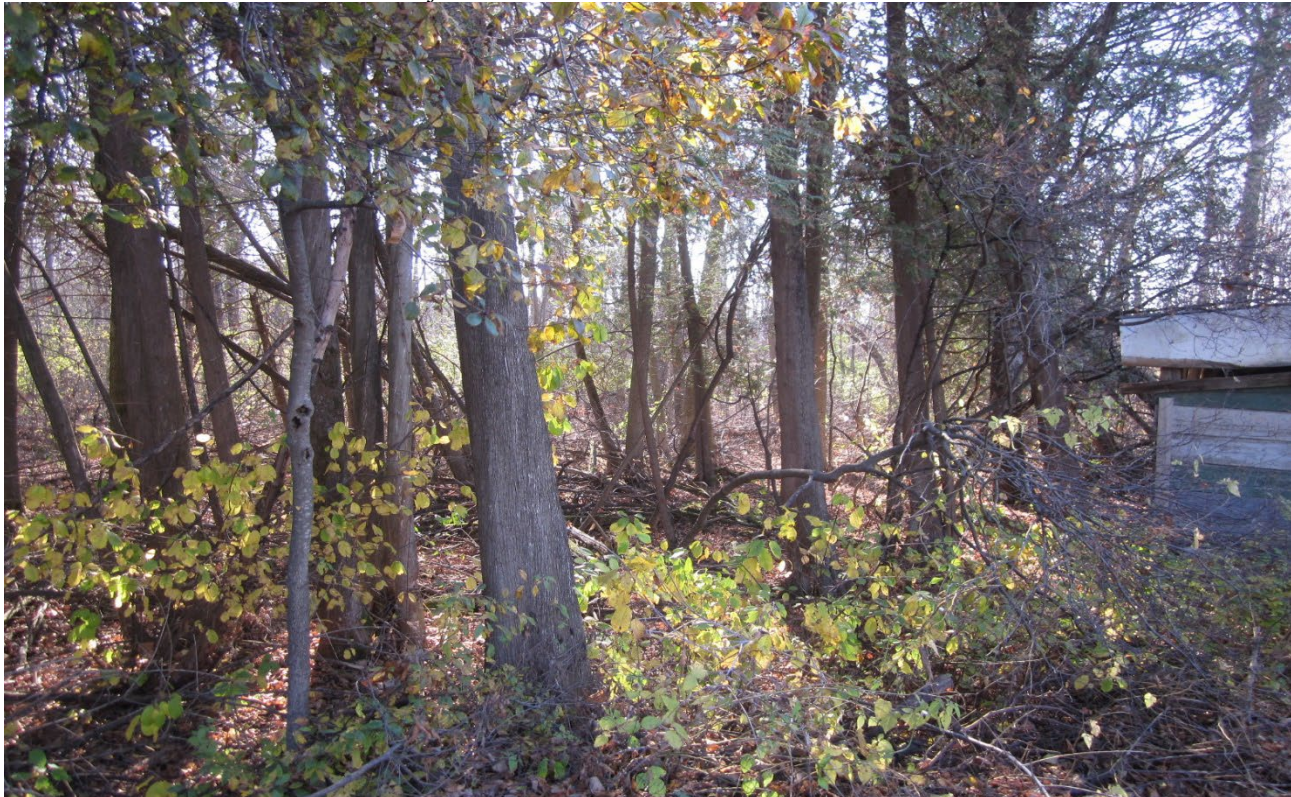
Picture 4. Stand #8, poplar and cedar trees adjacent to 5254 Bank Street

As excavation occurs within the CRZs of tree #6 and those within stand #8, the following measures will be taken:

1. Hydro excavation along the edge of excavation in proximity to the tree(s) to carefully expose roots. Exposed roots will then be cleanly cut and sealed before being reburied. Excavation can then resume using traditional mechanical means. Sealing the cleanly cut root ends with a beeswax product will help prevent the loss of moisture and facilitate healing.
2. If the excavation is to be left open for any time a covering of at least three layers of moistened burlap is to be draped over the exposed face of excavation closet to the tree. This will help reduce the loss of soil moisture.

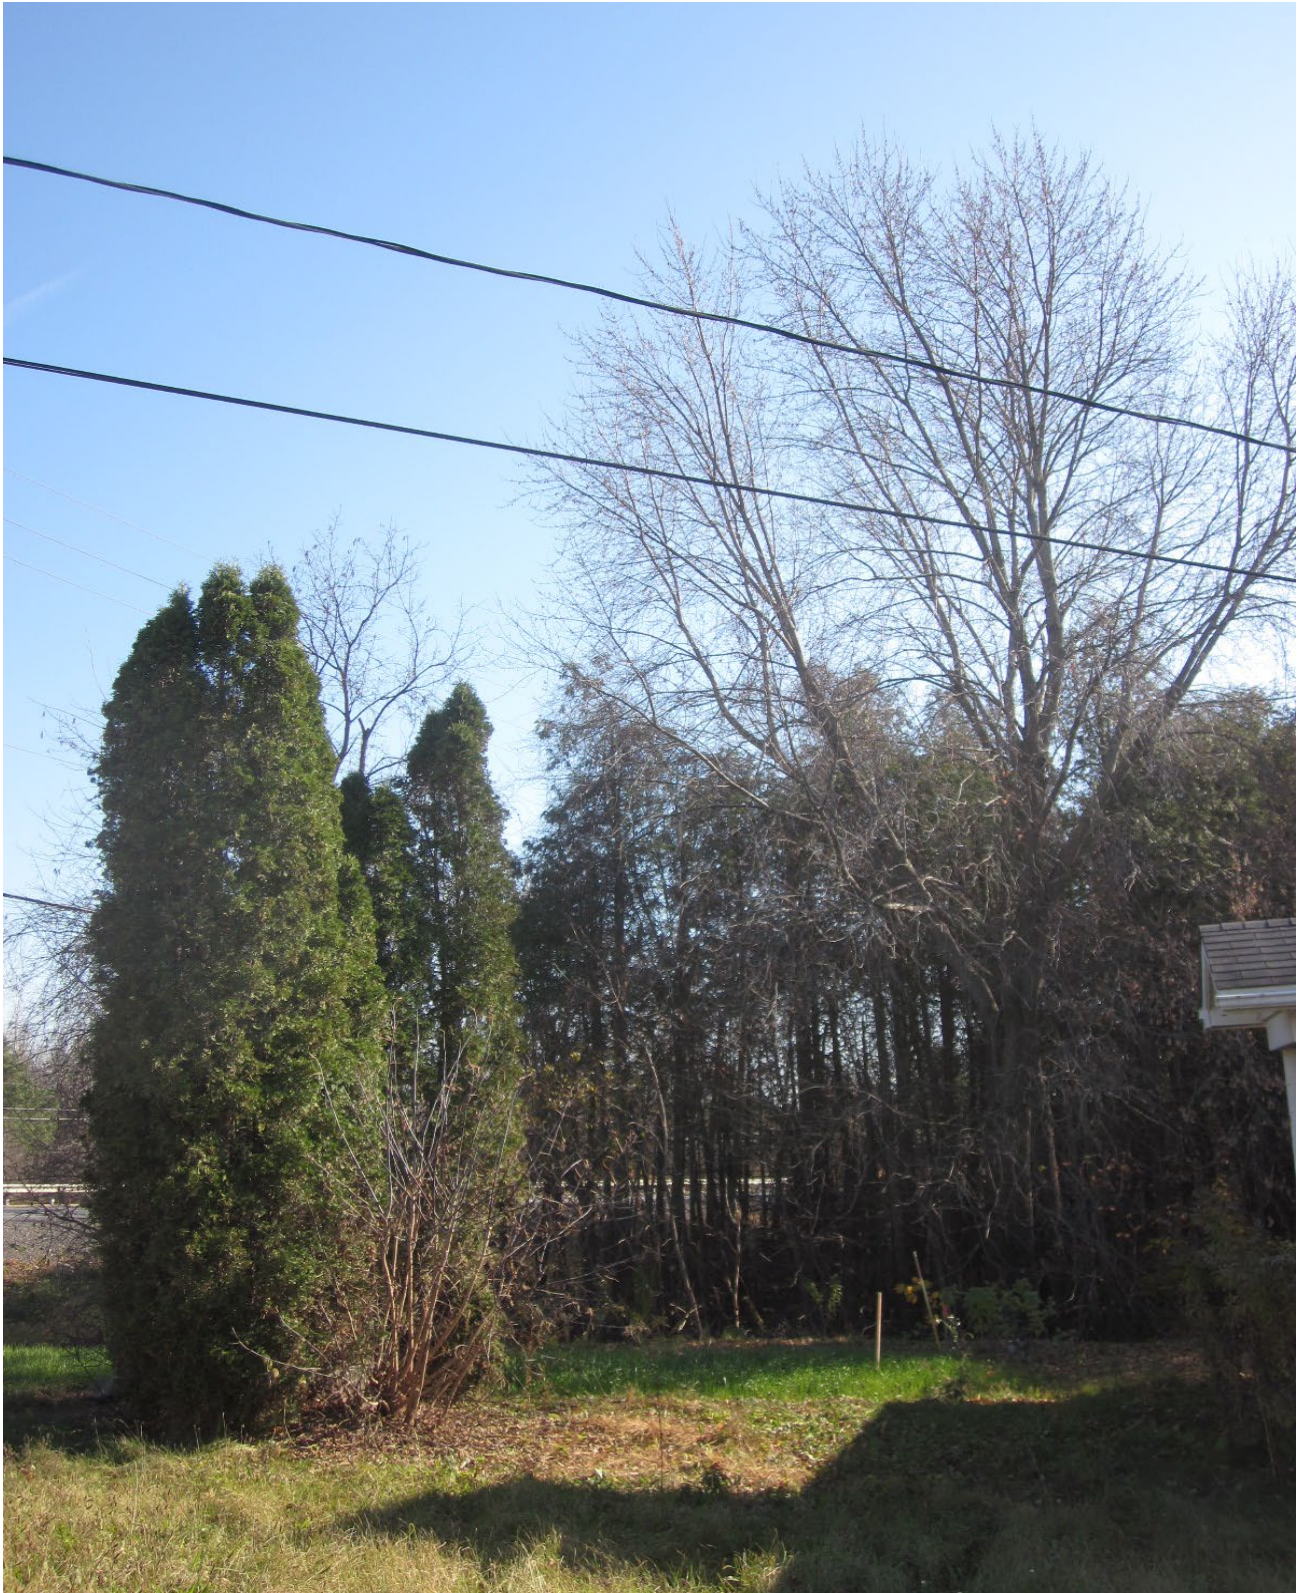
Picture 5. Tree #9 and 10 (right to left), maple and emerald cedar trees on City of Ottawa property adjacent to 5254 Bank Street
