August 28, 2020

RE: TREE CONSERVATION REPORT FOR 30-48 CHAMBERLAIN AVENUE, OTTAWA

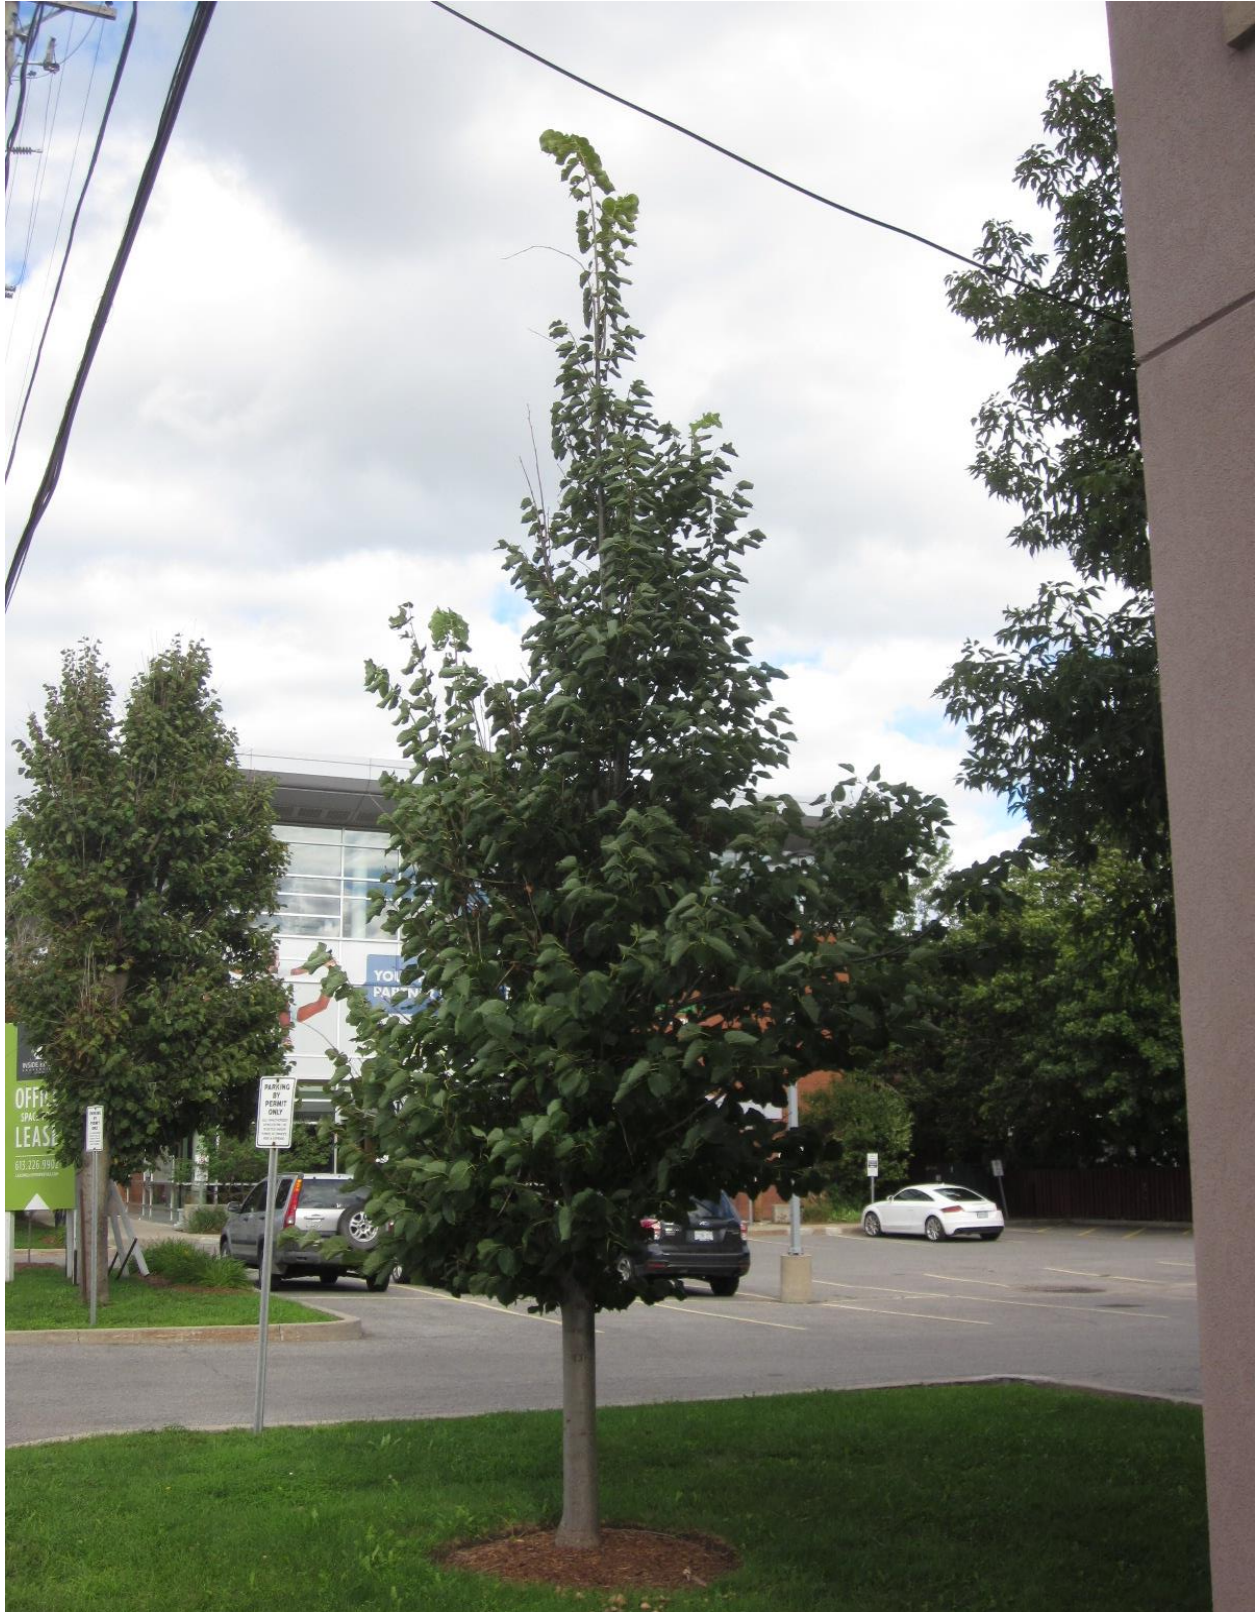
Picture 1. Tree #1 – Little-leaf linden on neighbouring private property

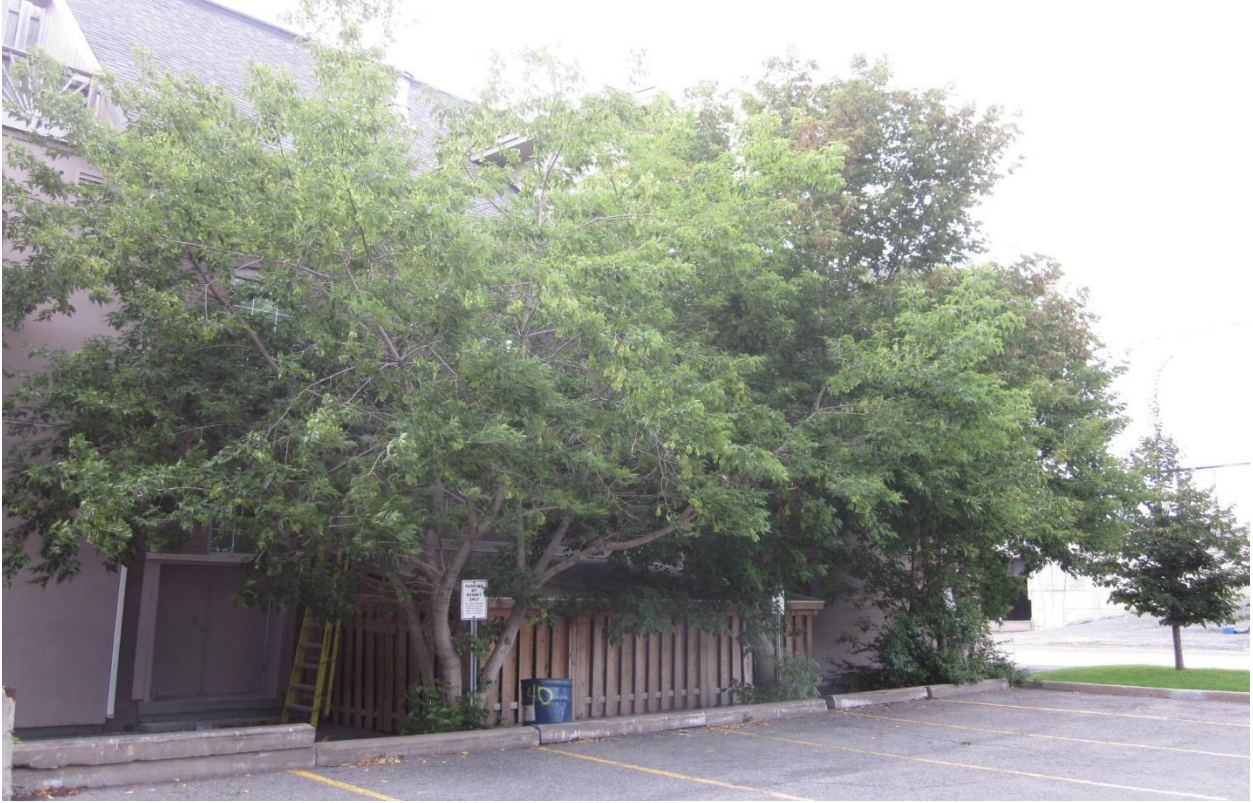
Picture 2. Trees #1-4 (right to left) – Little-leaf linden and Manitoba maples on neighbouring private property

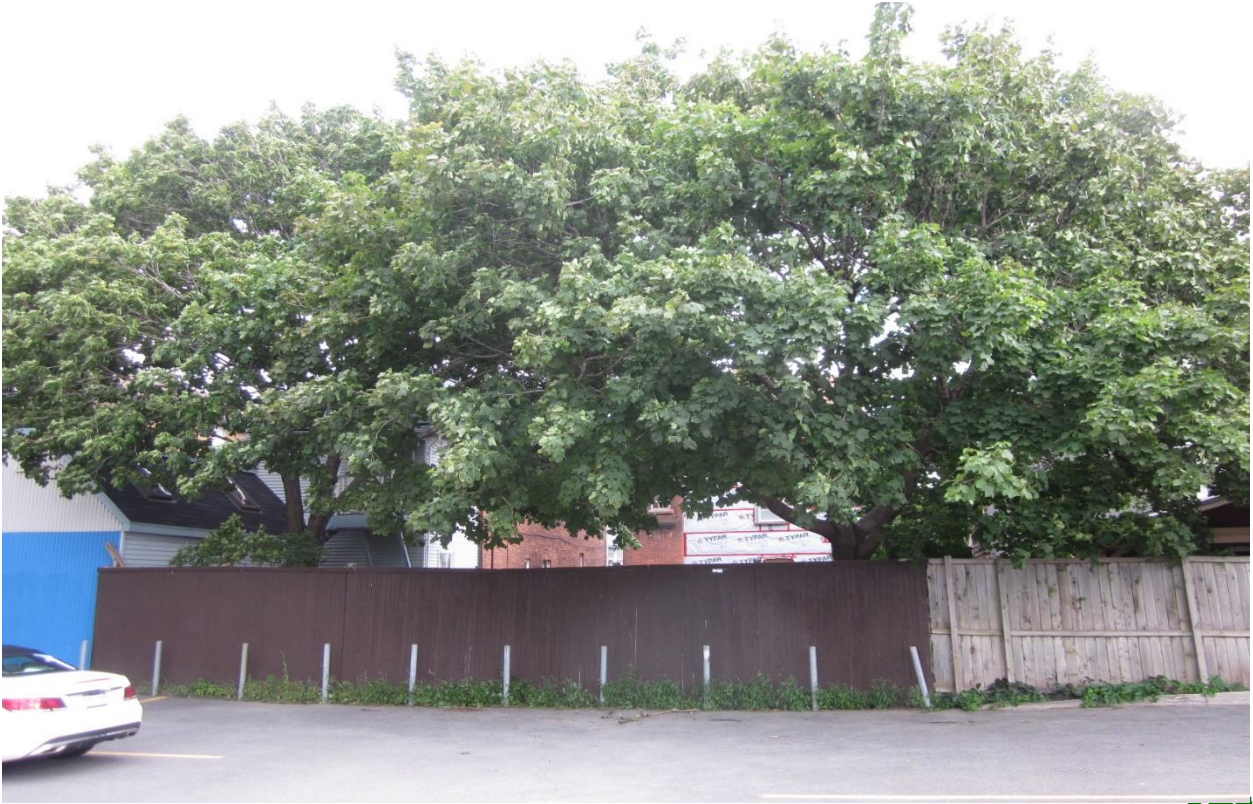
Tree No.	Tree Species	Condition (VP→E or dead)	DBH ¹ (cm)	Ownership	Age Class, Tree Condition Notes & Preservation Status (to be removed or preserved and protected)
9	Norway maple	Poor	+/-40	Neighbour	Mature; co-dominant stems at 3.5m with weak union; competing laterals at 3m on west and 3.5m on southwest and northeast – poor growth form; very broad crown; introduced invasive species; to be preserved and protected
10	Norway maple	Fair	+/- 20	Neighbour	Mature; single stemmed to 3.5m with co-dominant leaders; crown asymmetric toward south/southeast; introduced invasive species; to be preserved and protected
11	Norway maple	Poor	+/-35	Neighbour	Mature; tri-dominant stems at 2m; eutypella canker (<i>Eutypella parasitica</i>) at 2m; competing lateral on southwest side; introduced invasive species; to be preserved and protected
12	Crab apple (<i>Malus</i> spp.)	Very good	+/15	Neighbour	Mature; dense crown; heavy fruit year in 2020; cultivar; to be preserved and protected

Picture 3. Trees #8 and 9 – Norway maples on neighbouring private property

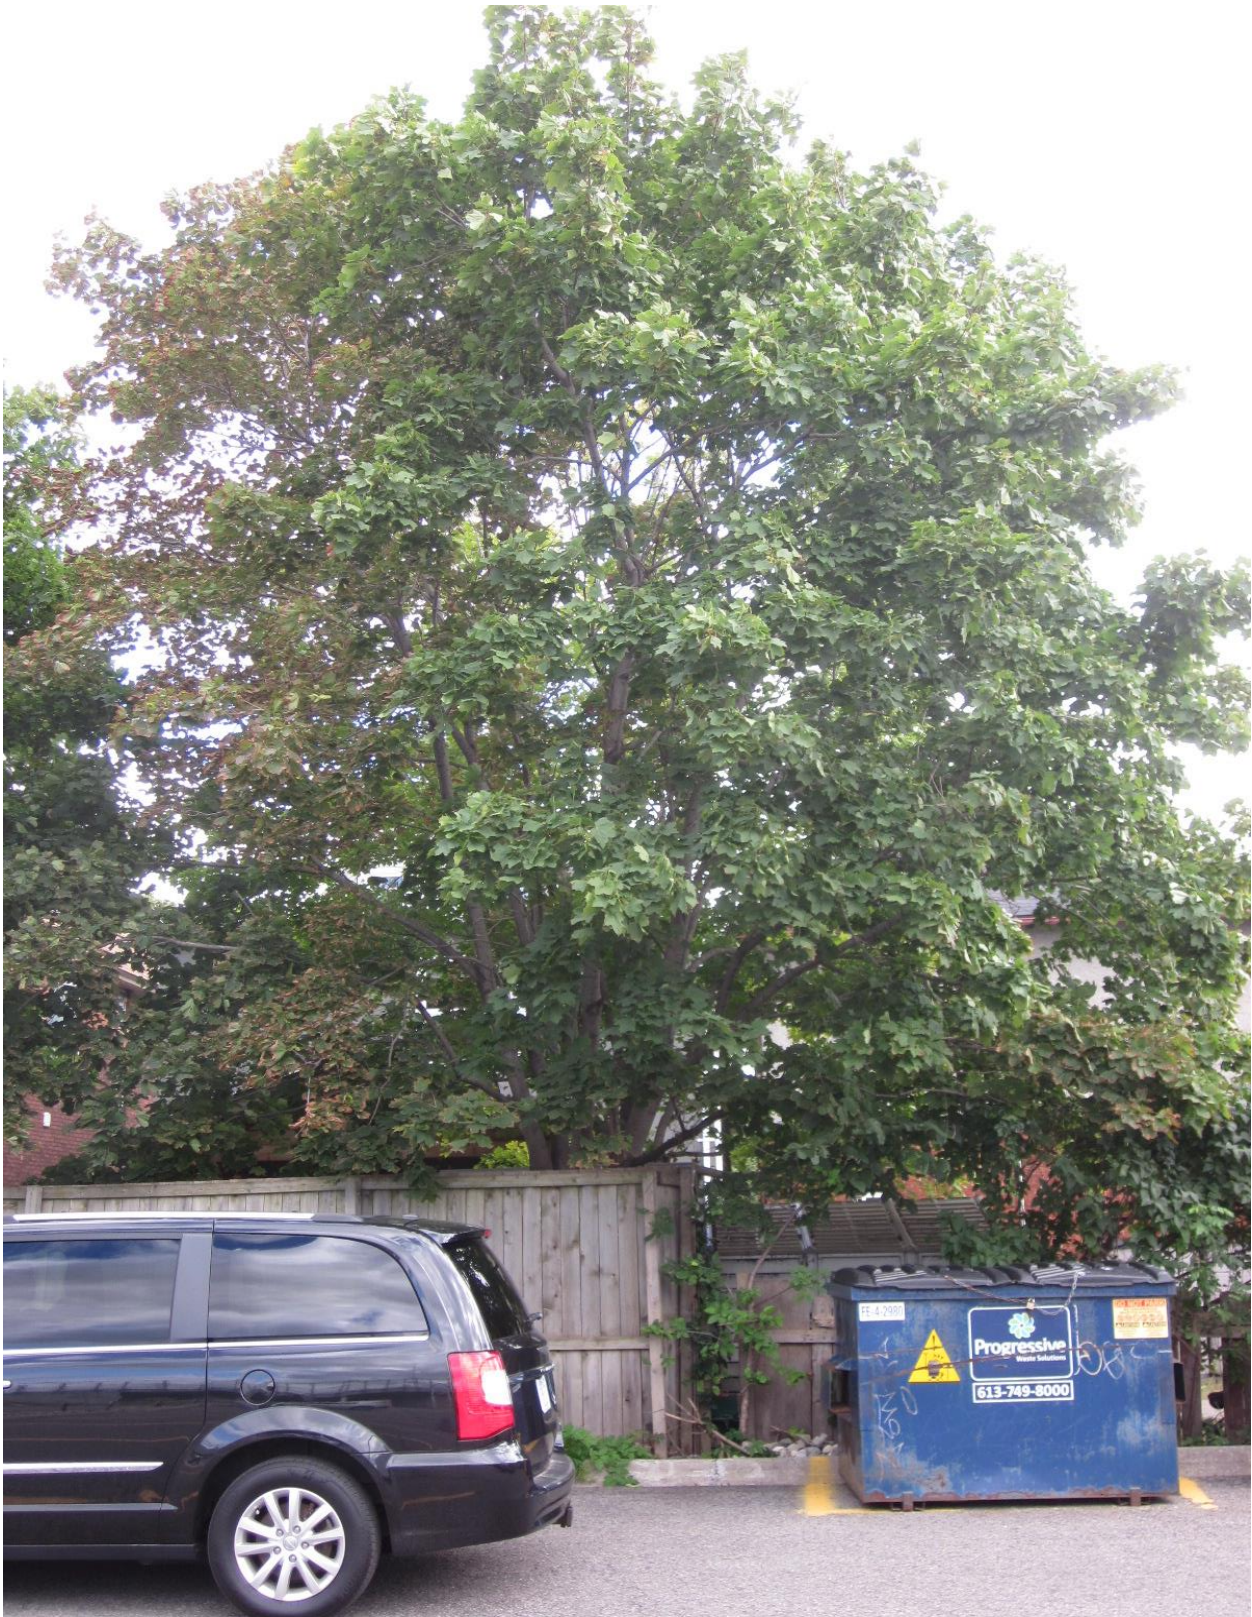
Picture 4. Tree #11 – Norway maple on neighbouring private property

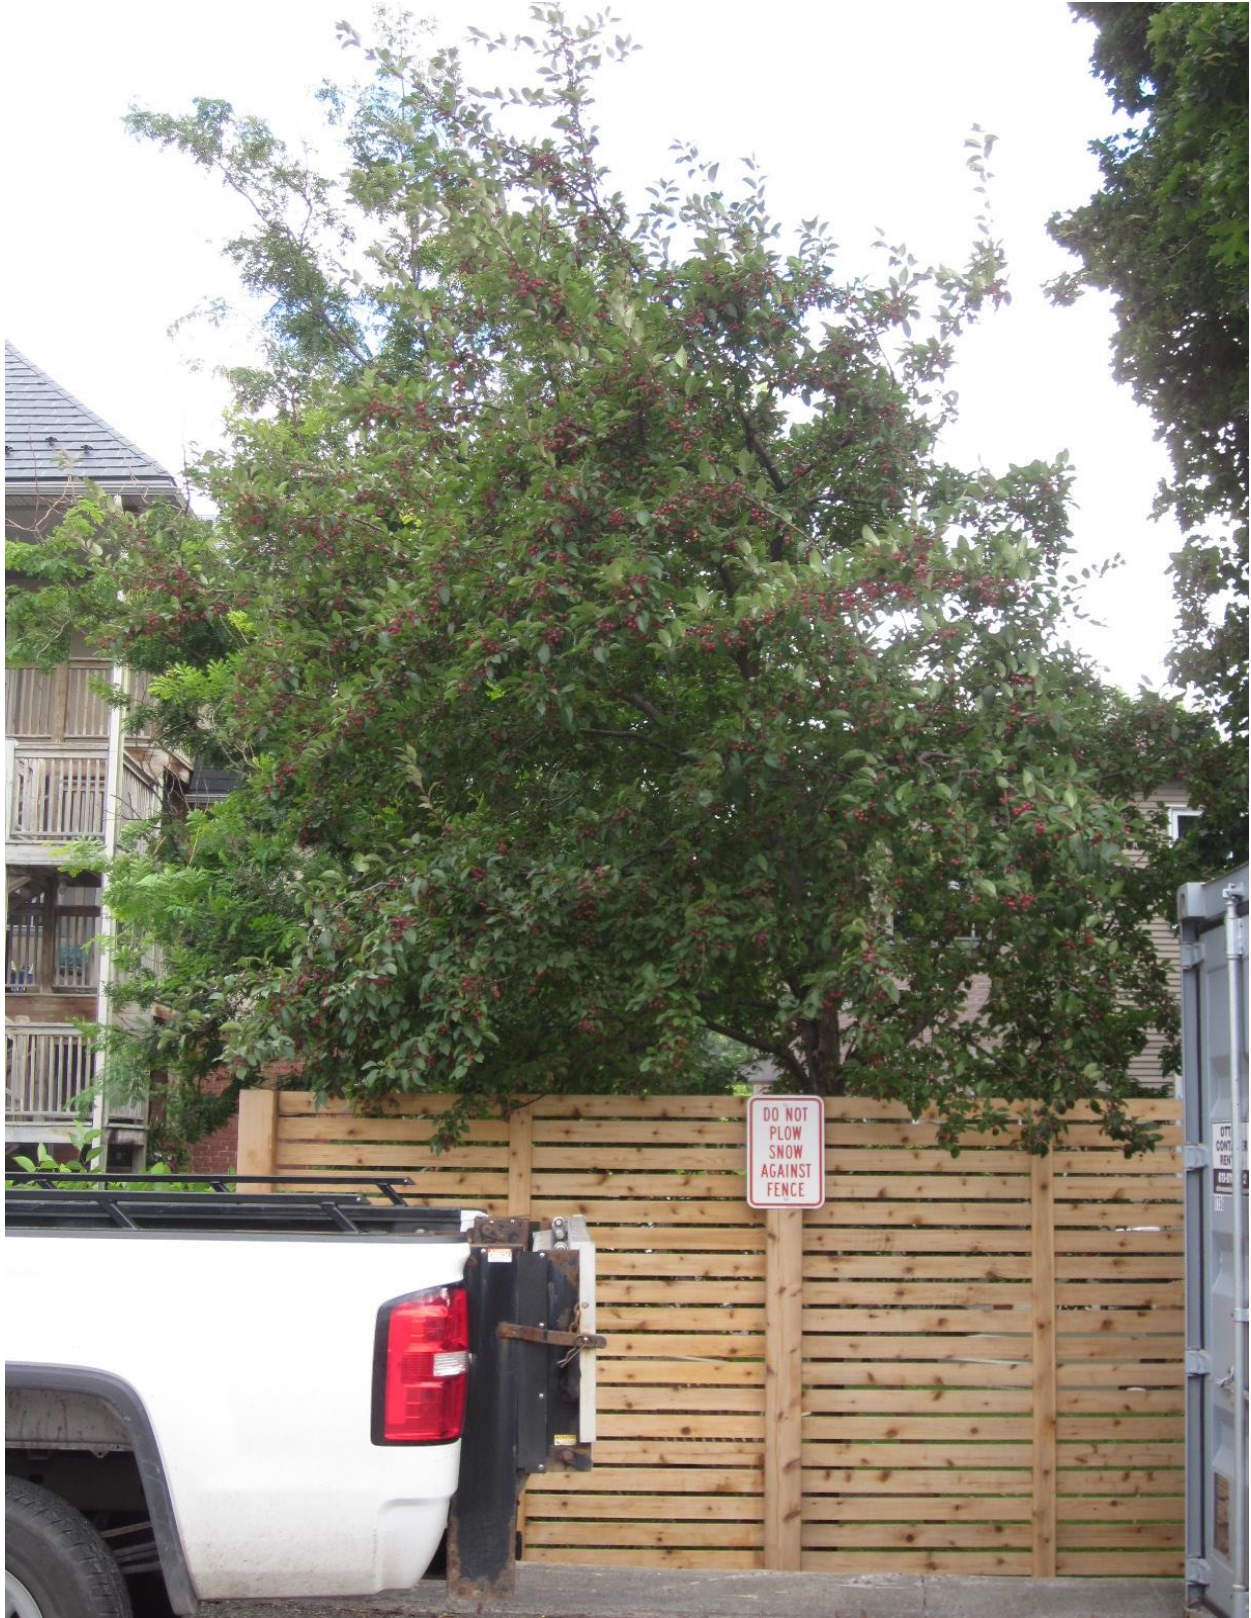
Picture 5. Tree #12 – crab apple on neighbouring private property
