TREE CONSERVATION REPORT

1299 Richmond Road

CIMA+ file number: A001359
May 29, 2023 – Review 000

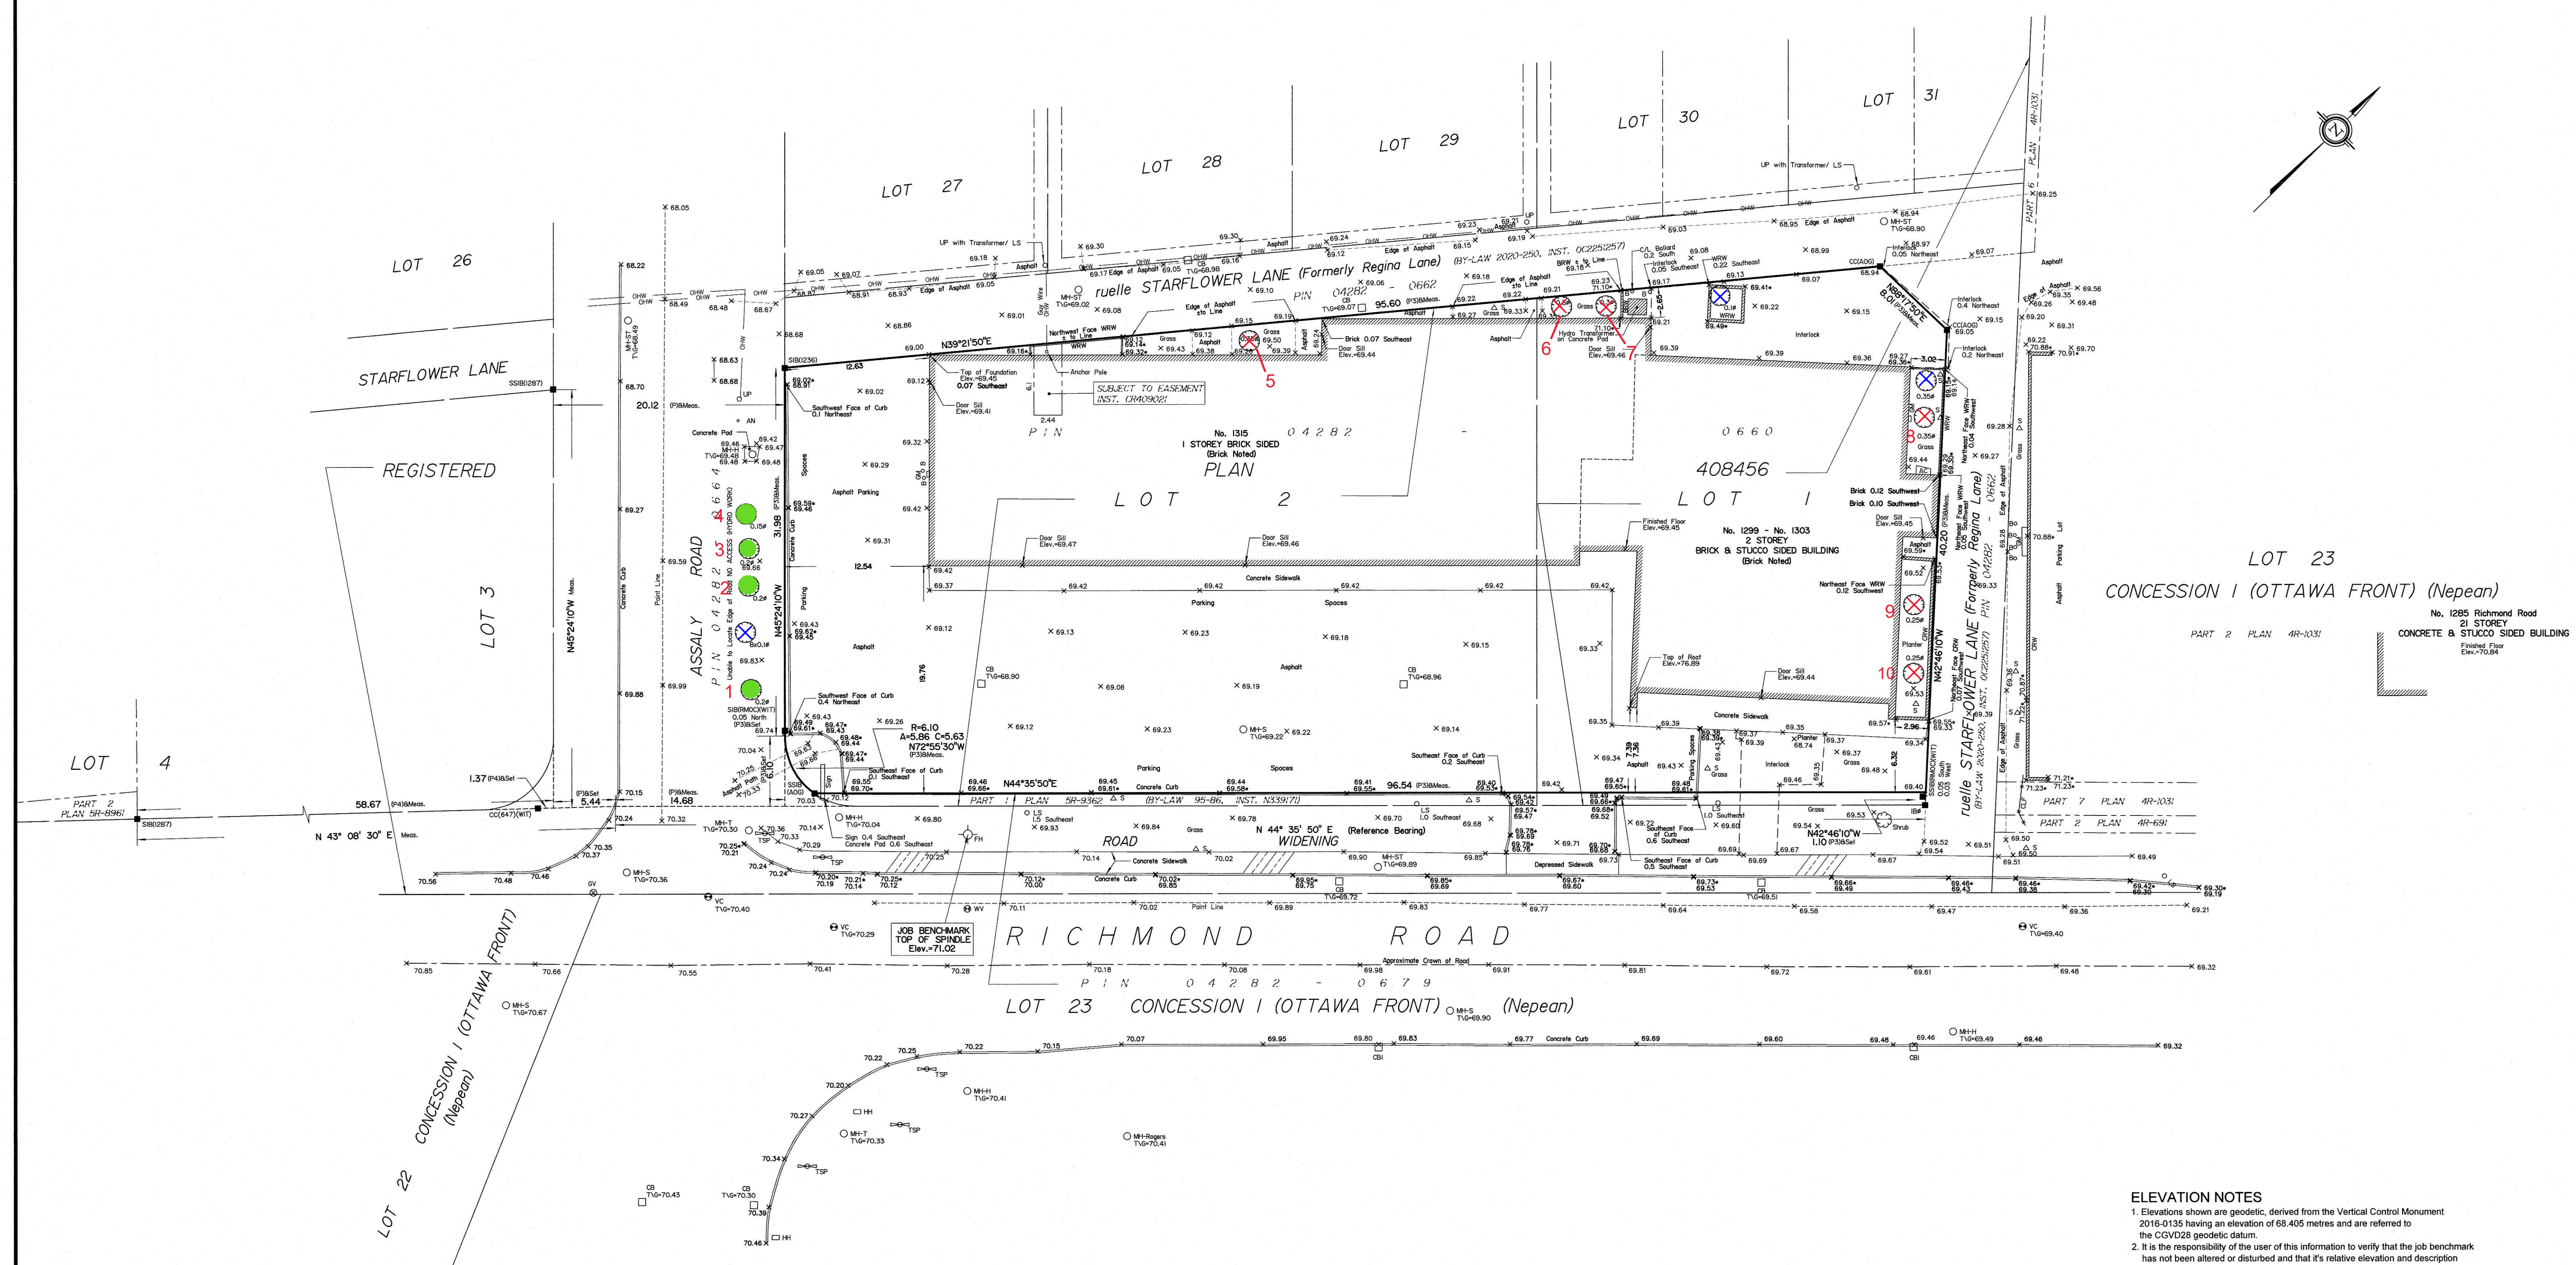
Figure 1: Richmond Road Topo_TreeIDs

Based on the species and conditions of the trees located within the site and the extent of the grading limits of the proposed project design it has been decided to retain 4 trees and remove 6 trees on site.

- Trees to be Retained
- ✗ Trees to be Removed
- ✕ Not Included (DBH < 10 cm/Absent)
