December 21, 2023

RE: TREE CONSERVATION REPORT FOR 4000 STRANDHERD DRIVE, OTTAWA

DRAWING: Tree Conservation Plan

PROJECT: 4000 STRANDHERD DRIVE CITY OF OTTAWA

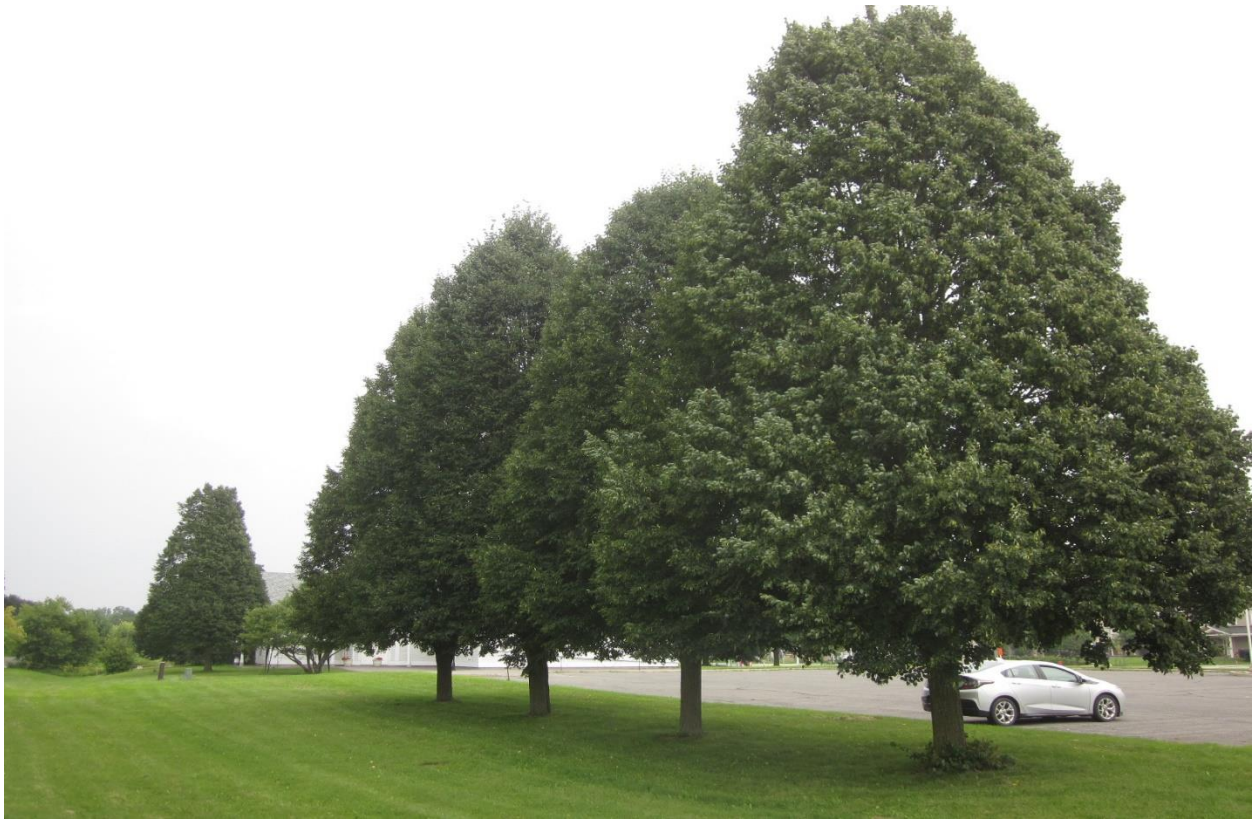
| Tree No. | Tree species | Owner-ship ¹ | DBH ² (cm) | Tree Condition; Age Class; Condition Notes; Species Origin & Preservation Status (to be removed or preserved and protected) |
|---|---|---|---|---|
| 1 | Little-leaf linden (<i>Tilia cordata</i>) | Private | 39 | Good; mature; co-dominant leaders at 2.5m – acutely angled; suppressed laterals starting at 1.5m from grade; dense crown; heavy basal sprouting; introduced species; to be preserved and protected |
| 2 | Little-leaf linden (<i>Tilia cordata</i>) | Private | 34 | Good; mature; tri-dominant stems at 1.5m – acutely angled; suppressed laterals starting at 1.5m from grade; very dense crown; introduced species; to be preserved and protected |
| 3 | Little-leaf linden (<i>Tilia cordata</i>) | Private | 42 | Fair; mature; co-dominant stems at 3.25m with weak union; open seam from grade to 2m on south – incipient decay and insect activity; laterals starting at 1.5m from grade; moderately dense crown; introduced species; to be preserved and protected |
| 4 | Little-leaf linden (<i>Tilia cordata</i>) | Private | 37 | Good; mature; central stem with competing laterals at 1.5m on northwest and 4m on west; co-dominant leaders at 5.5m; suppressed laterals starting at 1.5m from grade; dense crown; introduced species; to be preserved and protected |
| 5 | Little-leaf linden (<i>Tilia cordata</i>) | Private | 35 | Good; mature; central stem with competing lateral at 2m on north and suppressed lateral at 2m on south; dense crown; girdling root evident on northwest; introduced species; to be preserved and protected |

Picture 1. Trees #1-4 (right to left) and #5 in background, little-leaf linden trees at 4000 Strandherd Drive

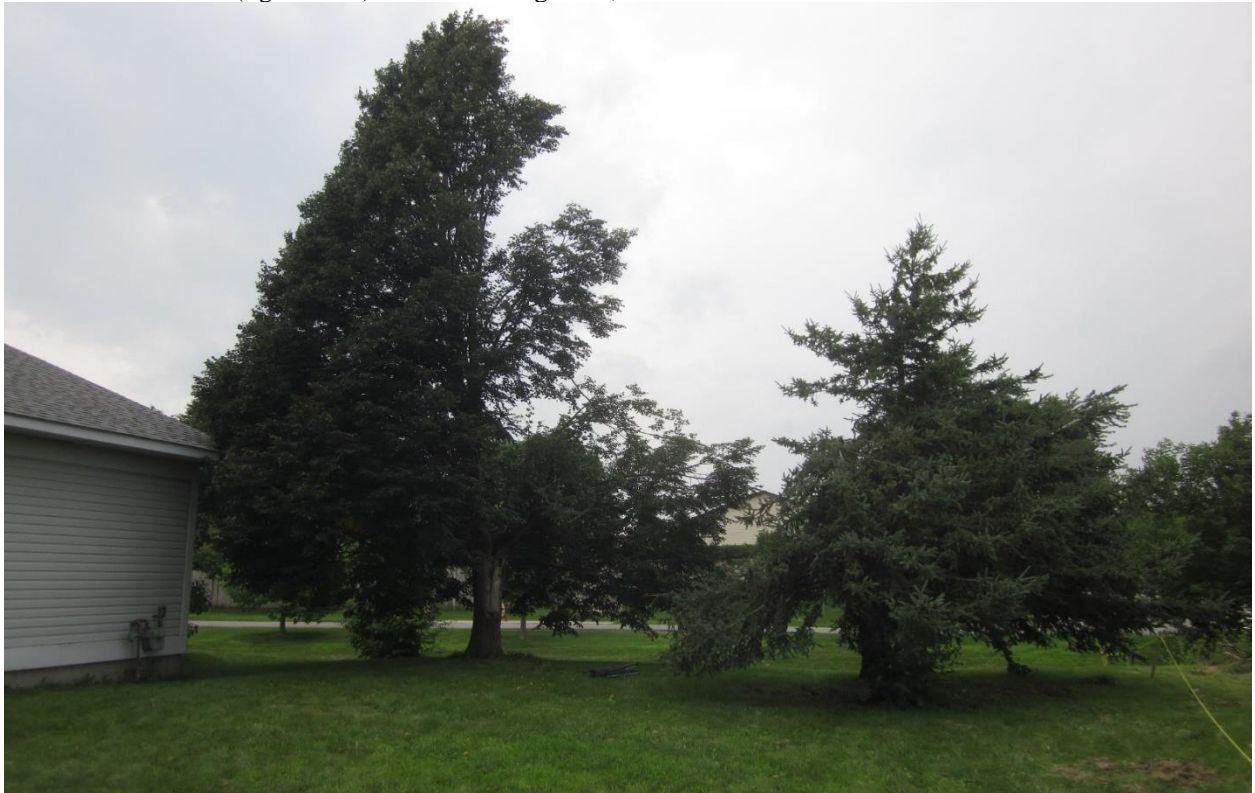
| Tree No. | Tree species | Ownership ¹ | DBH ² (cm) | Tree Condition; Age Class; Condition Notes; Species Origin & Preservation Status (to be removed or preserved and protected) |
|---|---|---|---|---|
| 6 | Little-leaf linden (<i>Tilia cordata</i>) | Private | 41 | Very poor; mature; east half of crown previously failed – fractures in bole between lost and remaining halves; risk of failure is high towards church building; introduced species; to be removed (due to condition) |
| 7 | White spruce (<i>Picea glauca</i>) | Private | 26 | Poor; maturing; very poor form – suffering from growing stress likely related to girdling roots or planting ropes/wire basket; native species; to be removed (due to condition) |

Picture 2. Trees #6 and 7 (left to right), little-leaf linden and white spruce trees at 4000 Strandherd Drive

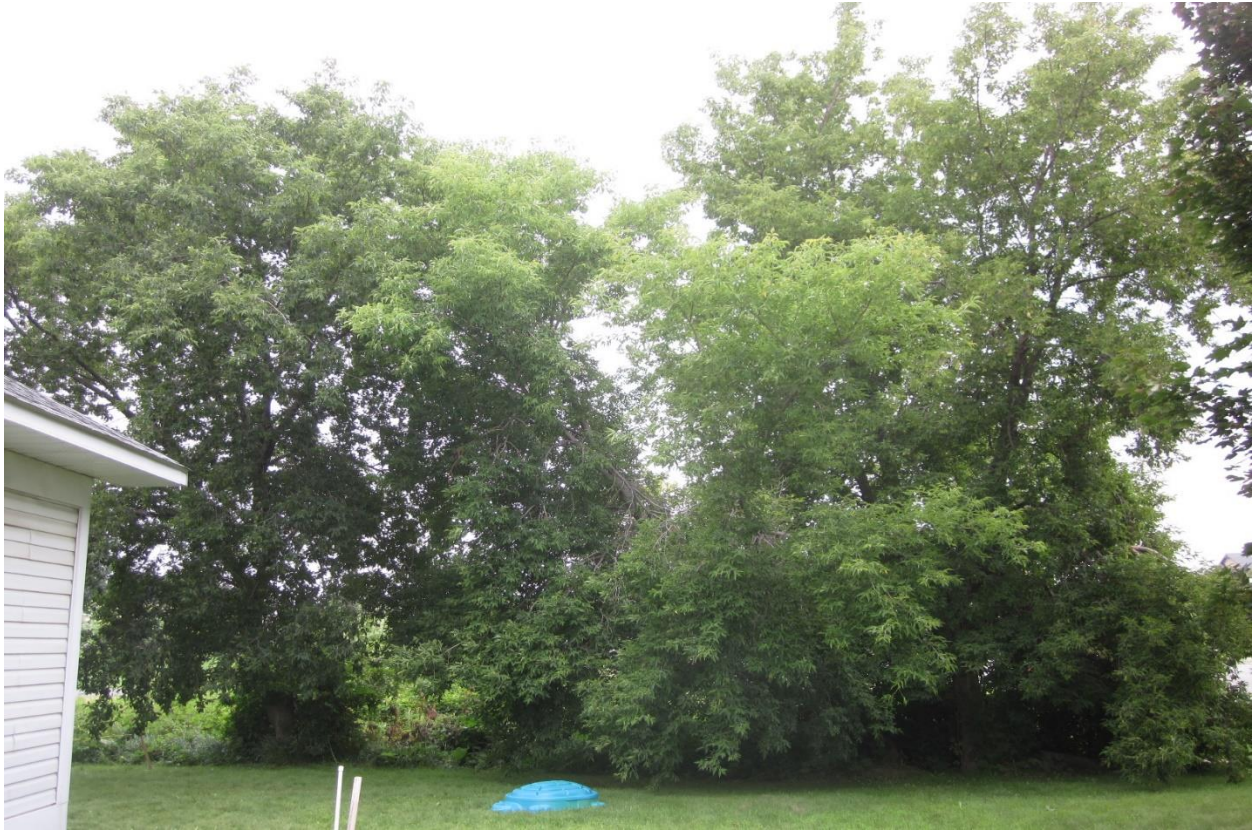
| Tree No. | Tree species | Ownership ¹ | DBH ² (cm) | Tree Condition; Age Class; Condition Notes; Species Origin & Preservation Status (to be removed or preserved and protected) |
|---|---|---|---|---|
| 8 | Manitoba maple (<i>Acer negundo</i>) | Shared with adjacent property | 45 | Fair; mature; remaining stem of co-dominants from grade; divergent and heavily asymmetric towards south (direction of church building); co-dominant leaders at 4m; suppressed lateral at 3.5m on southwest; naturalized species; to be preserved and protected (though recommended for removal) |
| 9 | Manitoba maple (<i>Acer negundo</i>) | Shared with adjacent property | 35 | Poor; mature; heavily divergent towards west (direction of church building); co-dominant leaders at 4.5m; suppressed lateral at 3m on north; naturalized species; to be preserved and protected (though recommended for removal) |
| 10 | Manitoba maple (<i>Acer negundo</i>) | Shared with adjacent property | 41 | Fair; mature; central bole with co-dominant leaders at 3.5m; north stem bisects at 5m; suppressed lateral at 3.5m on southeast; crown asymmetric towards north/west due to influence of ash previously located on east; heavy vine growth into lower crown; naturalized species; to be preserved and protected |

Picture 3. Tree #8, 9 and 10 (left to right), Manitoba maples shared with 4000 Strandherd Drive

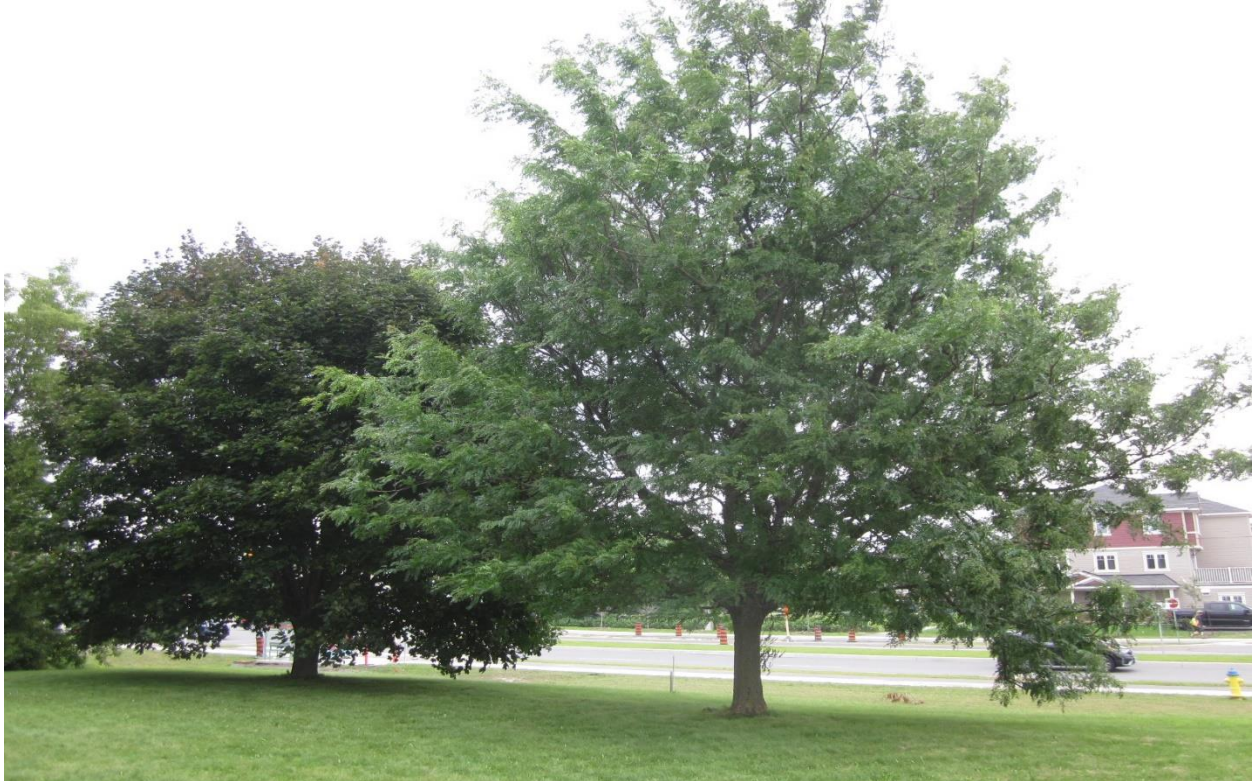
| Tree No. | Tree species | Ownership ¹ | DBH ² (cm) | Tree Condition; Age Class; Condition Notes; Species Origin & Preservation Status (to be removed or preserved and protected) |
|---|---|---|---|---|
| 11 | Norway maple (<i>Acer platanoides</i>) | Private | 47 | Fair; mature; central stem constricted by multiple competing laterals at 1.5m – forming branch cluster; binding roots at surface; introduced invasive species; to be removed (conflicts with footprint of new addition to church) |
| 12 | Honey-locust (<i>Gleditsia triacanthos</i>) | Private | 41 | Good; mature; central stem with competing laterals at 1.75m on west and 2.75m on north; dense crown for species; mild basal damage from mowers; introduced species; to be removed (conflicts with footprint of new addition to church) |

Picture 4. Trees #11 and 12 (left to right), Norway maple and honey-locust trees at 4000 Strandherd Drive

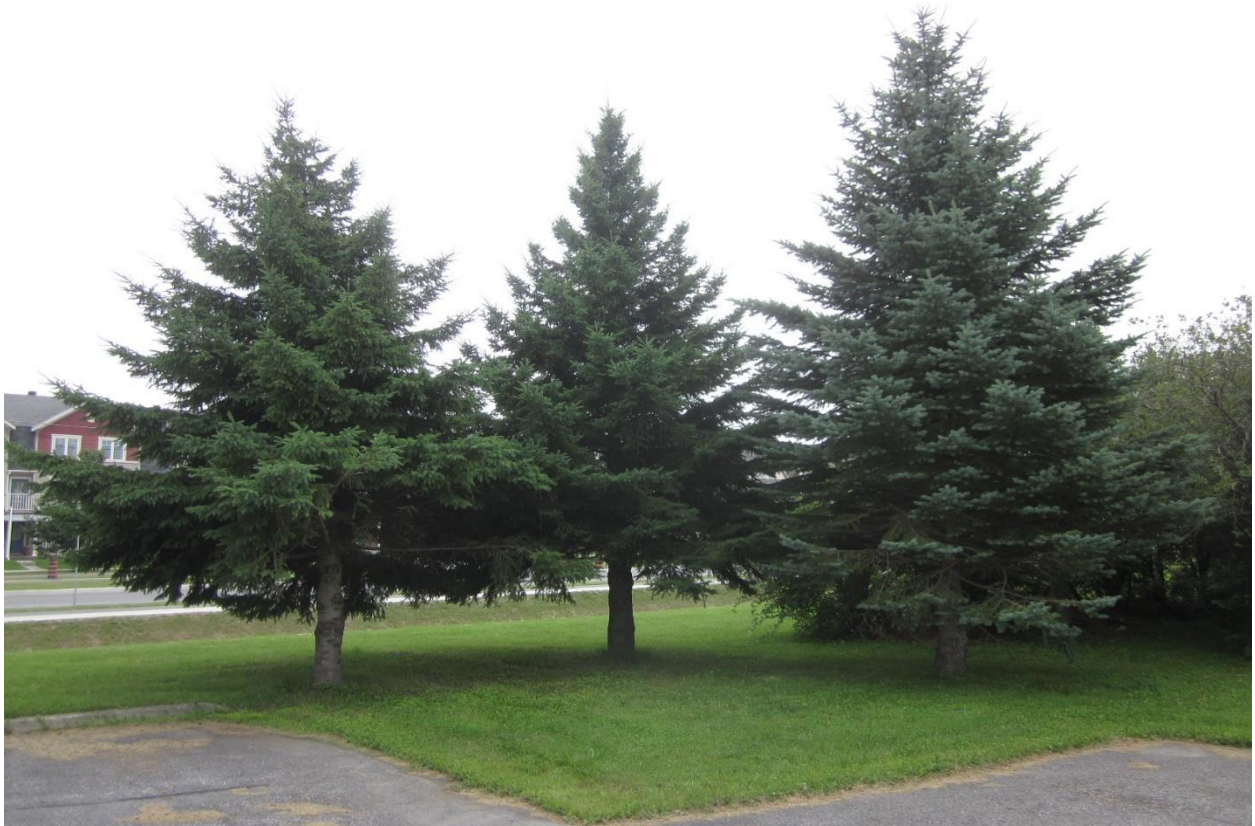
| Tree No. | Tree species | Ownership ¹ | DBH ² (cm) | Tree Condition; Age Class; Condition Notes; Species Origin & Preservation Status (to be removed or preserved and protected) |
|---|--|---|---|--|
| 13 | White spruce (<i>Picea glauca</i>) | Private | 29 | Fair; mature; mildly divergent toward east; some damage to lower crown from snow piling; good crown density, annual increment, and needle colour; native species; to be removed (conflicts with new parking area) |
| 14 | White spruce (<i>Picea glauca</i>) | Private | 34 | Good; mature; good form; good crown density, annual increment, and needle colour; native species; to be removed (conflicts with new parking area) |
| 15 | Colorado blue spruce (<i>Picea pungens</i> var. <i>glauca</i>) | Private | 29 | Good; mature; good form; good crown density, annual increment, and needle colour; introduced species; to be removed (conflicts with new parking area) |

Picture 5. Trees #13, 14 and 15, white and Colorado spruce trees at 4000 Strandherd Drive
