TREE CONSERVATION REPORT

2506 Innes Road

Dendron Forestry Services

September 16, 2024

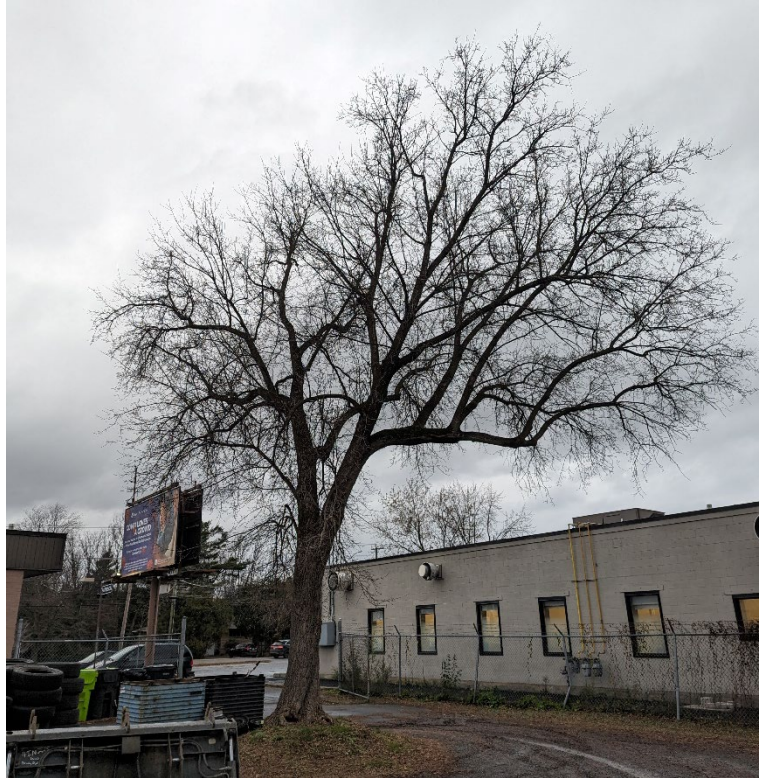
Above: Tree 1 - private manitoba maple to be removed.

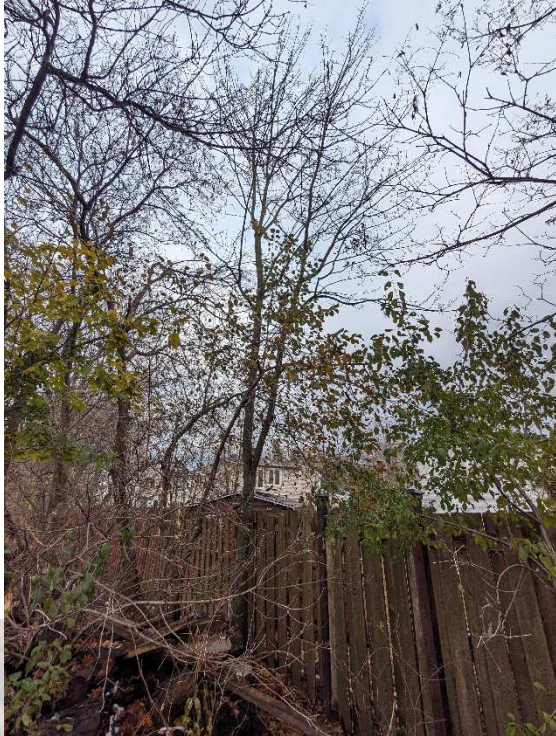
Left: Tree 22 – private maple to be removed.

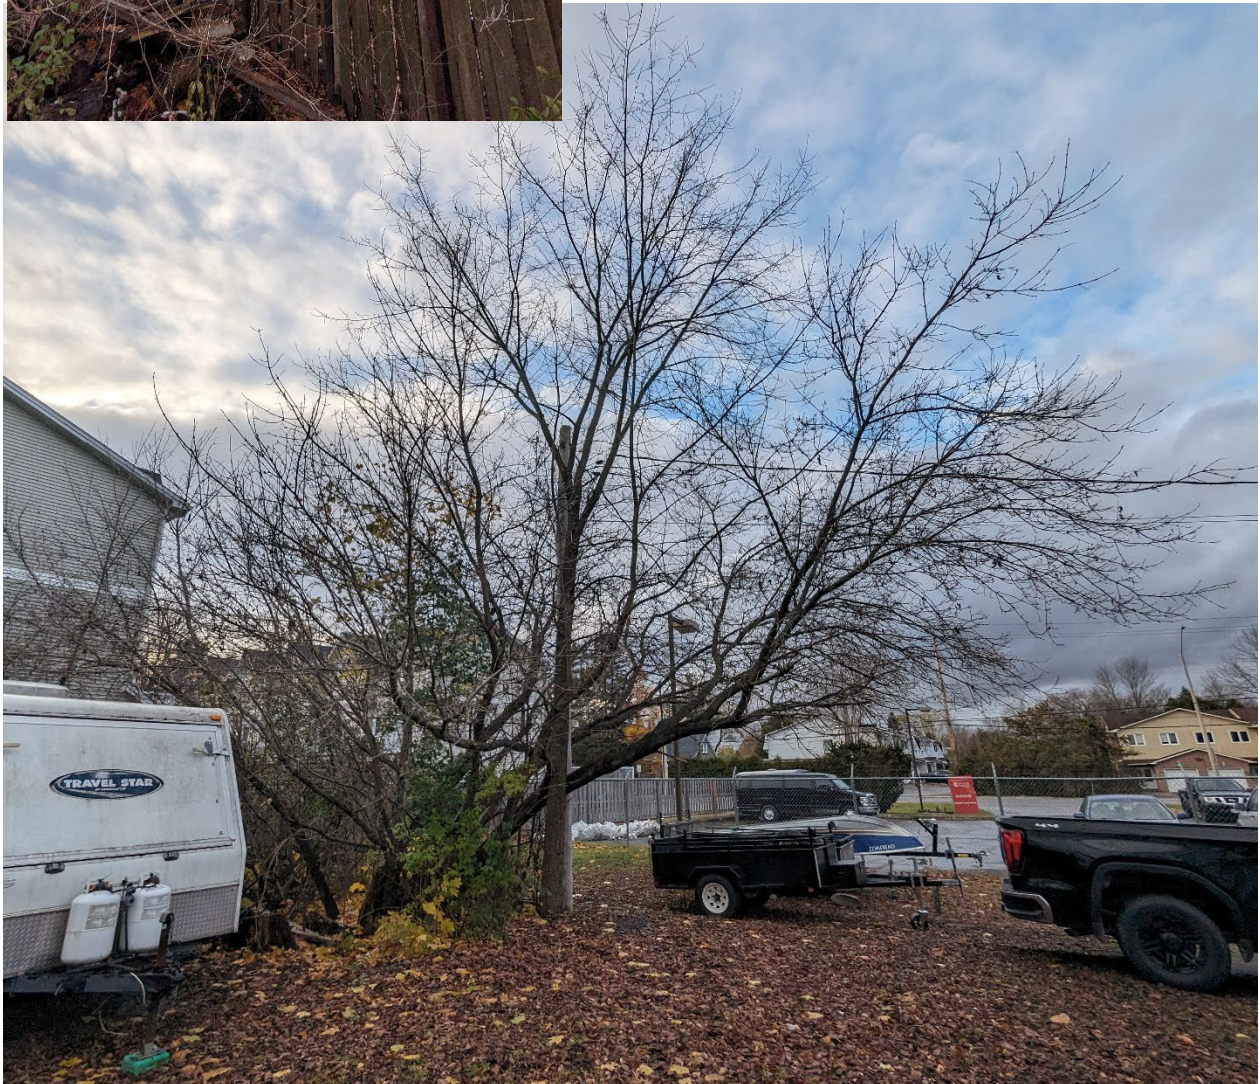
Below: Trees 34-36 - to be removed
