Tree Conservation Report

2940, 2944, and 2946 Baseline Road

CIMA+ file number: A0000180 September 24, 2025 – Review 004

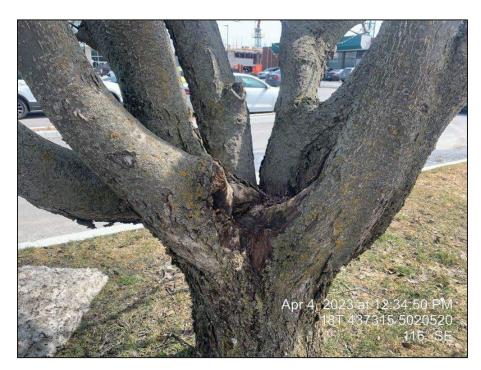
It should be noted that the one (1) oakleaf mountain ash (Tree #14 - Appendix A) was assessed as Fair due to its poor structure and crotch decay. The City has requested that this tree be retained. Photo 1 below displays the deficiencies of this individual.

Photo 1: View of the crotch decay and poor structure of Tree #14 - Oakleaf Mountain Ash

Ctro	uctura	l Dofe	otol							
Tree/Tree Group No.	Common Name	Scientific Name	No. Stems	dbh (cm)	Height (m)	Crown Spread			Sur	uctura					Overall Condition ⁱⁱ	Comments	Ownership	Recommendation	CRZ
Group No.	Name	113	Otto:	(0111)	()	(m)	DB	MBR	SC	INC.	SMD	COD	NR R	MEC	Condition				(m)
9	Eastern white pine	Pinus strobus	1	18	4-7	4									Good	Behind fence. Tree tag #693	City	Retain	1.8
10	Eastern white pine	Pinus strobus	1	22	8-11	3							V		Fair	Behind fence. Tree tag #691	City	Retain	2.2
11	Norway spruce	Picea abies	1	37	16-20	5							V		Good		Private	Retain	3.7
12	Skyline thornless honeylocust	Gleditsia triacanthos 'Skyline'	1	5	4-7	1					V				Good	Newly planted	Private 2946 Baseline Rd	Remove	0.5
13	Skyline thornless honeylocust	Gleditsia triacanthos 'Skyline'	1	4	4-7	1									Good	Newly planted	Private 2946 Baseline Rd	Remove	0.4
14	Oakleaf mountain ash	Sorbus x thuringiaca	1	70	8-11	5	V	V	V	V	V	V	V		Fair	Poor structure. Crotch decay.	Private 2946 Baseline Rd	Remove	7
