TREE CONSERVATION REPORT FOR 1DOOR4CARE TREATMENT CENTRE 401 SMYTH ROAD, CITY OF OTTAWA, ONTARIO

Date: March 31, 2025

File: C23080

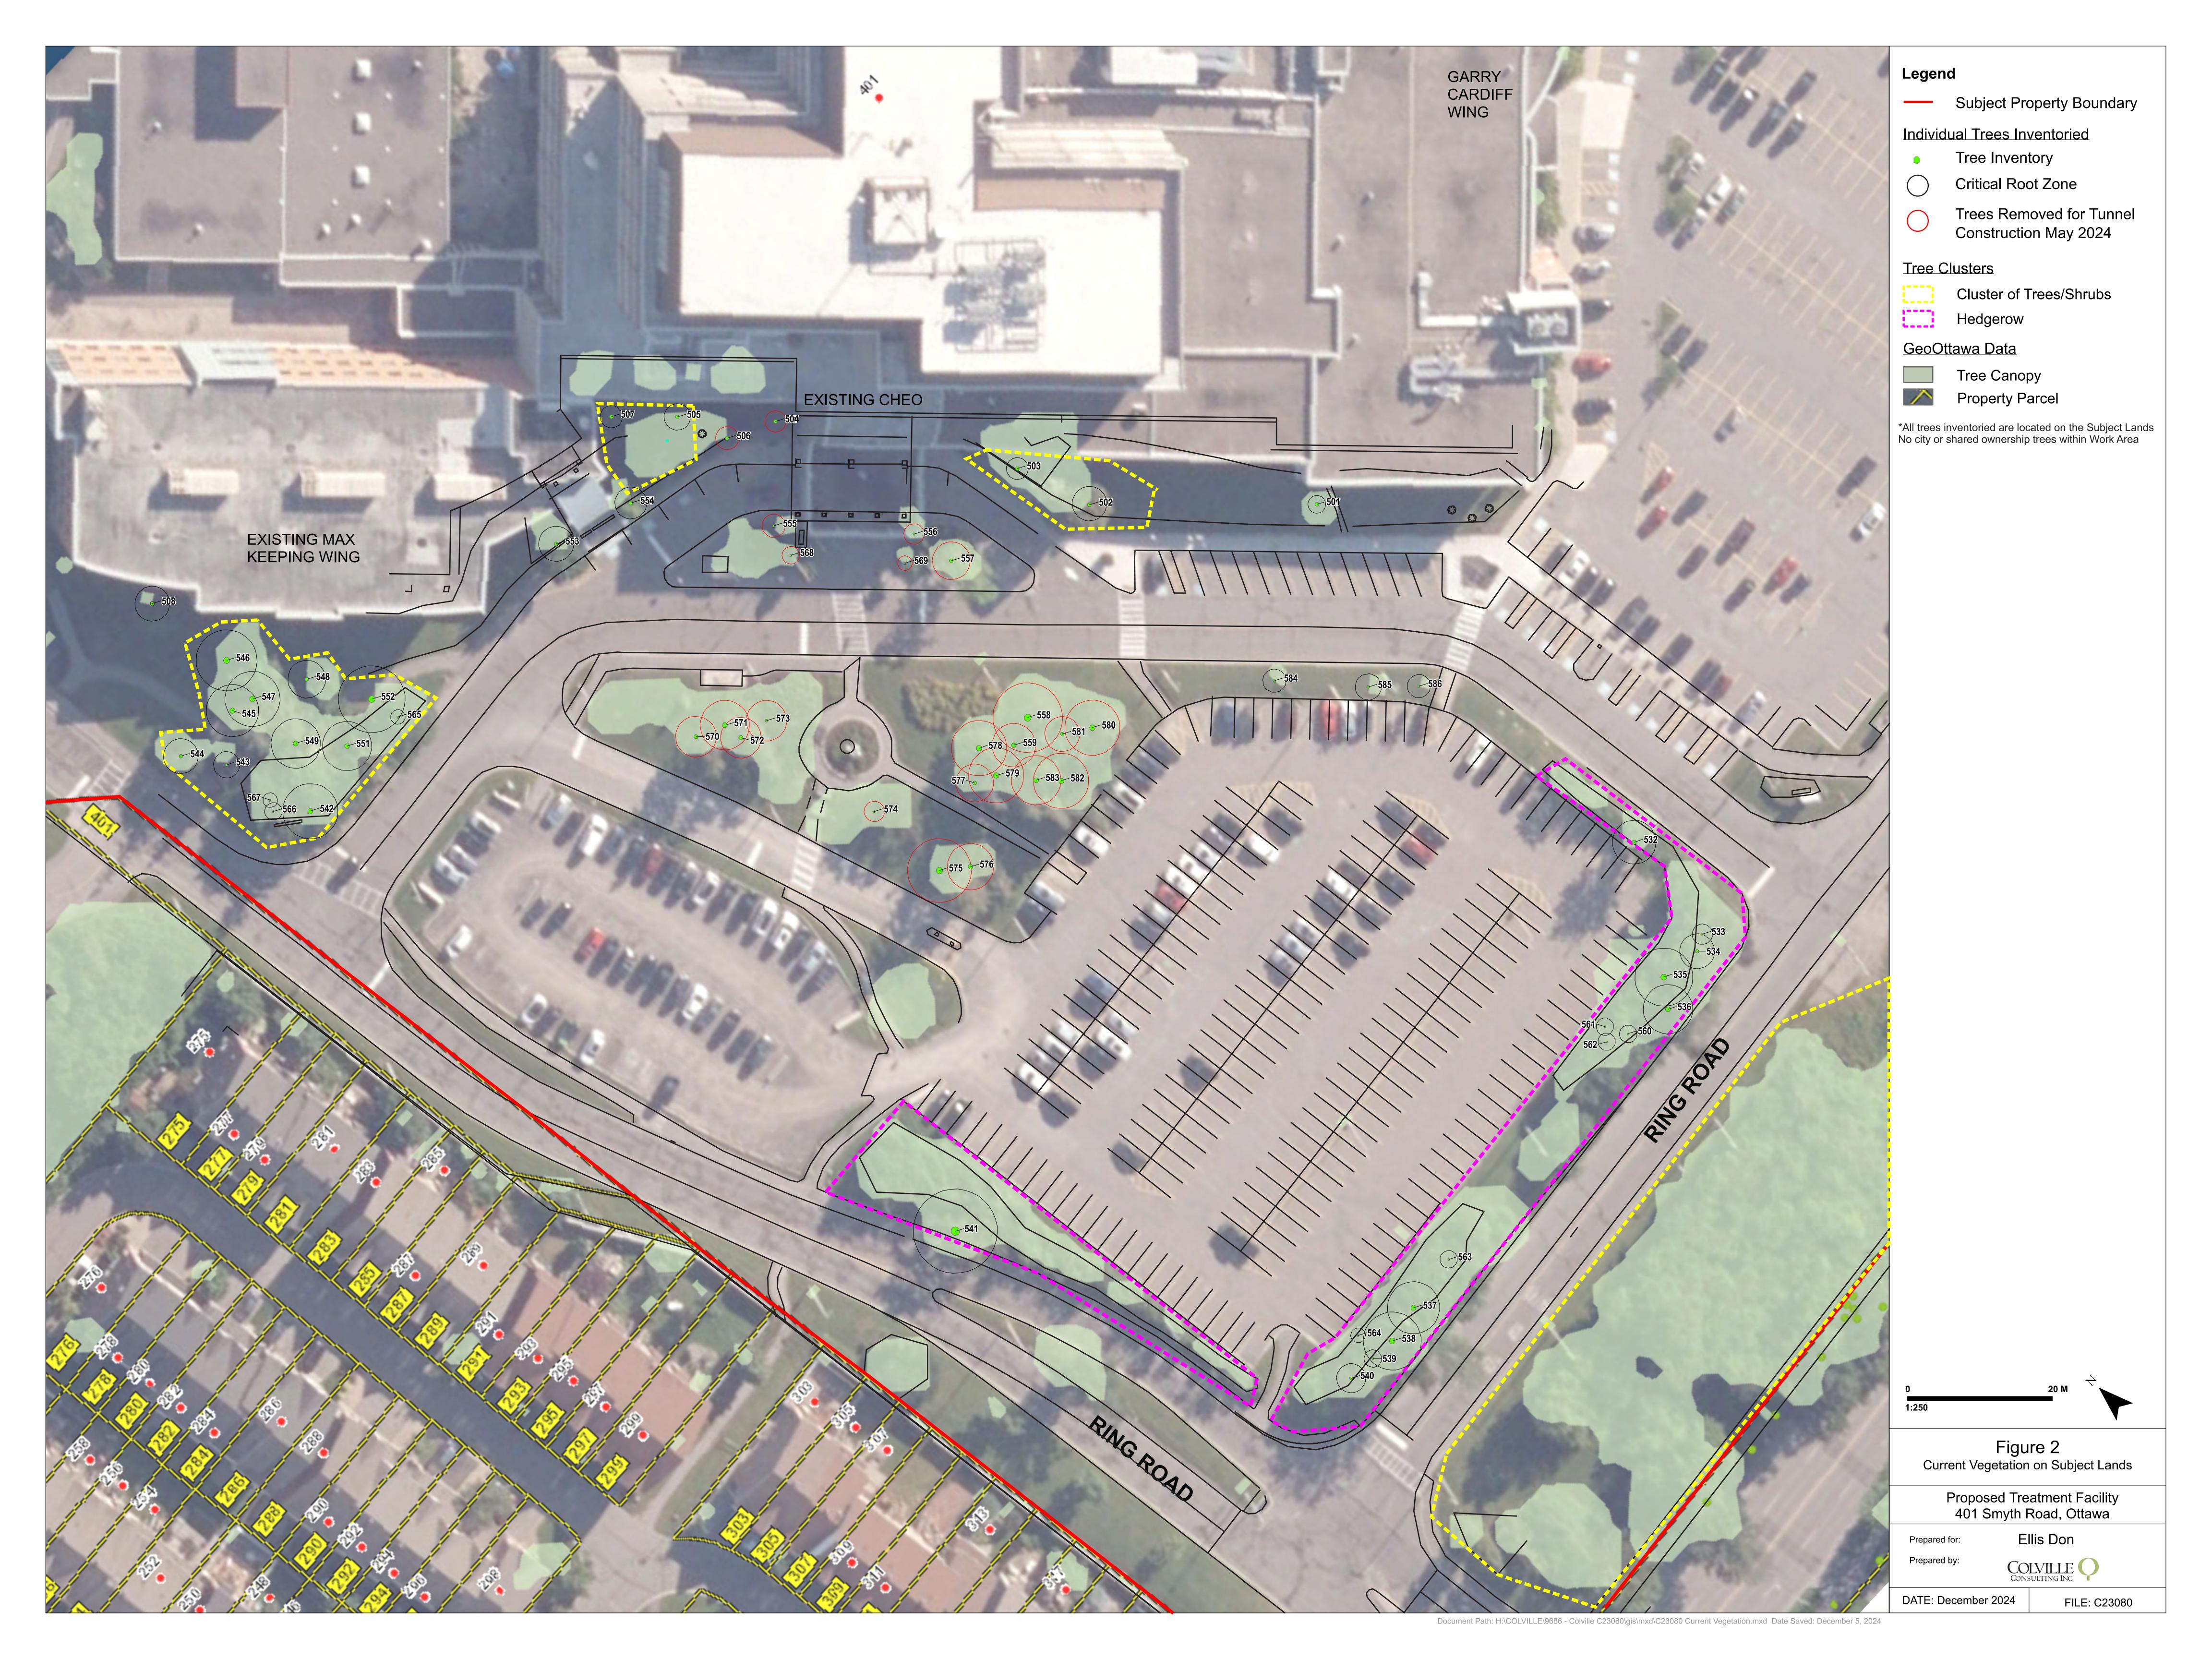
Figure #2 - Current Vegetation on Subject Lands

Additional work was undertaken in 2024 which included a nest sweep completed in May 2024. This assessment was completed as part of the requirement for the removal of 23 trees to facilitate work on the 1D4C Treatment Centre development including the construction of a tunnel. For the purposes of this report, these previously removed trees have been included in the total number of trees inventoried and required for removal to facilitate development on the Subject Lands. Trees removed to facilitate tunnel construction in May 2024 have been identified on mapping in Appendix B for reference.

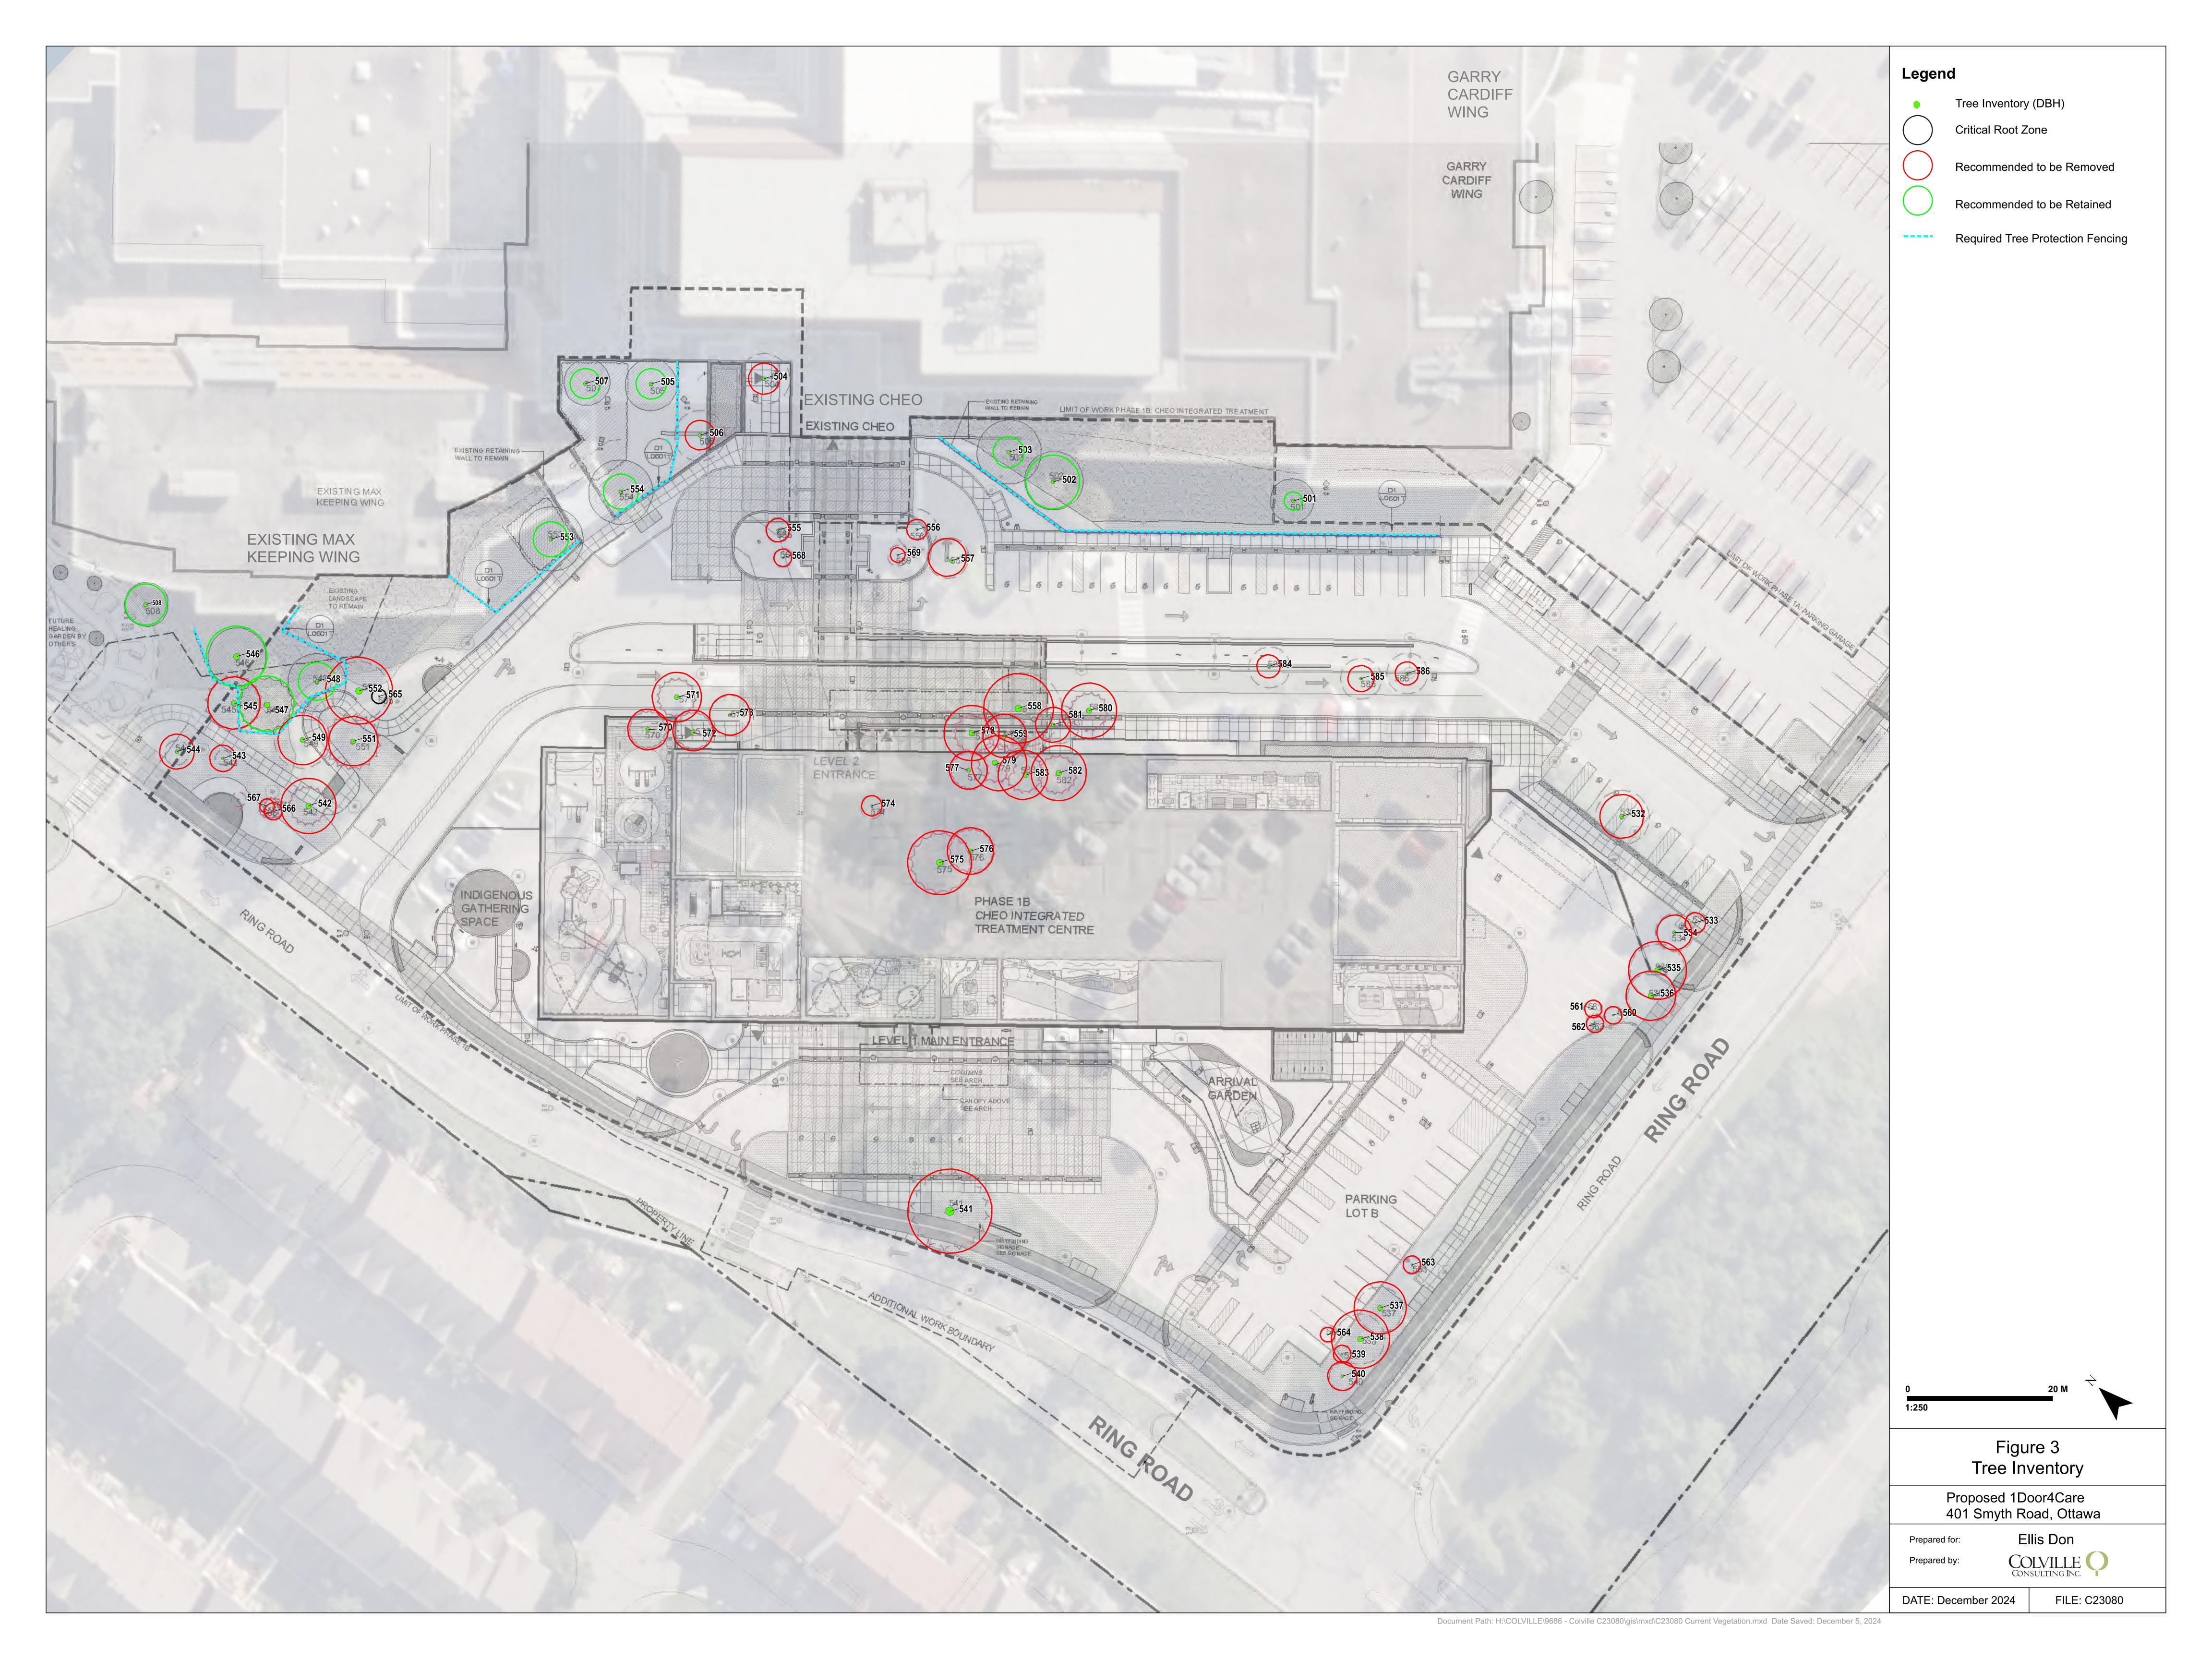
Figure #3 - Tree Inventory and CRZ for Proposed 1Door4Care Treatment Centre

a current aerial photograph. Mapping in Appendix C shows the proposed development plan with all trees inventoried on and adjacent the Subject Lands and Critical Root Zones (CRZ). Tree protection fencing and limits of construction are also shown on Mapping in Appendix C. A selection of site photographs taken during field inventories are provided in Appendix D.

- A limit of work fence/ tree hoarding shall be installed along the CRZ of trees to be retained as shown on the site plan in Appendix C.
- Where work within the CRZ cannot be avoided for trees recommended to be retained, mitigation measures described in the above tree care recommendations should be followed to reduce potential damage to the tree.

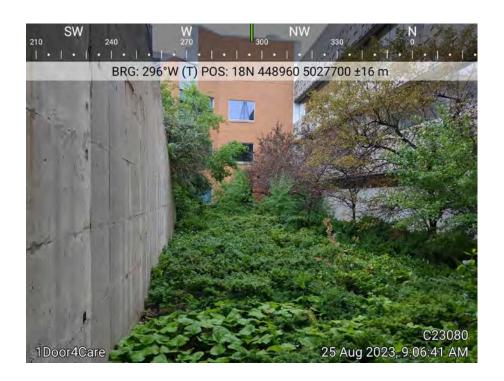
Photo 1: Landscaping adjacent existing hospital below drop off area.

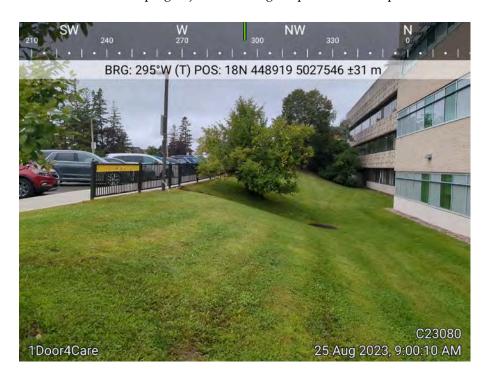
Photo 2: Viewing northwest at manicured area north of drop off area.

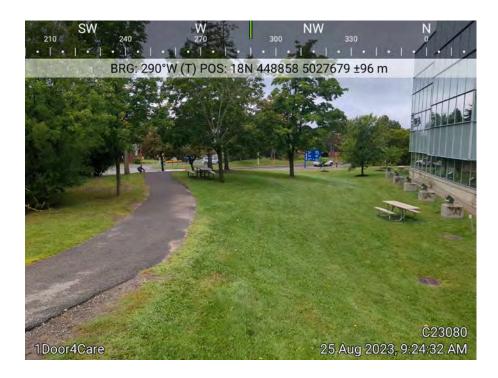
Photo 3: Trees adjacent walking path on northwest portion of proposed development

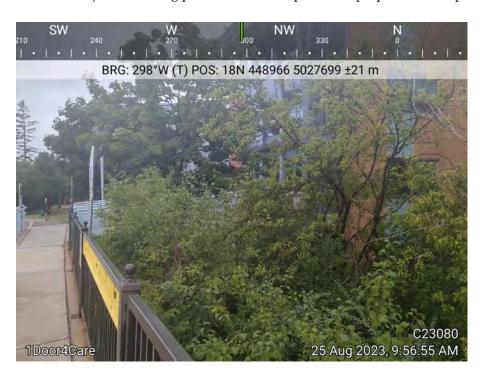
Photo 4: Vegetation adjacent existing hospital staff access

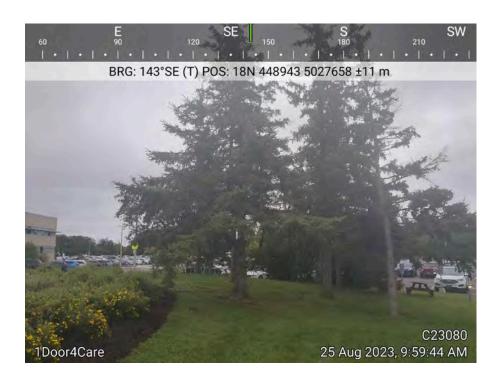
Photo 5: View of trees to be removed in footprint of new building.

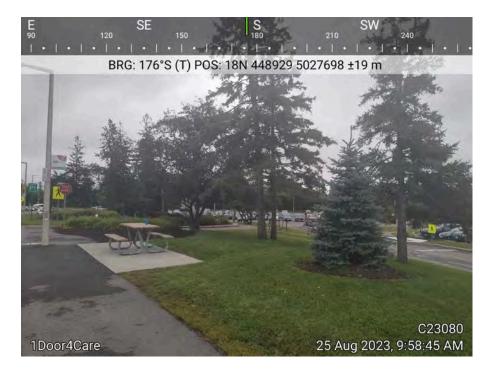
Photo 6: View of landscaped trees southeast of existing patient drop off door.

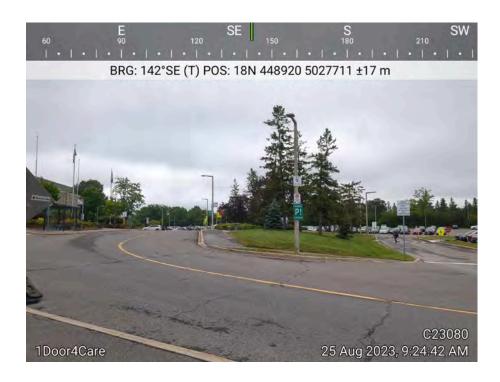
Photo 7: View of trees to be removed southwest of patient drop off door.

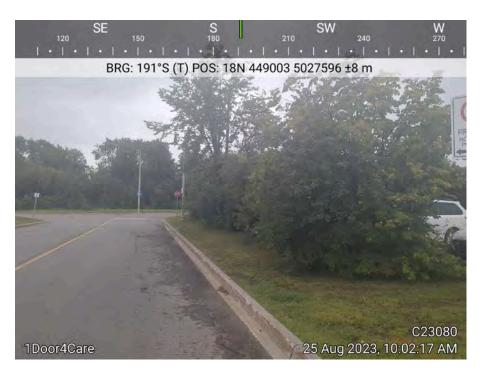
Photo 8: View of trees and vegetation in hedgerow adjacent Ring Road.

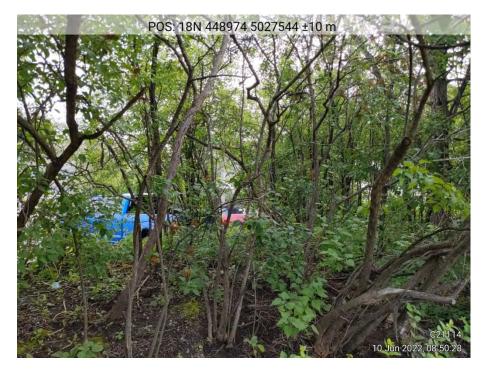
Of the trees to be removed, nine (9) are invasive common buckthorn. A significant amount of smaller common buckthorn was also observed within the thickets adjacent to Ring Road on the southern and western edges of the Subject Lands. Small thickets of Buckthorn were also observed along the northern edge of the Subject Lands.

Photo 9: Example of vegetation conditions within hedgerow along Ring Road.

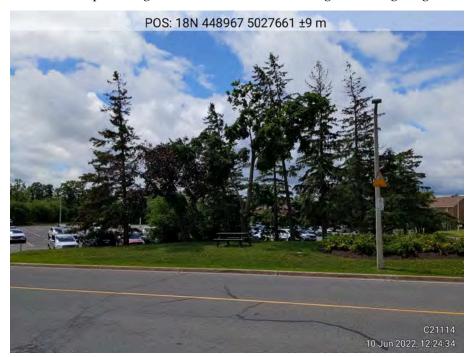
Photo 10: Cluster of trees in landscaped area southwest of CHEO main entrance.

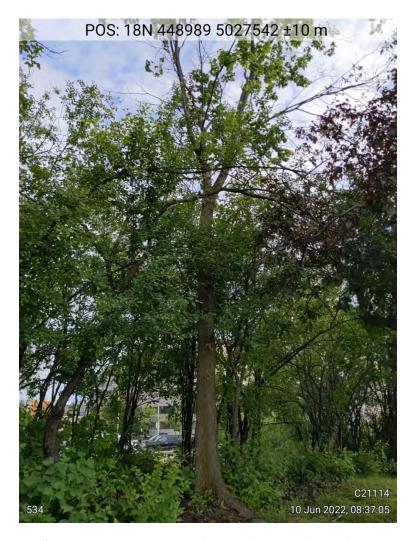
Photo 11: Tree #534 in poor/fair condition with significant canopy dieback.

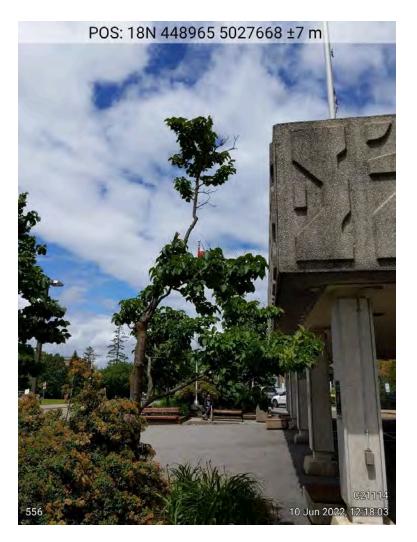
Photo 12: Tree #556 adjacent CHEO main entrance, fair condition with reduced canopy.

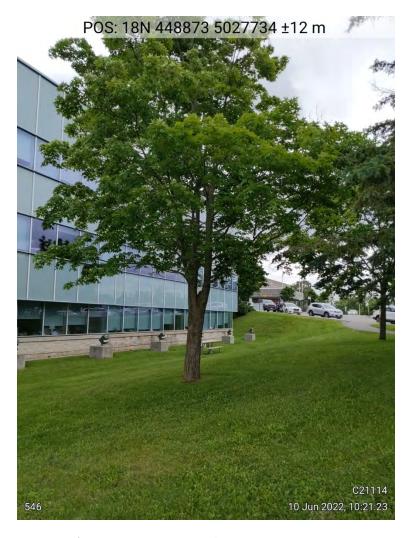
Photo 13: Tree #546, weak union at 1.5 metres.
