A HERITAGE IMPACT ASSESSMENT 384 ARLINGTON AVENUE. OTTAWA, ON

Prepared for: Windmill Developments
By: John Stewart, Commonwealth Historic Resource Management
Revised October 2024

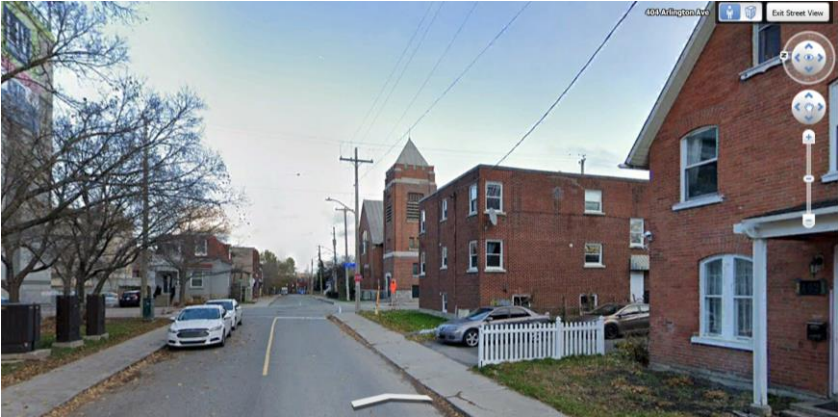
Figure 3: 2022 context view looking east on Arlington to the church, illustrating the built form. A circa 1890 brick clad detached residence (right) and a circa 1930 brick clad apartment block are located to the west of the church. Source: Google Earth

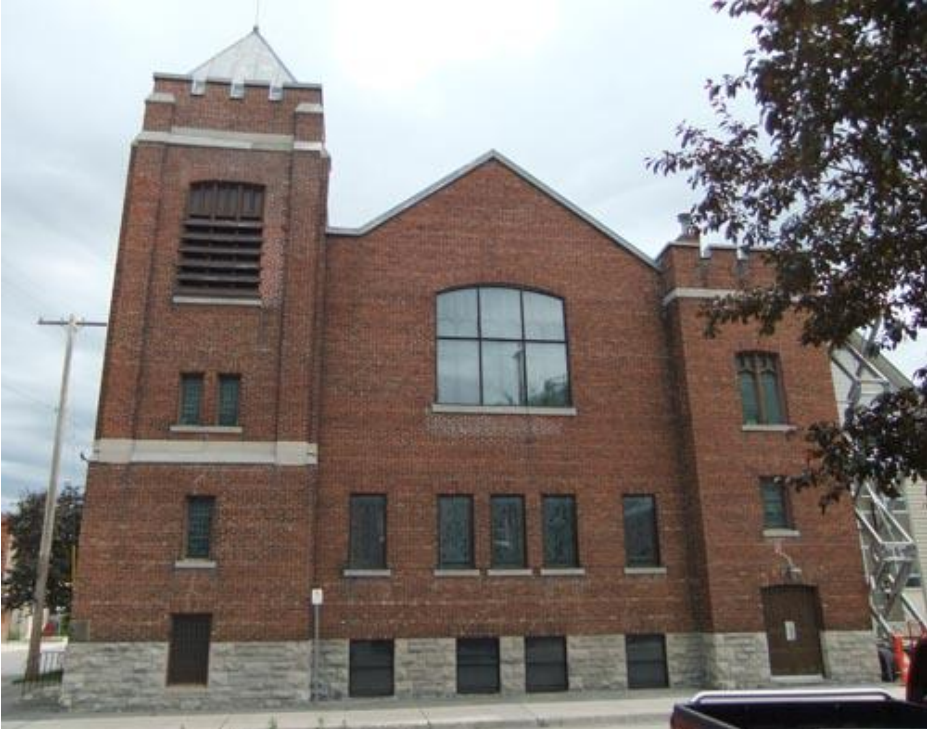
Figure 8: View of the west Bell Street façade of the 1910 United Church. The six (6) art/stained-glass windows in the west façade are intact and have been protected with recently installed double glazing units. Source: Ontario Heritage Trust.

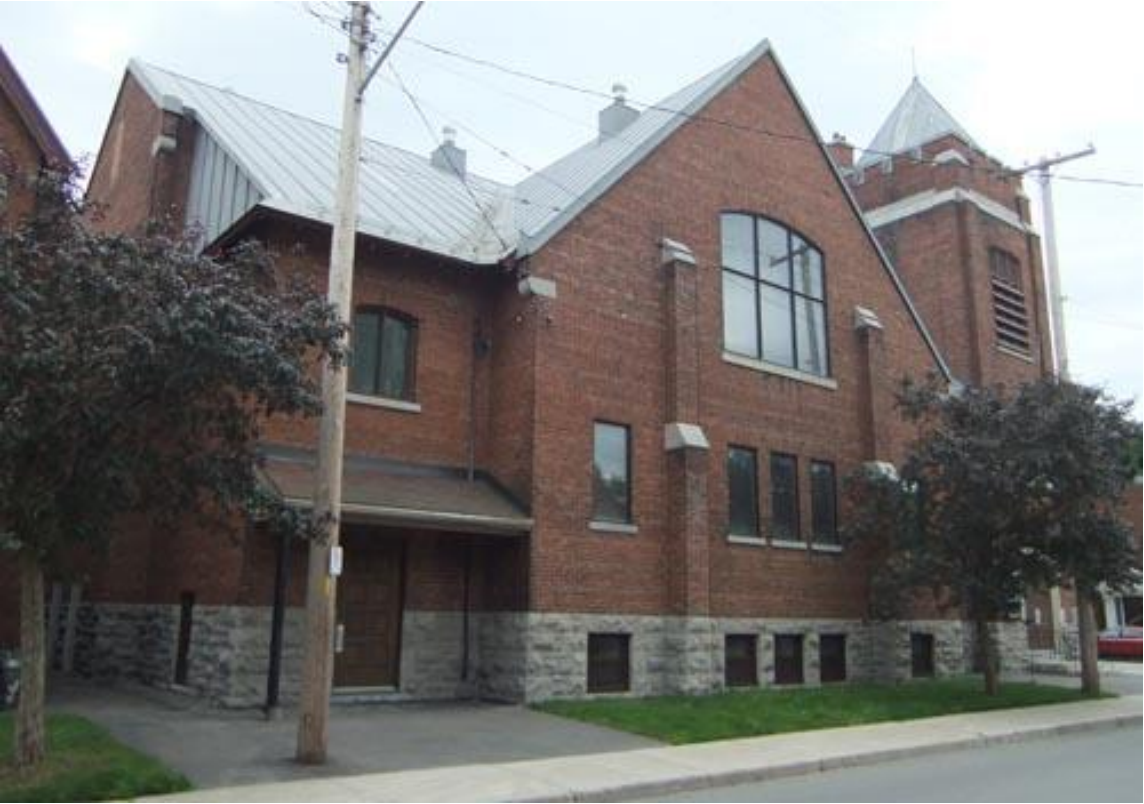
Figure 9: Street view of the Arlington Avenue façade of the 1910 church. Note the cross-gable roof form. There are six (6) art/stained-glass windows on the north façade. Source: Ontario Heritage Trust

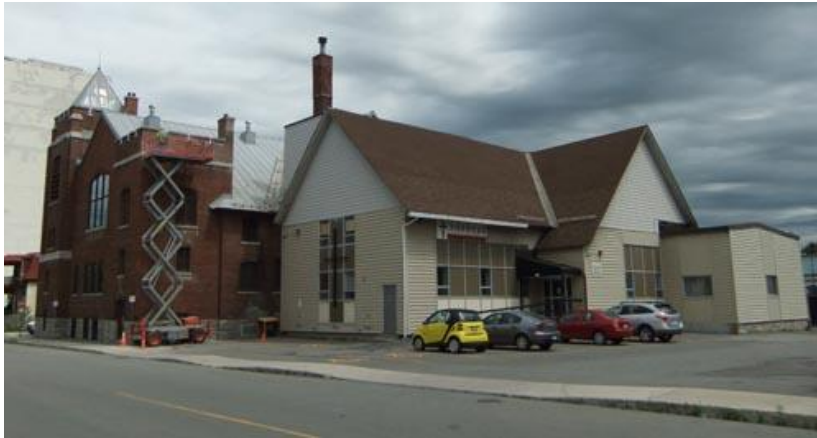
Figure 10: View of the shell of the 1890 Bell Street Methodist Church that was converted to a hall in 1910 and renovated in 1969. A forty (40') wood tower was located at the northwest corner of the 1890 structure (Figure 13). Note the south return wall with a crenellated parapet behind the scissor lift. Source: Ontario Heritage Trust

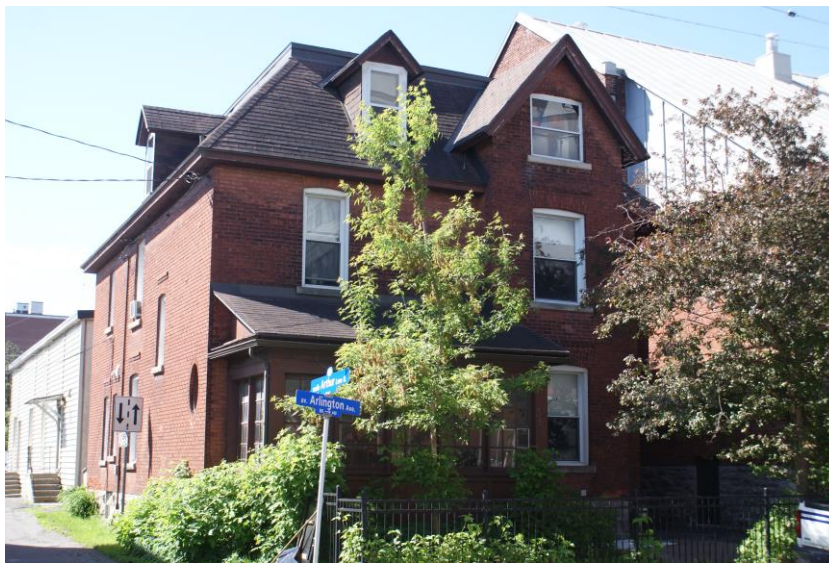
Figure 11: View of the 1902 Parsonage. The building is a brick-clad wood frame structure set on a coursed limestone foundation enclosed with a hip roof with a projecting bay enclosed with a gable roof. Source: Commonwealth 2024

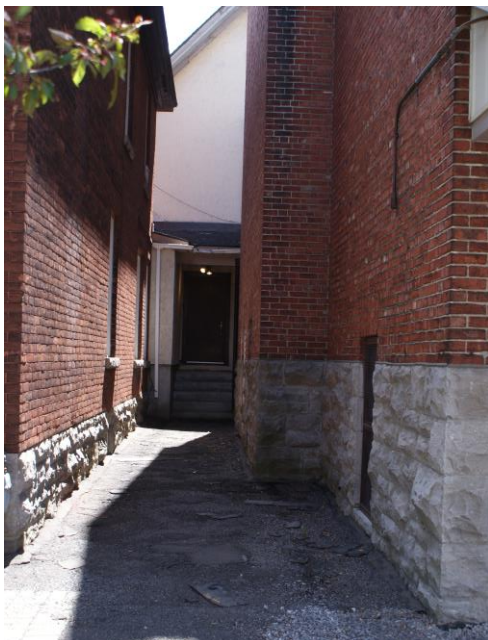
Figure 12: View of the coursed limestone foundations of the 1910 Church (right) and the 1902 Parsonage (left). Note the difference in the stone module (size and finish) between the front and side elevations of the church. The stone from the demolished foundation walls will be used to accommodate changes to the grade level windows in the Bell and Arlington facades. The limestone foundation walls of the Parsonage should be salvaged for potential landscape use. Source: Commonwealth 2024

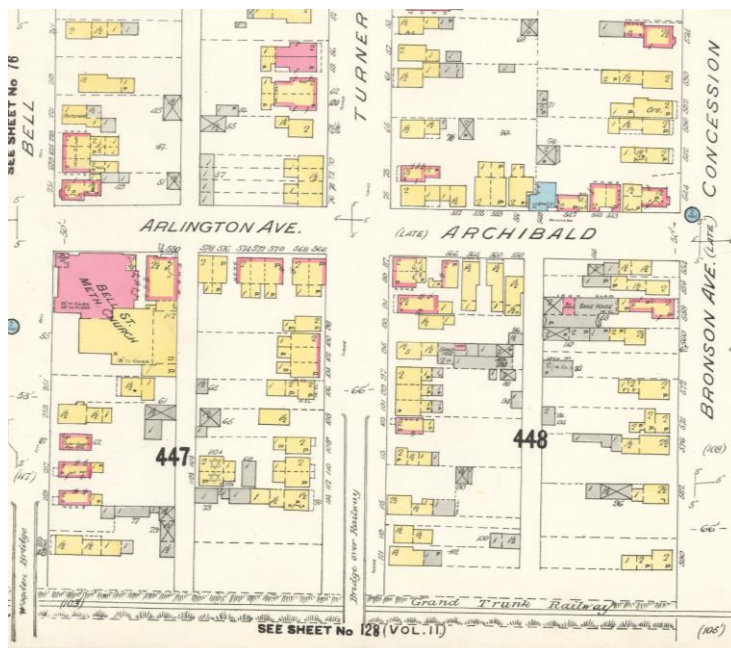
Figure 14: 1912 Fire Insurance Plan Sheet 77. Arlington Street had been extended through the area. The 1902 Parsonage had been completed, and the second church was completed in 1910 to the north of the original church, which became a hall. Source: Collections Canada

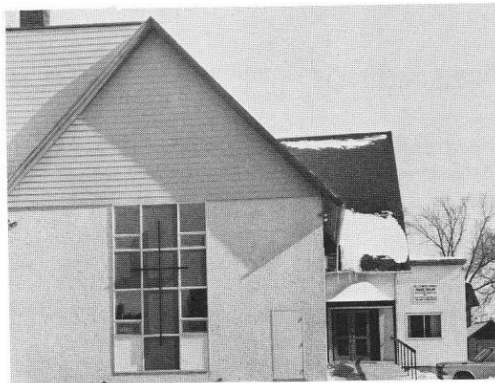
BELL STREET UNITED CHURCH HALL
— Renovated and re-dedicated in 1969 —

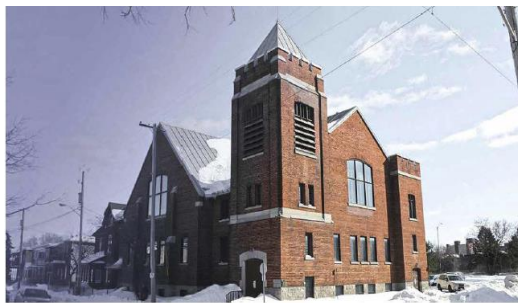
A primary goal of the project is to maintain the aesthetics of the facade to accentuate the Roman Church's historical materials. The church's facade is mainly composed of red brick, an important traditional material seen prominently throughout the neighborhood.

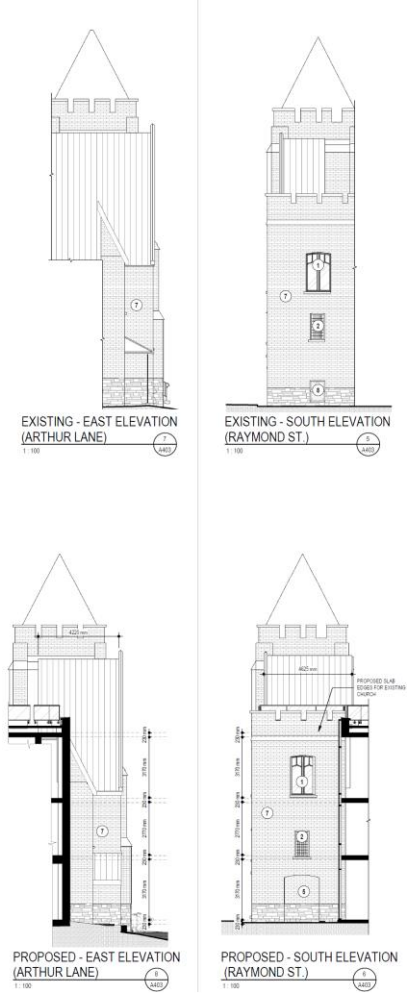
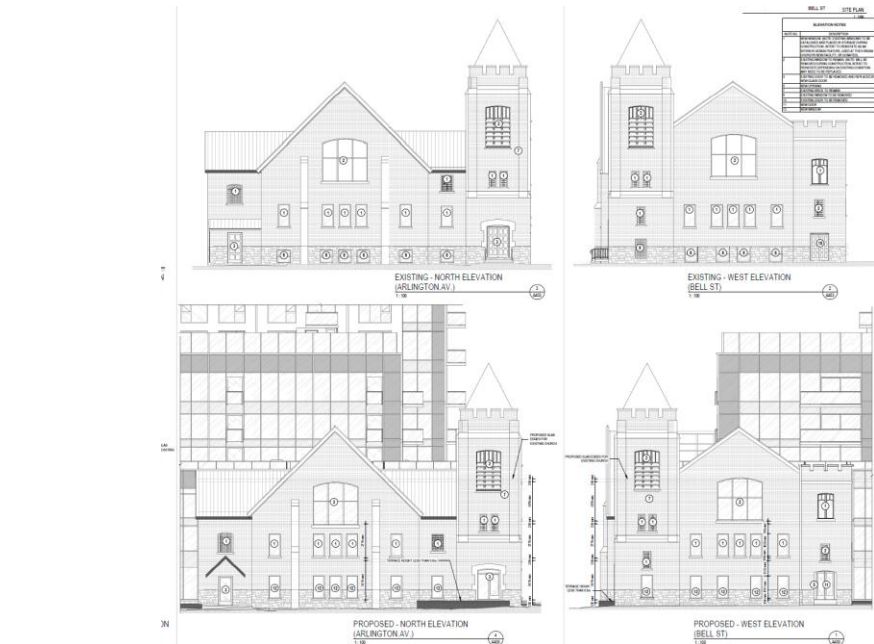
Figure 30: Existing and Proposed Arlington/north elevation and West Bell elevation, illustrating the vertical alteration of the windows. The large three-storey windows on the third level will not be altered. Elevation notes (left) describe the treatment for all the windows will be impacted. Source: Neuf 2024

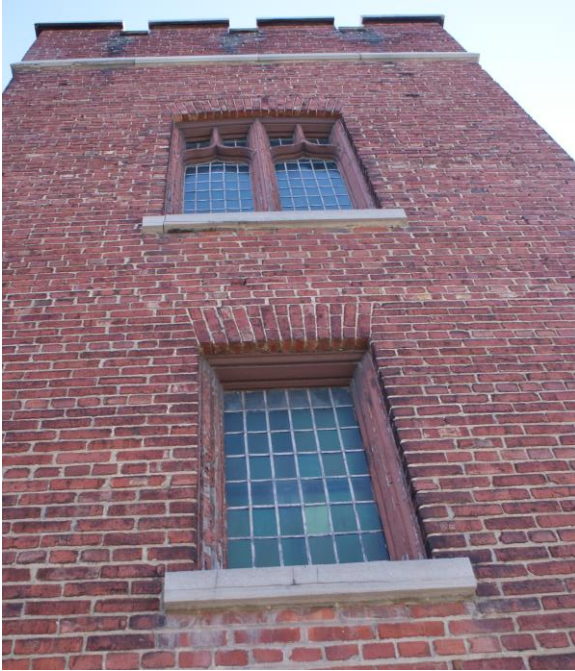
Figure 32: A view of the two windows in the southwest tower above the proposed main entrance. Note the gauged brick arches and the cast stone sills. The lower window will be retained in its existing location and the upper window will be moved vertically. Note the leaded glass sash that is typical of secondary windows. The wood window frame assemblies are illustrated. Note the condition of the stone sill on the lower window. Source: Commonwealth May 2024

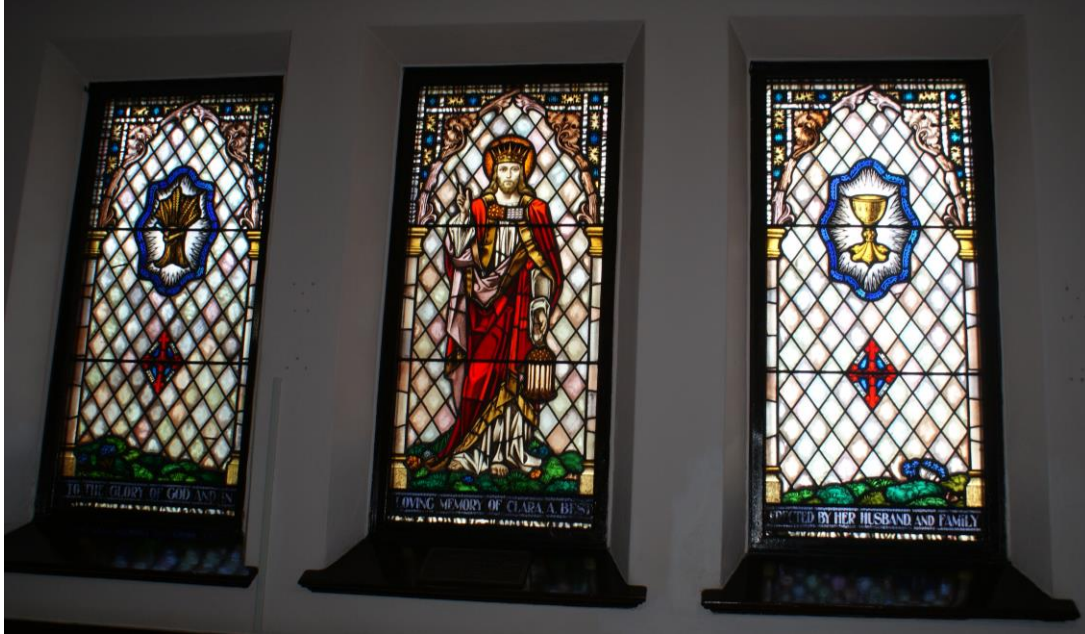
Figure 35: View of the memorial windows installed at the ground floor level. The windows memorialize Clara A. Best and were funded by her husband and family. Source: Commonwealth May 2024.

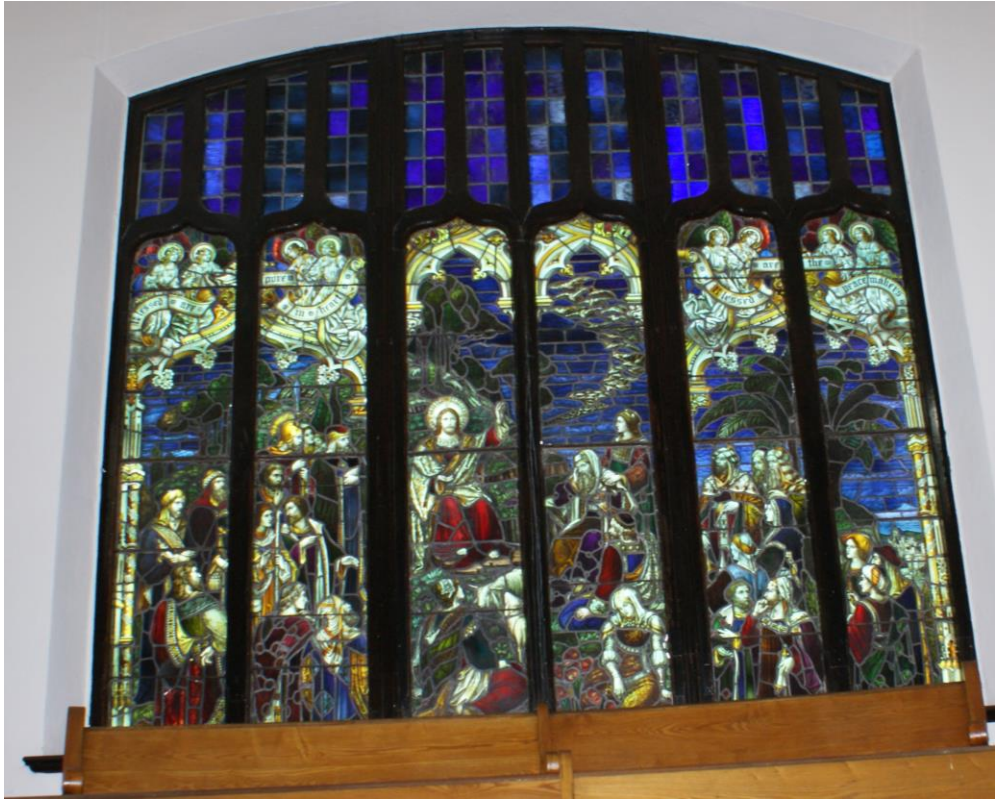
Figure 44: Memorial window in the west gable. The upper portions of the west gable window appears to have stained/coloured glass that was not replaced.

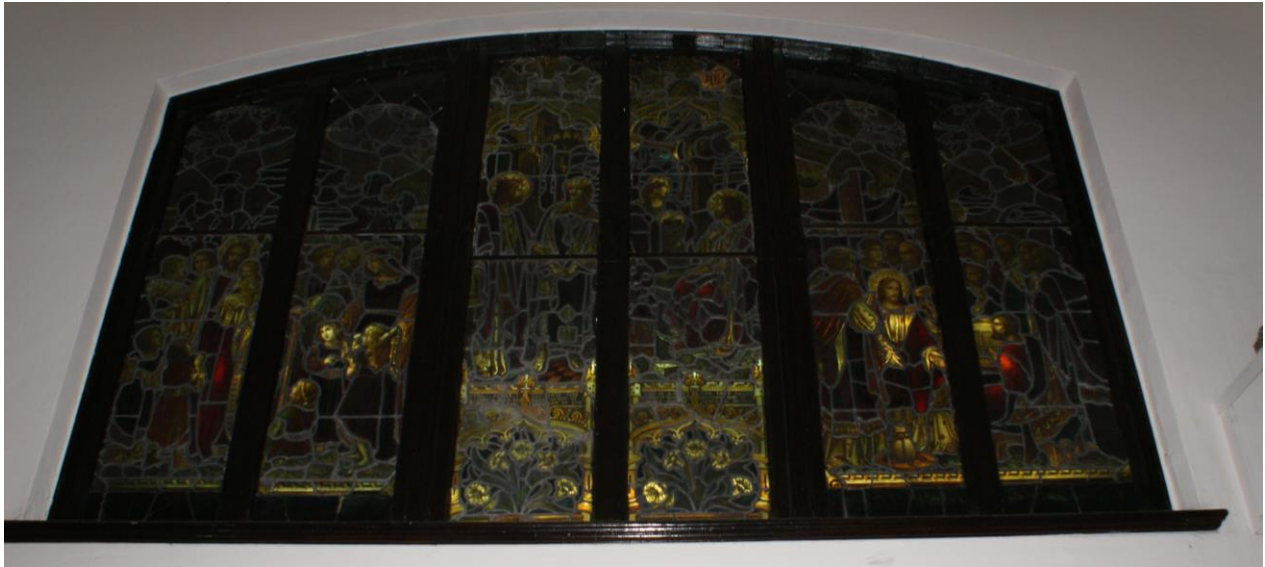
Figure 45: Art glass window that was sourced from the Albert Road Methodist Church located in Penarth, Wales. The church was constructed in 1907 and converted to a public use in 1973. The window was noted to be part of the John Fraser Memorial Collection. Source: Commonwealth May 2024.

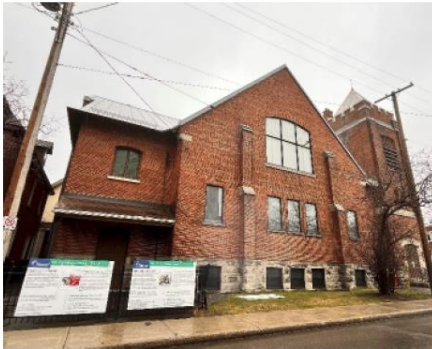
Figure #1: Heritage Façade along Arlington Ave. [JCAL 2024]
