# TREE CONSERVATION REPORT V3.0

2104 Roger Stevens Drive

Tree Conservation Report submitted as Partial  
Requirements for a Site Plan Control Application.

June 19, 2025

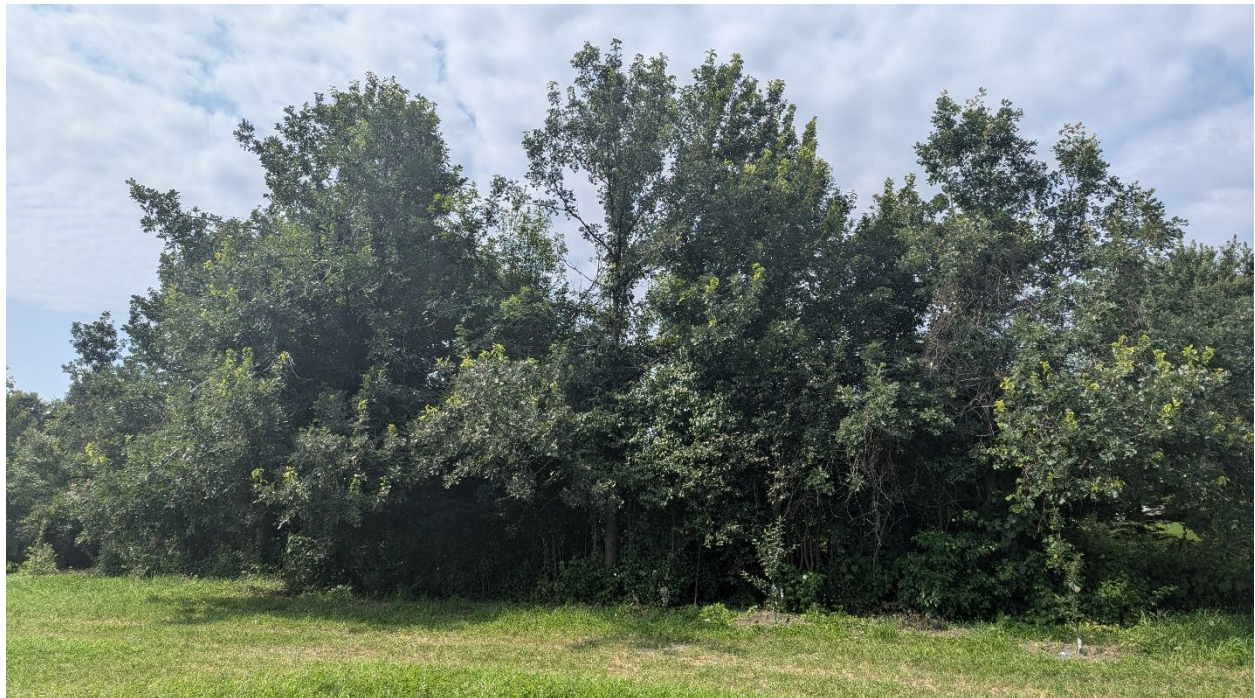
The grading for the proposed septic bed will likely necessitate removal of one or two stems of **Group 1** – the exact number can be determined once extent of excavation is marked in the field. To best protect the remainder of the stand, the extent of required excavation is to be marked in the field and fencing erected at that line. All roots along that line are to be revealed and cleanly severed by hand so that roots of the remaining trees are not torn. The required trees can then be removed. The fence should then remain in place during the remainder of site works. Past this fence, the following should apply:

Below: Group 1 - bur oaks, the majority of which are to be retained and protected.

The tree protection fencing must be 1.2 m in height and constructed of a rigid or framed material (e.g. modulus – steel, plywood hoarding, or snow fence on a 2"X4" wood frame) with posts 2.4 m apart such that the fence location cannot be altered. All supports must be placed outside of the CRZ and installation must minimize damage to existing roots.
