Report

Trail Road Battery Energy Storage System (BESS)  
Fluvial Geomorphology Assessment

H375035-0000-2B0-066-0001

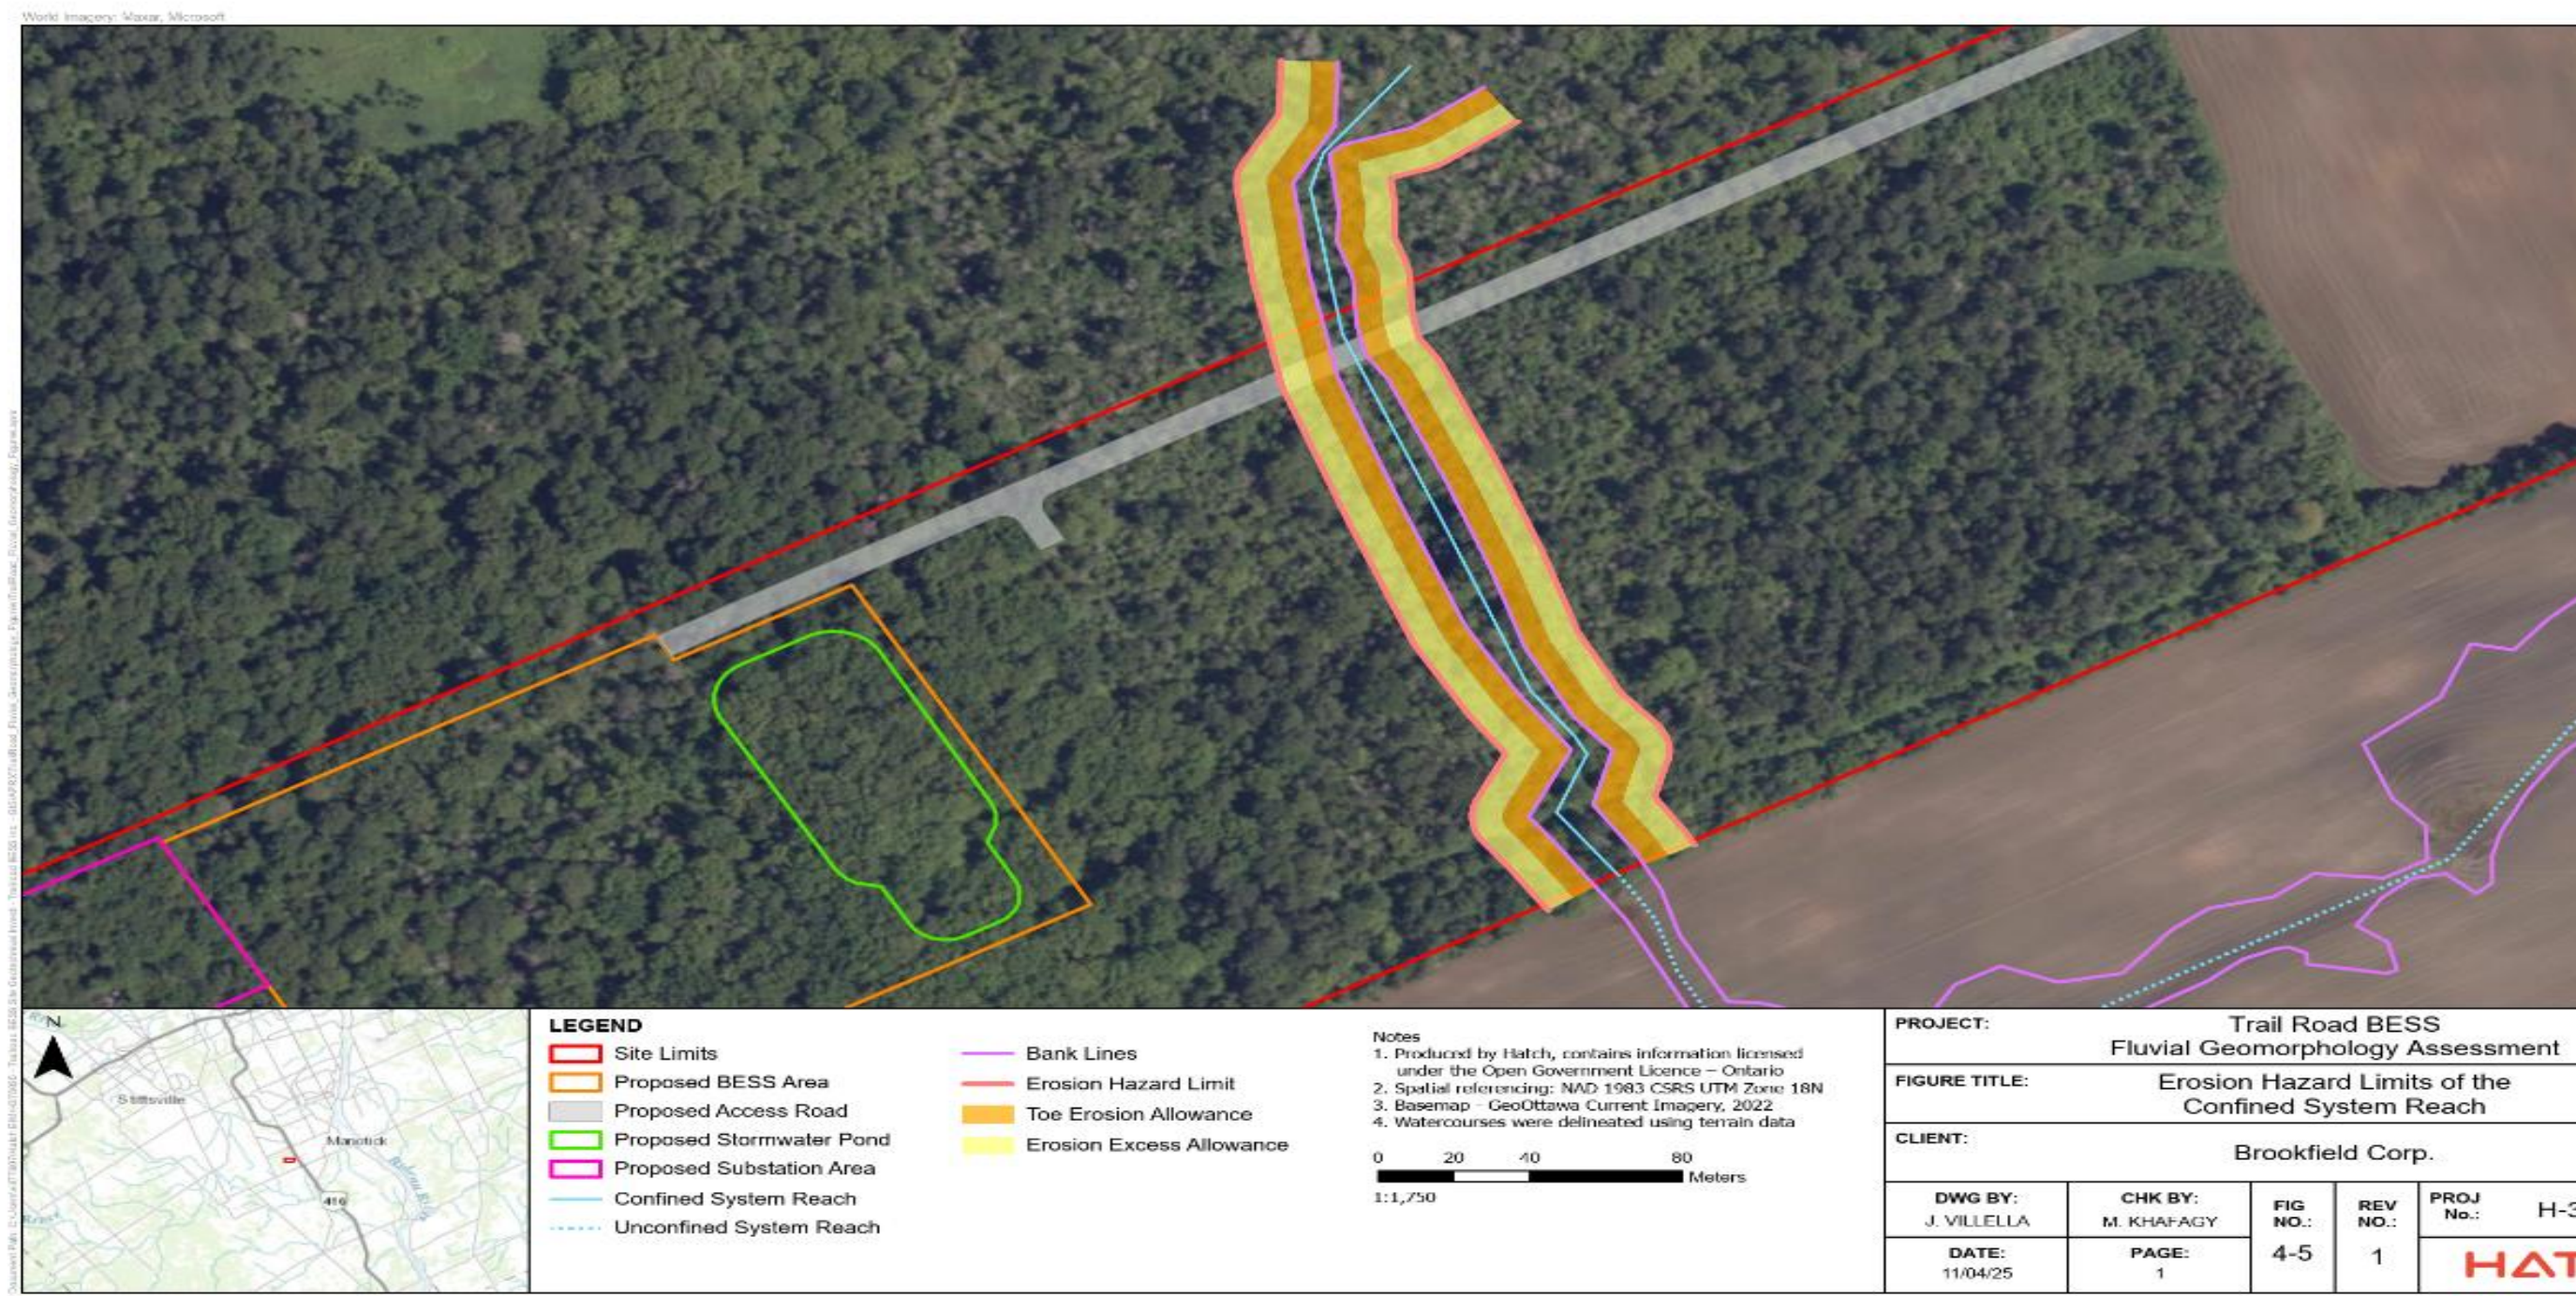
Figure 4-5: Erosion Hazard Limit of the Confined System Reach

Therefore, a stable slope allowance is not considered necessary for this reach of the watercourse. Erosion Access Allowance is a minimum access distance is typically applied at the top of the valley slope to allow space for maintenance or future stabilization works. Regarding the erosion access allowance, MNR Technical Guide (2002) guidelines note that for stiff/hard cohesive soil (clays, clay silt) and coarse granular (gravels) tills, a 5 to 8 m erosion access is to be applied. Given the evidence of erosion along the Creek, erosion access allowance of 8 m is recommended.

The proposed development area is located entirely outside the delineated erosion hazard limit associated with the confined system reach of the Creek. As shown in Figure 4-5, there is no overlap between the development footprint and the defined erosion hazard components, including the toe erosion allowance and erosion access allowance. Some considerations should be applied for the proposed service road crossing the Creek and discussed in Section 4.6. This confirms that the development, as currently planned, does not encroach upon areas identified as geomorphologically sensitive or at risk of fluvial erosion.

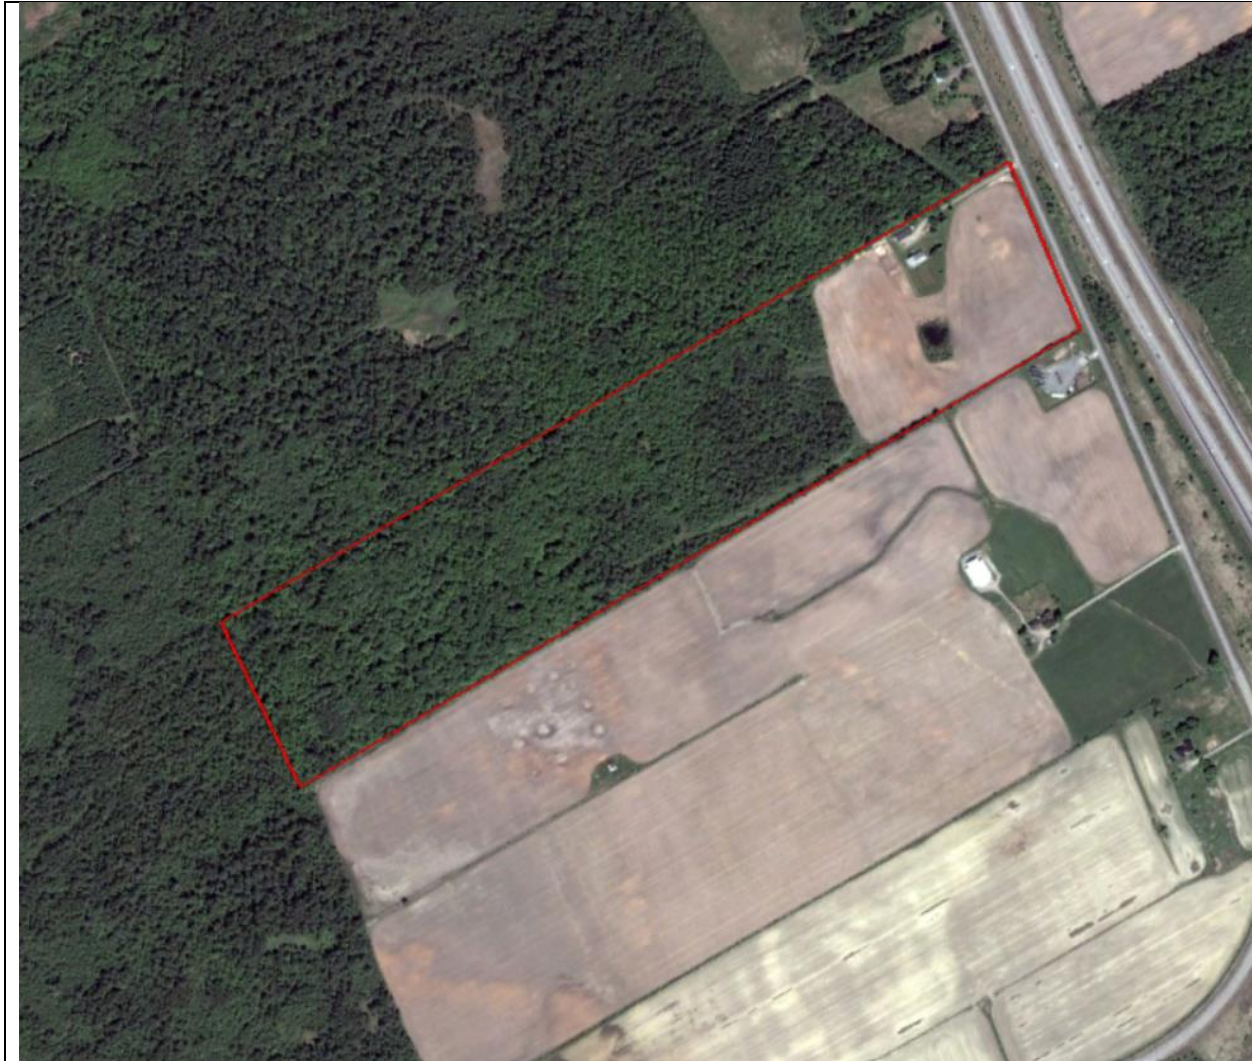
By 2012, a small wetland or pond feature is present along the tributary to the south. The constructed side banks of the Creek are no longer visible, and the channel condition appears to deteriorate. This may have resulted from a flooding event. By 2016, the Creek shows signs of widening, and an additional pond feature emerges along the tributary downstream of the project site. Tree cover within the subject property remains consistent.

**Location:** Ottawa, ON  
**Year:** 2012  
**Scale:** 1:14,000  
**Source:** Google Earth Pro  
**Red Boundary:** Site Limits

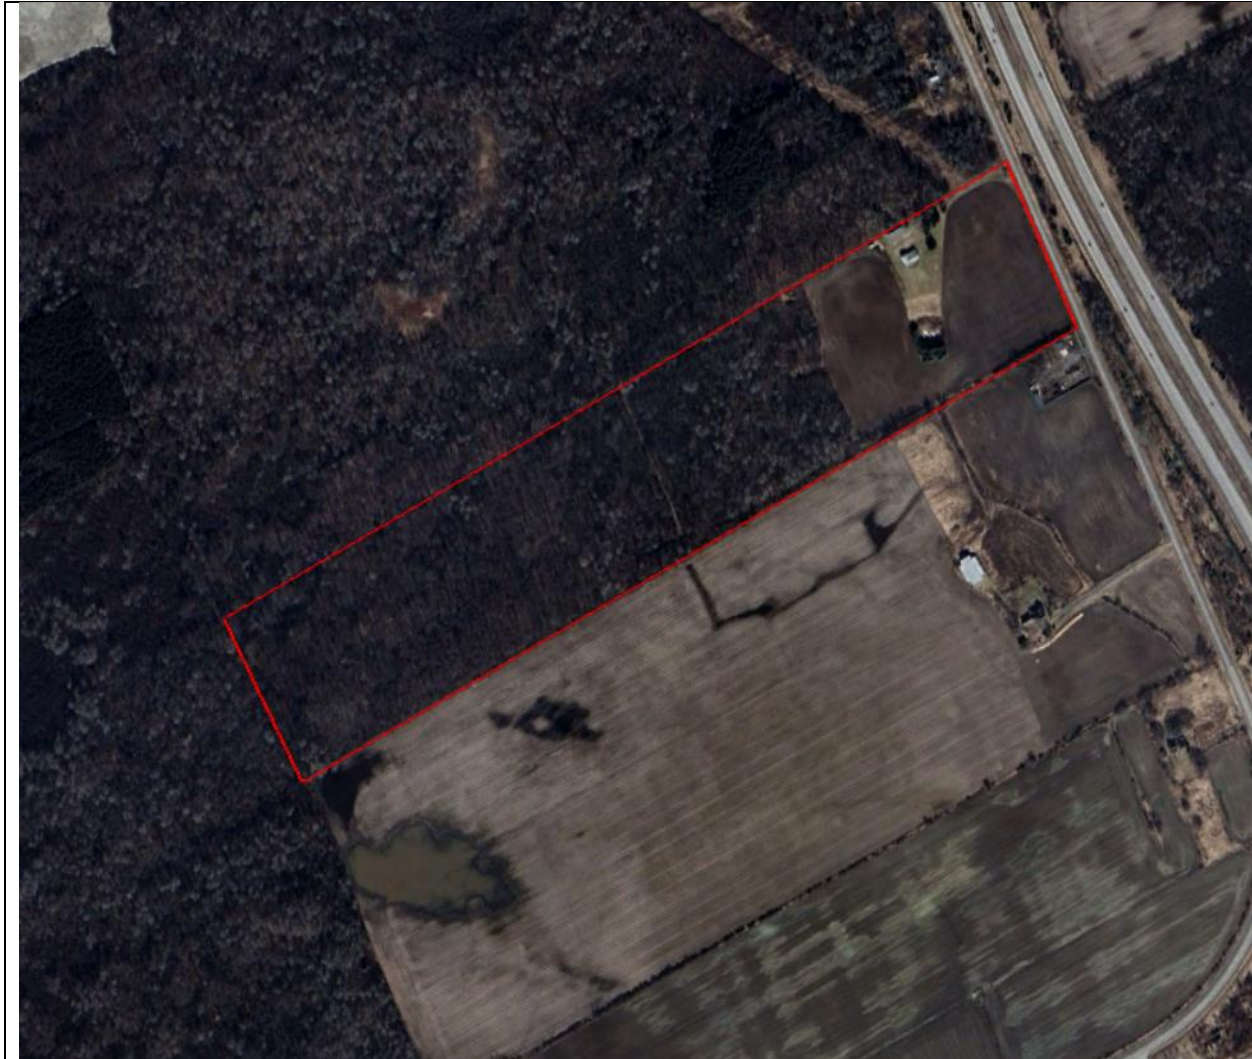
By 2020, the constructed banks are no longer visible, and the condition of the Creek continues to degrade through to 2024. In general, the Creek within the Project site follows a straight alignment; however, no visible changes to the planform of the tributary are observable in all aerial imagery due to tree cover.

**Location:** Ottawa, ON  
**Year:** 2024  
**Scale:** 1:14,000  
**Source:** Google Earth Pro  
**Red Boundary:** Site Limits

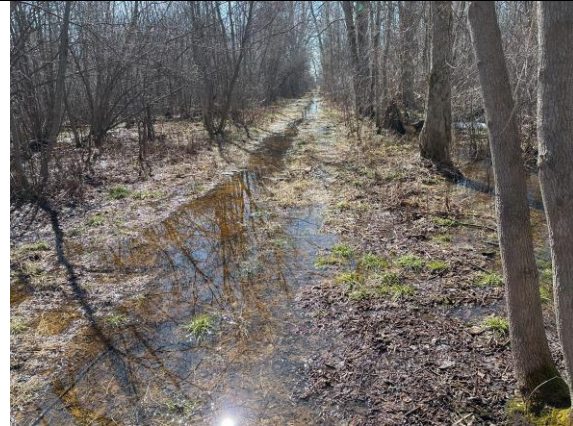
At the north boundary of the Project site, along the property line shared with the adjacent parcel, stagnant water was observed accumulating in a depressed corridor perpendicular to the main Creek alignment as shown in Photo 2 (Appendix B) from location S1. The presence of standing water outside the defined channel zone may also suggest the existence of secondary flow paths or backwater effects during wet periods, although no defined channel is visible in this area.

**Photo 2:** View looking northeast at the north site boundary (perpendicular to the creek), showing stagnant water on April 7, 2025.
