**REPORT ON  
GEOTECHNICAL INVESTIGATION  
CAMPEAU DRIVE & DIDSBURY ROAD  
KANATA, ONTARIO**

**REPORT NO.: 1475-05-G-LPL-A  
REPORT DATE: OCTOBER 31, 2005**

**LOBLAW PROPERTIES LIMITED  
3563 LAKESHORE BLVD., WEST  
TORONTO, ONTARIO  
M8W 1P4**

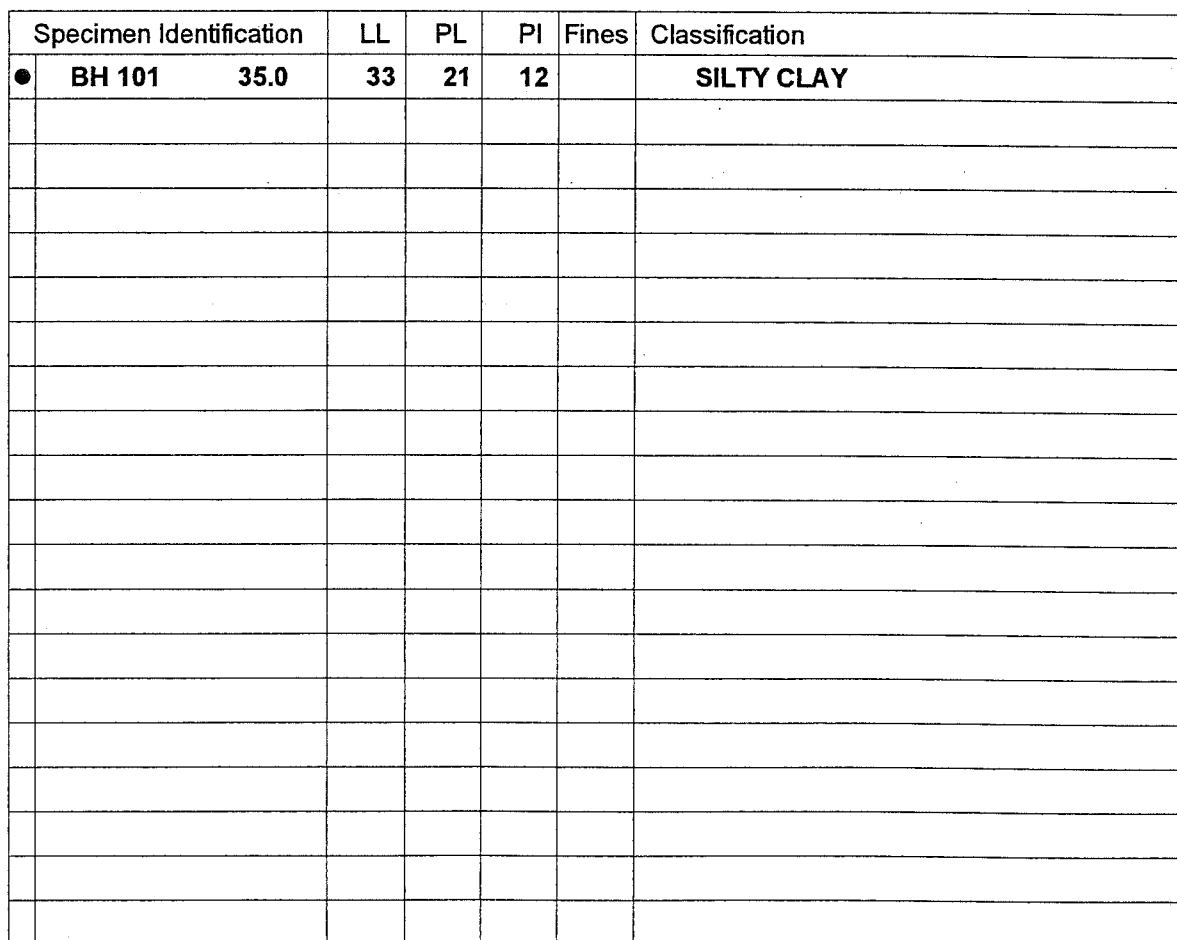
Figure No. 1

Atterberg Limits tests, conducted on a clay sample obtained from the location of BH101, at a depth of 10.9m, were as follows:

Plastic Limit:  $w_p = 21\%$

Liquid Limit:  $w_L = 33\%$

Plasticity Index =  $w_L - w_p = 12\%$

The results, plotted on the Plasticity Chart (Figure 1), indicated that the deposit can be classified as inorganic clay of medium plasticity.
