Updated Geotechnical Investigation Proposed Residential Subdivision 1154-1208 Old Montreal Road, Ottawa, Ontario

Final Report

OTT-00234493-A0

October 7, 2021 (Supersedes February 12, 2021 updated report)

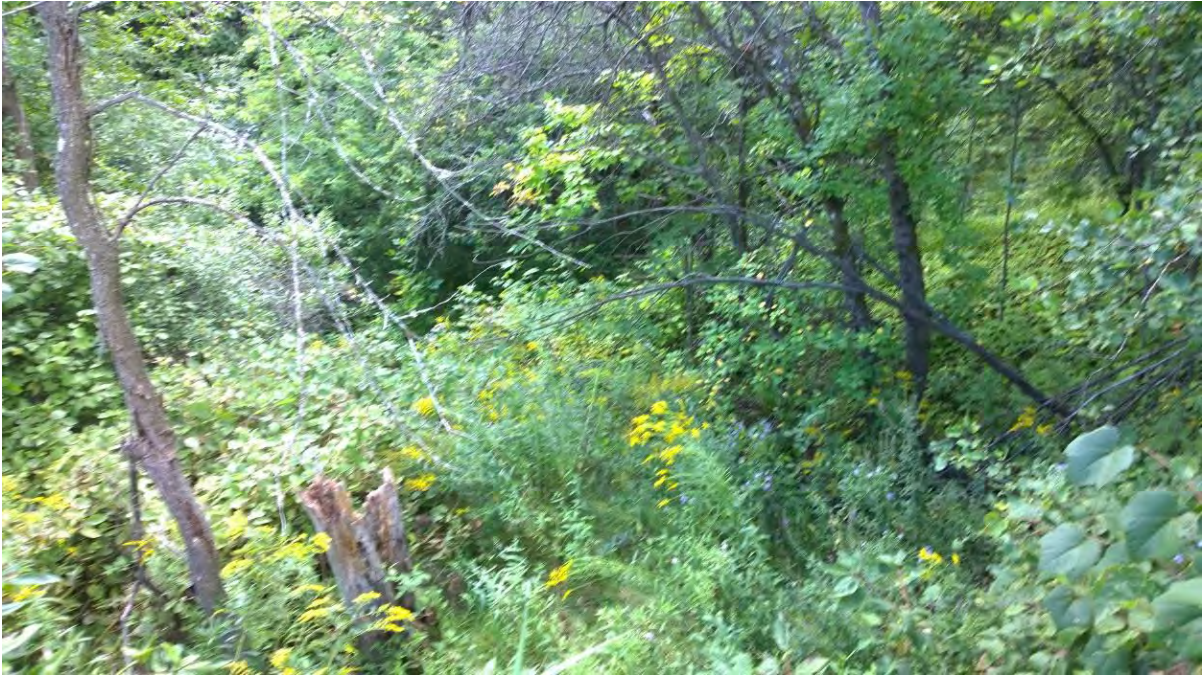
Photograph No. 1: View of creek south of Pedestrian Bridge (Location 1 on Figure 2)

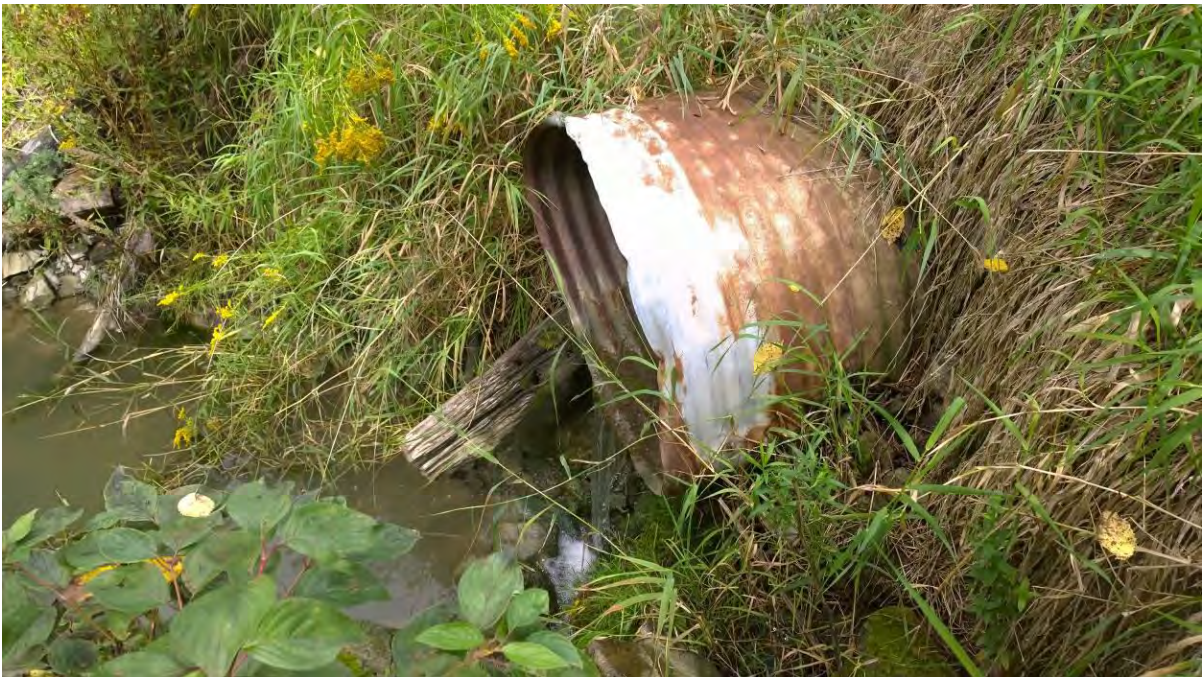
Photograph No. 2: View of south end of culvert under the roadway (Location 2 on Figure 2)

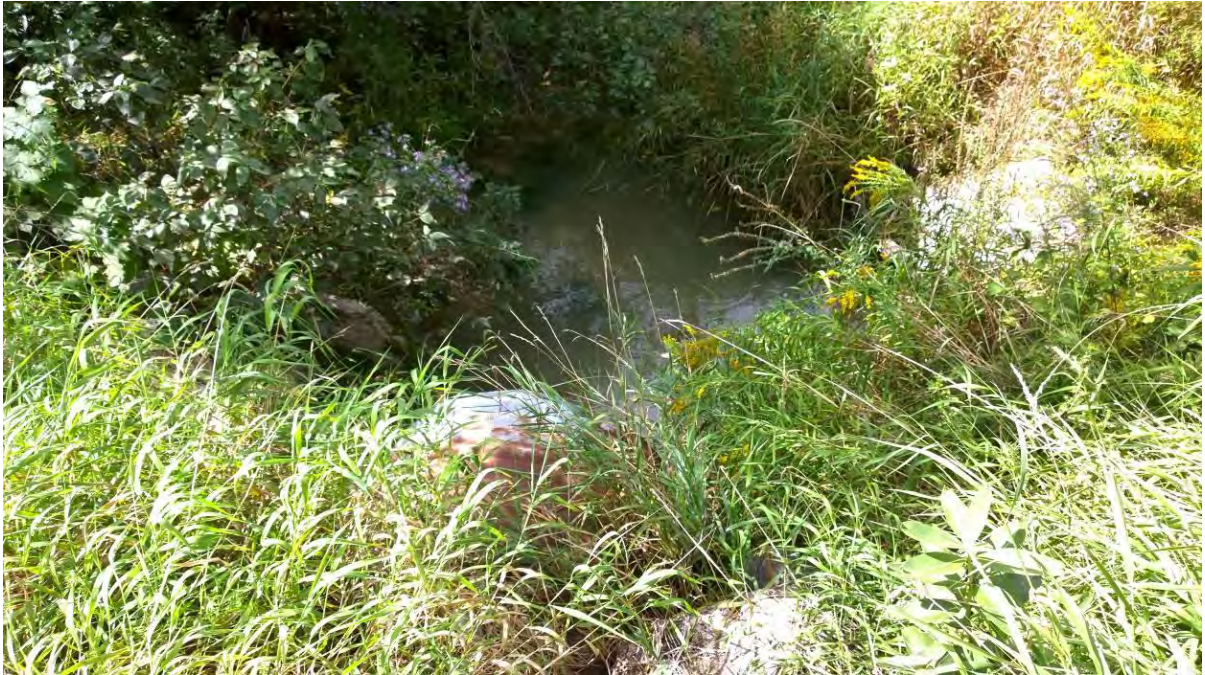
Photograph No. 3: View of creek looking south from pathway (Location 3 on Figure 2)

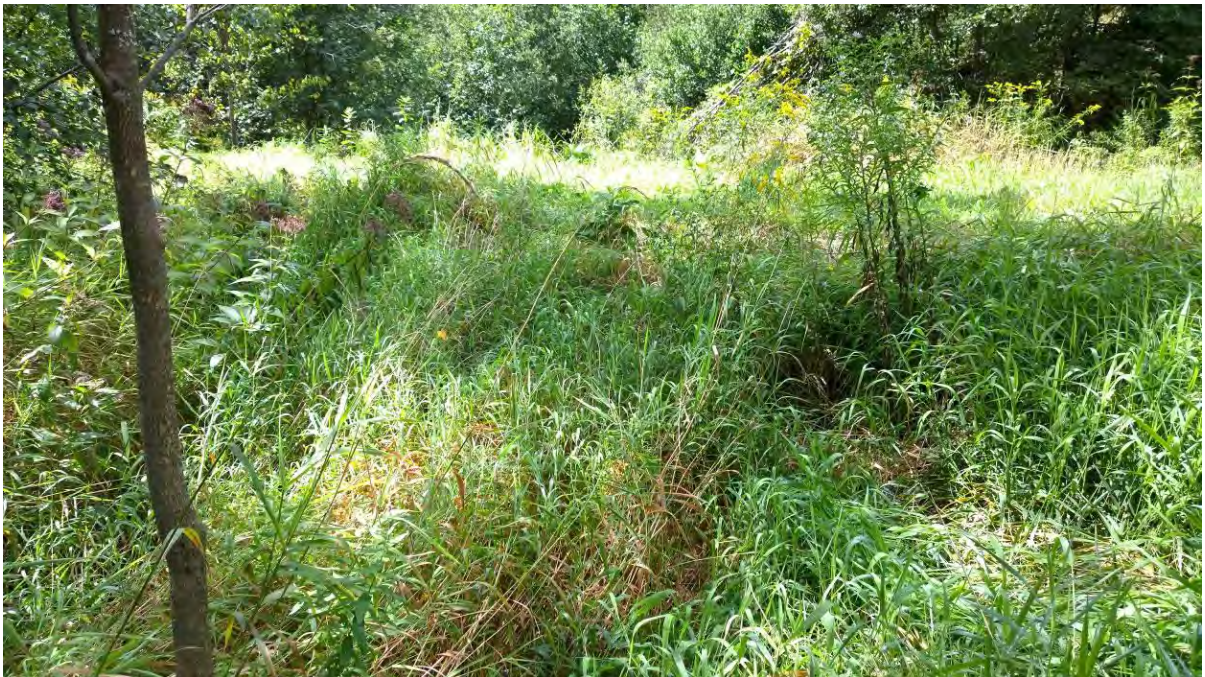
Photograph No. 4: View looking south from north side of pathway near creek (Location 4 on Figure 2)

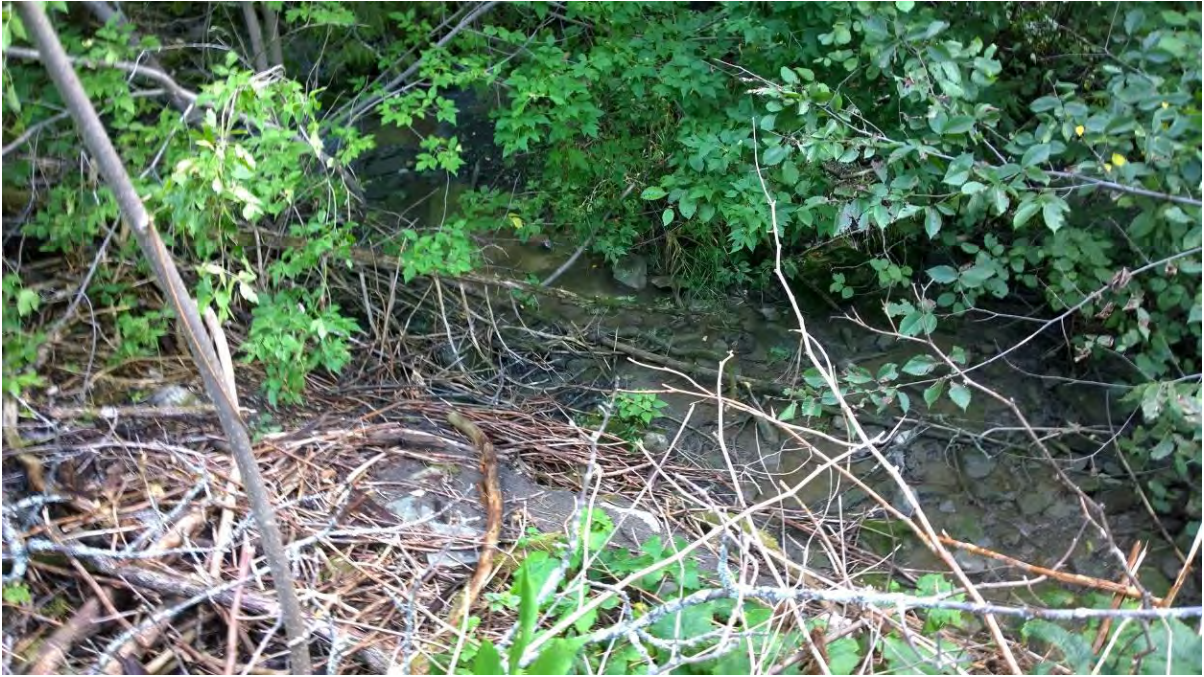
Photograph No. 5: View of creek looking north from Location 5 on Figure 2

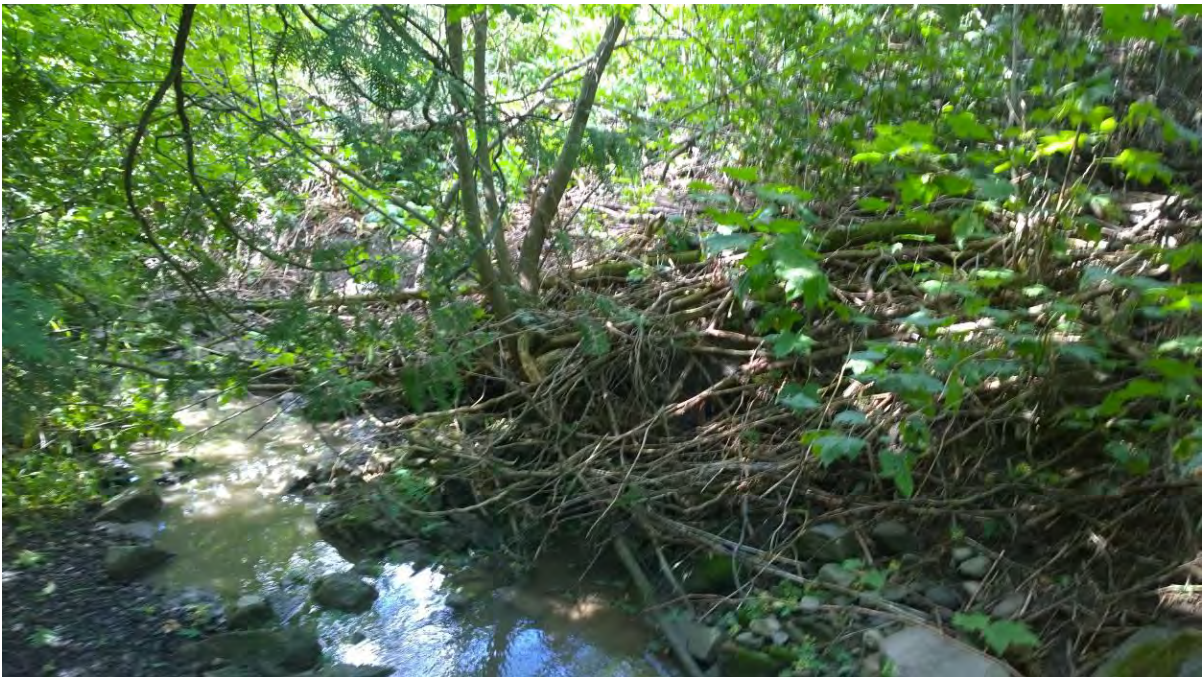
Photograph No. 6: View along creek bank looking south from west bank at Location 6 on Figure 2

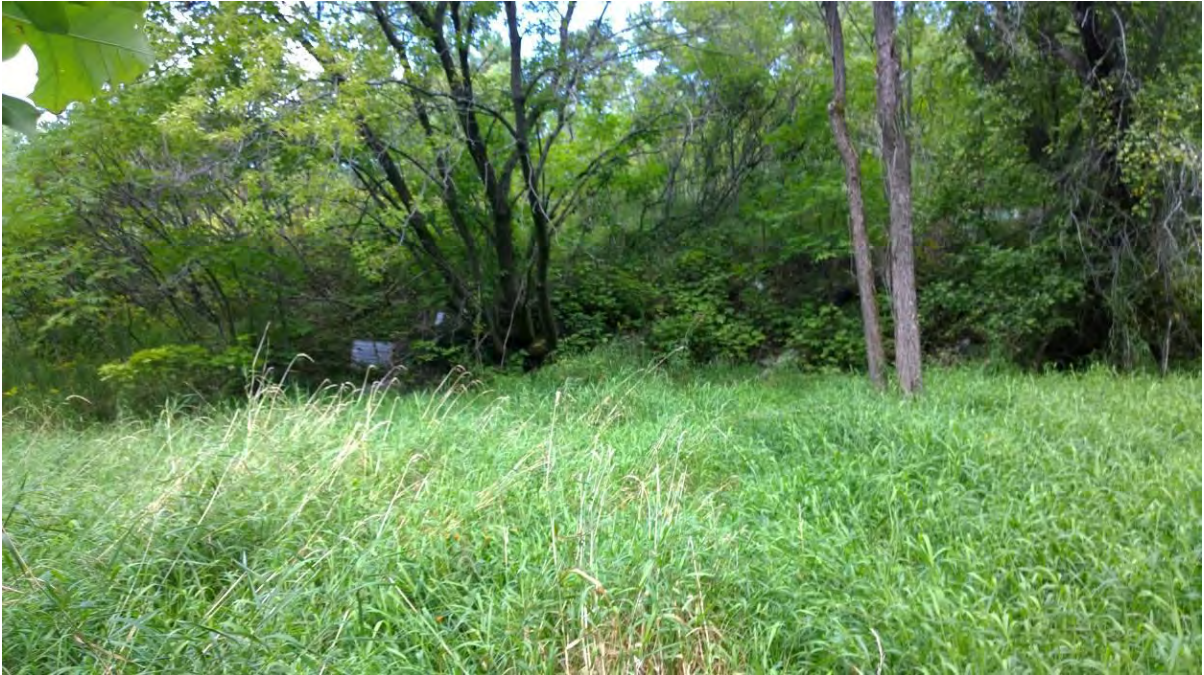
Photograph No. 7: View of creek looking west from east bank of creek at Location 7 on Figure 2

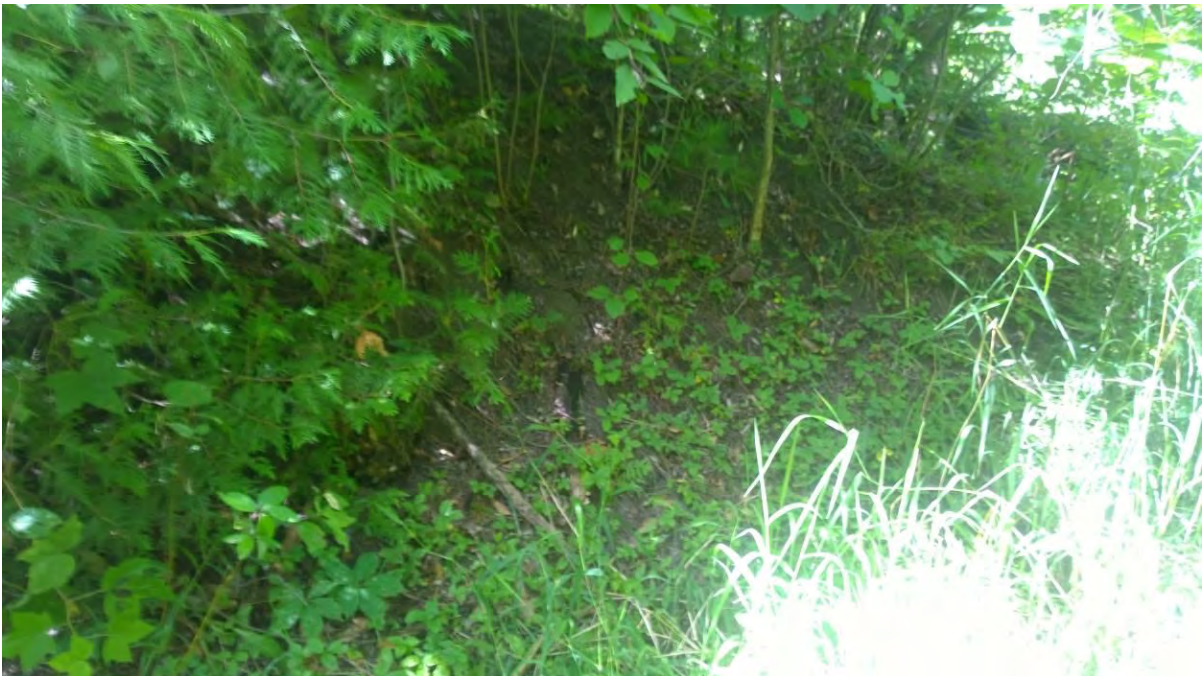
Photograph No. 8: View of toe of slope looking south from Location 8 on Figure 2

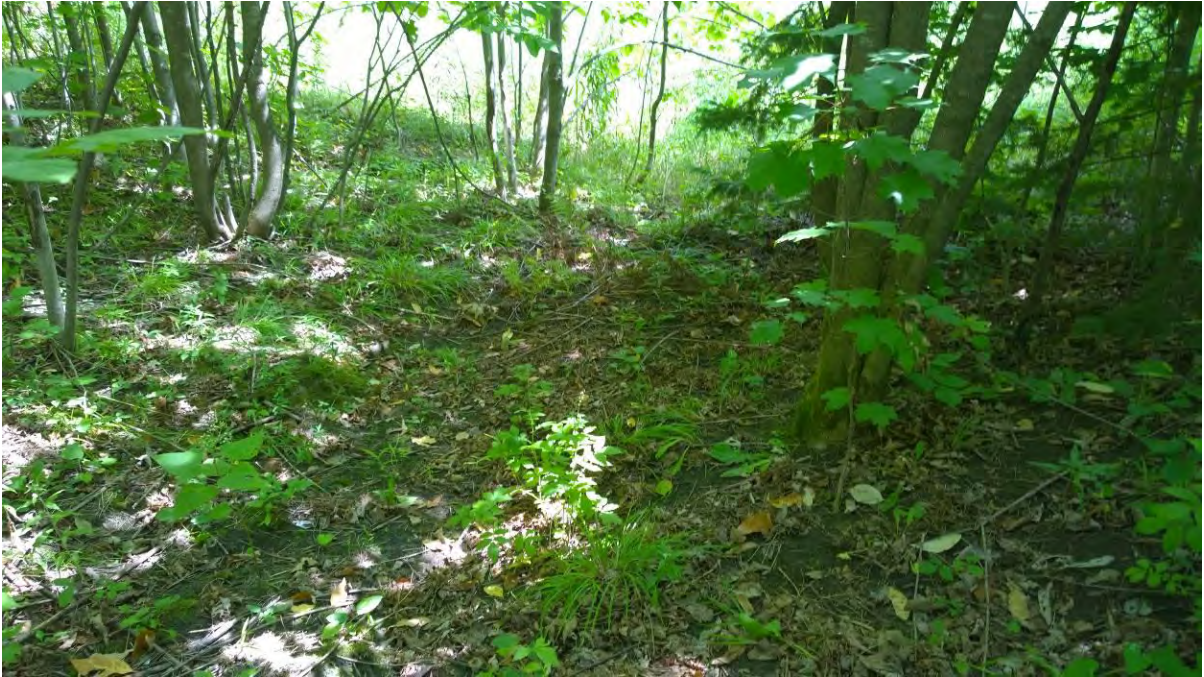
Photograph No. 9: View of creek looking east from Location 9 on Figure 2

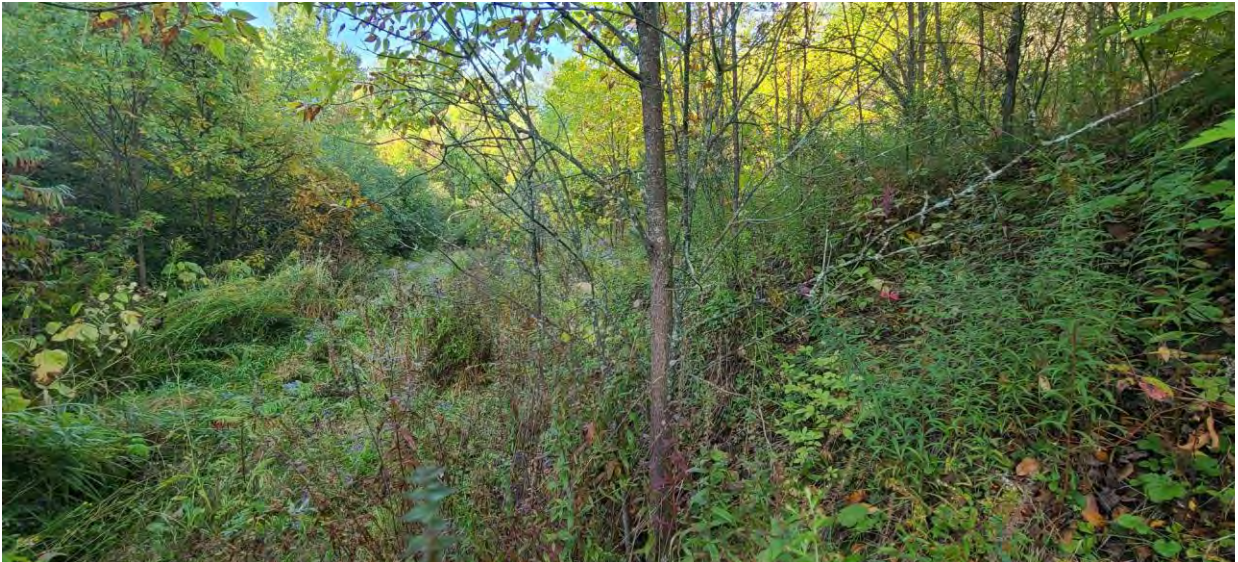
Photograph No. 10: General view at toe of slope showing gradient /vegetation at section B-B

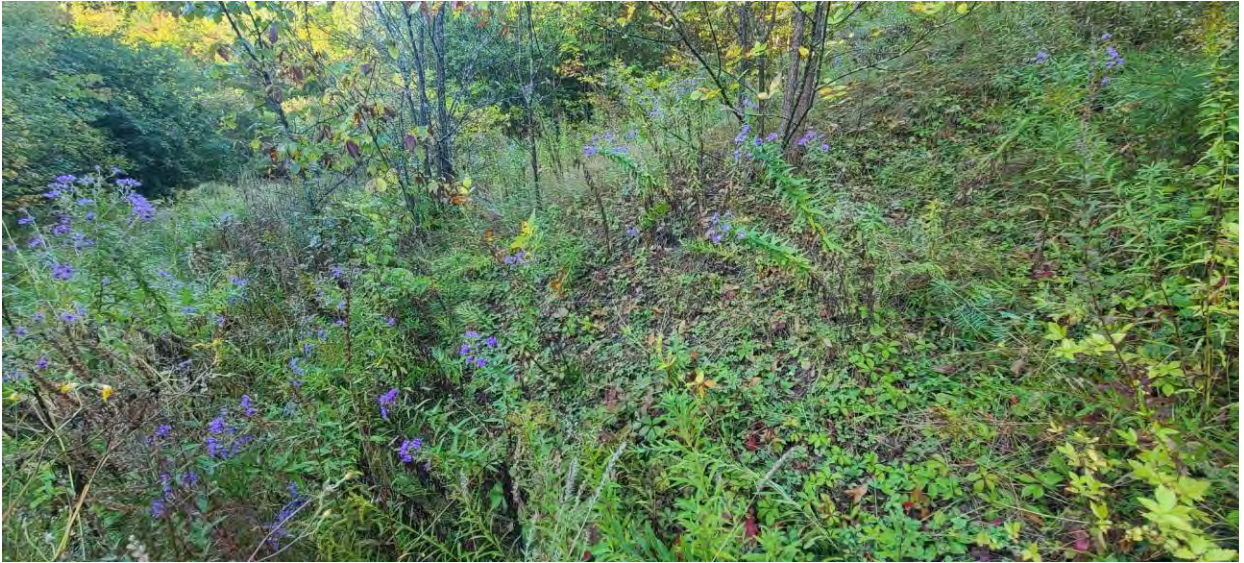
Photograph No. 11: Vegetation at toe of slope (Section B-B)

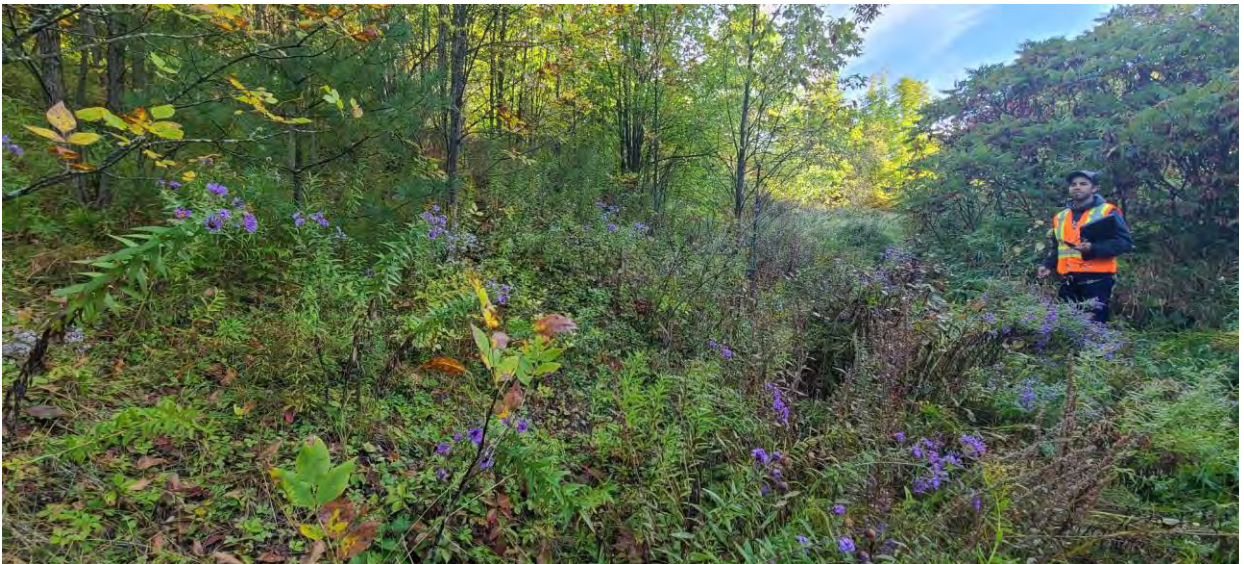
Photograph No. 12: Slope gradient and vegetation with worker for scale

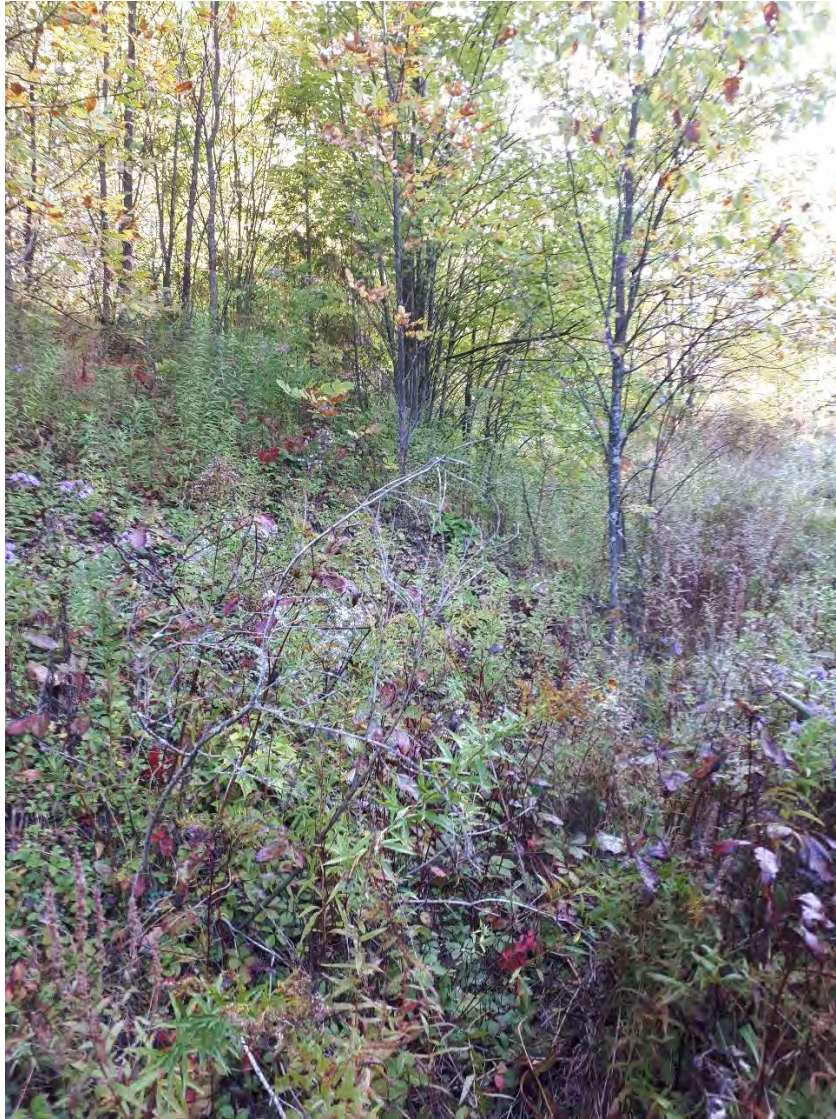
Photograph No. 13: Saplings near toe of slope (Section B-B)

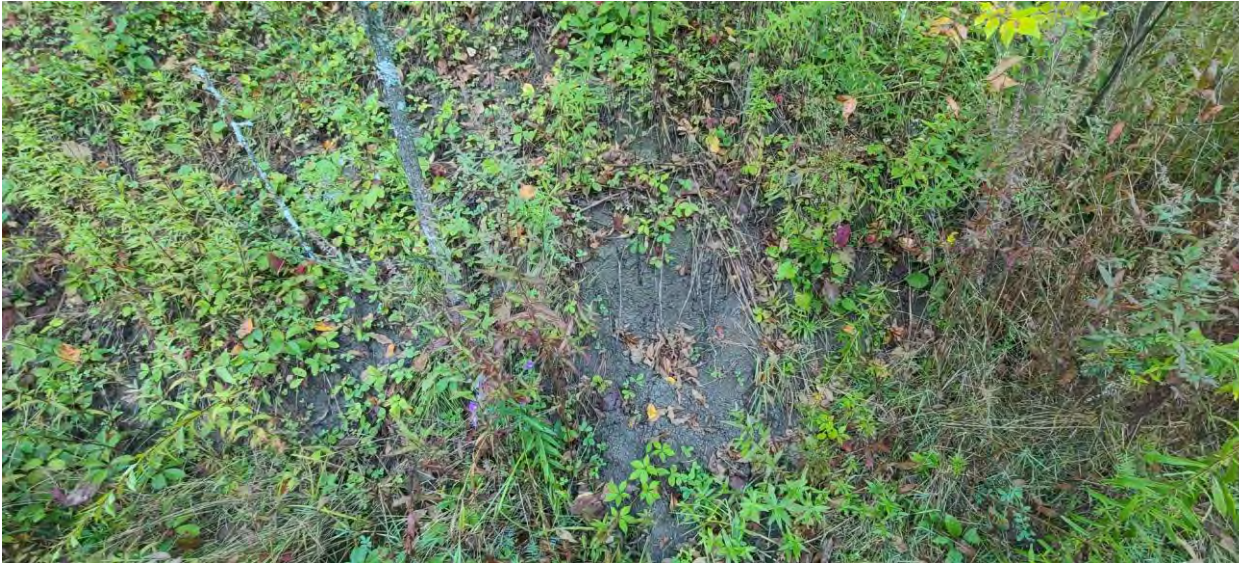
Photograph No. 14: Minor sloughing leaving bare clay, less than 1 m wide

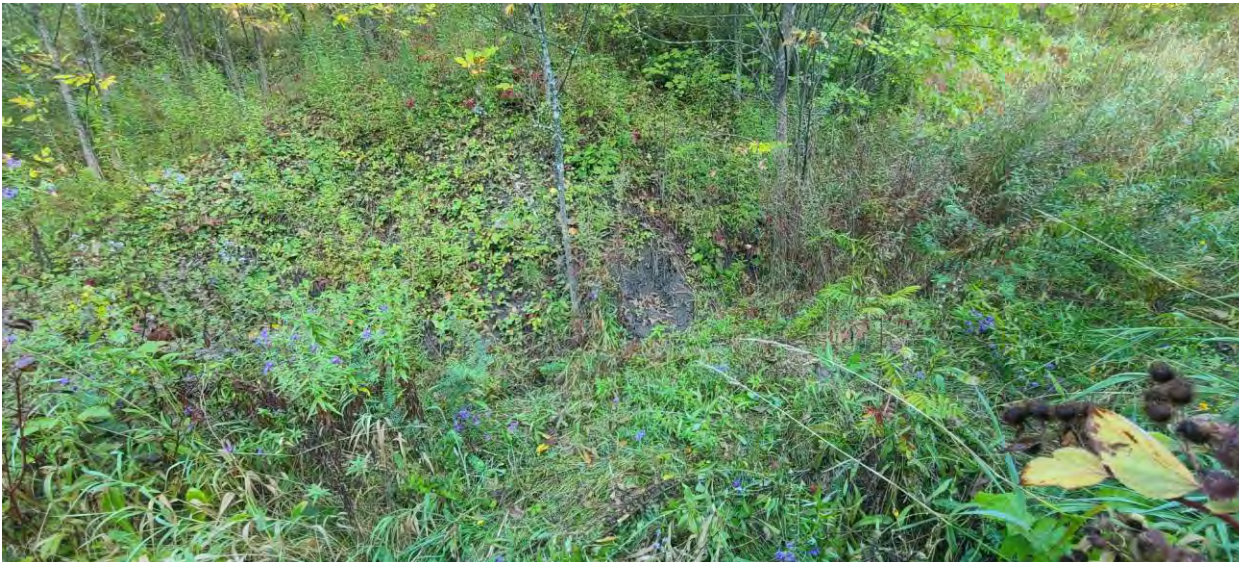
Photograph No. 15: Minor sloughing leaving bare clay with greater sloughing area lightly vegetated

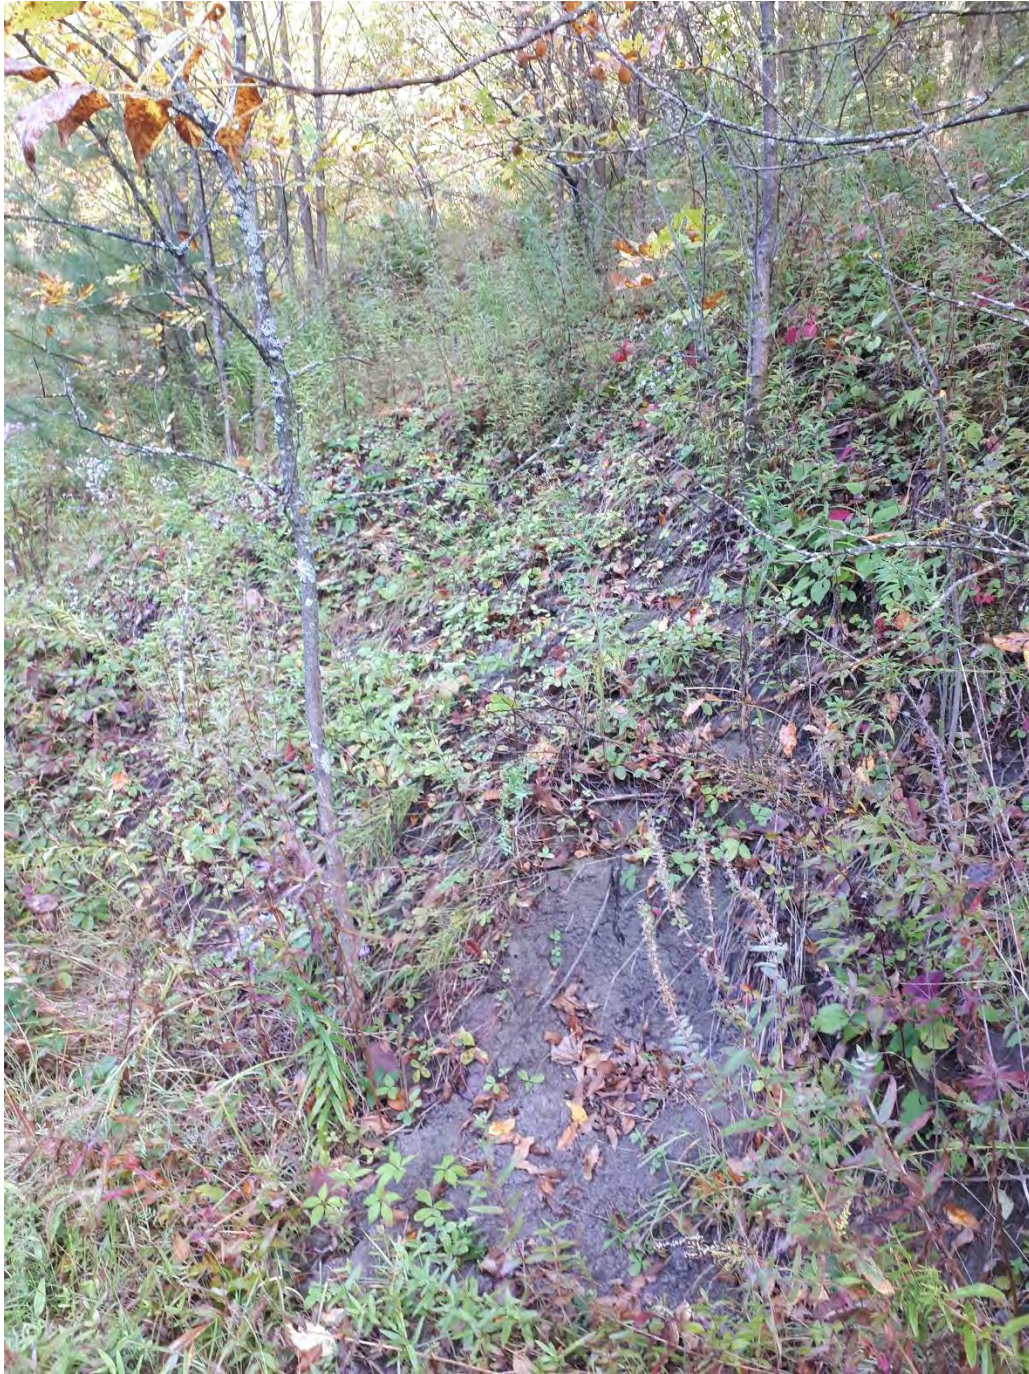
Photograph No. 16: Same sloughing area as Photo 6 viewed from a different angle

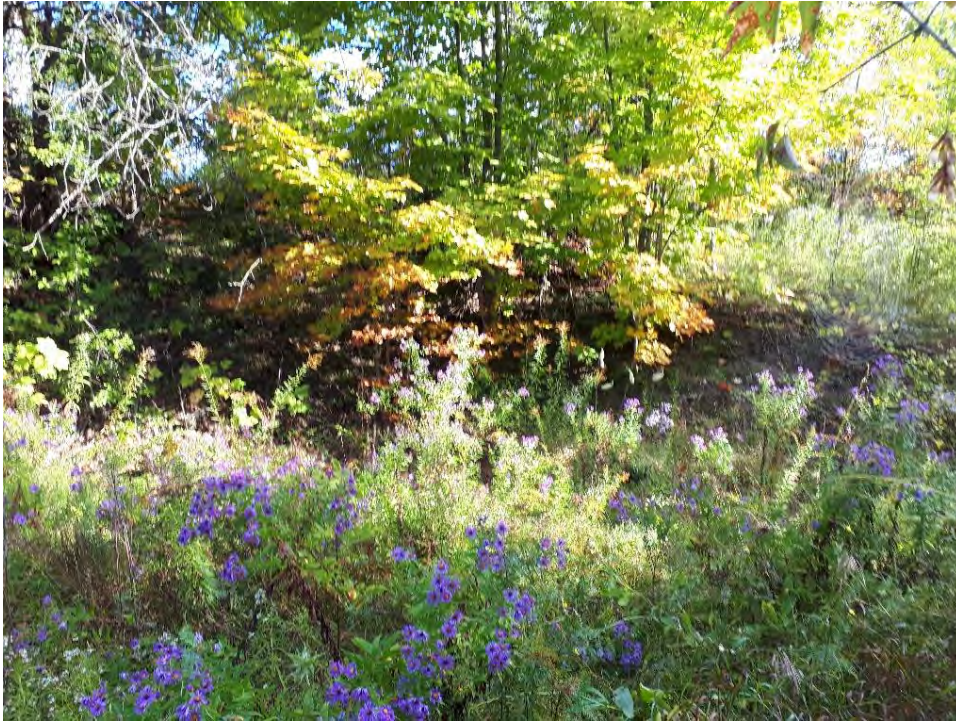
Photograph No. 17: Sloughing of slope, just north of the marsh

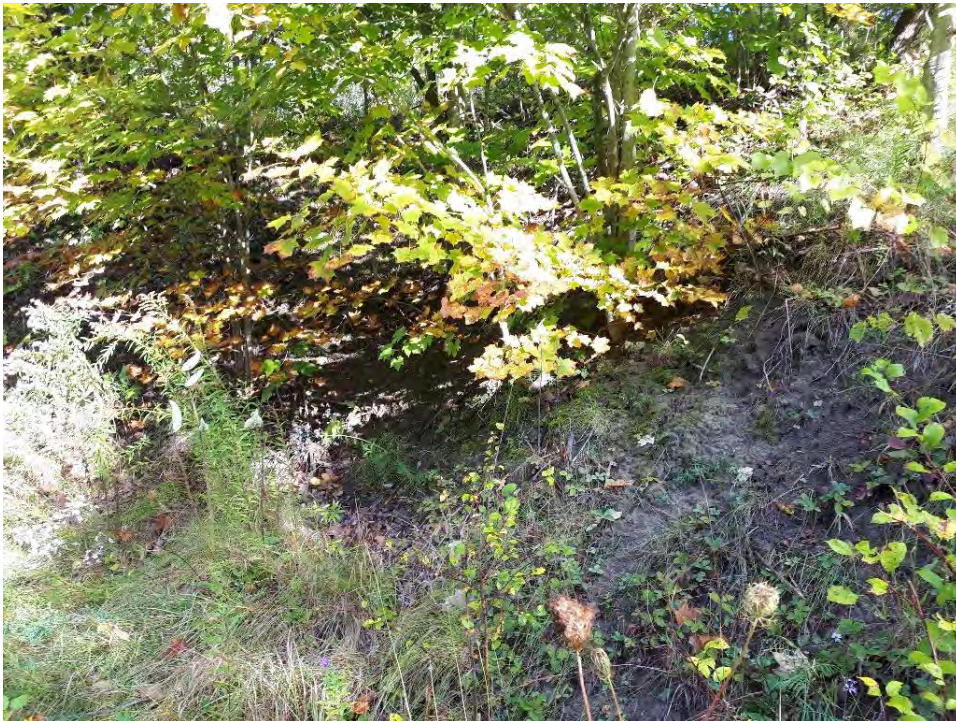
Photograph No. 18: Same area as Figure 8 with different angle showing bare clay

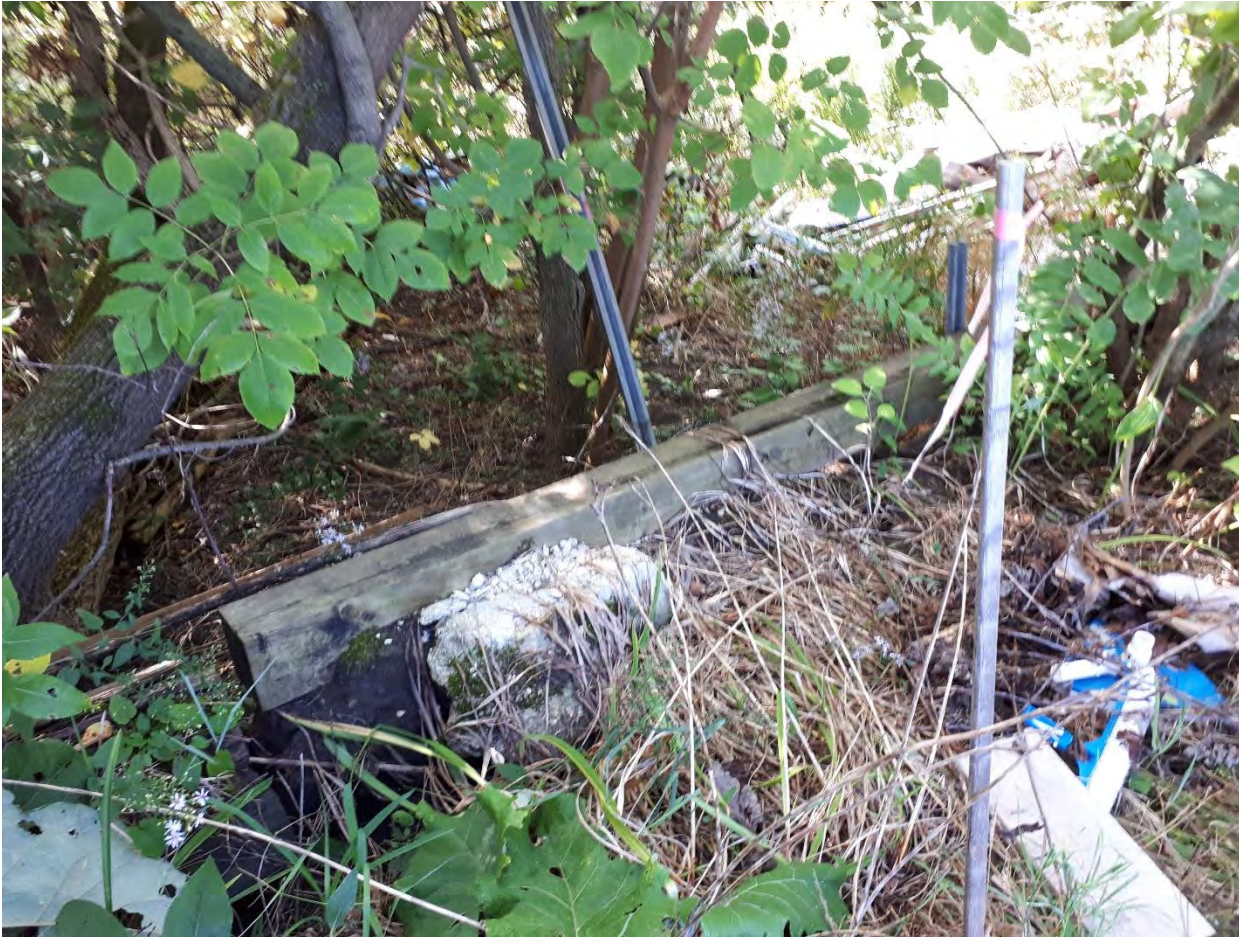
Photograph No. 19: Homemade retaining wall with signposts and 6x6 lumber at crest of slope, section B-B
