June 3rd, 2019

RE: Woodlot S-23 Large Tree Inventory – Minto Communities and Valecraft Homes Kanata North
Developments

APPENDIX A – TREE PHOTOS

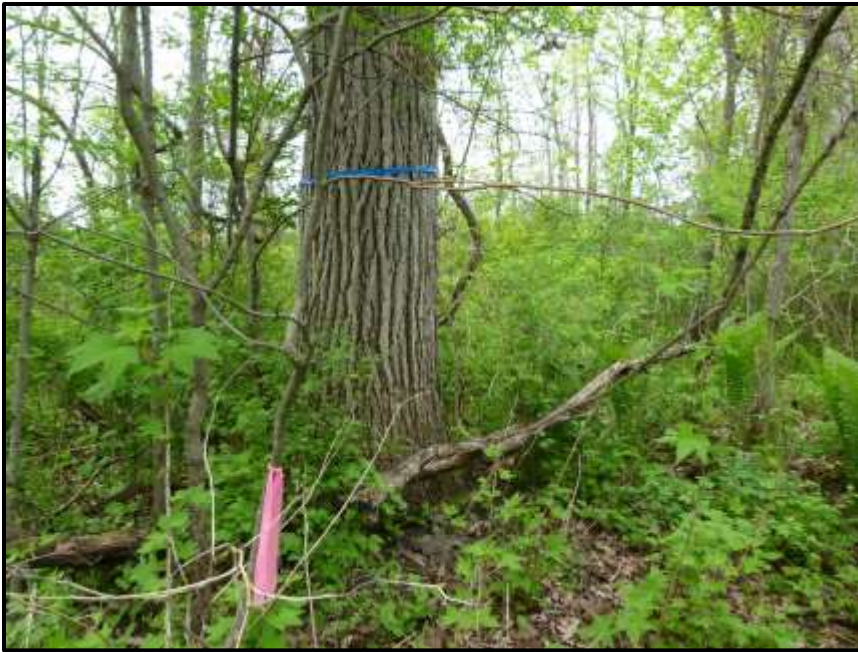
Photograph 1: Tree #1 – Bur Oak in good condition (May 27th, 2019).

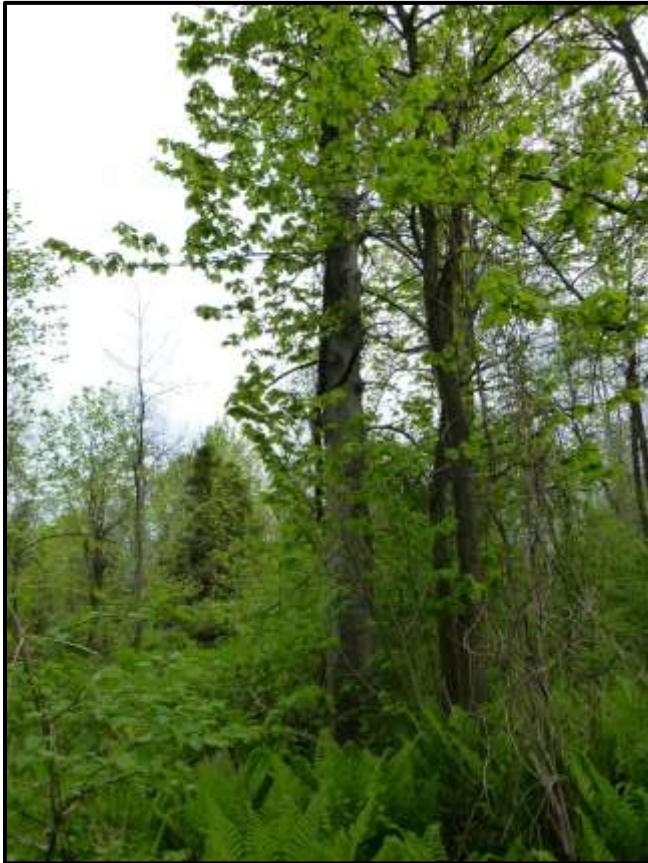
Photograph 2: Tree #2 – dead White Ash (May 27th, 2019).

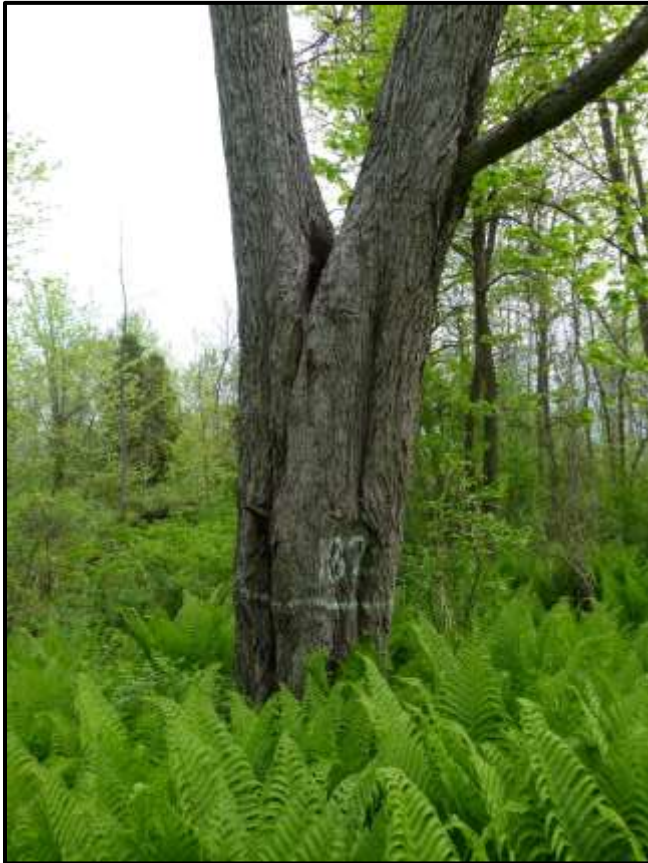
Photograph 3: Tree #3 – Category 3 Butternut Tree (May 27th, 2019).

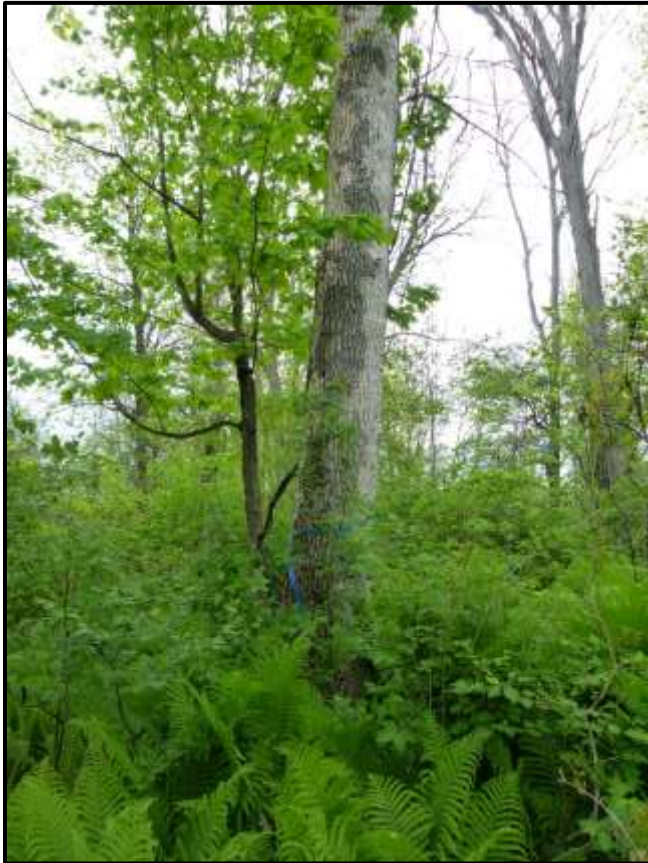
Photograph 4: Tree #4 – dead White Ash (May 27th, 2019).

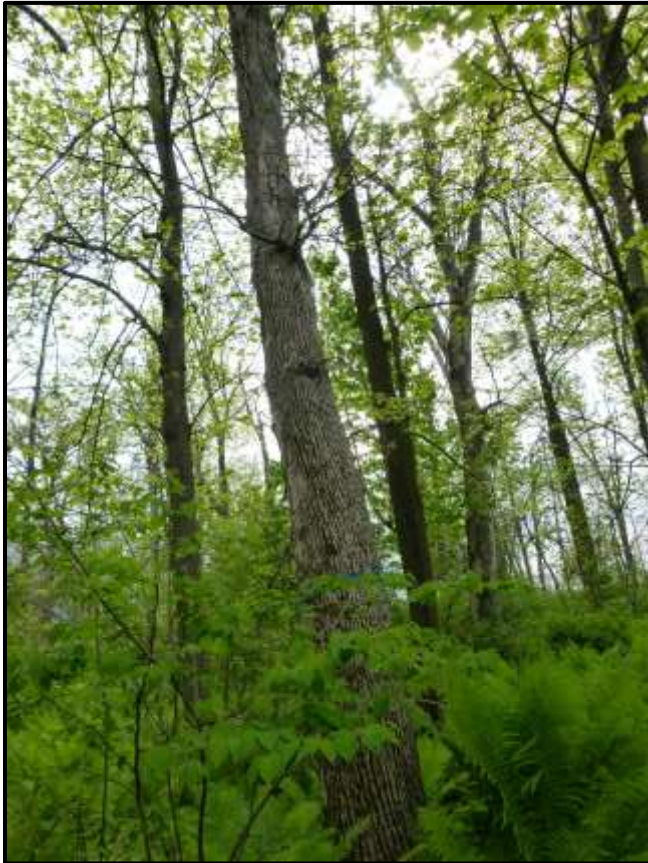
Photograph 5: Tree #5 – dead White Ash (May 27th, 2019).

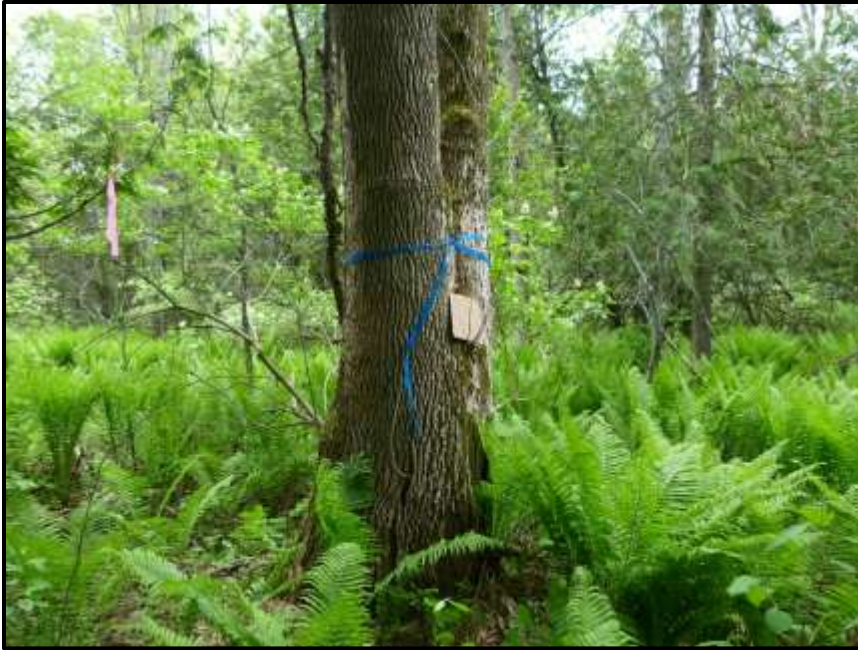
Photograph 7: Tree #8 – dead White Ash (May 27th, 2019).

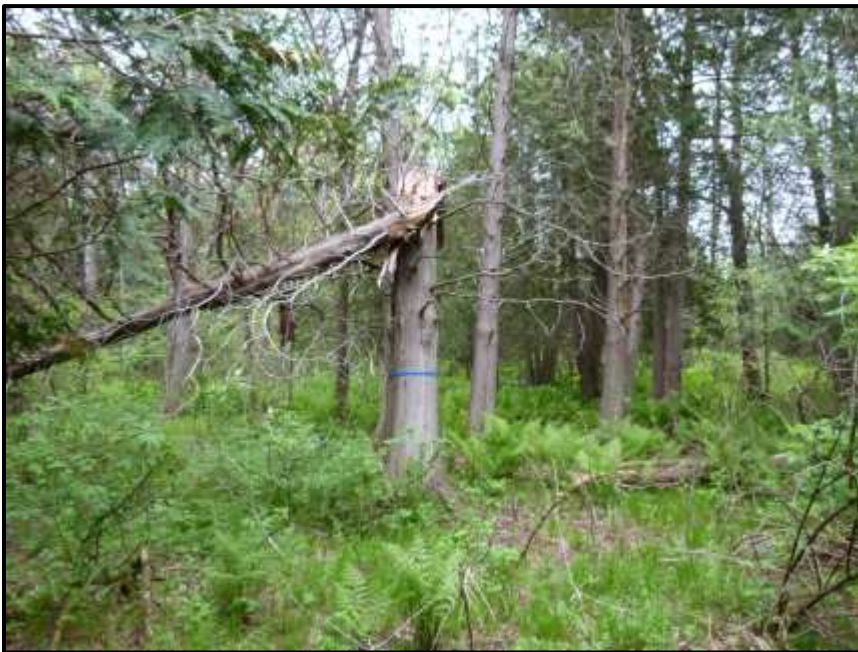
Photograph 10: Tree #11 – dead White Cedar (May 27th, 2019).

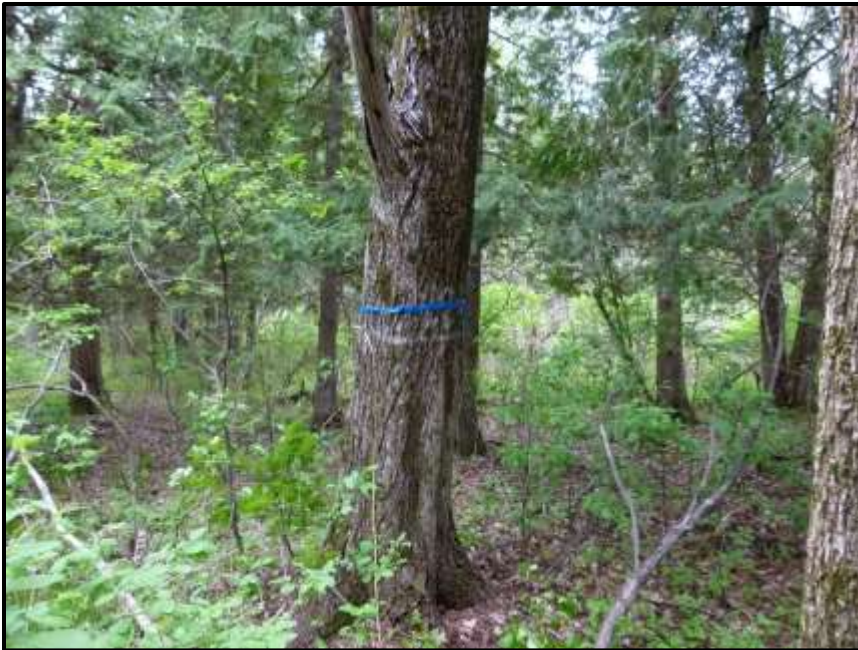
Photograph 15: Tree #16 - Category 1 Butternut (May 27th, 2019).

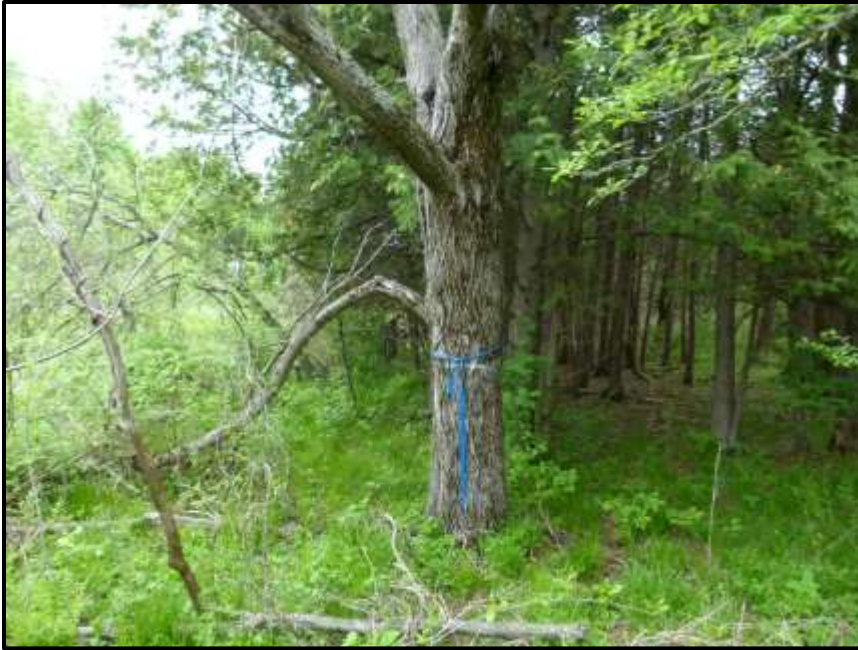
Photograph 17: Tree #18 – Category 2 Butternut (May 27th, 2019).

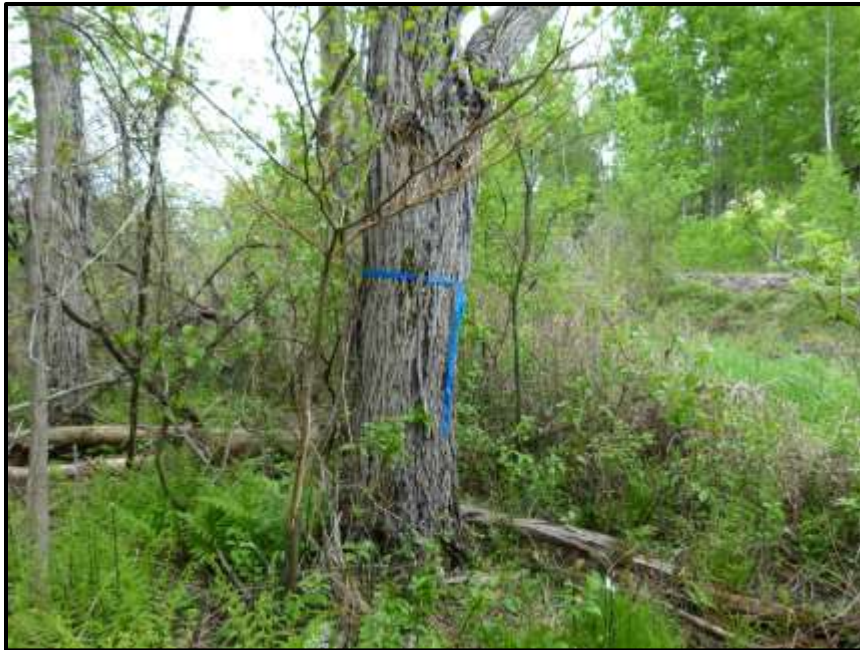
Photograph 19: Tree #20 – Category 1 Butternut (May 27th, 2019).

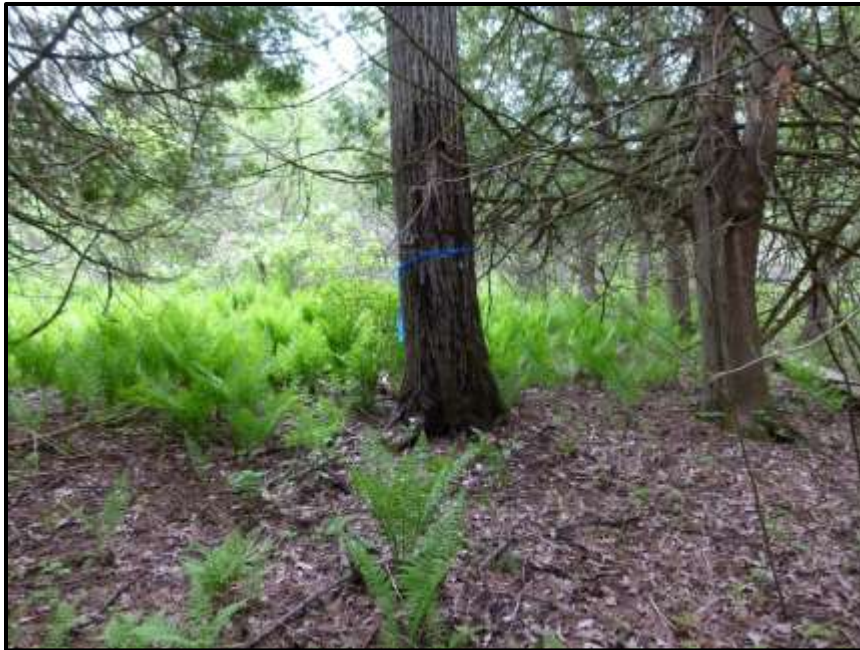
Photograph 23: Tree #24 – Category 1 Butternut Tree (May 27th, 2019).

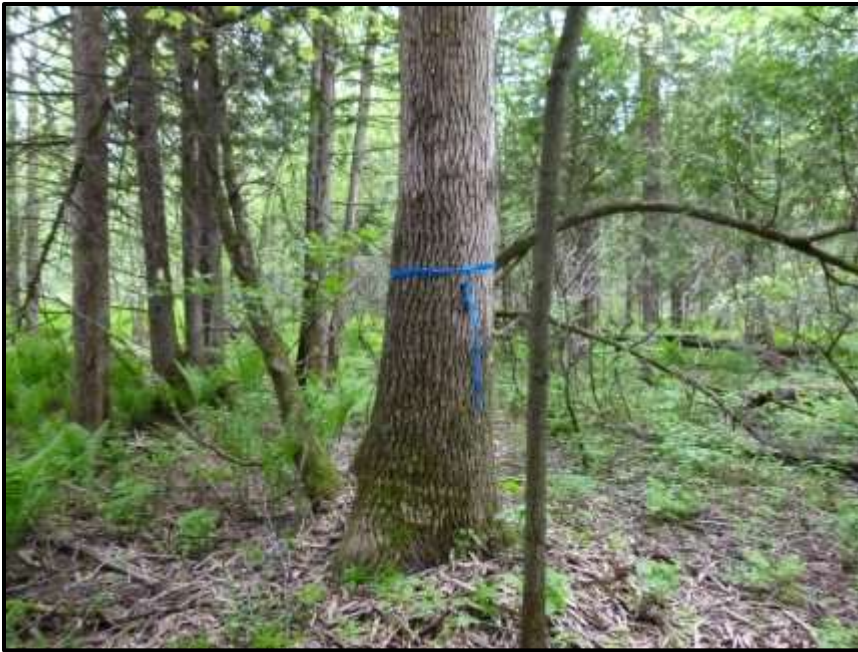
Photograph 25: Tree #26 – dead White Ash (May 27th, 2019).

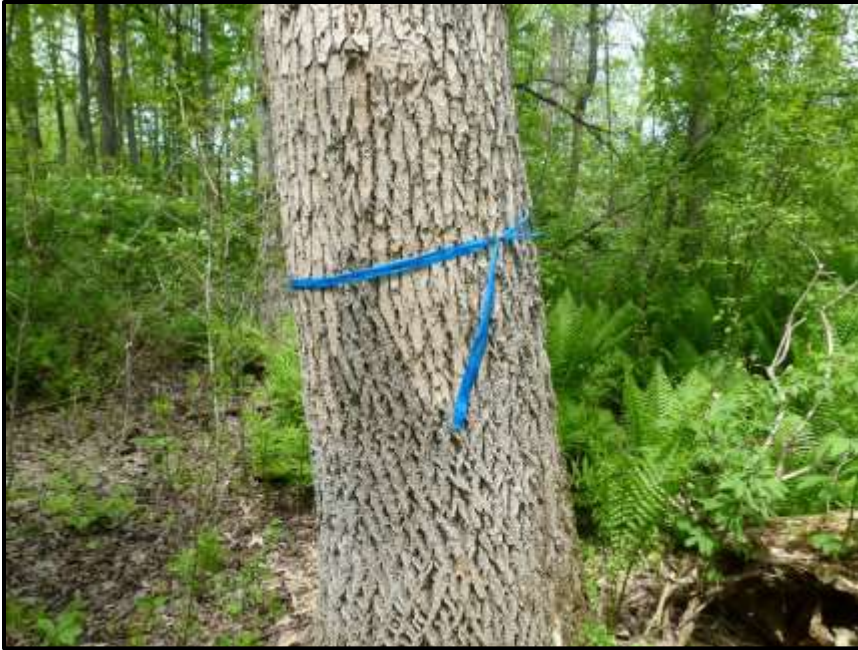
Photograph 31: Tree #32 – dead White Ash (May 27th, 2019).

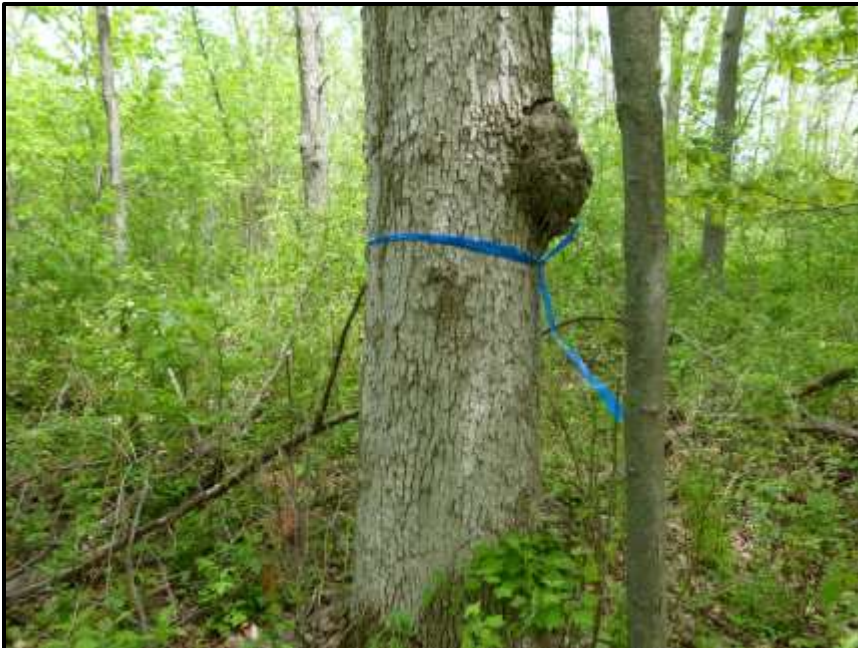
Photograph 36: Tree #37 – dead White Ash (May 27th, 2019).

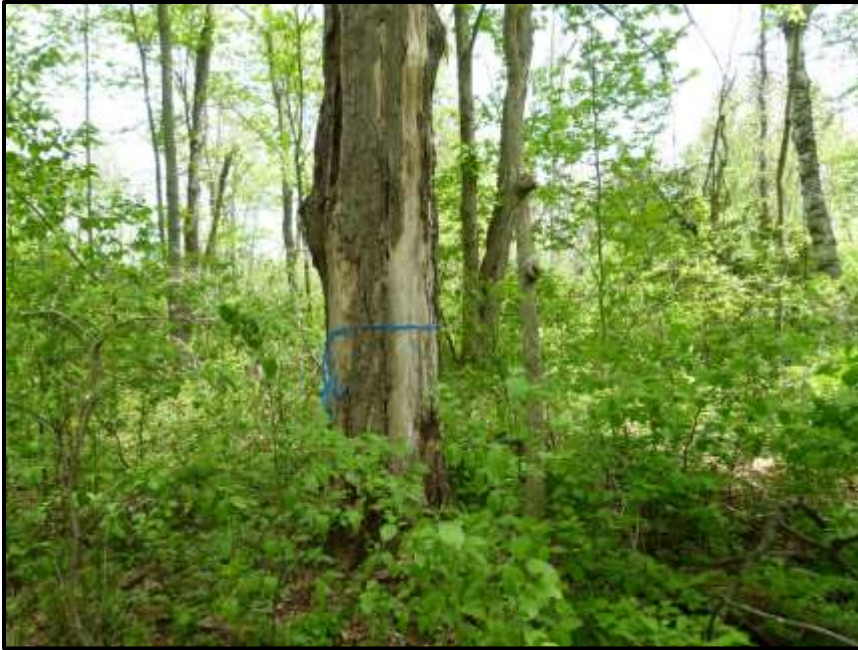
Photograph 37: Tree #38 – Sugar Maple in poor condition (May 27th, 2019).

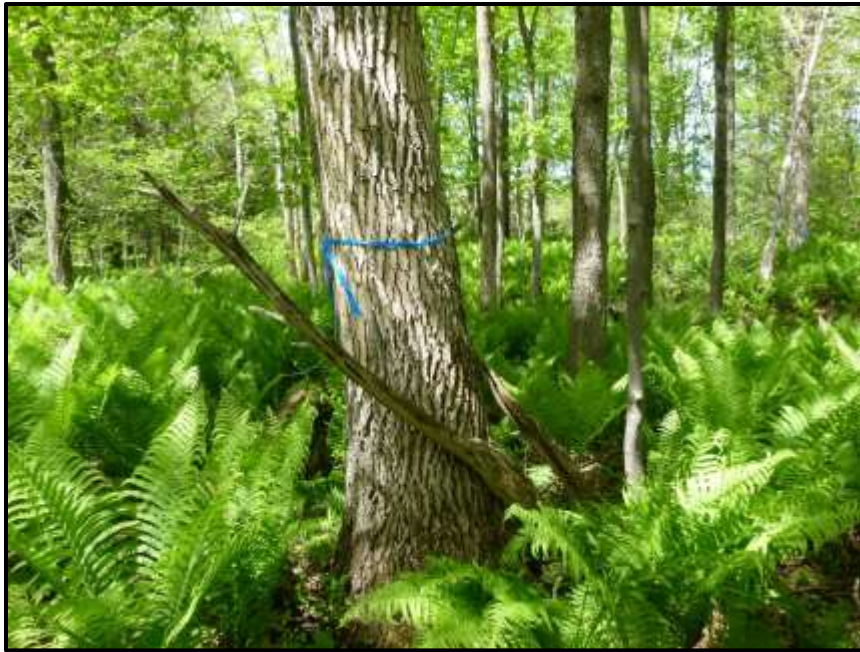
Photograph 47: Tree #48 – dead White Ash (May 27th, 2019).

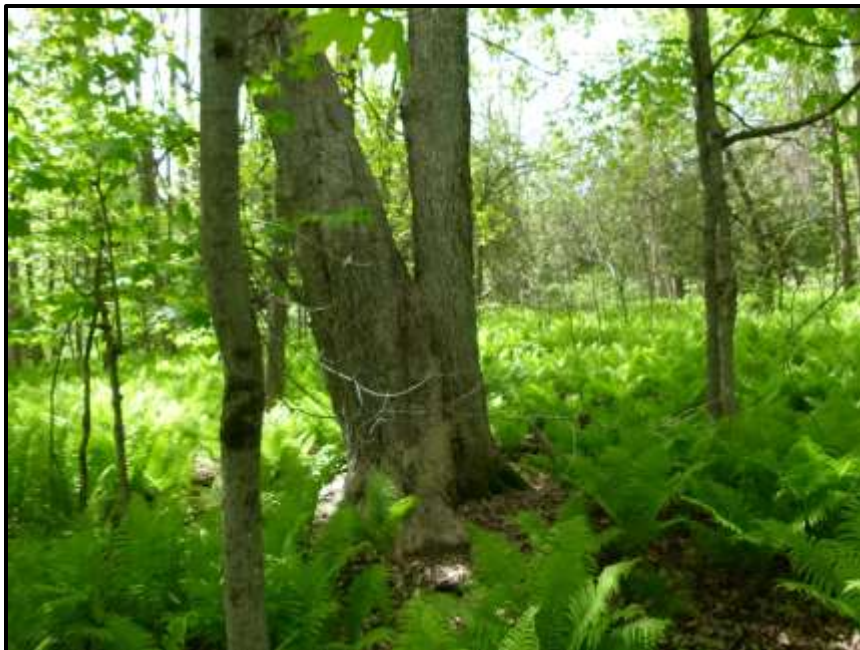
Photograph 48: Tree #49 – Sugar Maple in good condition (May 27th, 2019).

Per the KNUEA EMP, it is recommended that all trees within the Study Area that occur outside of the limits of the future SWM pond blocks should be preserved. In addition, wherever feasible, trees that occur along the edge of the retained area should also be preserved. Based on the estimated limits of the SWM pond shown above in Figures 1 to 3, the only potentially retainable tree (healthy) that currently occurs along the edge of the SWM pond blocks is Tree #49, which is approximately 4 m from the edge of the anticipated retained area. If feasible and compatible with the SWM pond design, Tree #49 should be preserved adjacent to the edge of the retained area during the development of the SWM pond.

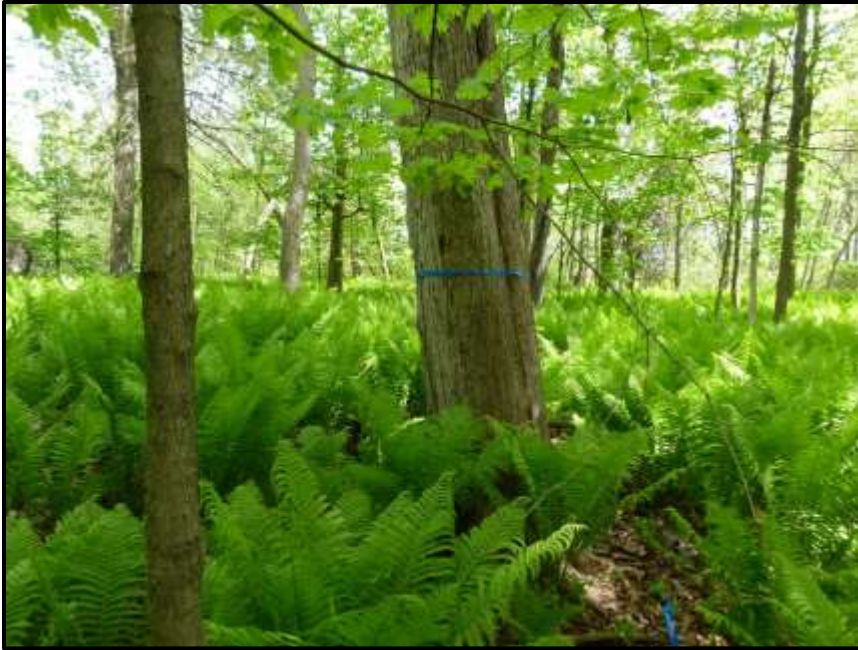
Photograph 49: Tree #50 – Basswood in poor condition (May 27th, 2019).

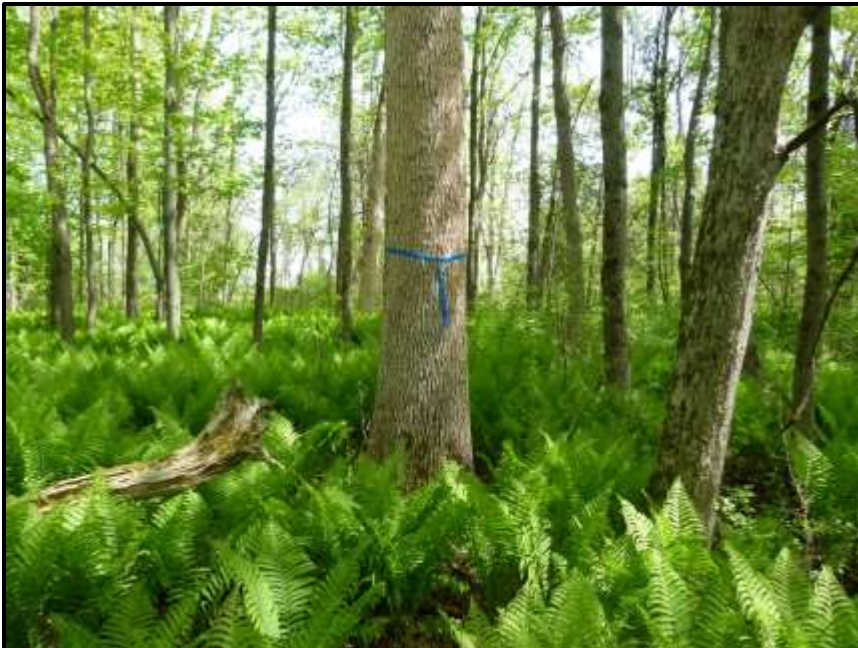
Photograph 50: Tree #51 – dead White Ash (May 27th, 2019).

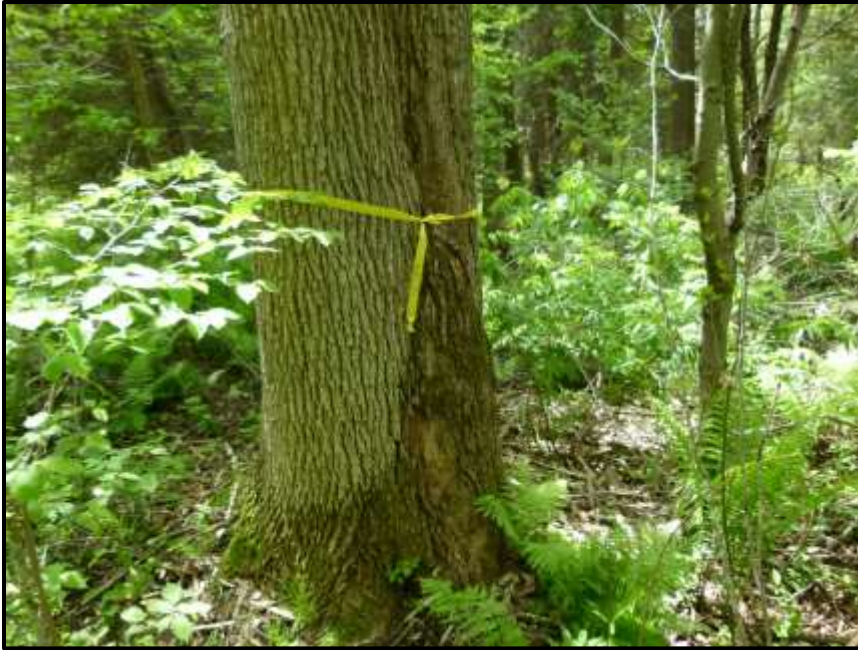
Photograph 51: Tree #52 – dead White Ash (May 27th, 2019).

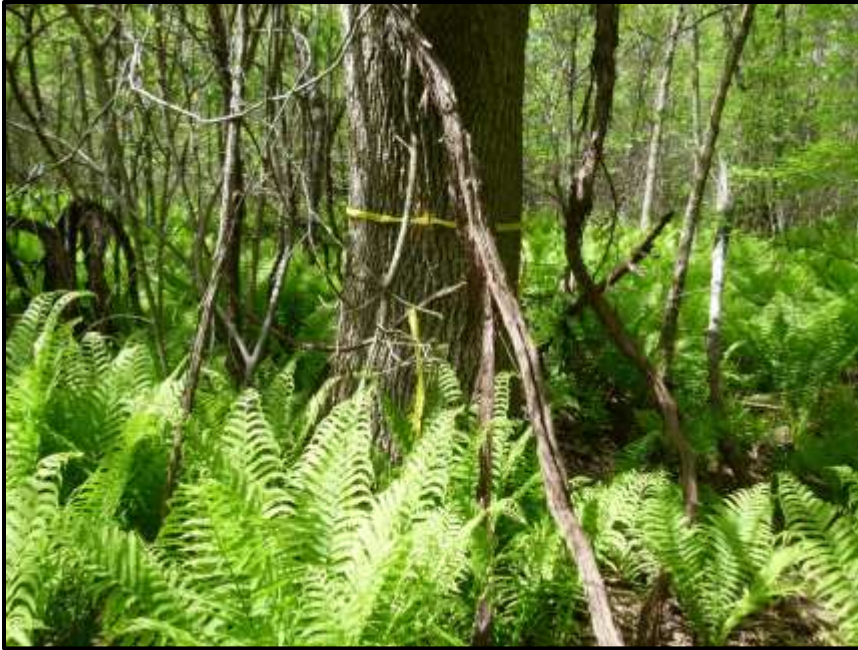
Photograph 53: Tree #54 – dead White Ash (May 30th, 2019).

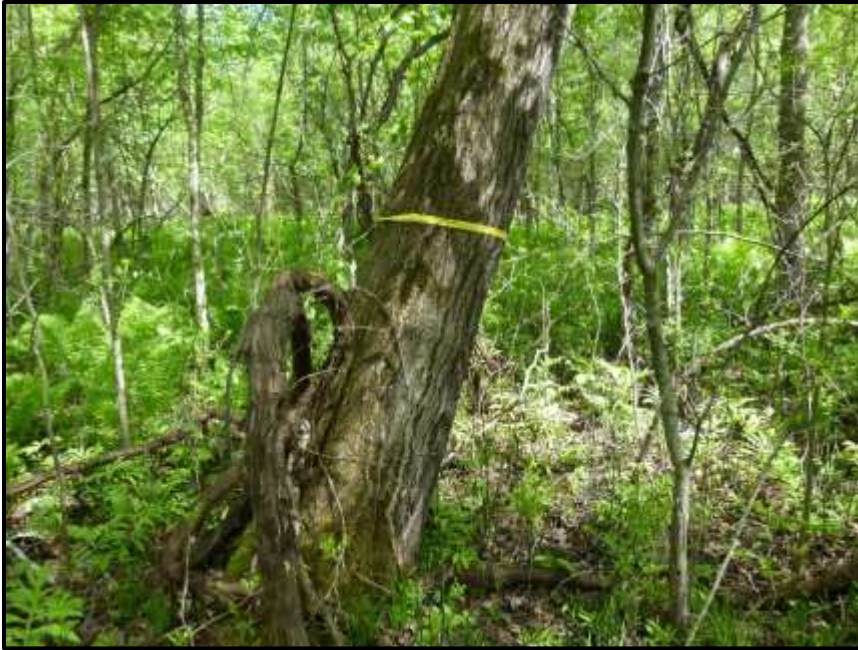
Photograph 57: Tree #58 – Trembling Aspen in poor condition (May 30th, 2019).
