3194 Jockvale Road Development Tree Conservation Report

December 2018
Prepared for Richcraft Homes Inc.

RE: Tree Conservation Report for the 3194 Jockvale Road Development

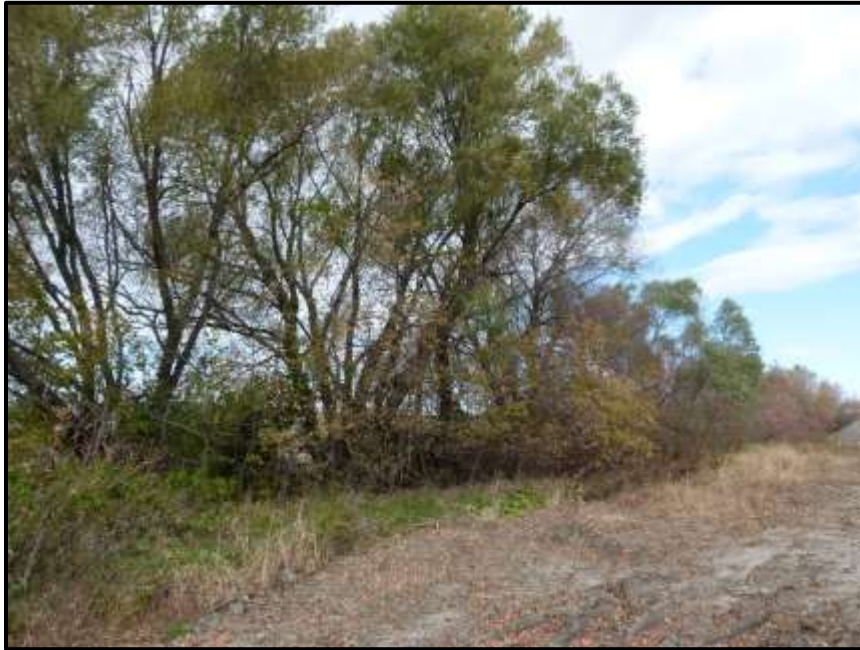
- **Tree Stand M:** Tree Stand M includes a Deciduous Hedgerow that is dominated by Crack Willow (*Salix fragilis*) between 25 cm and 50 cm dbh in size. As noted above, some of the Crack Willow began growing around 1976, and hence are approximately 40 years of age. However, the majority of stems are younger. Also present are Manitoba Maple and White Ash up to approximately 30 cm dbh in size, and small numbers of young Silver Maple (*Acer saccharinum*). Shrub cover is dominated by Wild Red Raspberry (*Rubus idaeus*), Red Osier Dogwood (*Cornus sericea*), and Common Buckthorn.

Photograph 13: Looking east at Tree Stand M (dominated by Crack Willow) (October 24th, 2018).

- **Tree Stands M and N:** Tree Stands M and N are Deciduous Hedgerows that are dominated by invasive Crack Willow, with a high proportion of invasive Manitoba Maple. Both features also include White Ash, which are dead and/or dying due to the effects of the invasive Emerald Ash Borer. Due to the fact that these features are dominated by invasive species and degraded, they should not be a priority for retention.

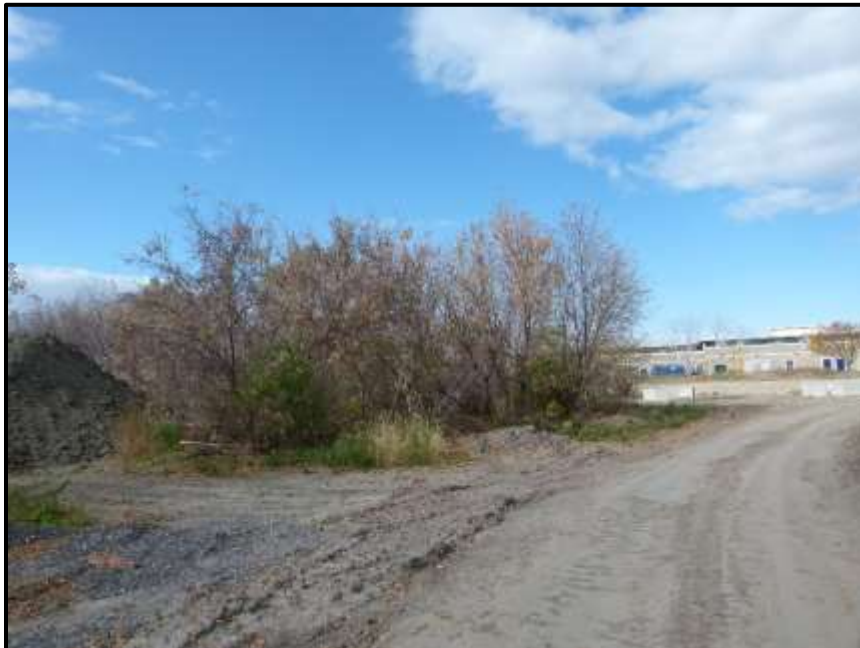
- **Tree Stand N:** Tree Stand N is a young tree stand dominated by Manitoba Maple, White Ash, and Crack Willow. Most trees are less than 15 cm dbh in size, although a few Manitoba Maple up to 30 cm dbh in size are present. Shrub cover includes Staghorn Sumac, Wild Red Raspberry, Common Buckthorn, and Red Osier Dogwood. As discussed below, one (1) Butternut (*Juglans cinerea*) seedling was noted within Tree Stand N.

Photograph 14: Looking north at Tree Stand N (dominated by Manitoba Maple, White Ash, and shrubs) (October 24th, 2018).

Photograph 15: Looking east at Tree Stand N (dominated by Manitoba Maple, White Ash, and shrubs) (October 24th, 2018).
