July 7, 2020

Re.: Tree Conservation Report for 6171 Hazeldean, Stittsville, Ontario

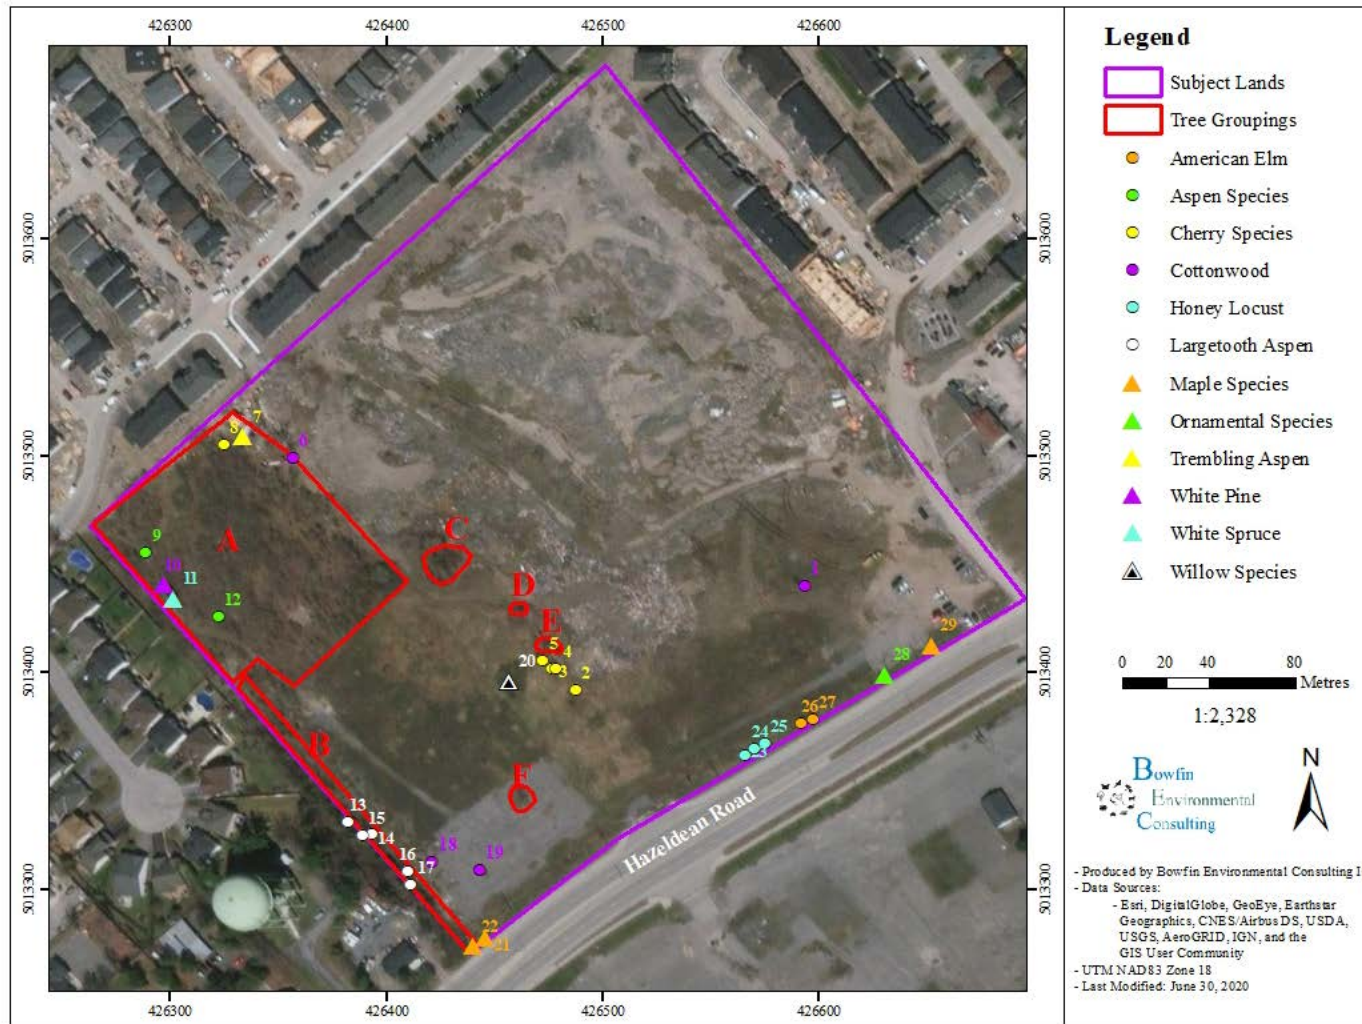
Map 1: Location of Existing Trees

In addition to six groupings of trees, there were 29 individual trees assessed on-site with a DBH of 10 cm or greater. The most common species were: gray birch, trembling and largetooth aspen. A summary of these is provided in Table 1. Most of the trees were healthy apart from some dead aspens.

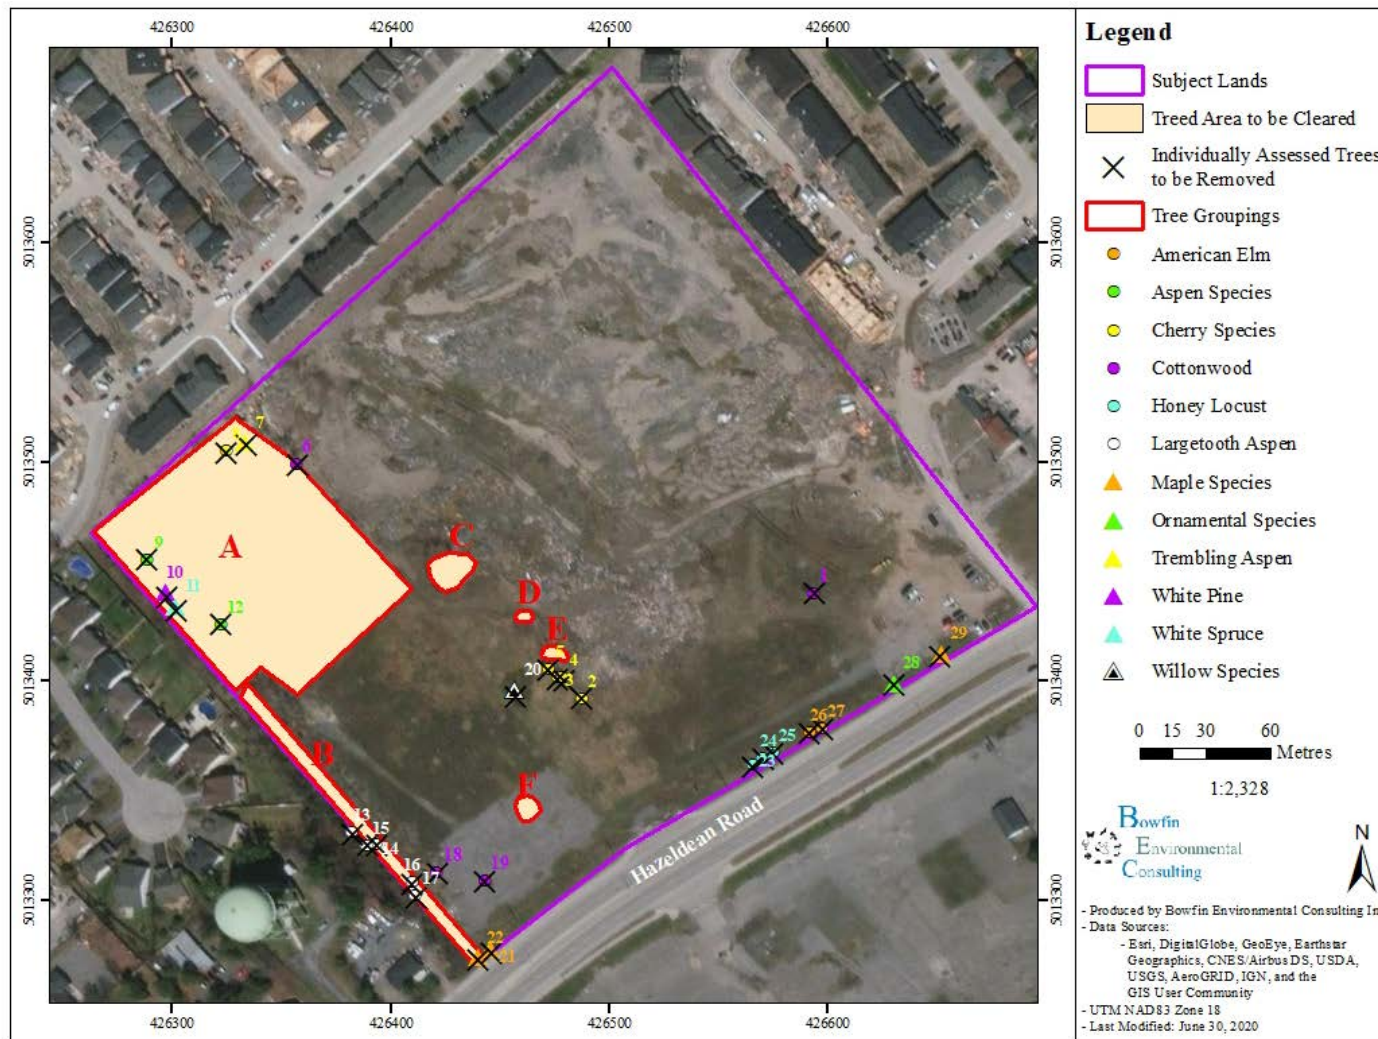
Figure 2: Location of Trees to be Removed

All trees will be removed. Trees on neighbouring lands are separated by fences and those were not assessed. Grading, infilling and underground works should be limited to outside of Critical Root Zone of the neighbouring lands to prevent root damage to trees meant to be left in place.

- All trees on-site will be removed. When clearing near trees on neighbouring lands, mitigation measures to prevent harm to the root systems of trees adjacent to the proposed works will be implemented to protect them from indirect harm:

- Sturdy fencing will be installed outside of the Critical Root Zone (CRZ) (defined by the City as 10 x the DBH) of the trunk of the closest trees to the work area.
