# Marlborough Creek Meander Belt Width Delineation

**6038 Ottawa Street**  
City of Ottawa (Richmond), Ontario

March 10, 2025

GEO Morphix Project No. 25011

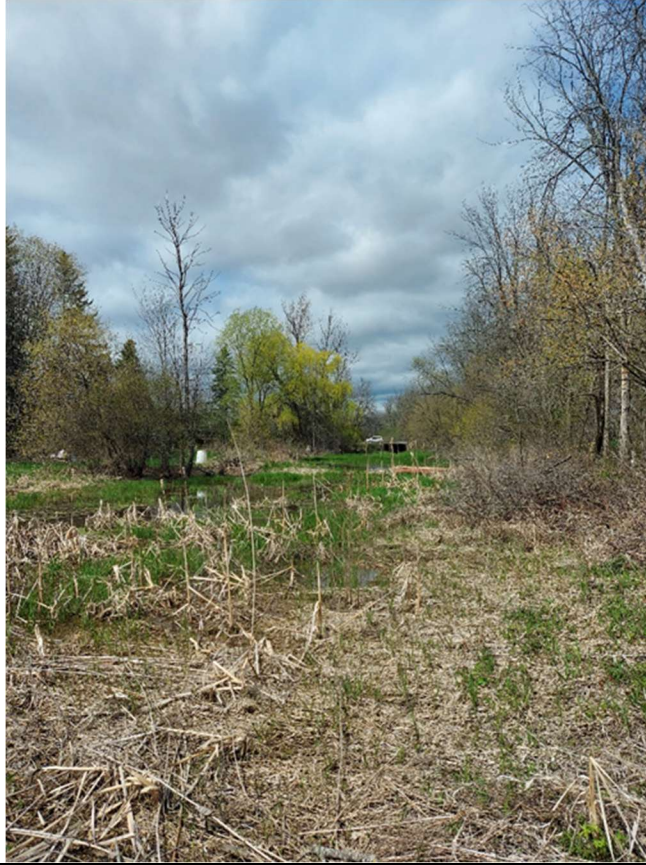
**Photo 1**  
Marlborough Creek (MC1) – Richmond, Ontario

Photograph looking downstream towards the Ottawa Street bridge crossing (the furthest upstream extent of MC1). The riparian corridor was less than four times bankfull width and consisted of grasses and trees.

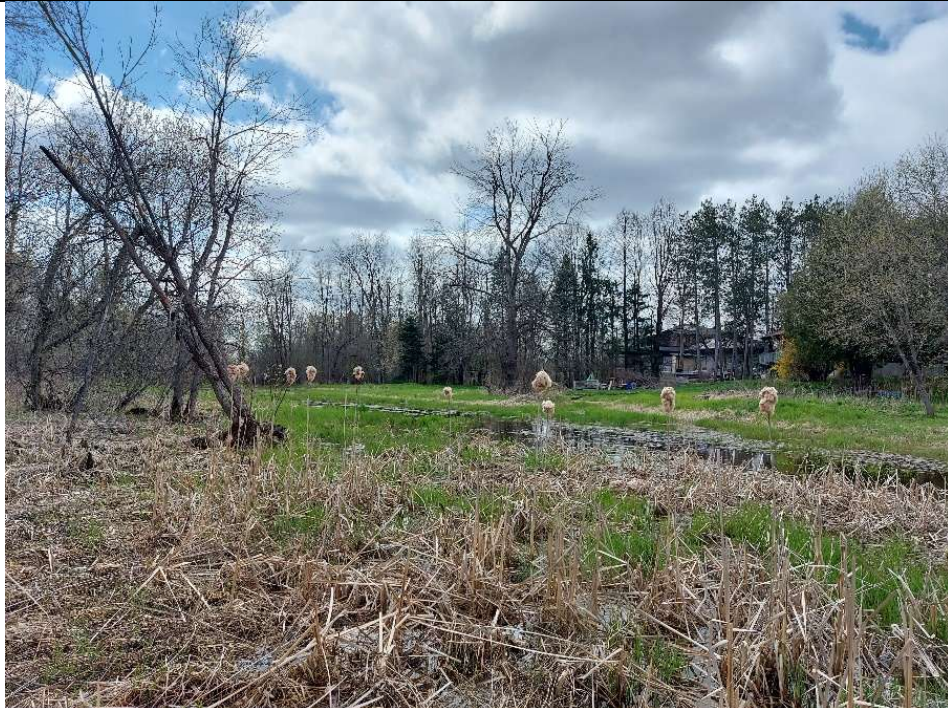
**Photo 2**  
Marlborough Creek (MC1) – Richmond, Ontario

Photograph looking upstream towards Marlborough Creek. Channel banks were occupied by grasses and aquatic plant species.

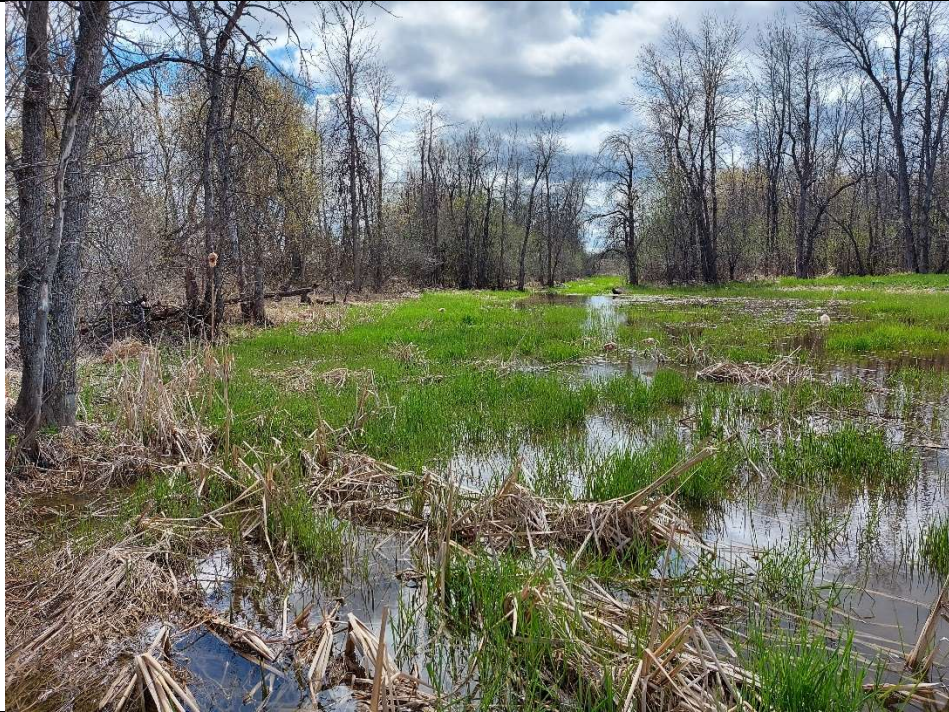
**Photo 3**  
Marlborough Creek (MC1) – Richmond, Ontario

Photograph looking towards the downstream extent of MC1. Emergent aquatic plant species occupied greater than 80% of the channel.

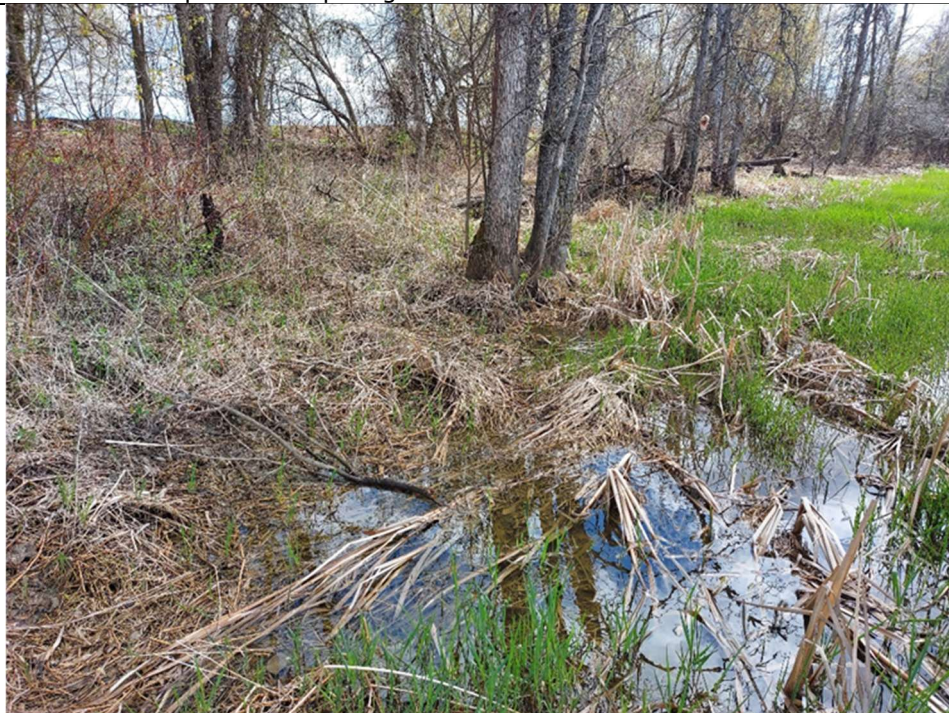
**Photo 4**  
Marlborough Creek (MC1) – Richmond, Ontario

Photograph looking towards the right bank (facing downstream). Bank materials consisted of clay, silt, with minor sand. Channel banks were occupied by vegetation and there was no evidence of erosion.

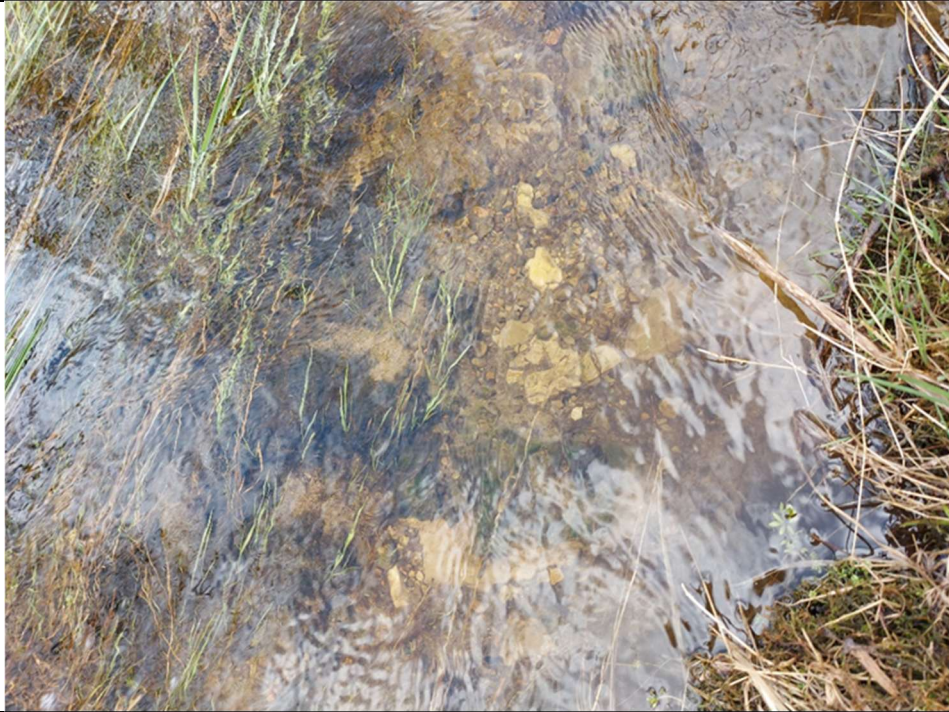
**Photo 5**

The channel bed was occupied by gravel, small cobble, and large cobble. Further, bed substrates were underlain by bedrock in some locations.

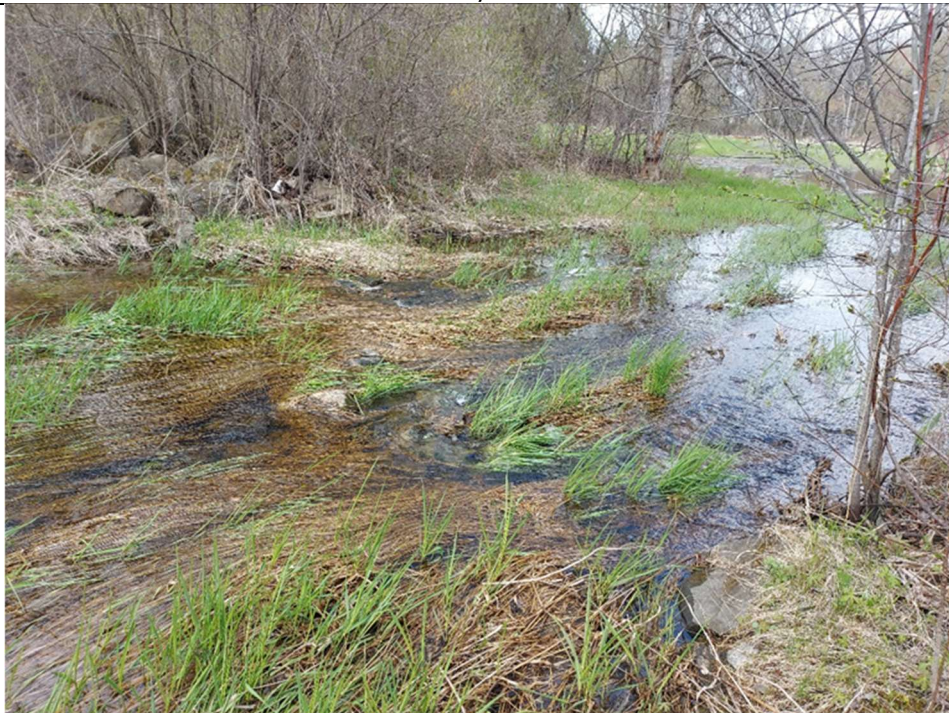
**Photo 6**

Photograph looking downstream at a riffle. Riffle substrate consisted of small and large boulders. The reach was occupied by 75% large pools and 25% riffles.

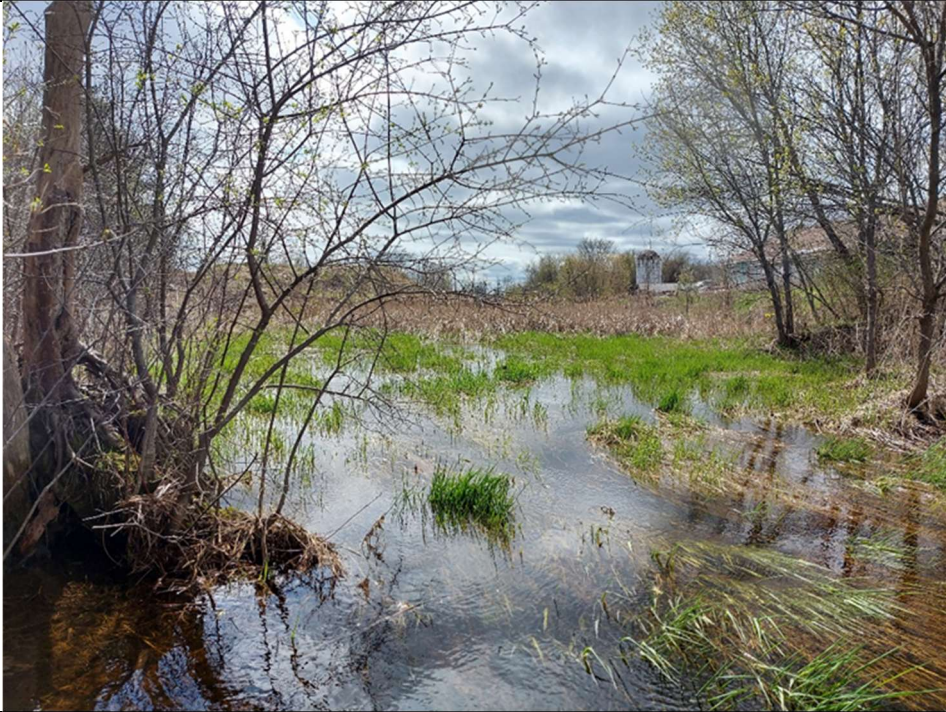
**Photo 7**  
Marlborough Creek (MC1) – Richmond, Ontario

**Reach MC1** was assigned an RGA score of 0.14, indicating the reach was in regime. The dominant geomorphological indicator was evidence of widening due to the observations of fallen and leaning trees and occurrence of large organic debris. However, it is important to note that falling and leaning trees were likely attributed to human modification adjacent to the watercourse rather than from active channel processes. **Reach MC1** had an RSAT score of 30, or "good". There was one limiting factor, riparian habitat conditions, that was attributed to the narrow riparian area outside of the well-connected flood plain, which was with predominantly wooded vegetation (i.e., trees) and fragmented in some areas.

Photograph looking upstream. There was heavy encroachment of vegetation into the channel, as well as leaning trees along the channel banks.

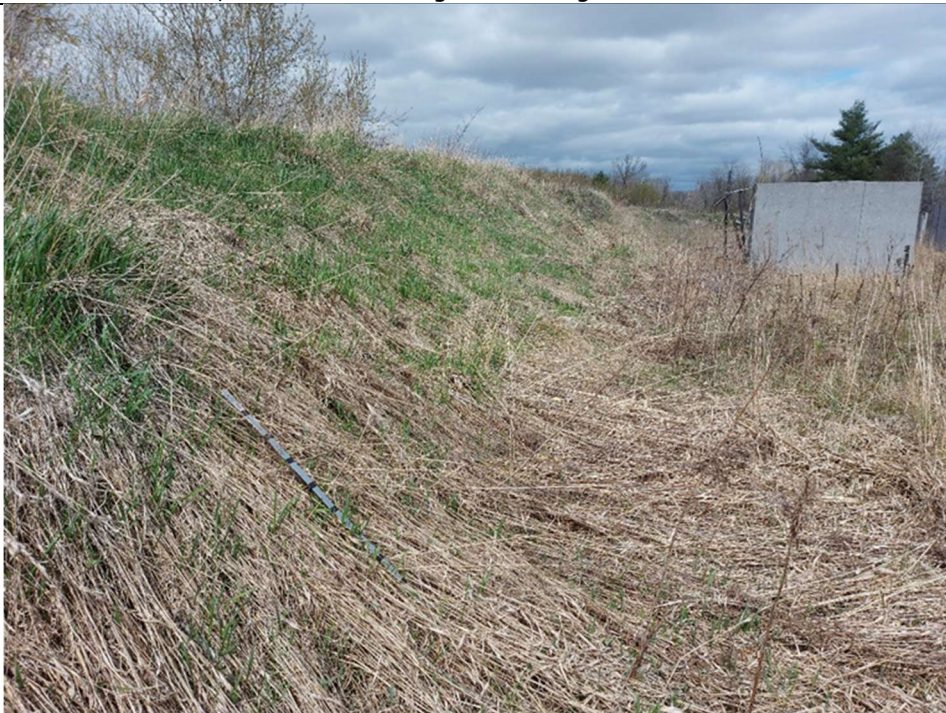
**Photo 8**  
Marlborough Creek (MC1) – Richmond, Ontario

A large berm was constructed along the right bank (facing downstream) of MC1. The watercourse was unconfined in all areas besides the location of the berm.

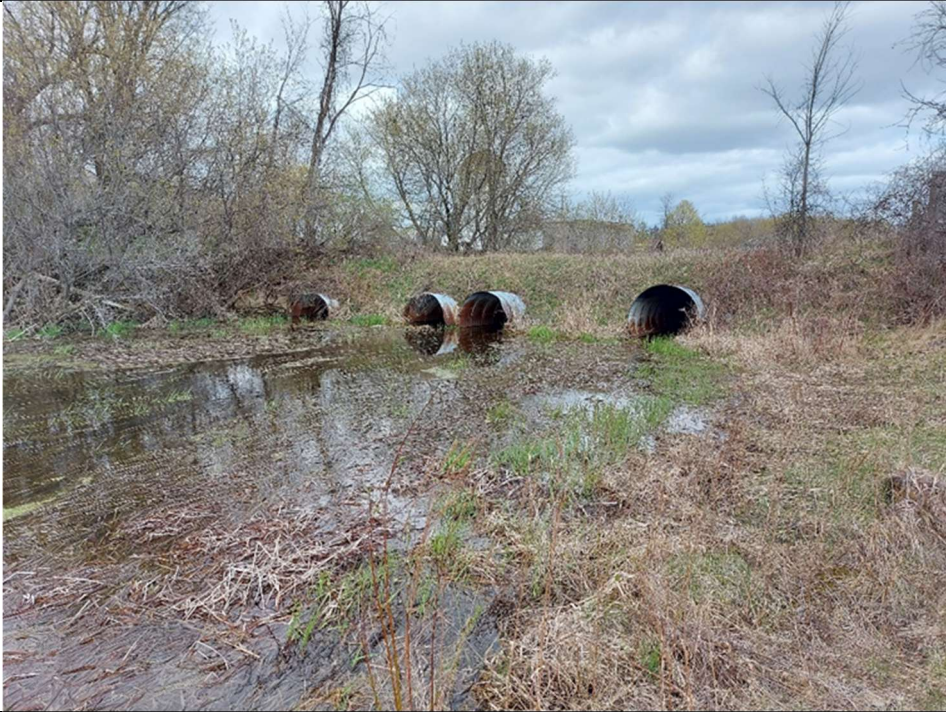
**Photo 9**  
Marlborough Creek (MC1) – Richmond, Ontario

Photograph looking downstream towards a single-lane crossing. Four large corrugated steel pipe culverts conveyed flows beneath the crossing.

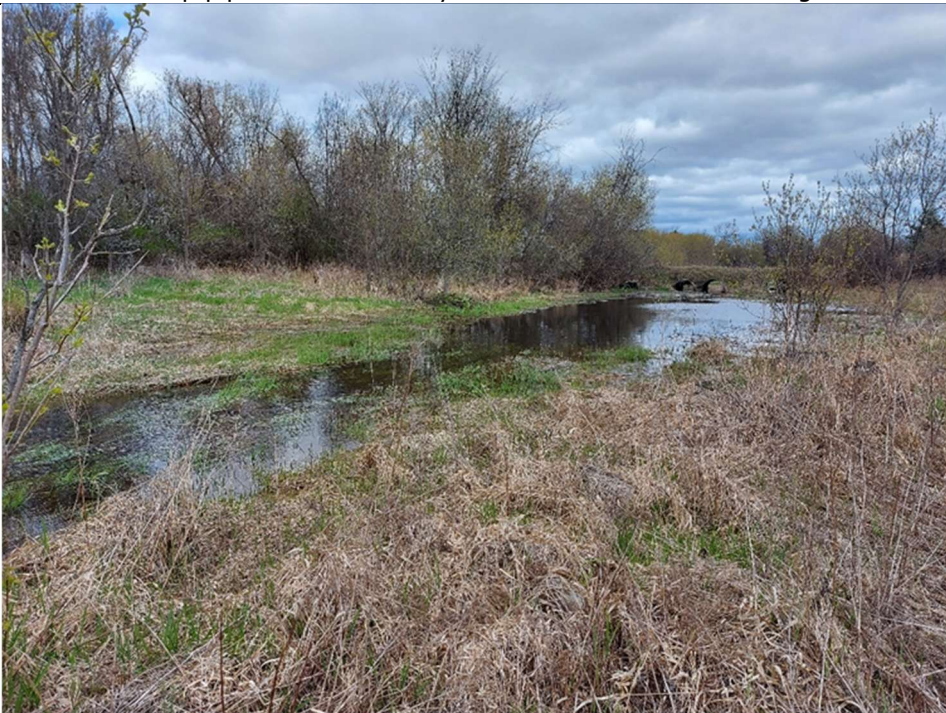
**Photo 10**  
Marlborough Creek (MC1) – Richmond, Ontario

Geomorphic units were established through the reach and consisted of large, deep pools, and riffles. There was good connectivity between the watercourse and the floodplain.

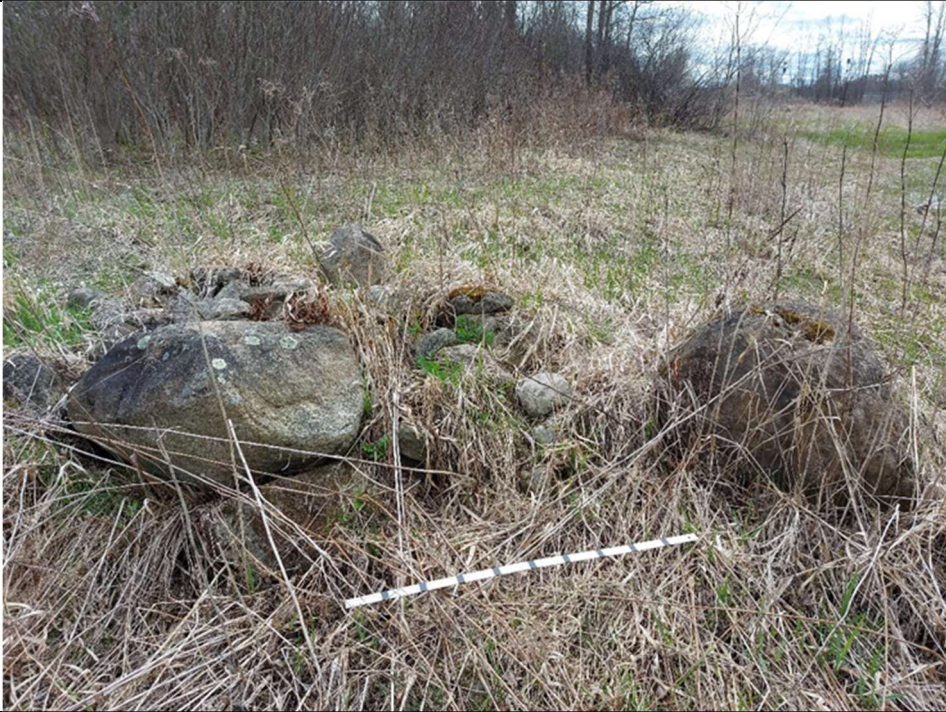
**Photo 11**  
Marlborough Creek (MC1) – Richmond, Ontario

Clusters of large boulders and exposed bedrock were present along channel banks and within the floodplain.

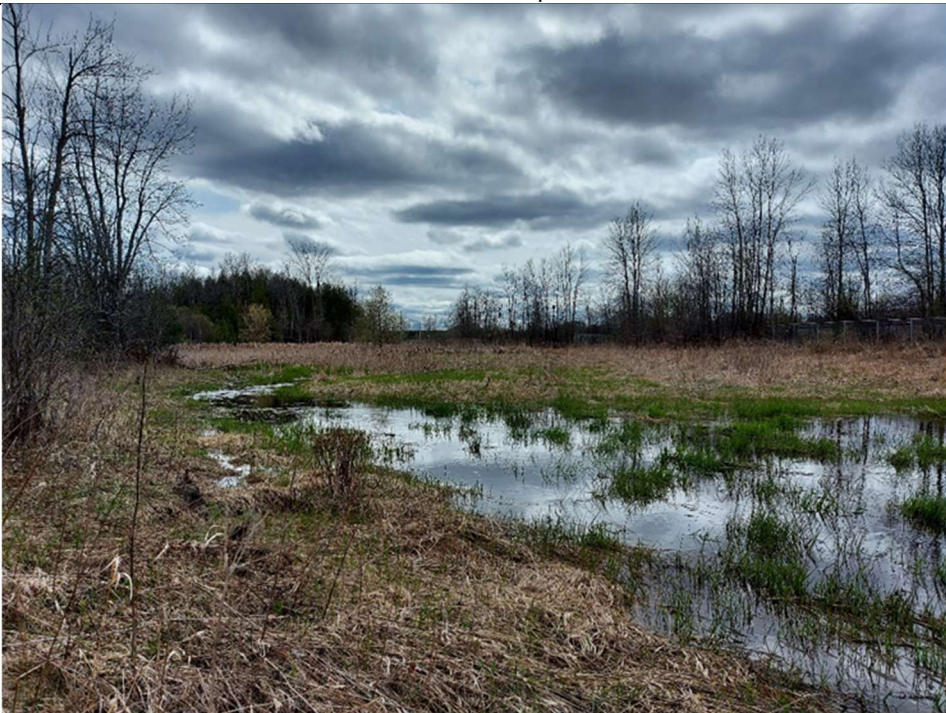
**Photo 12**  
Marlborough Creek (MC1) – Richmond, Ontario

Photograph looking upstream towards the McBean Street bridge. A large pool with emergent aquatic species occupied the channel in this location, with good connectivity to the floodplain.

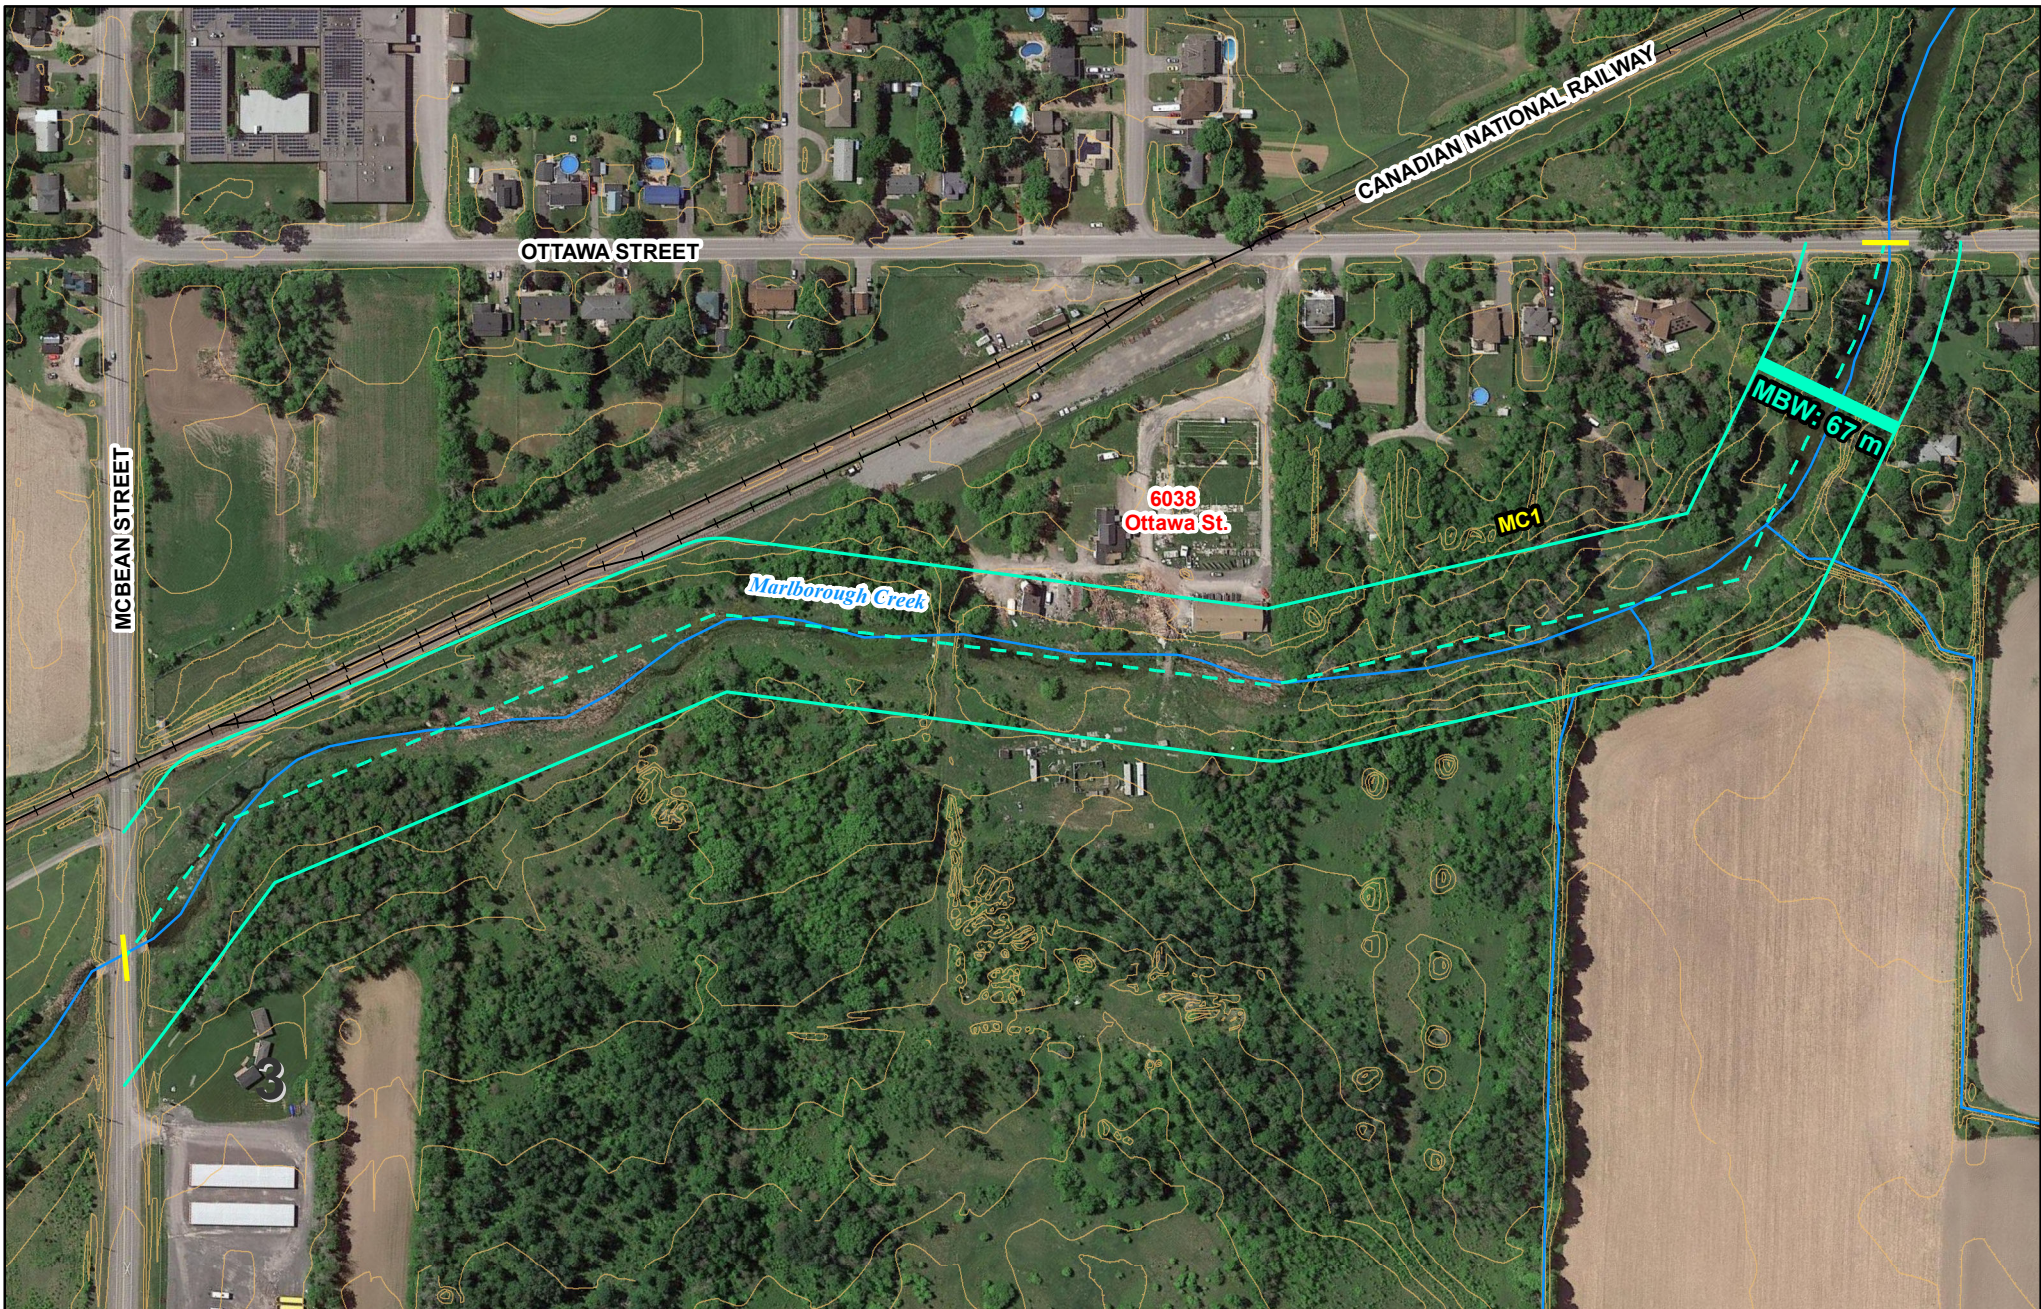
## **Appendix F: Meander Belt Width Delineation Mapping**

To determine the meander belt width (i.e., erosion hazard) extent for the creek, the amplitude of two (2) meander bends were measured along Marlborough Creek. Meander amplitudes ranged between 39.2 and 60.5 metres. A 10% safety factor was applied to the largest meander amplitude (60.5 m) to account

for changes to creek morphology over time. With this 10% factor of safety, the calculated meander belt width is 67 m.

Given the results of the rapid assessment, including no evidence of erosion, cohesive substrate characteristics along channel banks and bedrock outcrops contributing to the overall stability of the watercourse, a meander belt width of 67 metres is appropriate and conservative in nature. A map presenting the final meander belt width delineation is provided in **Appendix F**.
