# **Landslide Hazard Assessment**

## **Proposed Residential Development**

Old Montreal Road  
Ottawa, Ontario

Report PG5201-2 Revision 5 dated December 20, 2024

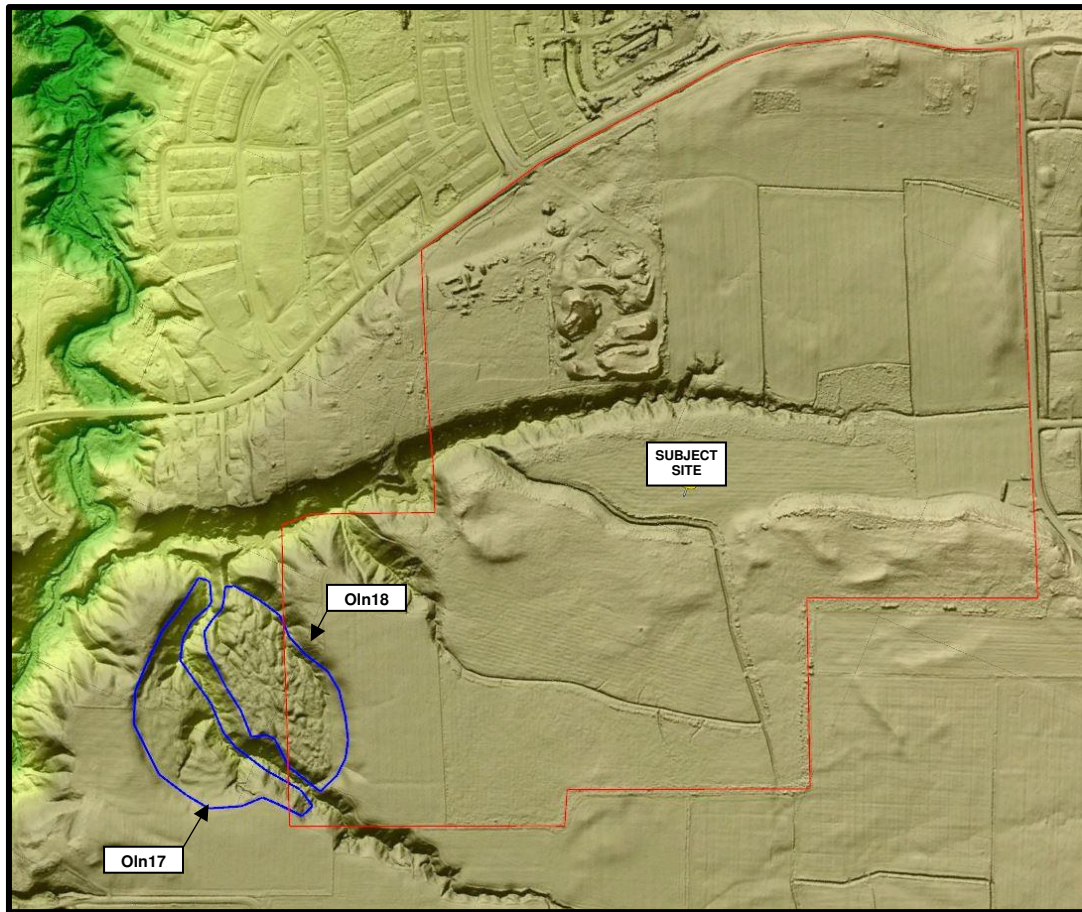
**Figure 2** – LiDAR Image of Subject Site and closest landslide and slope failure.

Further to the above-noted large-scale landslides that have occurred within the vicinity of the subject site, recent small-scale and localized slumps have formed in recent years in response to active erosion and sheet drainage. Given the high concentration of local small- and large-scale landslides throughout the area and within the subject site, it is considered appropriate to increase the baseline probability for landslides to occur throughout the subject site by a factor of 2 in Section 4.3 – Hazard Assessment of this report.

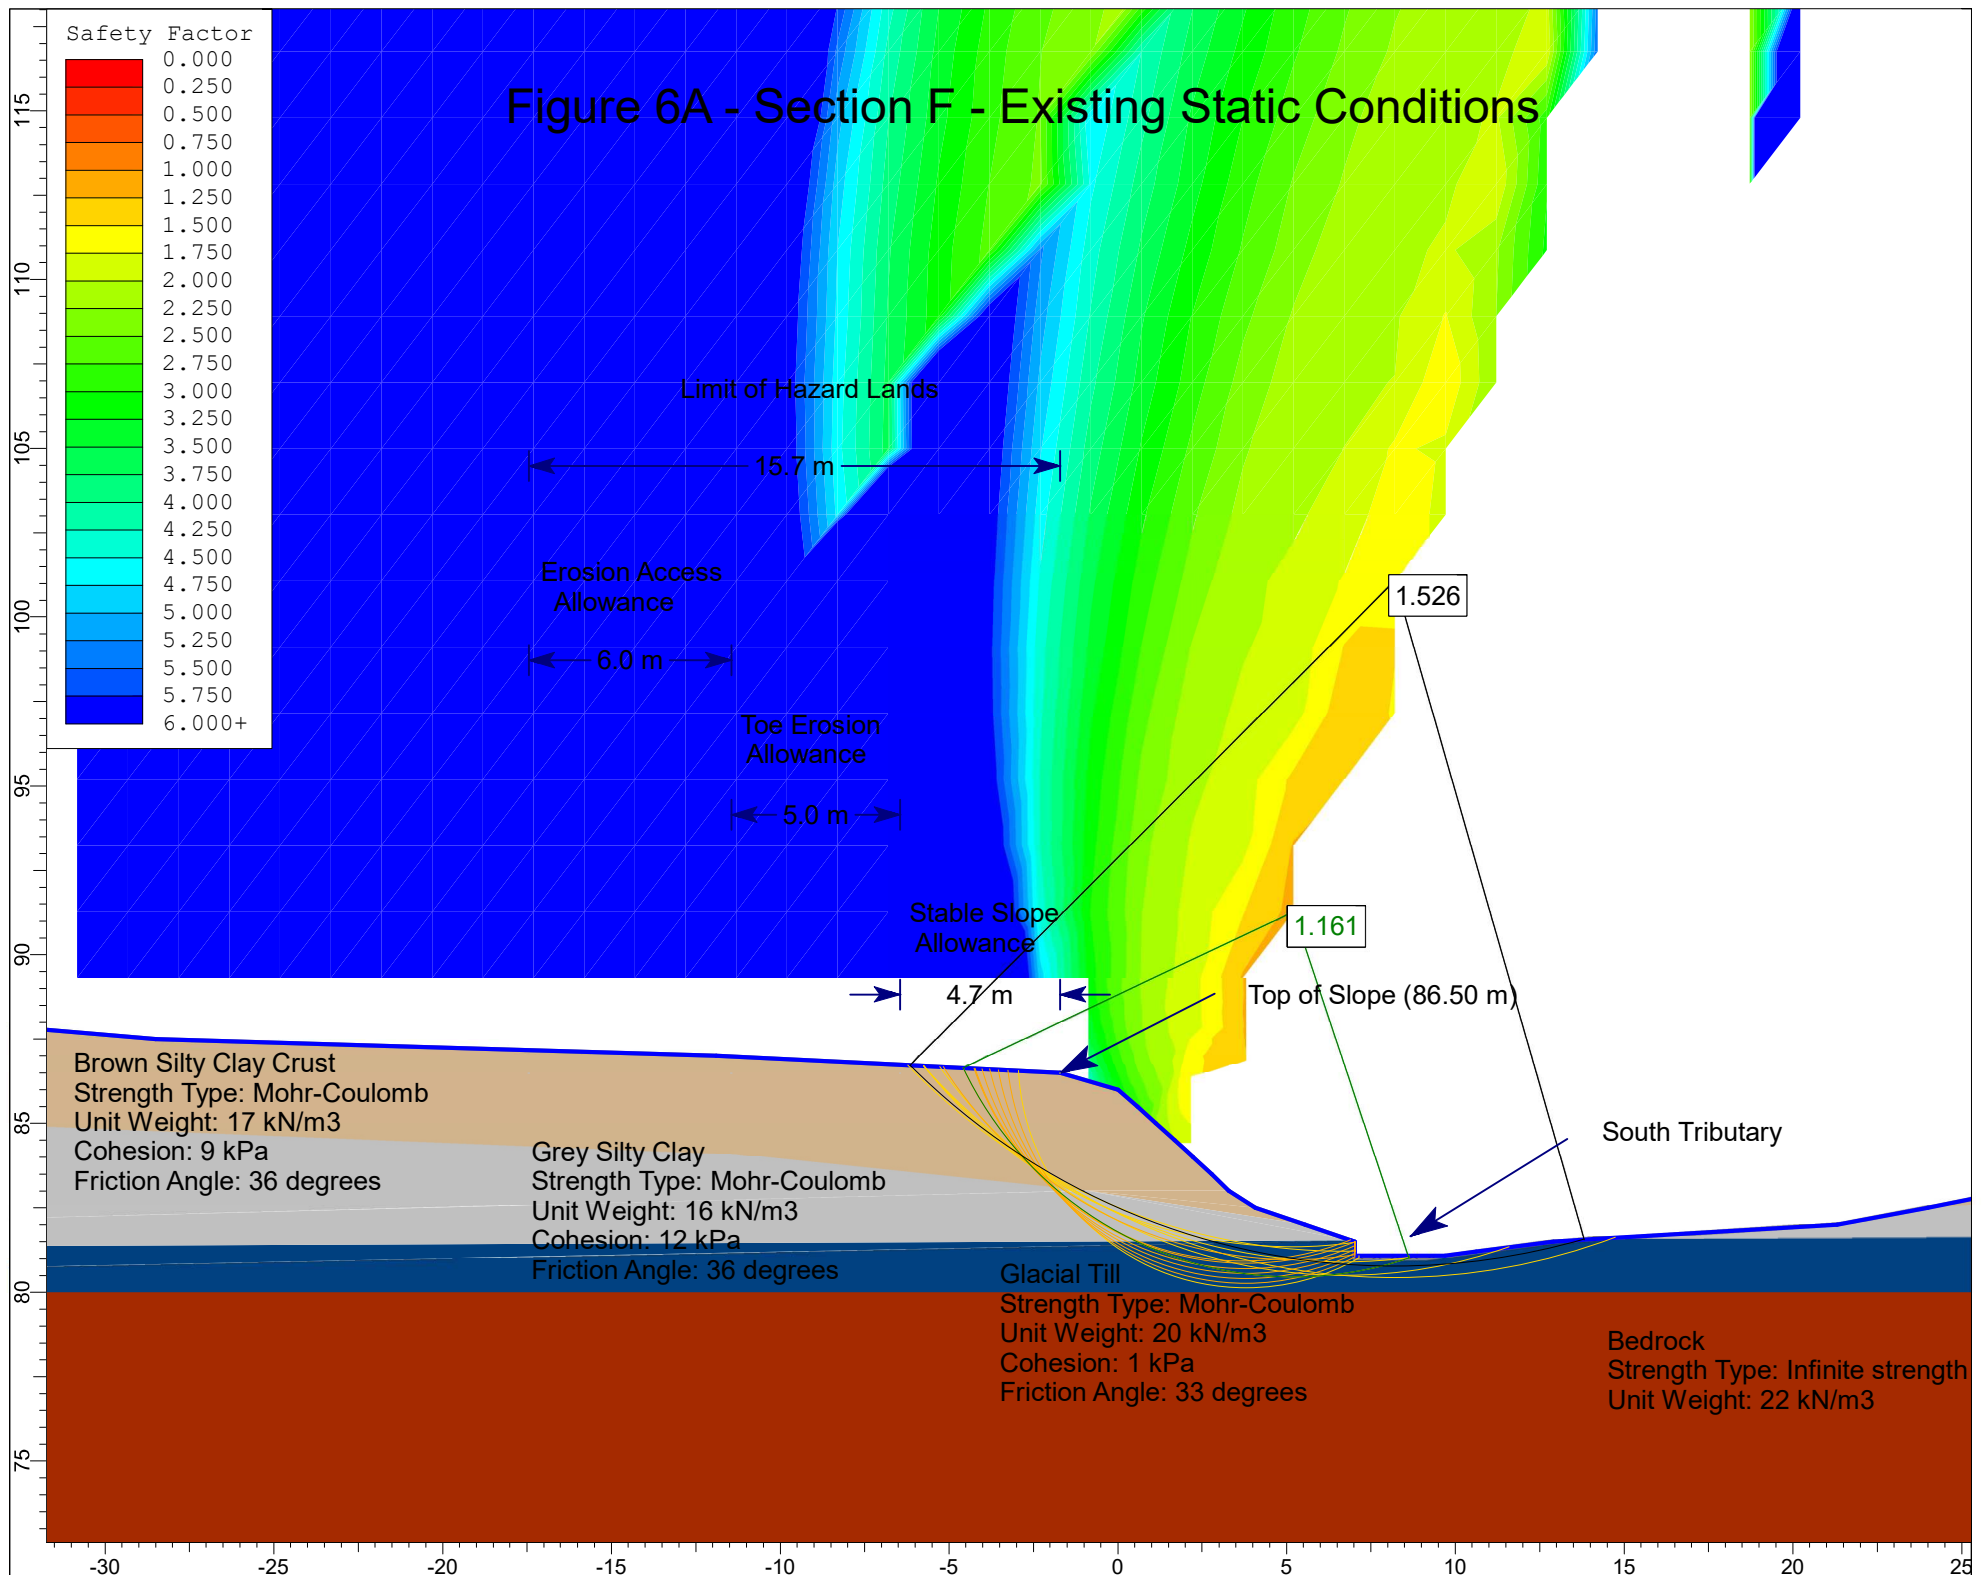
Figure 6A - Section F - Existing Static Conditions

The results for the existing static slope conditions at the slope stability sections are presented in Appendix 2. The slope stability factors of safety were found to be greater than 1.5 at all sections analyzed, except for Sections F and JJ, which require a 4.7 and 17 m setback, respectively from top of slope to obtain a factor of safety greater than 1.5.

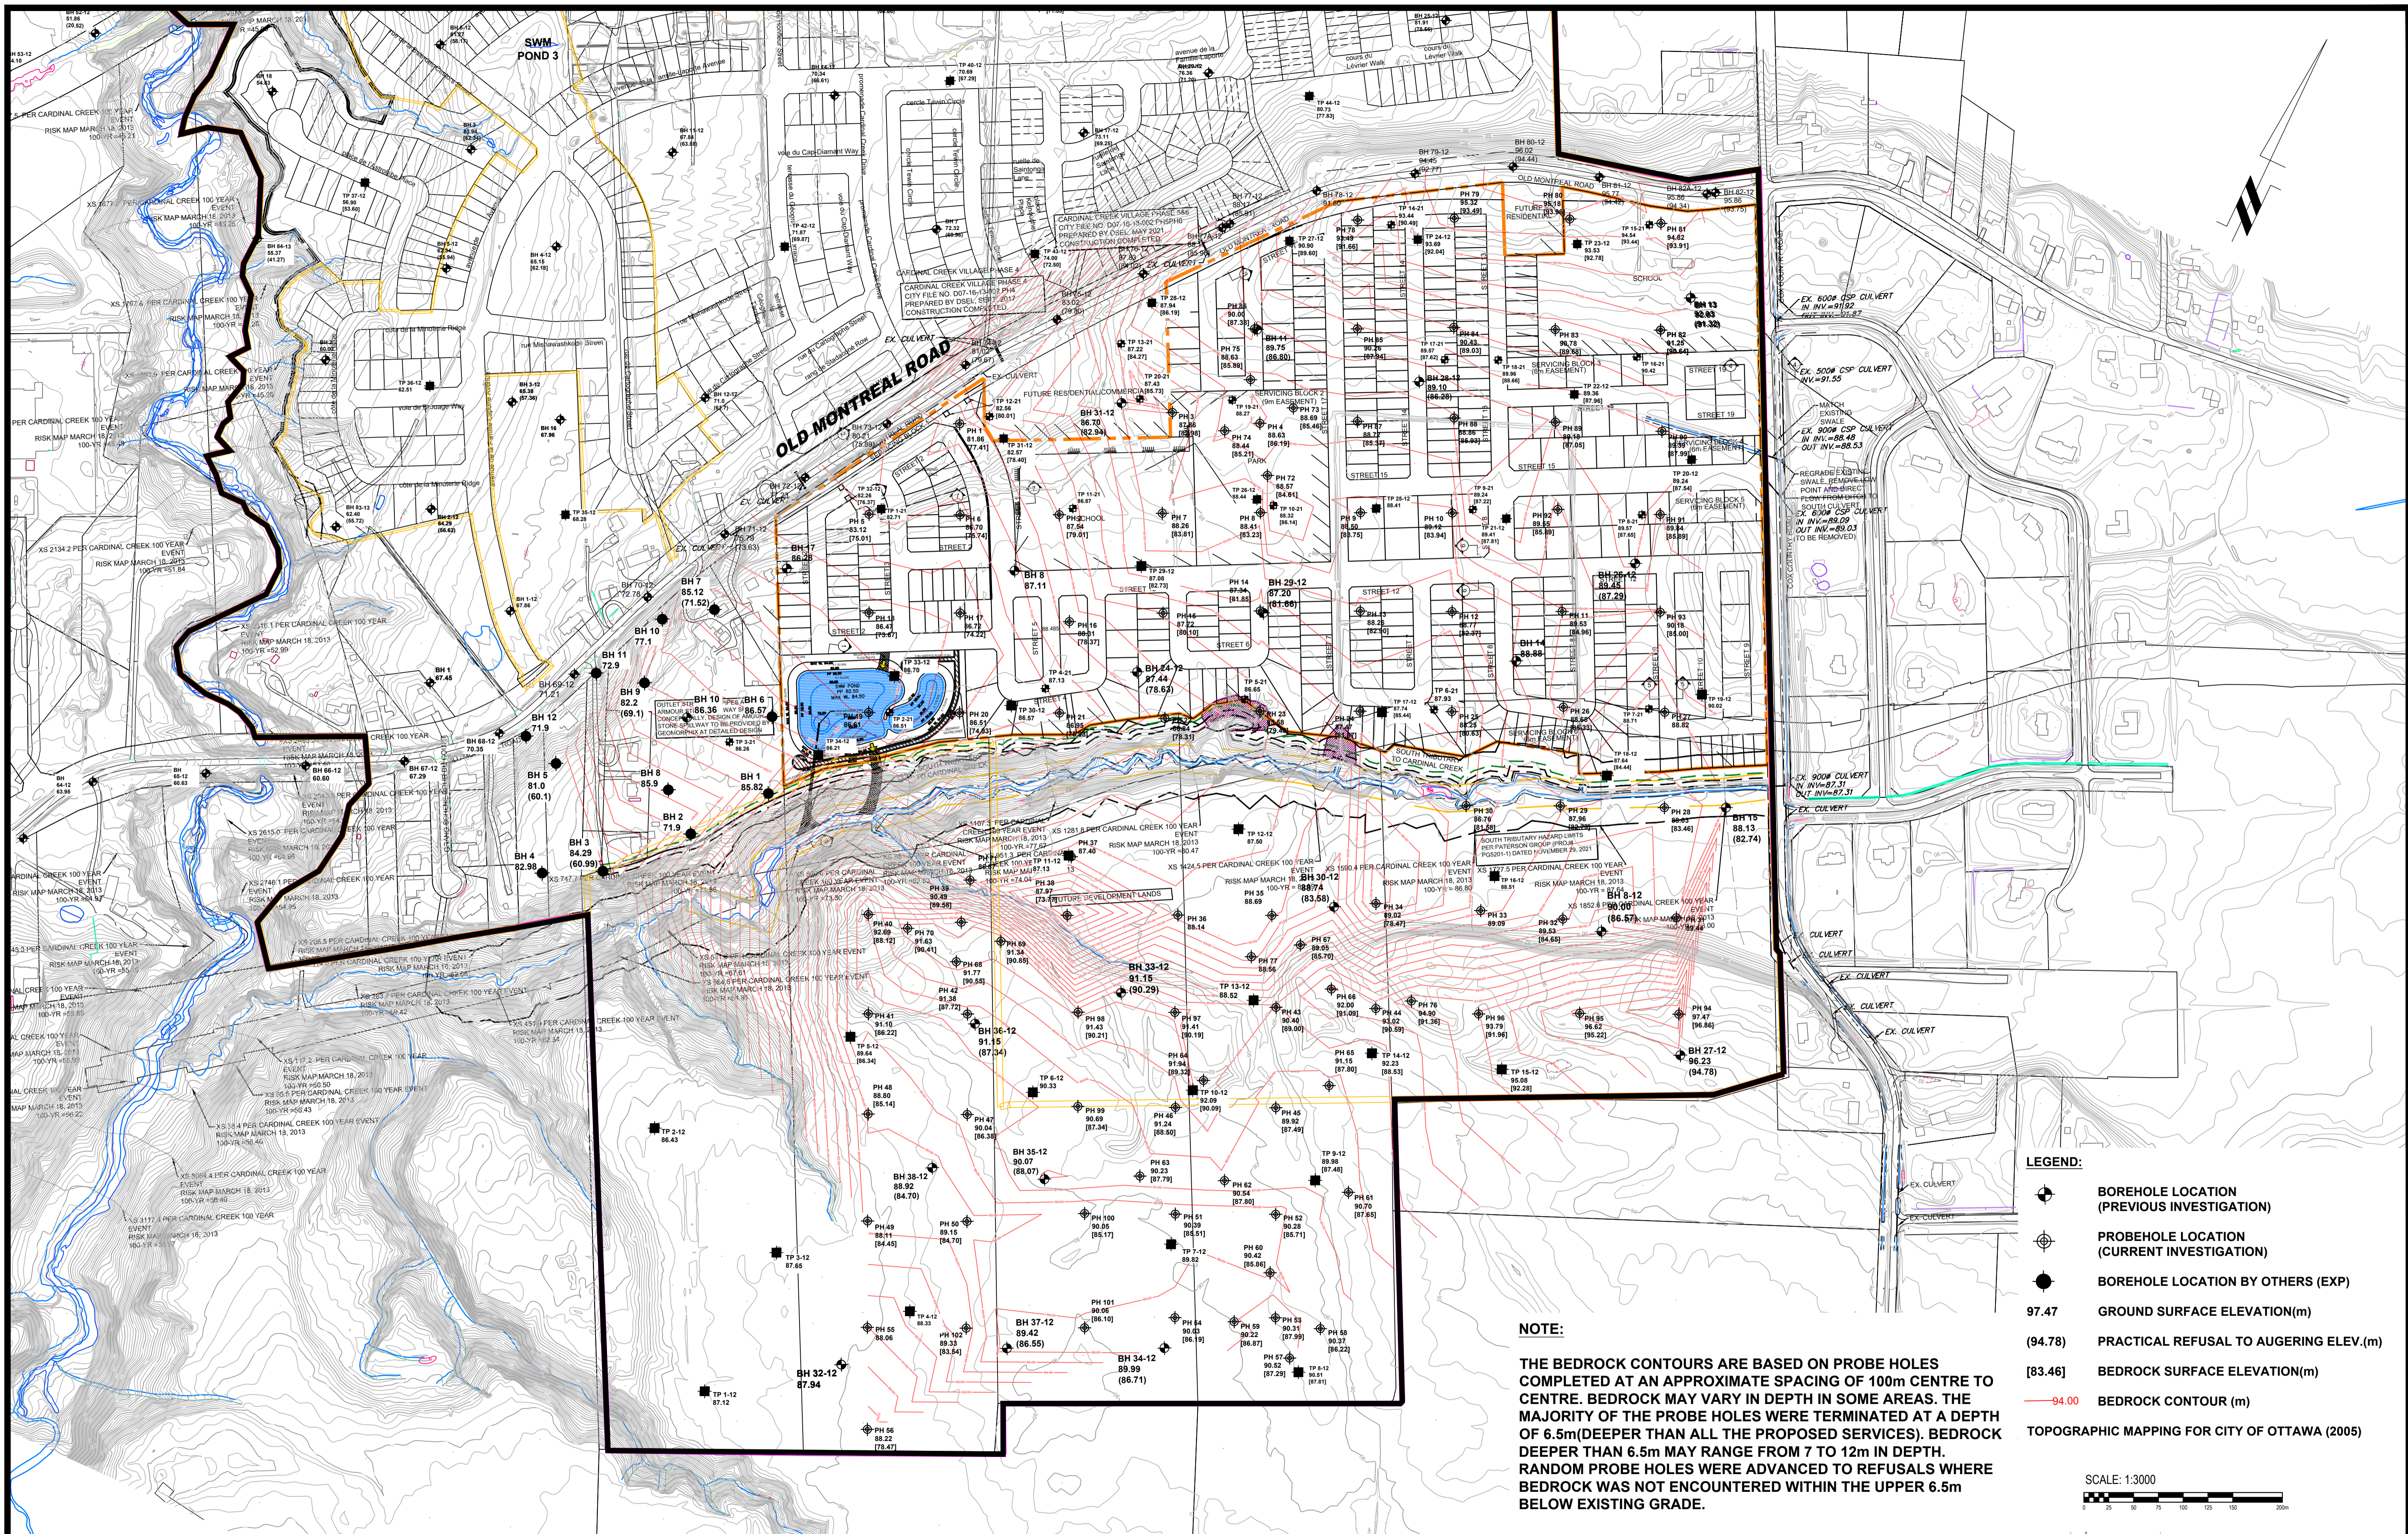
Photo 26: Photo taken on July 19, 2023 of the north slope face, looking west (downstream) near Section F.
