Fluvial Geomorphological and Erosion Threshold Assessment, Tributary of Cardinal Creek

1296 and 1400 Old Montreal Road
City of Ottawa, Ontario

Submitted:
November 11, 2024

GEO Morphix Project No. 23076

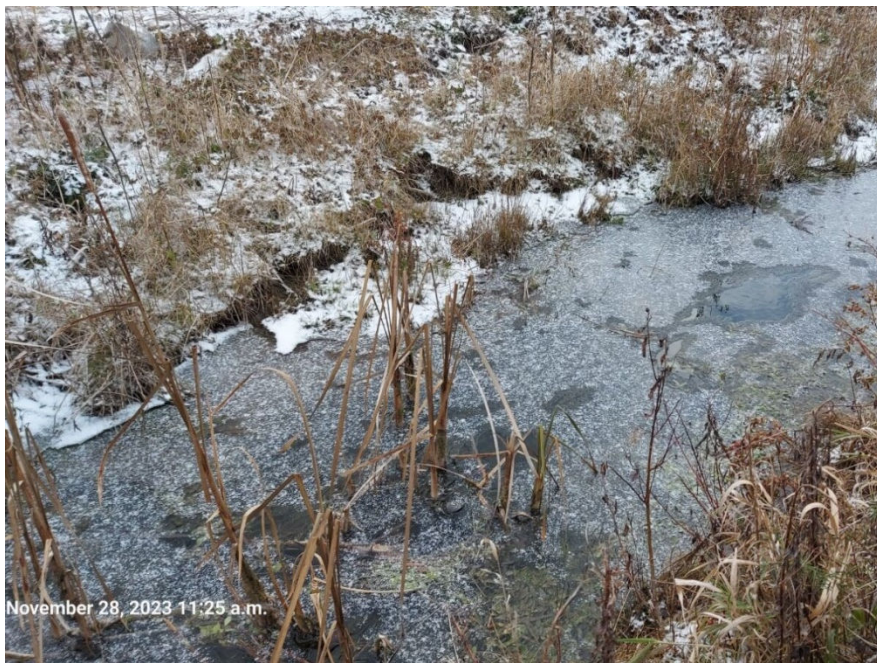
Photo 4
Tributary of Cardinal Creek
Reach: R1

Photograph taken facing the left bank at the downstream extent of **R1**. Minor scour was observed along both banks.

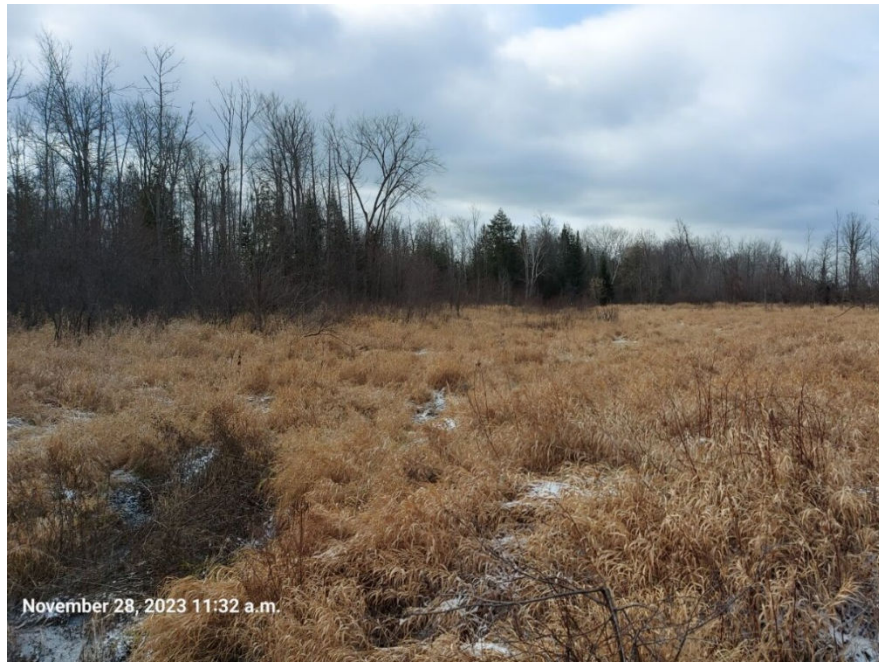
Photo 5
Tributary of Cardinal Creek
Reach: R1A

Photograph taken facing downstream along **R1A**. The channel was poorly defined and flowed through a historic beaver meadow.

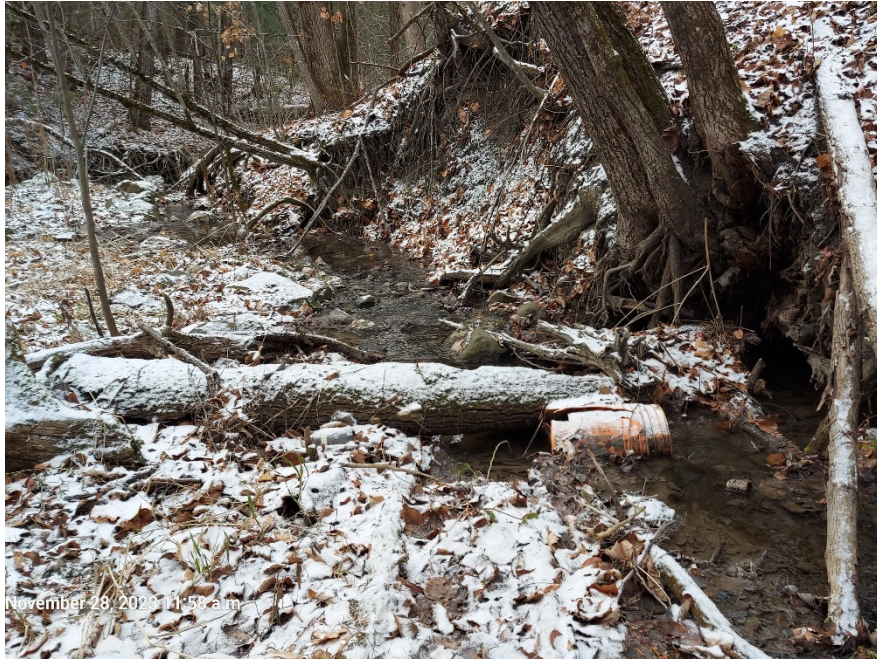
Photo 9
Tributary of Cardinal Creek
Reach: R2

Photograph taken facing downstream at the upstream extent of reach **R2** (Fall 2023). Valley wall contact was observed throughout the reach.

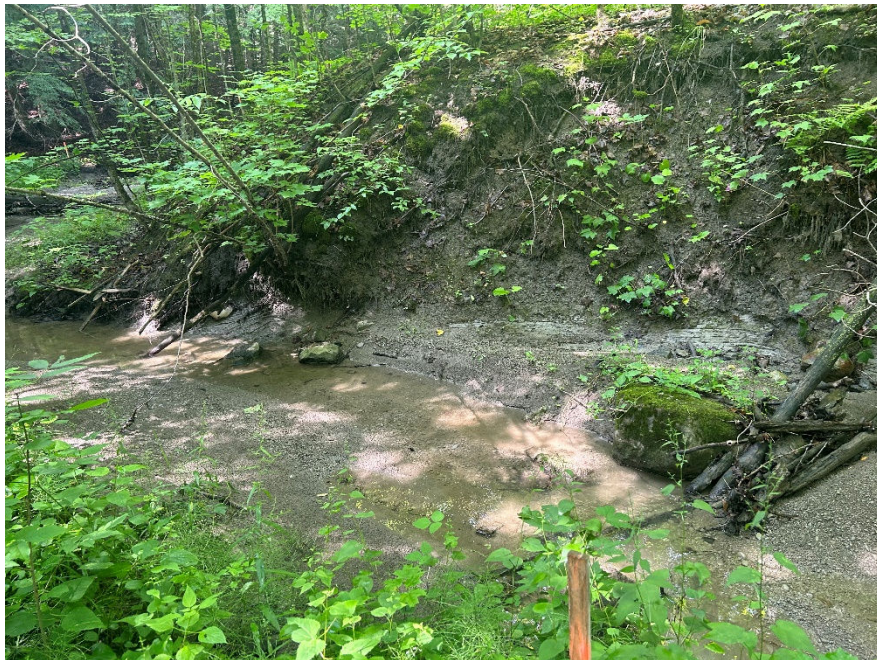
Photo 10
Tributary of Cardinal Creek
Reach: R2

Photograph taken facing downstream along reach **R2**. An additional location where valley wall contact was observed. Leaning trees and instream woody debris was commonly observed.

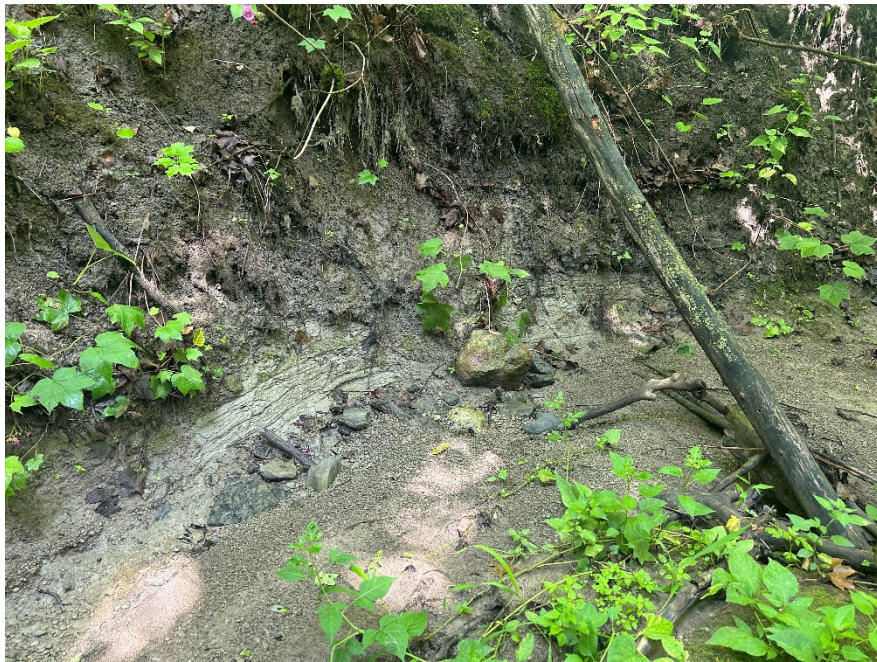
Photo 11
Tributary of Cardinal Creek
Reach: R2

Photograph taken facing upstream along reach **R2**. An additional location where valley wall contact was observed. At several locations, exposed laminated clay-till at the base of the banks were observed (up to 1.5 m)

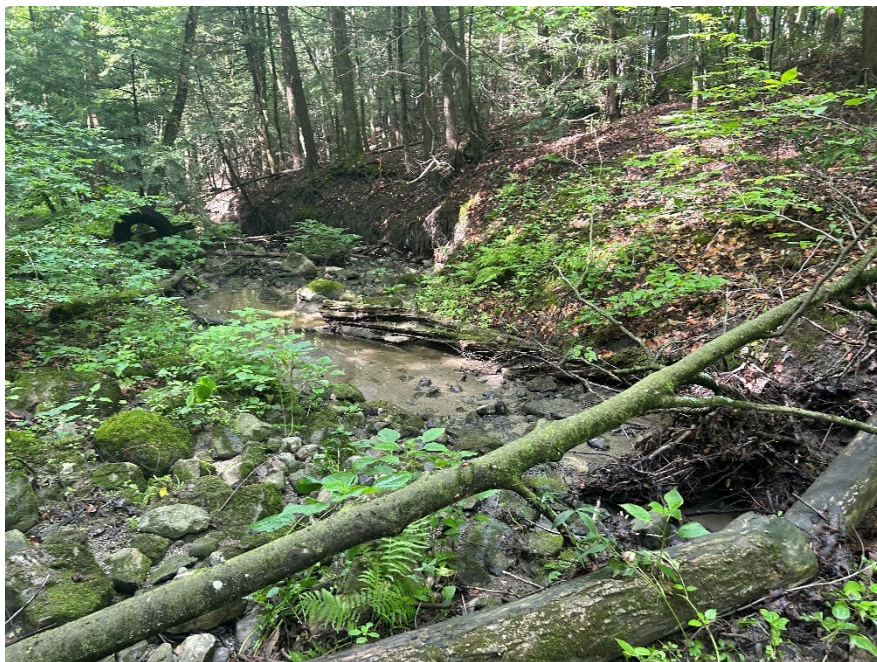
Photo 12
Tributary of Cardinal Creek
Reach: R2

Photograph taken facing downstream along reach **R2**. Riparian vegetation was composed of mature trees and shrubs, and herbaceous vegetation. An additional valley wall contact located along the centre of the reach.

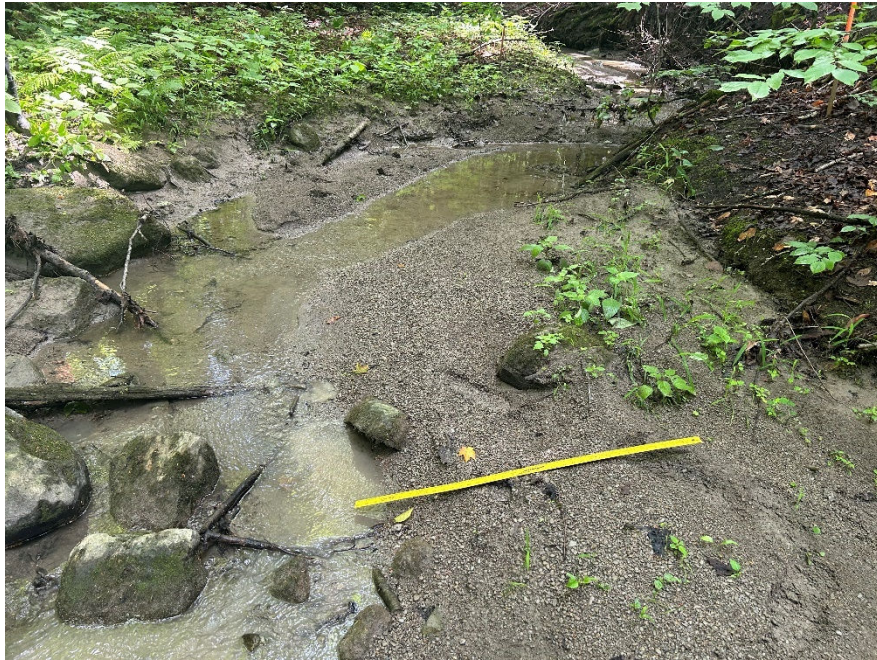
Photo 13
Tributary of Cardinal Creek
Reach: R2

Photograph taken facing downstream along **R2**. Channel bed substrate ranged from fine silt and clay-till (pebble shaped clay conglomerates were commonly observed) in the runs and pools, and cobble to boulders in the riffles.

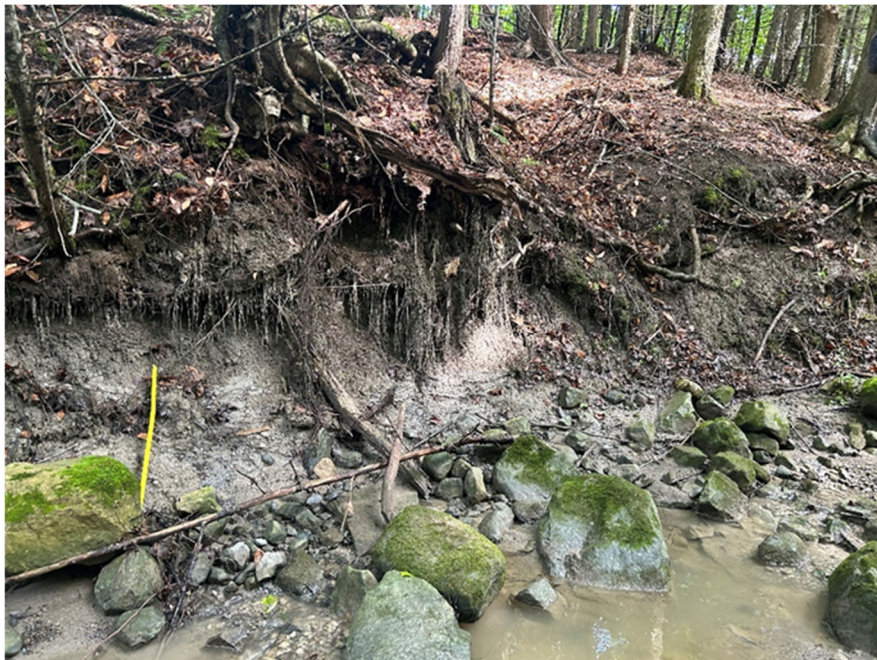
Photo 14
Tributary of Cardinal Creek
Reach: R2

Photograph taken facing the left bank along **R2**. Exposed tree roots and undercutting was commonly observed. An additional location with valley wall contact. Note the exposed clay-till at the base of the bank.

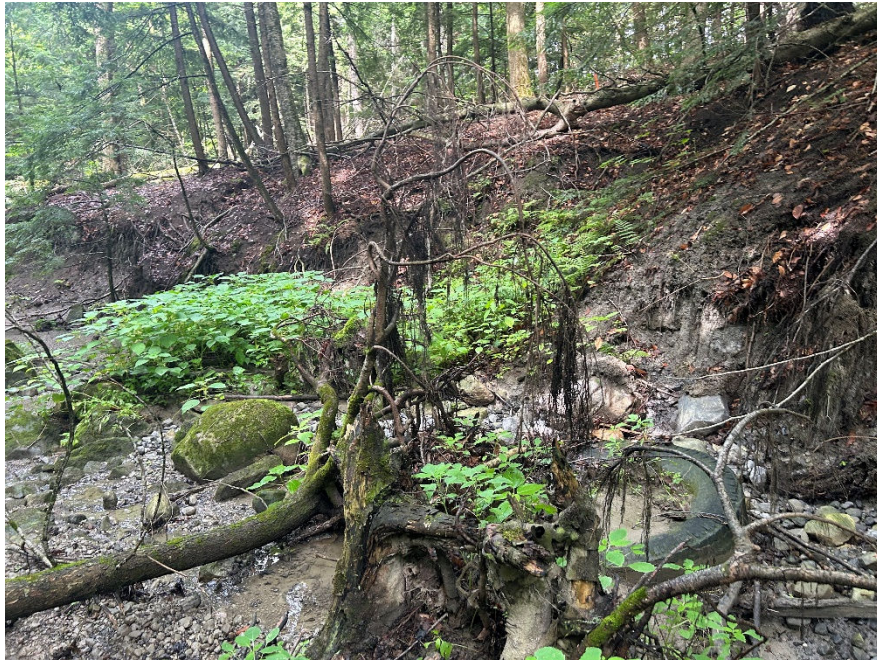
Photo 15
Tributary of Cardinal Creek
Reach: R2

Photograph taken facing downstream along reach **R2**, at an additional location where valley wall contact was observed.

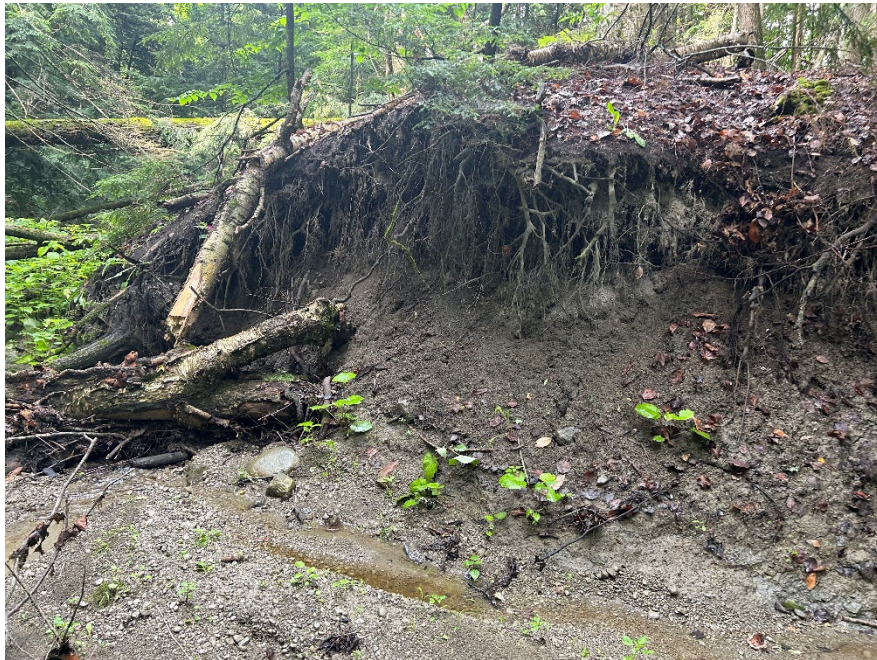
Photo 16
Tributary of Cardinal Creek
Reach: R2

Photograph taken facing downstream along reach **R2**, where valley wall contact was observed.

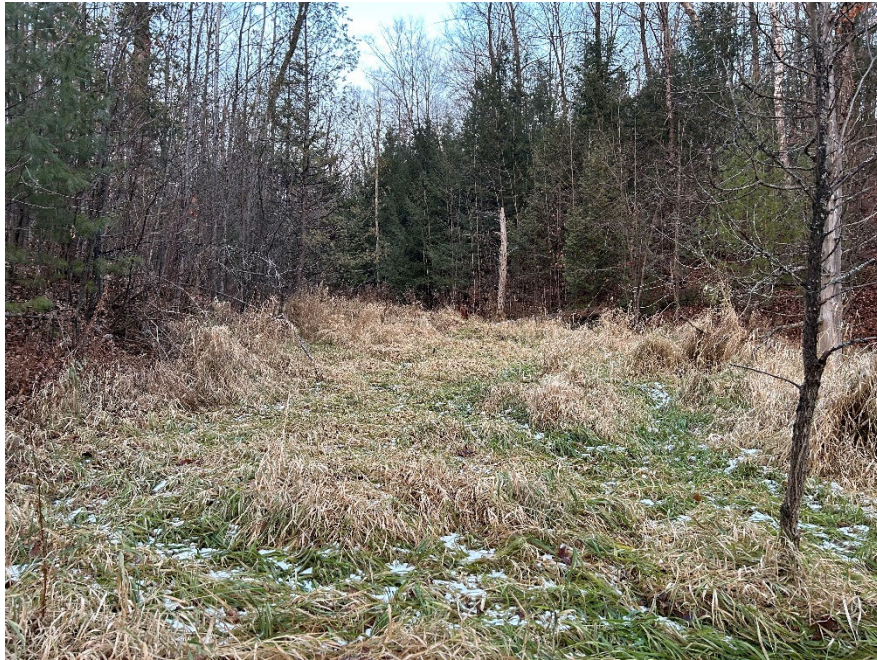
Photo 17
Tributary of Cardinal Creek
Reach: R2A

Photograph taken facing downstream along **R2A**. The channel travels through a historic beaver meadow, which is heavily encroached with grasses.

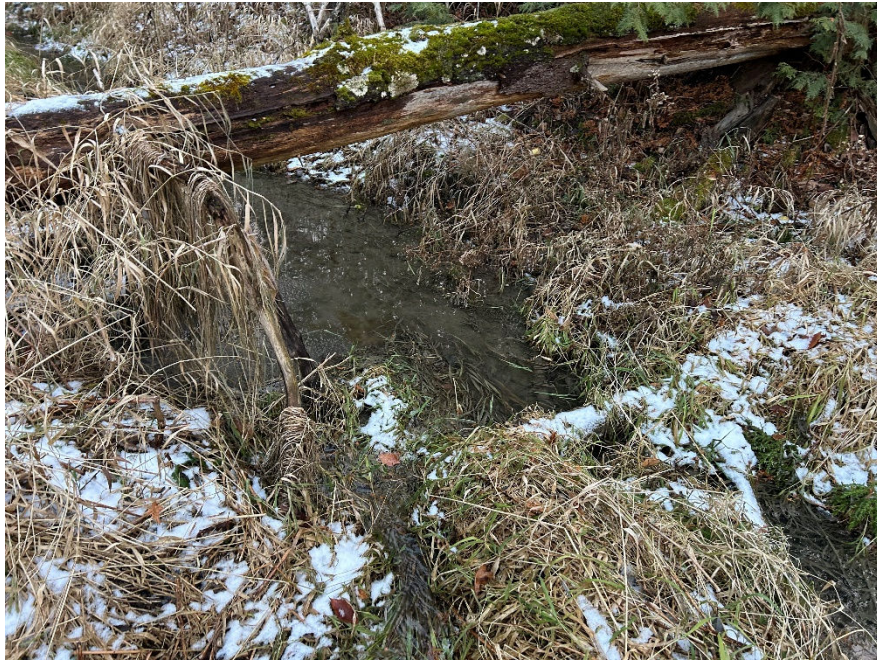
Photo 19
Tributary of Cardinal Creek
Reach: R2A

Photograph taken facing downstream along **R2A**. Formation of islands, cut off channels as well as minor undercutting was observed along the reach.

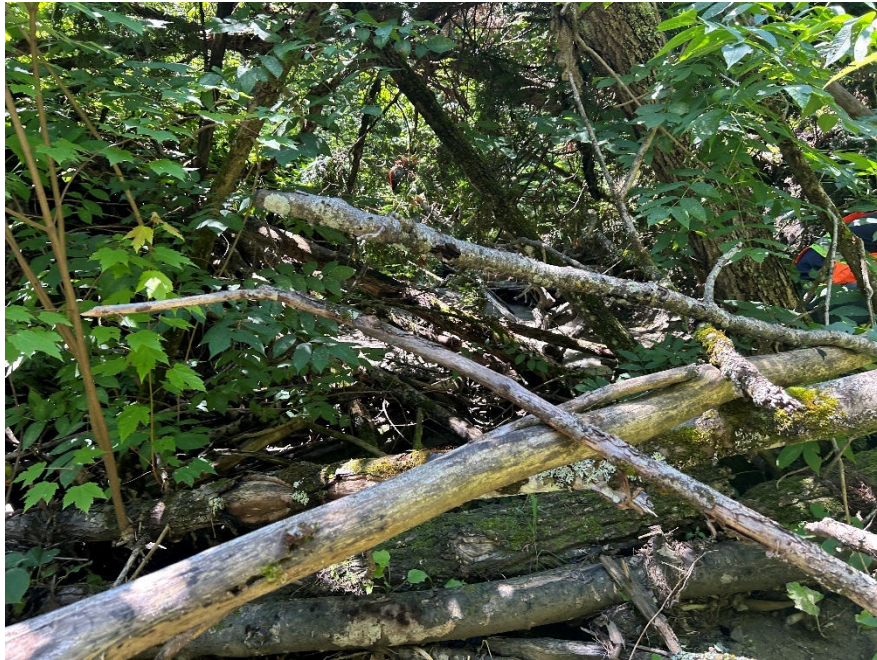
Photo 21
Tributary of Cardinal Creek
Reach: R3

Photograph taken facing downstream at the upstream extent of **R3** Riparian vegetation was primarily composed of mature trees and herbaceous vegetation. Instream woody debris jams were extreme and frequently observed.

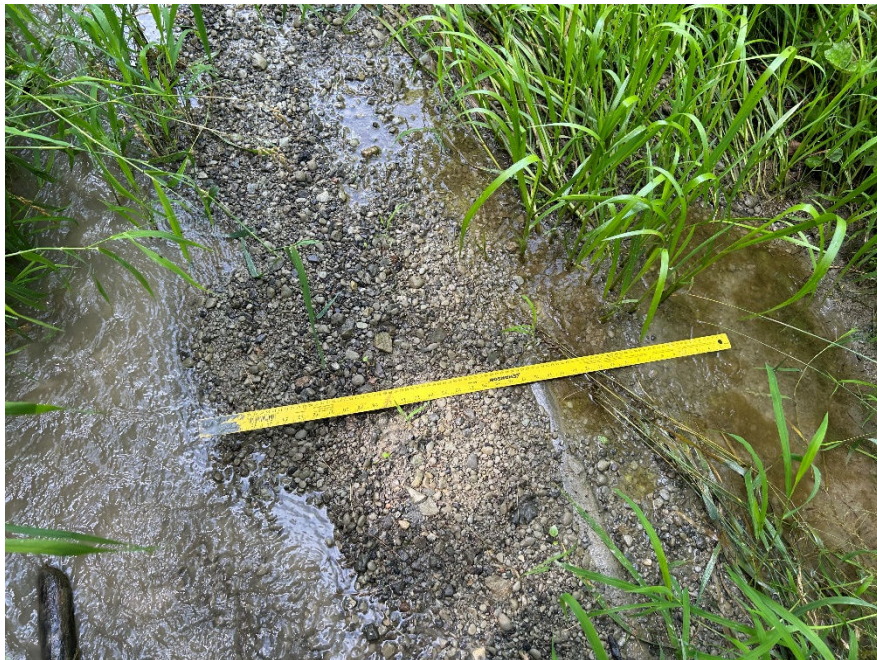
Photo 22
Tributary of Cardinal Creek
Reach: R3

Photograph taken facing the channel bed along **R3**. Substrate was composed of exposed clay-till and pebble sized clay conglomerates.

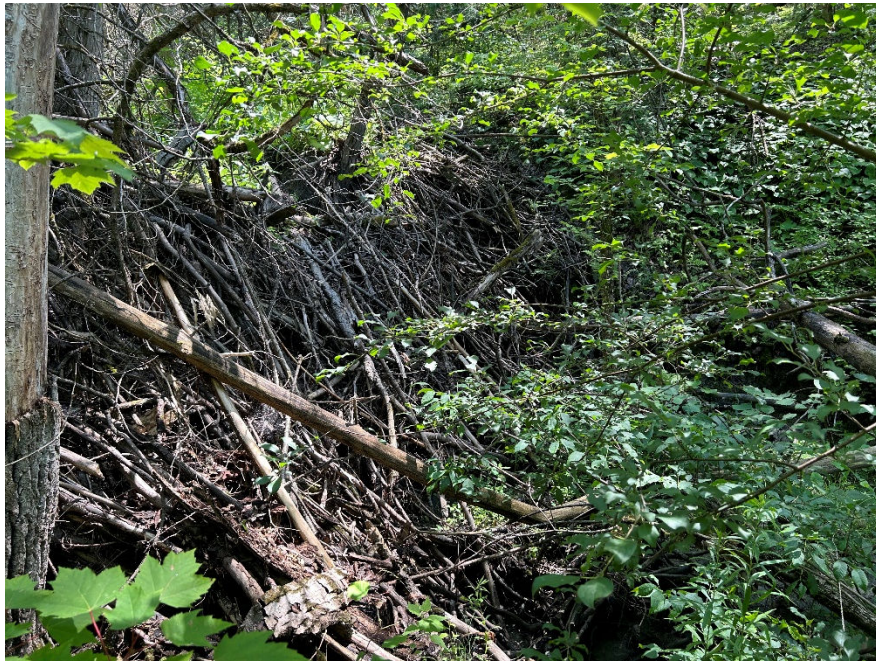
Photo 23
Tributary of Cardinal Creek
Reach: R3

Photograph taken facing the left bank at the downstream extent of **R3**. A large (3-4 m) beaver dam was observed, with flow travelling interstitially through the dam.

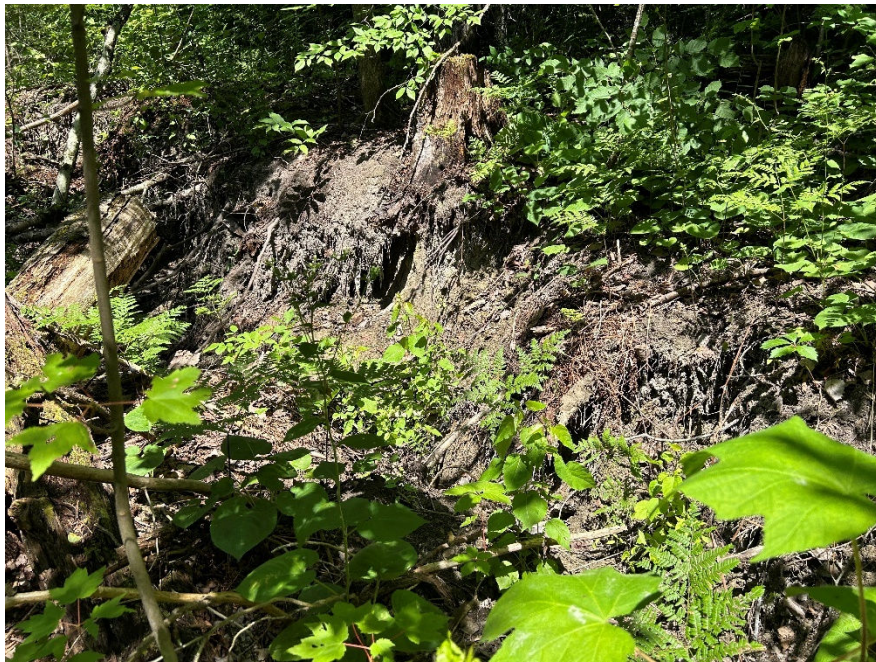
Photo 24
Tributary of Cardinal Creek
Reach: R3

A failure surface ranging from 0.40 to 1.2 m in height was observed along the top of the valley slope in the rear yard of **1320 Grand-Chêne Court** by Paterson in July 2023. Additional slip surfaces were also noted along the base of the slope. The subsurface profile consisted of a relatively thick layer of the aforementioned fill, overlying a relatively thin layer of brown silty clay, which was overlying a saturated layer of firm to stiff grey silty clay (Paterson, 2023). Depth to bedrock was estimated to be approximately 18.2 m based on public well records. The valley slope was 14 m in height with a 3.5H:1V profile with local sections up to 1.5H:1V (Paterson, 2023).

Photograph taken at the downstream extent of **R3** facing the top of a large slump. The slump was located on the right bank and carried debris over the channel.

The slope stability analysis for the valley slope at **1320 Grand-Chêne Court** found that the factor of safety was 1.1 for slope conditions prior to in-filling (Paterson, 2023). The minimum factor of safety generally recommended where slope failure would endanger permanent structures is 1.5. The report concluded that a limit of hazard lands setback should have been applied to the lot, and fill placement in the tablelands and along the valley slope should have been avoided (Paterson, 2023). The slope failure was ultimately attributed to a combination of the fill placement and ongoing erosion at the toe of the valley slope by the watercourse. Additional geotechnical studies were recommended to verify undisturbed soil characteristics and depth of the failure plane and to delineate a stable slope setback with a minimum 1.5 factor of safety.

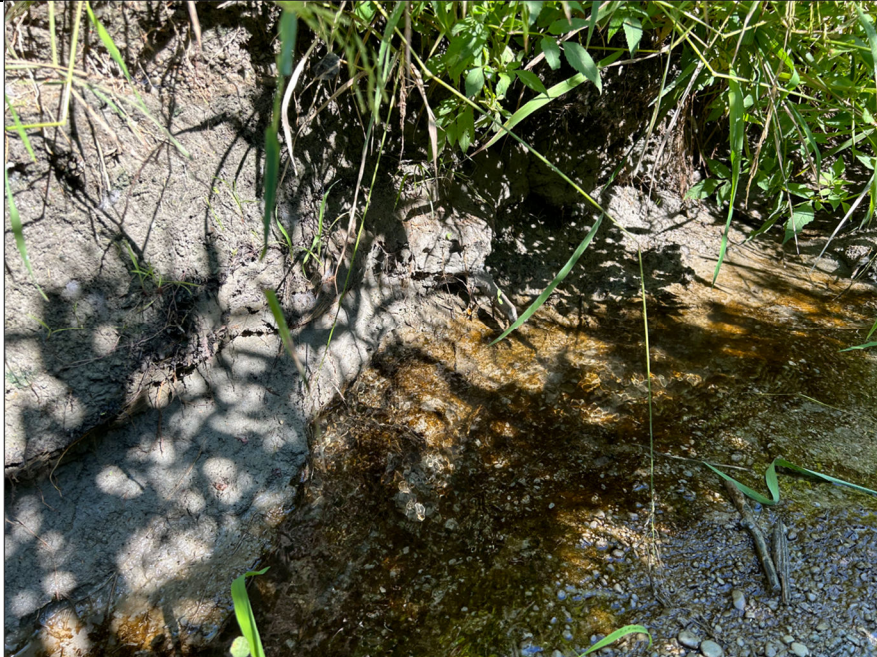
Photo 25
Tributary of Cardinal Creek
Reach: R3

Photograph taken facing the right bank. Bank materials were composed of thick and loose clay deposits. Undercutting of up to 15 cm was observed along the right bank.

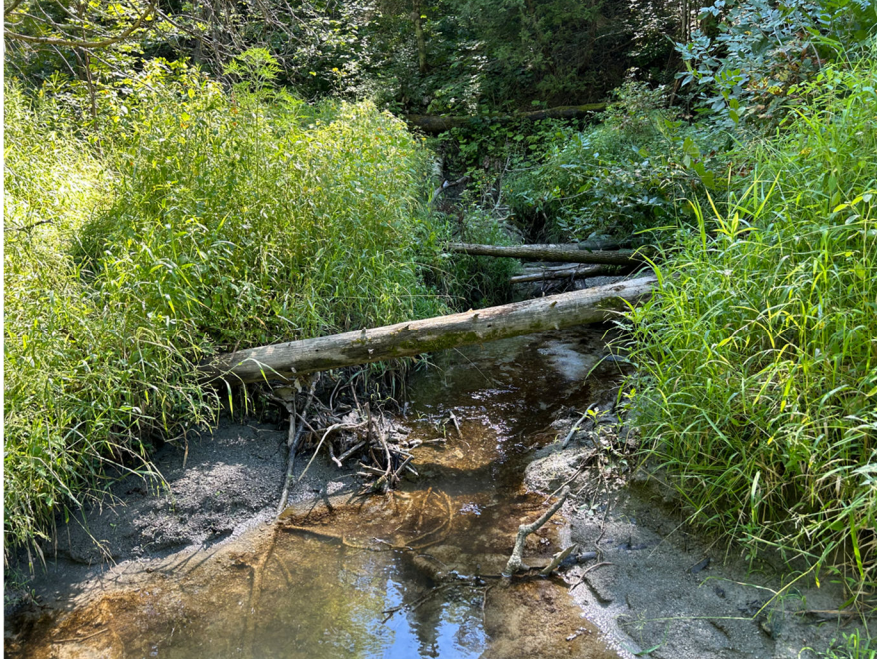
Photo 26
Tributary of Cardinal Creek
Reach: R3

Photograph taken facing downstream. Fallen trees and woody debris were observed throughout the reach, in particularly high densities near the slope failure.

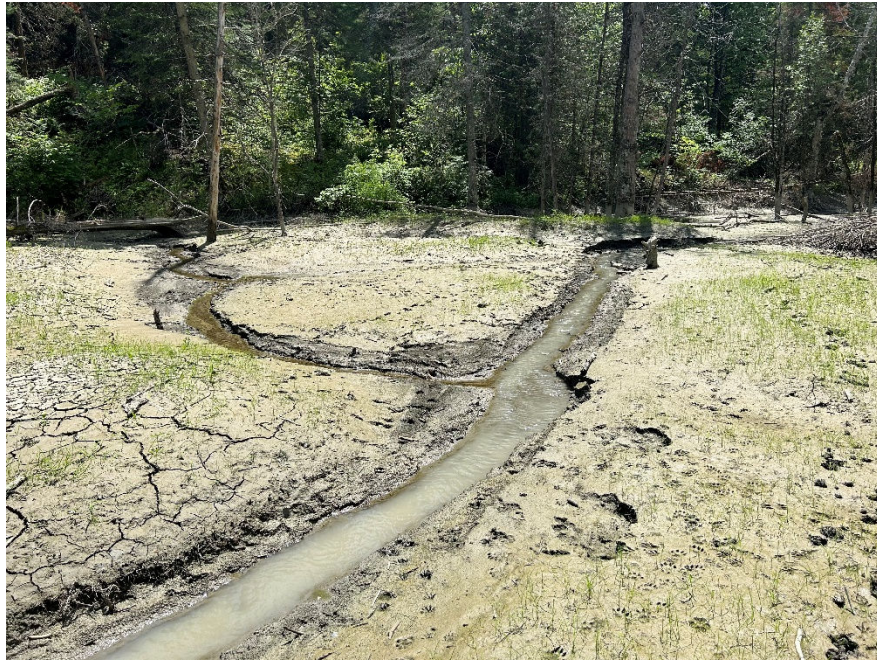
Photo 27
Tributary of Cardinal Creek
Reach: R4

Photograph taken facing downstream along **R4** (summer 2023). The upstream portion of the reach exhibited signs of recent de-watering including dry cracked sediments and the channel carving a path through exposed sediments.

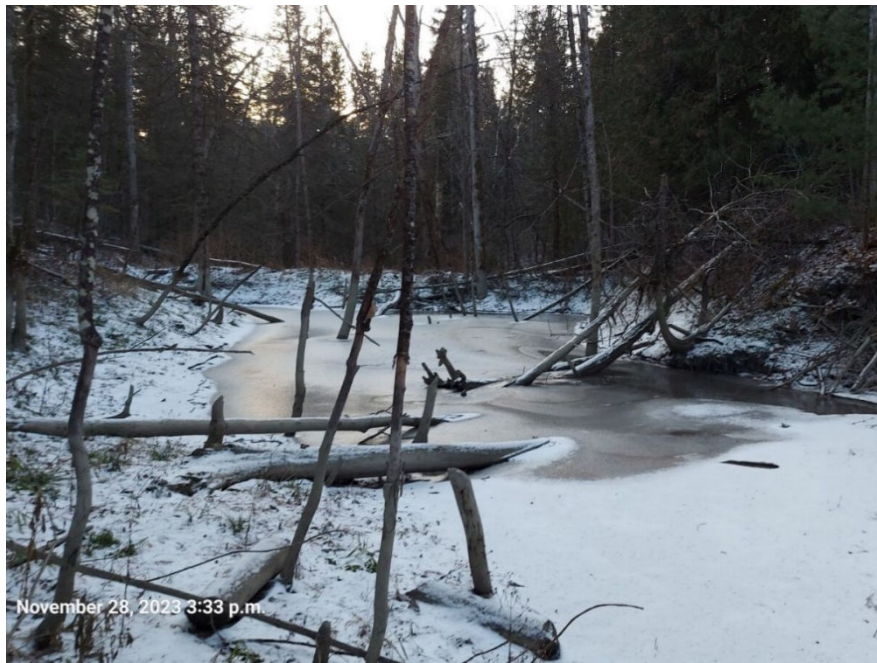
Photograph taken facing downstream along **R4** (fall 2023). A large beaver pond was still observed directly upstream of the beaver dam.

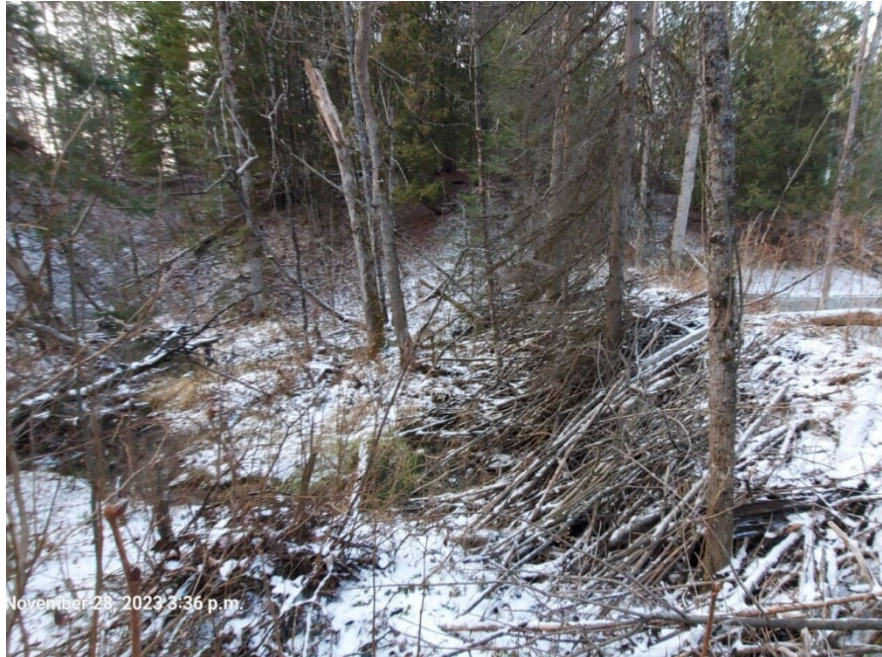
Photograph taken facing the right bank along **R4**. The large (2-3m) beaver dam was still intact and partially breached as flows were traveling through the dam.

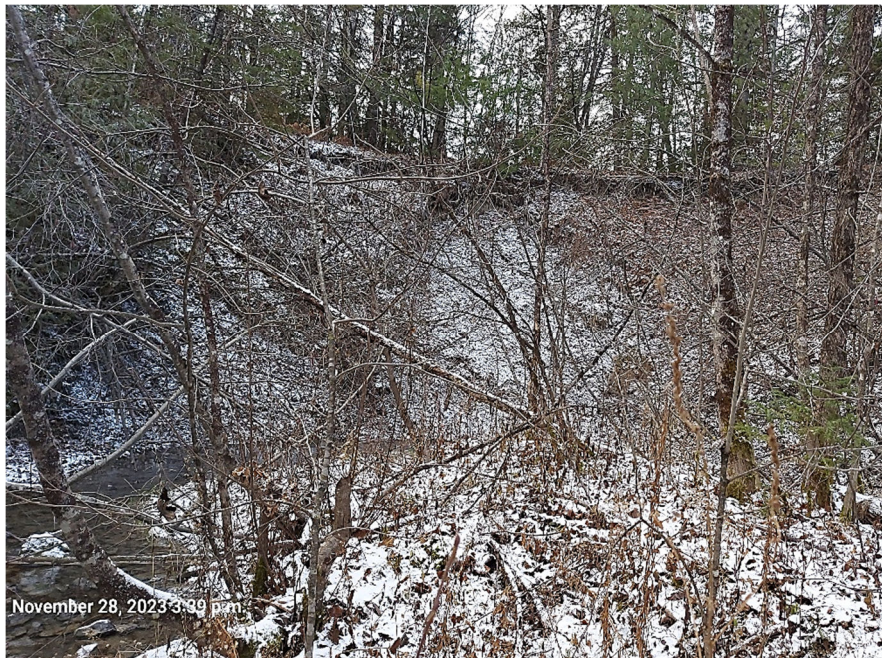
Photograph taken facing the left bank along the upstream extent of **R4**. Valley wall contact was observed. Scour, undercutting and woody debris in the channel were commonly observed. The downstream extent of the reach was backwatered due to a second dam at the confluence with Cardinal Creek.

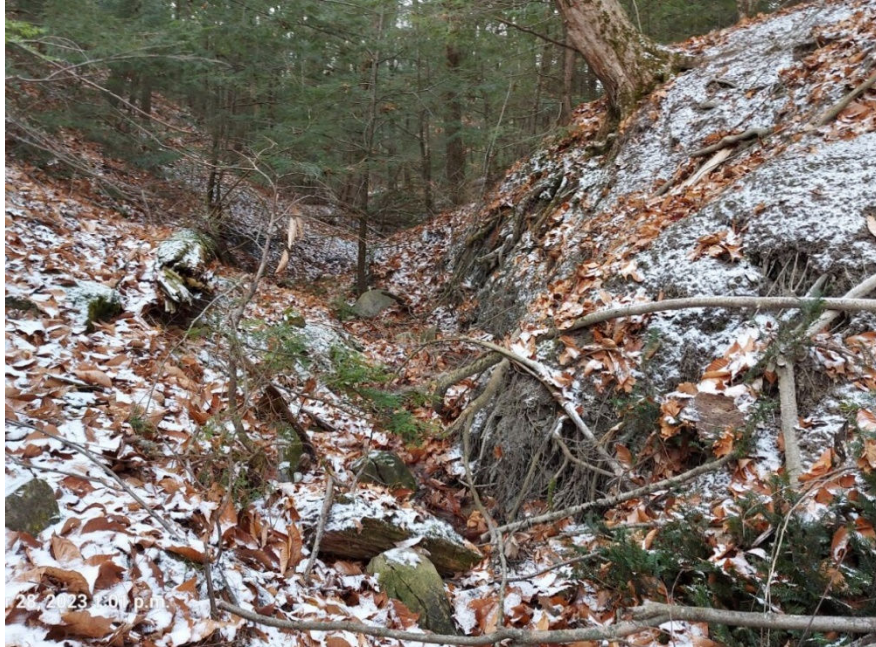
Photograph taken facing downstream from the upstream extent of **T1**. The channel had a high gradient as it travelled through a ravine. Riparian vegetation was composed of trees.

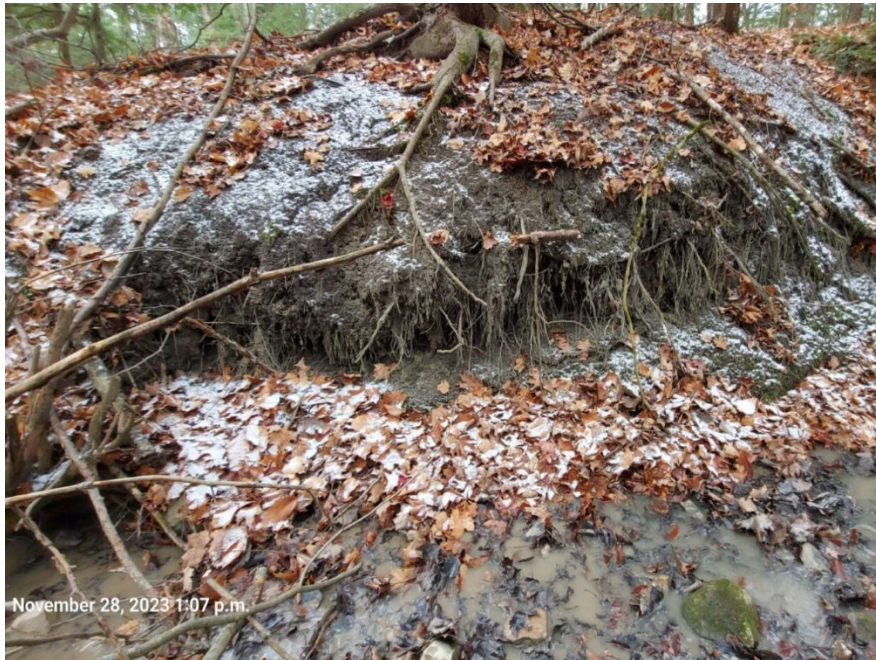
Photograph taken facing the right bank along **T1**. Undercutting, exposed roots and woody debris jams were commonly observed.

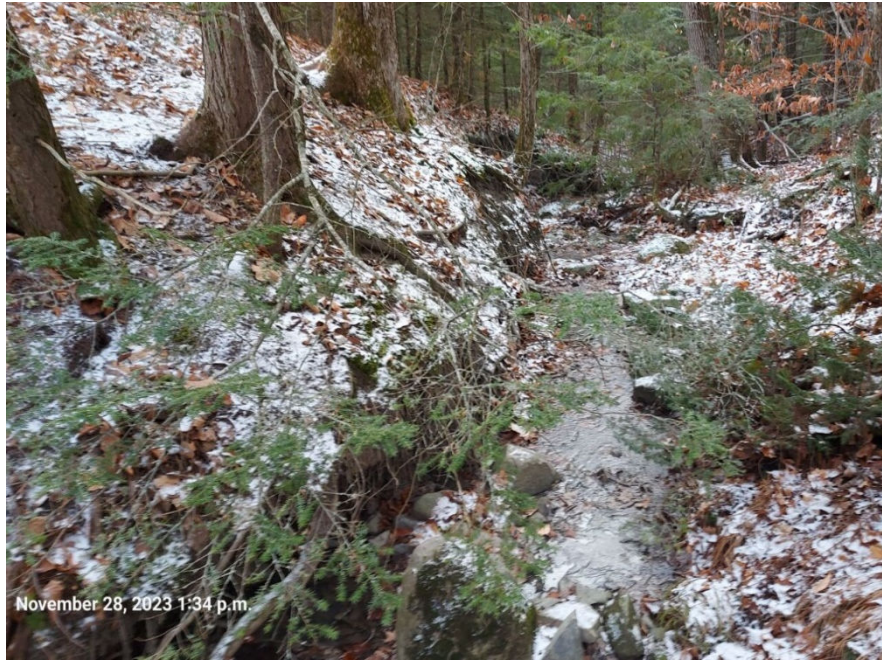
Photograph taken facing downstream along **T2**. The channel travelled through a ravine. Channel substrate ranged from exposed clay-till to boulders.

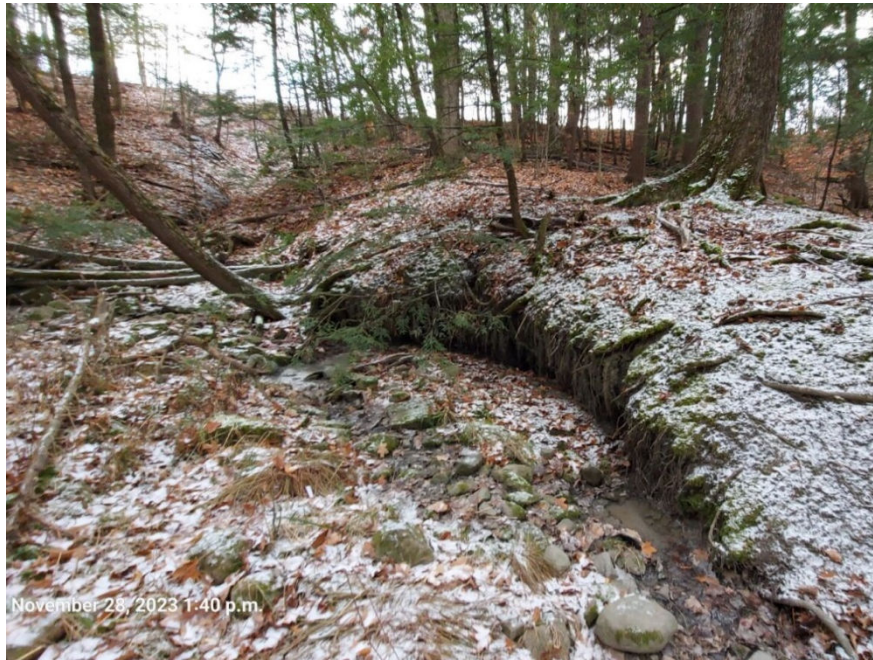
Photograph taken facing upstream along **T2**. Undercutting, exposed roots and rotational slumps were commonly observed.

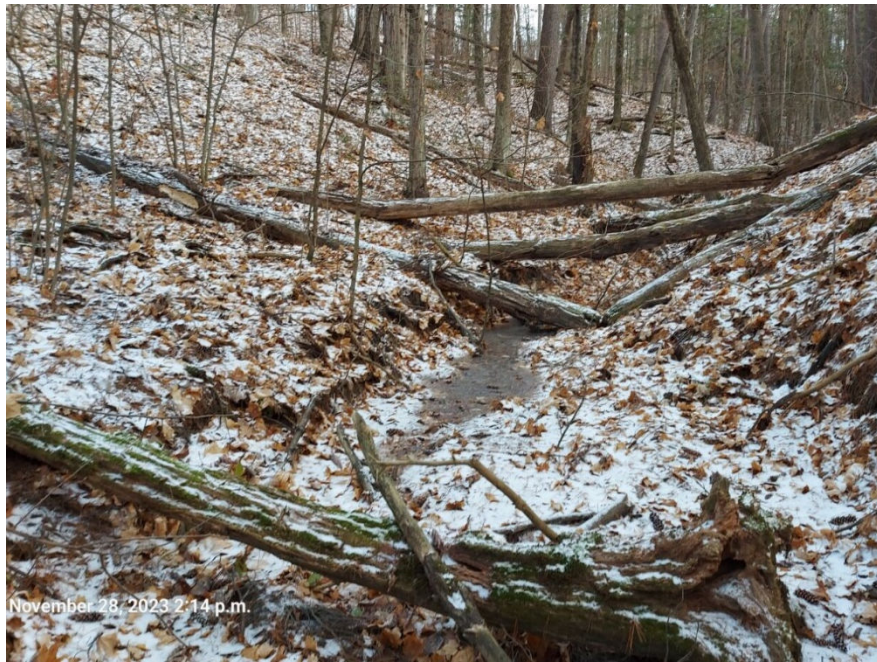
Photograph taken facing upstream along **T3**. The channel travels through a ravine feature with frequent tree fall observed. Riparian vegetation was predominantly trees.

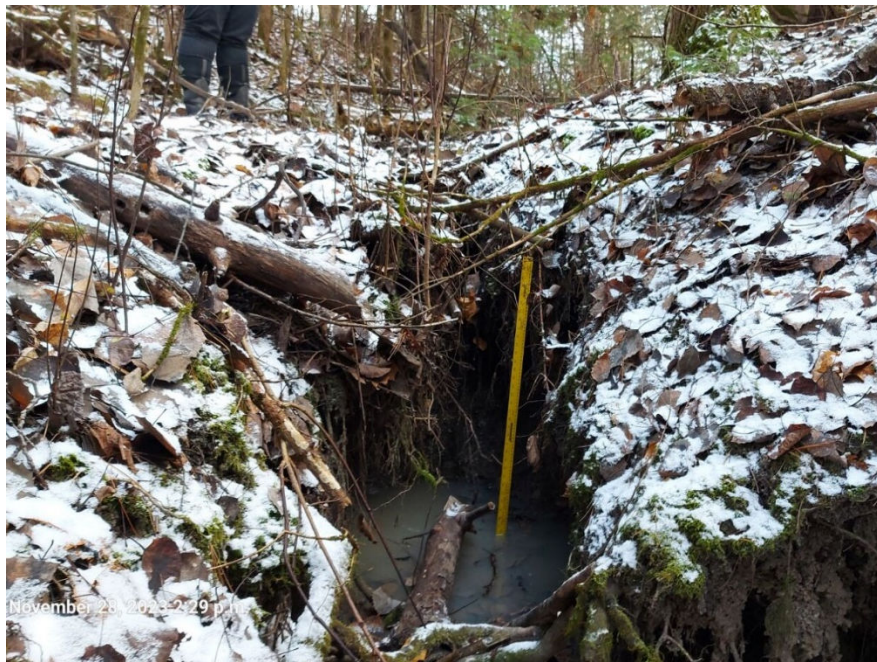
Photograph taken facing upstream along **T3**. Multiple forced knickpoints were observed throughout the reach.

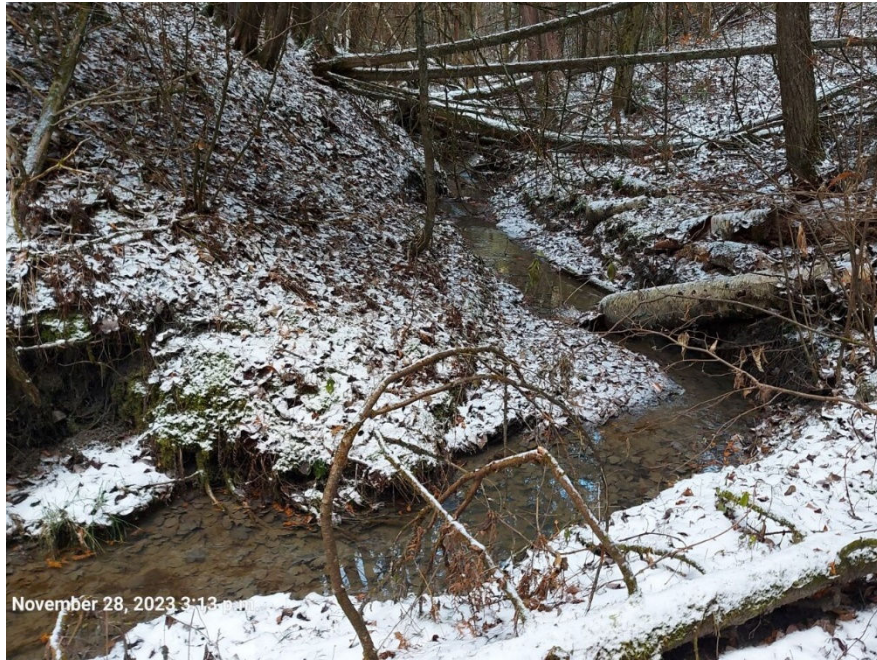
Photograph taken facing downstream along **T4**. The channel exhibits a high gradient as it travels towards the confluence with the Cardinal Creek tributary. The riparian vegetation was predominantly tree. Exposed roots and undercutting was commonly observed.

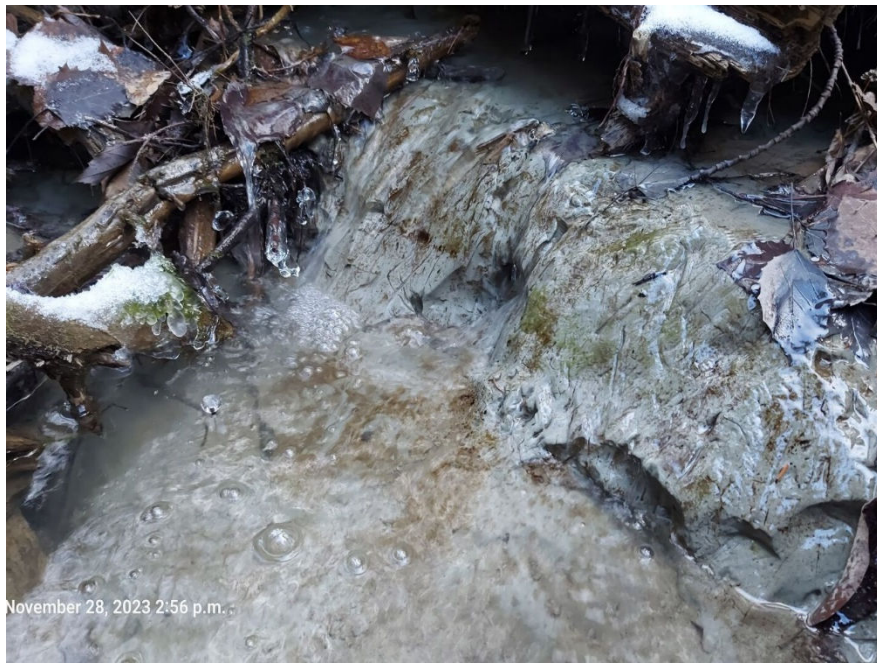
Photograph taken facing upstream along **T4**. Several forced knickpoints were observed as well as knickpoints in exposed clay-till.

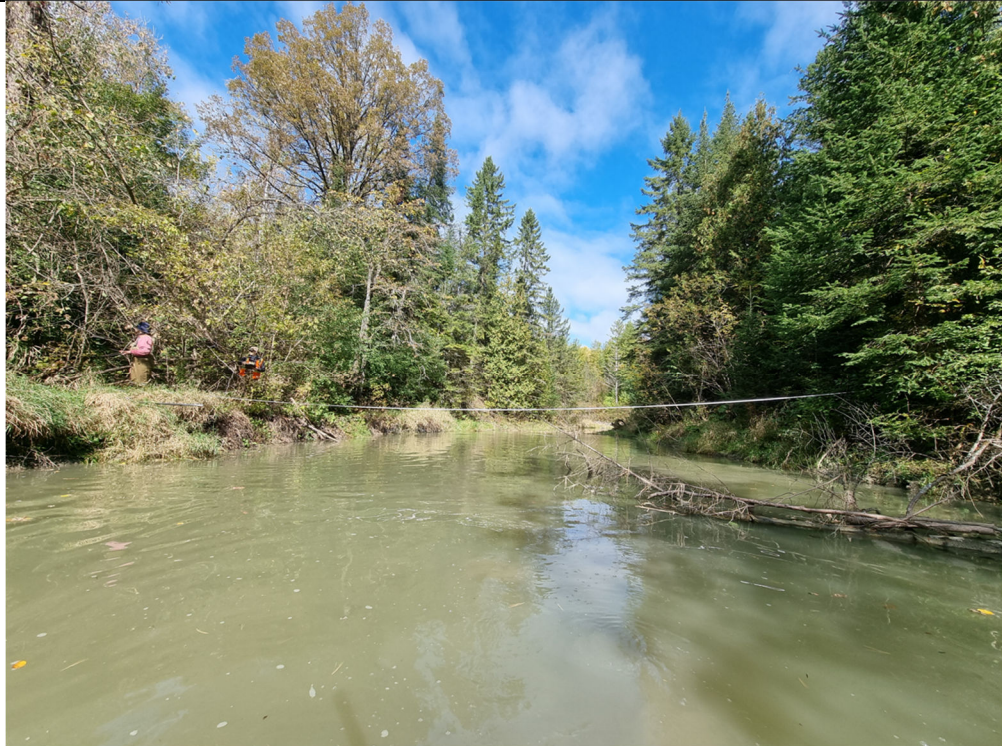
Photograph taken facing downstream at cross-section 2, downstream of the first beaver dam near the confluence. Reach C10 is a relatively large and deep channel, receiving flow from the South Tributary at its confluence with Reach R4.

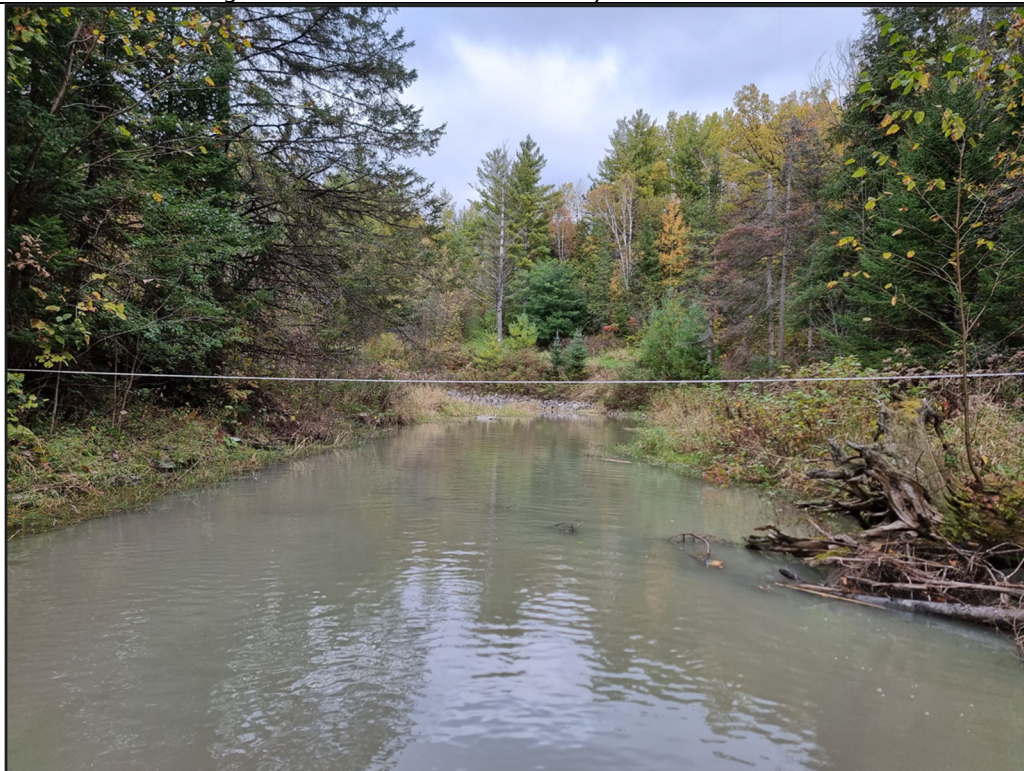
Photograph taken facing downstream at cross-section 3. Woody debris was observed in moderate densities along both banks throughout the reach.

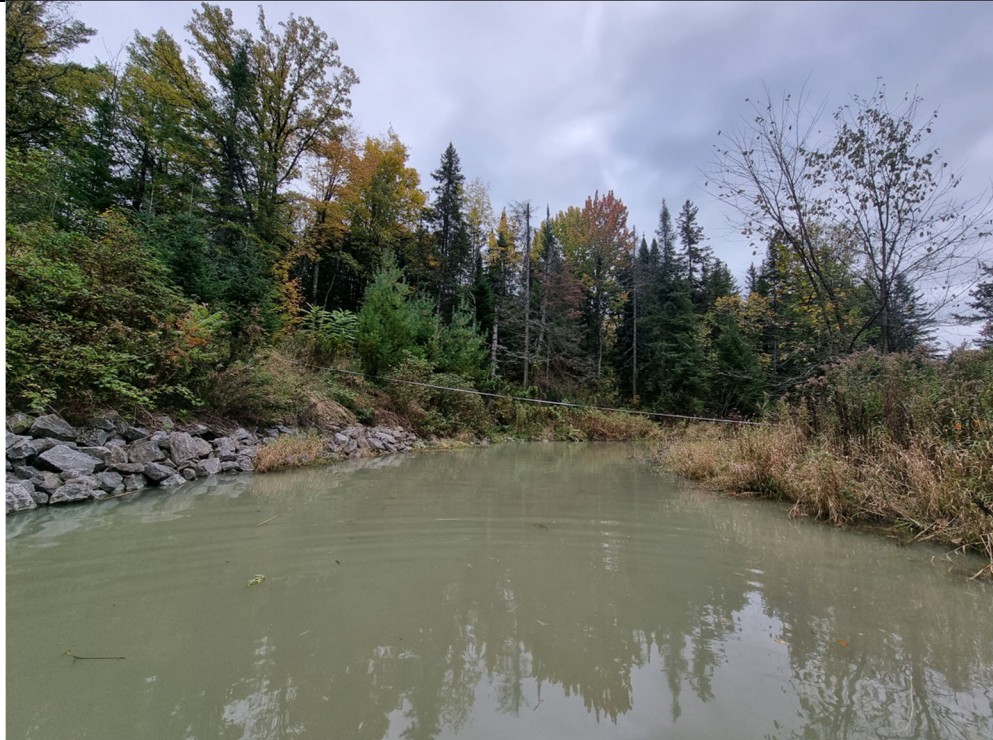
Photograph taken facing upstream at cross-section 5; located upstream of one of three beaver dams observed. Slope stabilization works comprise the right bank around the meander bend for erosion protection.

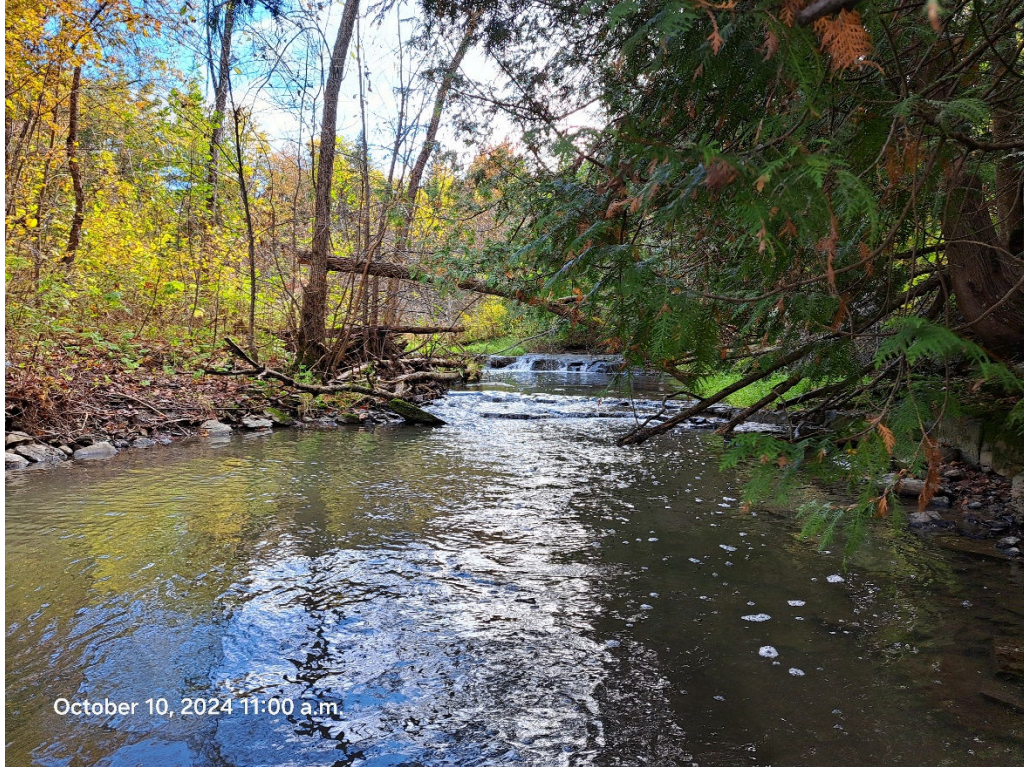
Photograph taken facing upstream near cross-section 7. A bedrock knickpoint was observed in the middle section of C10, corresponding with a local change in channel bed gradient.
