Fluvial Geomorphological and Erosion Threshold Assessment, Tributary of Cardinal Creek

1296 and 1400 Old Montreal Road
City of Ottawa, Ontario

Submitted:
November 11, 2024

GEO Morphix Project No. 23076

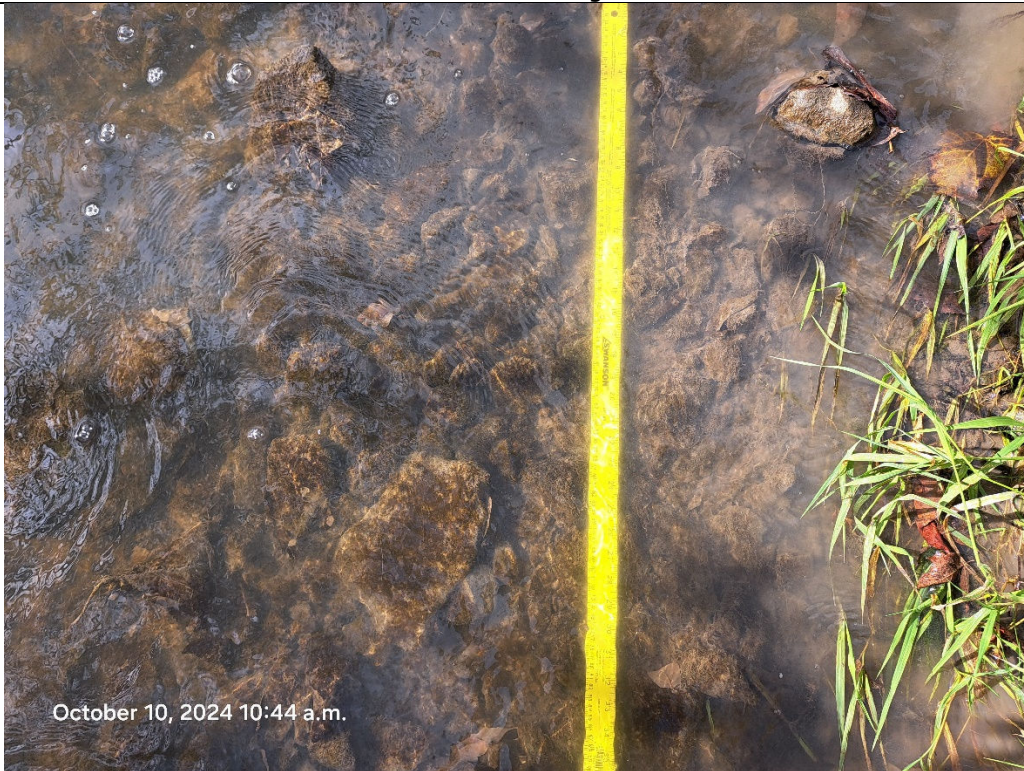
Coarse bed sediments were observed throughout the downstream half of C10.

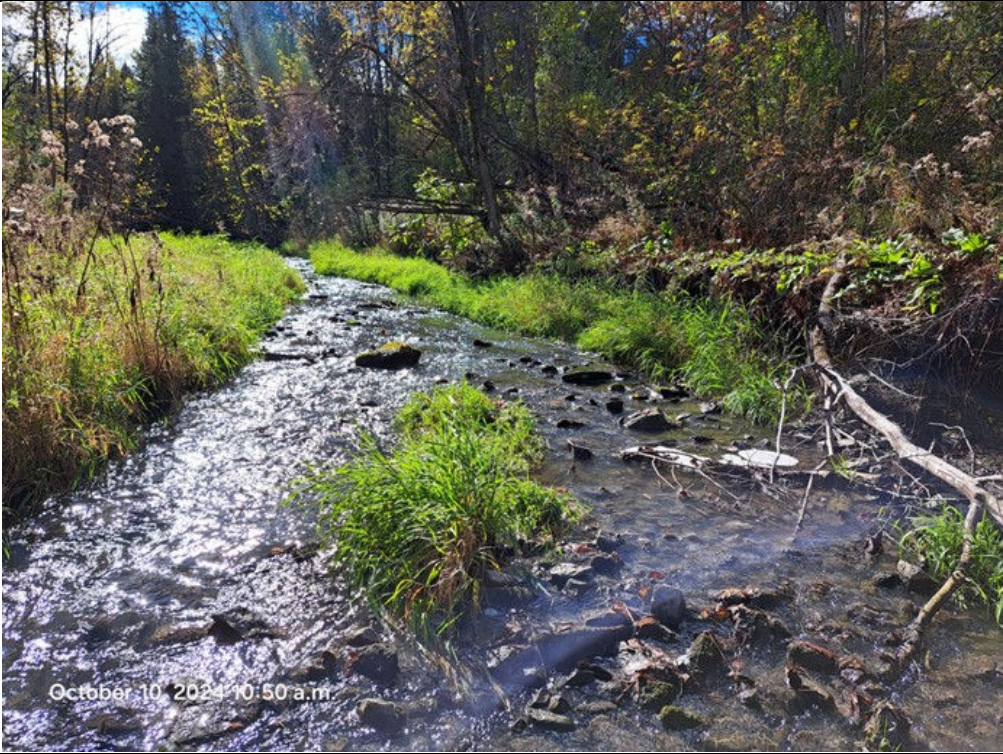
<p>Photograph taken facing upstream. Riffle-pool sequences characterized the downstream half of C10.</p>	
<p>Photo 46 Tributary of Cardinal Creek Reach: C10</p>
