Cardinal Creek Village – South Side

Headwater Drainage Feature Assessment

March 2021

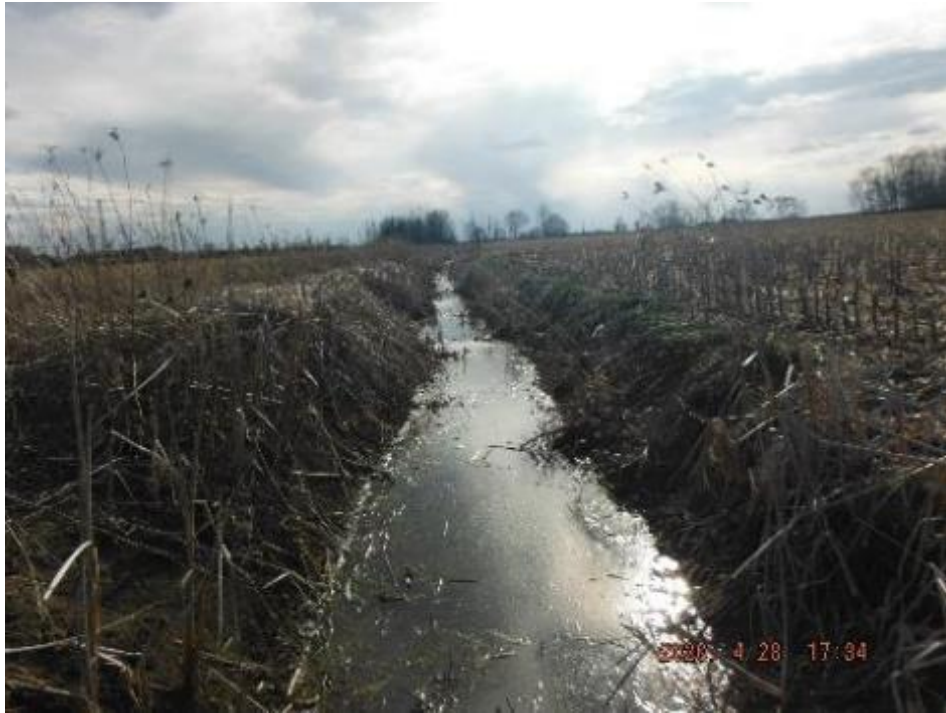
Photo 1: North Channel through the windrow, looking upstream (April 6, 2020).

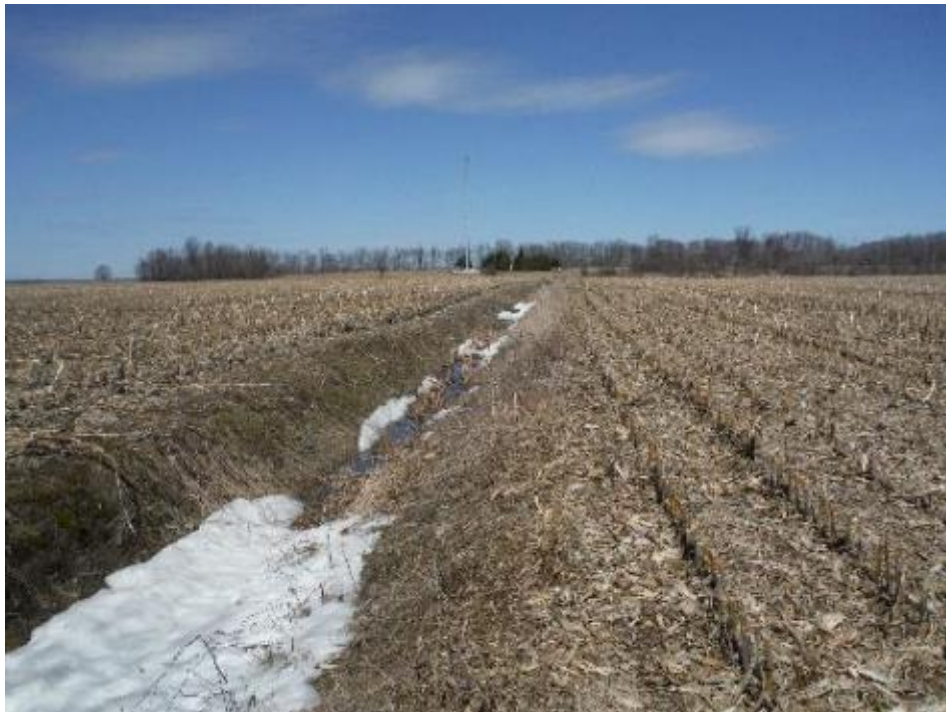
Feature 1 is found on the east side of the site. It is a short feature (35 m) that is connected to the North Channel. This channel is inclined to the north and there was a gradient barrier between it and the Feature 2. This is compounded by a blocked culvert.

Photo 5: Feature 1 (April 6, 2020)

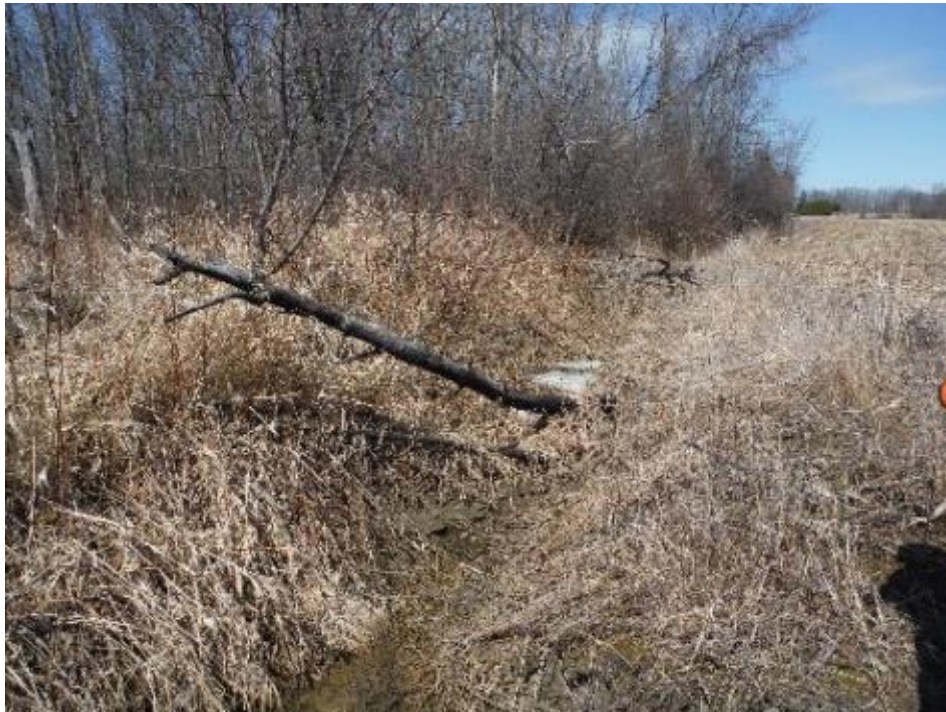
The station was not fished as there was a fish barrier on the downstream end, in the form of vegetation and gradient issues, and is too densely vegetated to sample. No fish habitat was

Photo 17: View of the fish barrier from downstream (April 6, 2020)
