FLUVIAL GEOMORPHIC AND EROSION HAZARD ASSESSMENT
STINSON LANDS
OTTAWA, ONTARIO

Prepared for:
NOVATECH ENGINEERING AND CONSULTANTS LTD.

Prepared by:
MATRIX SOLUTIONS INC.

Version 1.0
November 2022
Guelph, Ontario

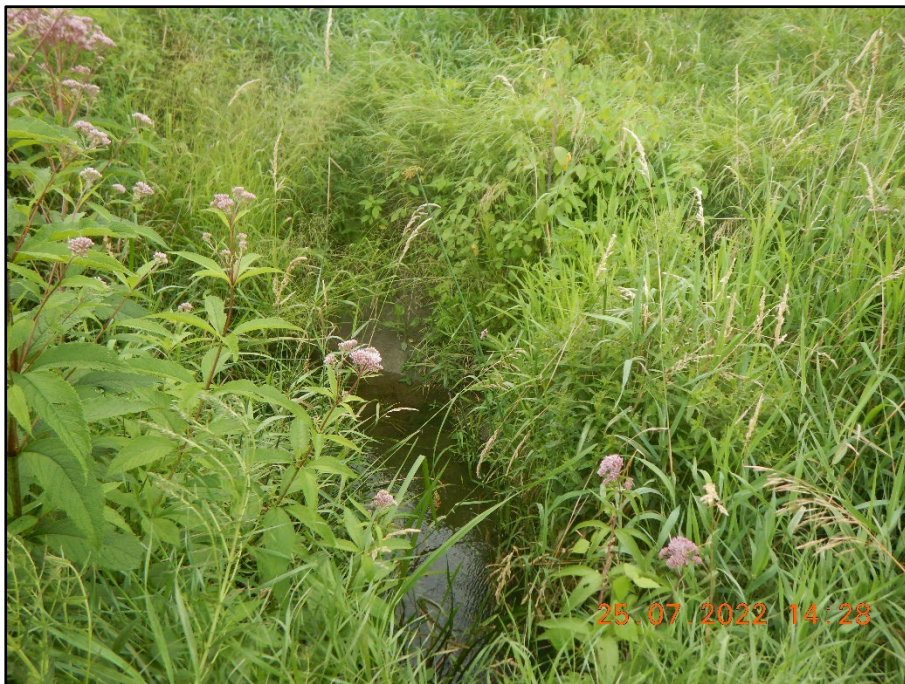
Results of the rapid assessments classified this section of the Wilson-Cowan Drain as In Regime or stable (RGA) and of Moderate stream health (RSAT) with scores of 0.093 and 27, respectively (Tables 3 and 4). Very few geomorphic indicators were observed, and solely those indicative of channel widening, including basal scour along most of the reach and fracture lines on the top-of-bank. It is likely that channel widening will continue to occur as a lot of the banks lack well-rooted vegetation.

6. Wilson Cowan Drain - Facing downstream, the reach showed consistent signs of erosion in the form of steep outside meander banks, slumped banks, and failed banks

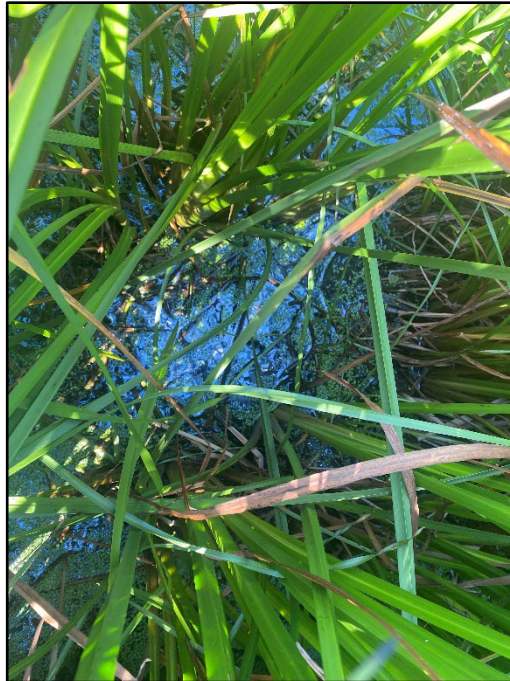
15. Oxbow Feature – Facing down, water surfaces in parts of the oxbow show pollution in the form of mineral staining

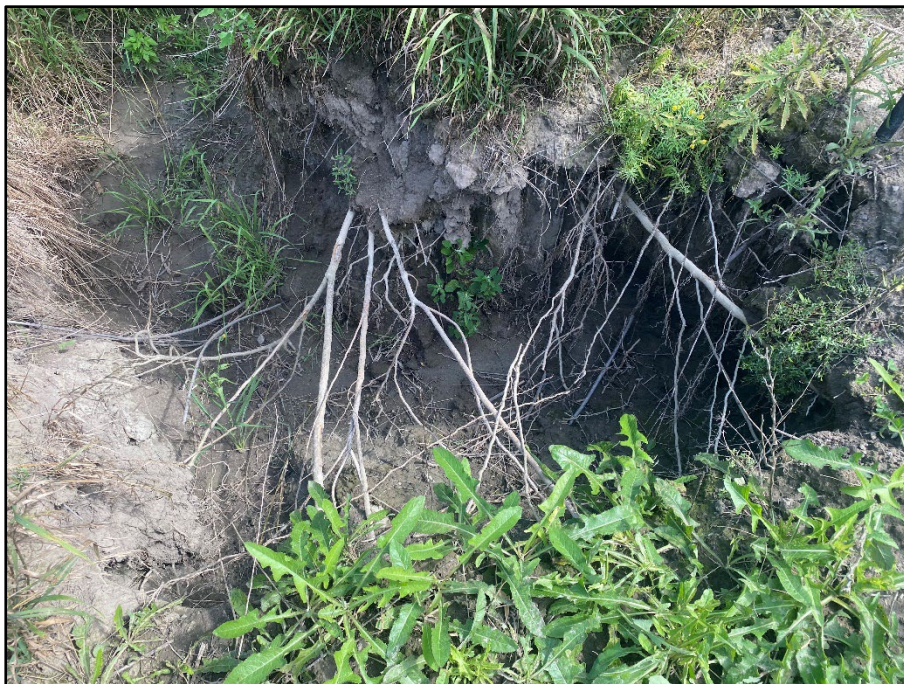
16. Mud Creek– Drainage from the adjacent field has resulted in a significant washout along the southern bank of Mud Creek
