Subject: 4386 Rideau Drive, Manotick – Headwater Drainage Features Review and Assessment

4386 Rideau Valley Drive Headwater Drainage Features Assessment

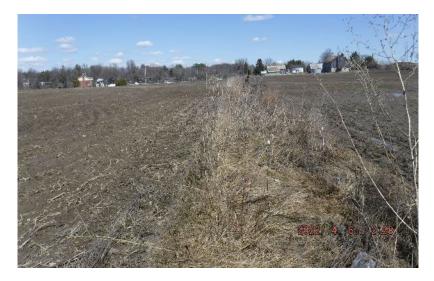
Photo 1: Looking upstream, towards the east, along the feature (April 5, 2022)

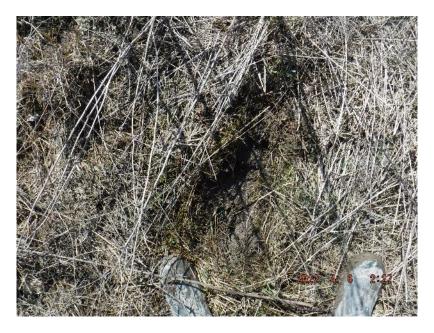
Photo 2: After moving vegetation aside, the lack of water was confirmed (April 5, 2022)

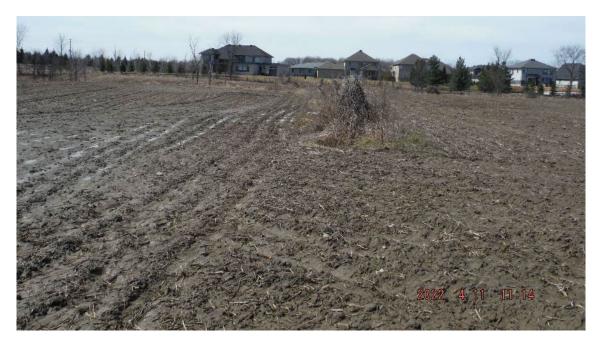
Photo 3: Section that was ploughed (looking downstream towards Wilson Cowan M. D.) (April 11, 2022)

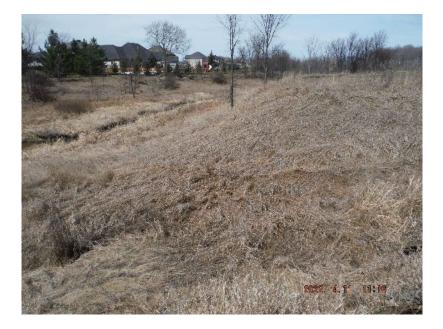
Photo 4: Looking north, across the slope of Wilson Cowan Municipal Drain, where the headwater feature would have flowed (no connection found in vegetation) (April 11, 2022)
