Tree Conservation Report

1495 Heron Road

November 23, 2022

Canada Lands Company

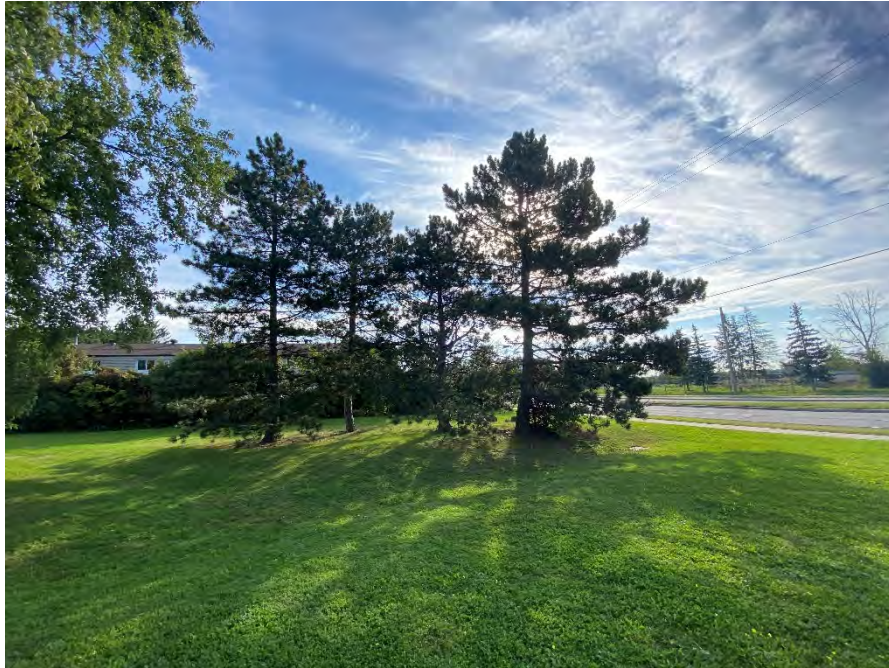
Photograph 1 – Grouping of coniferous trees along Heron Road

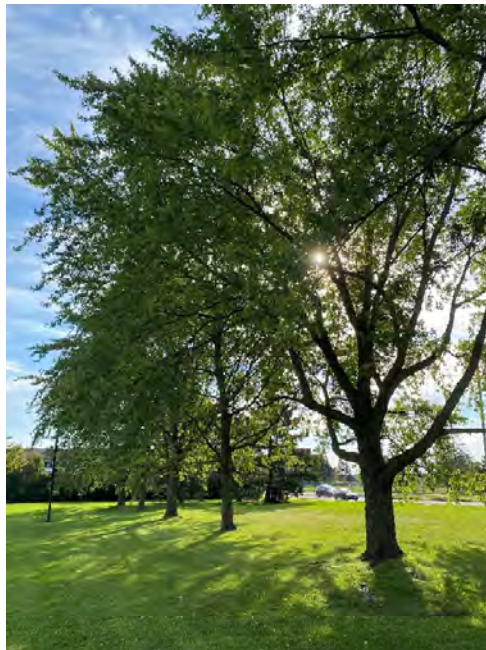
Photograph 2 – Row of well established trees along Heron Road

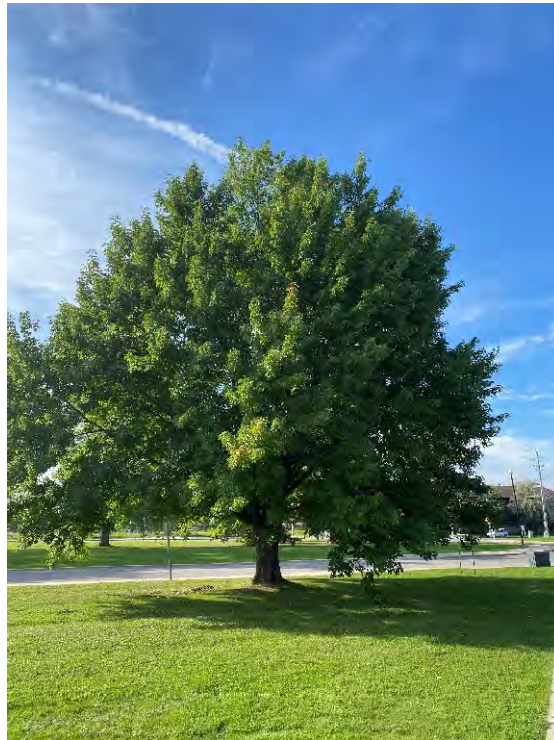
Photograph 3 – Specimen tree

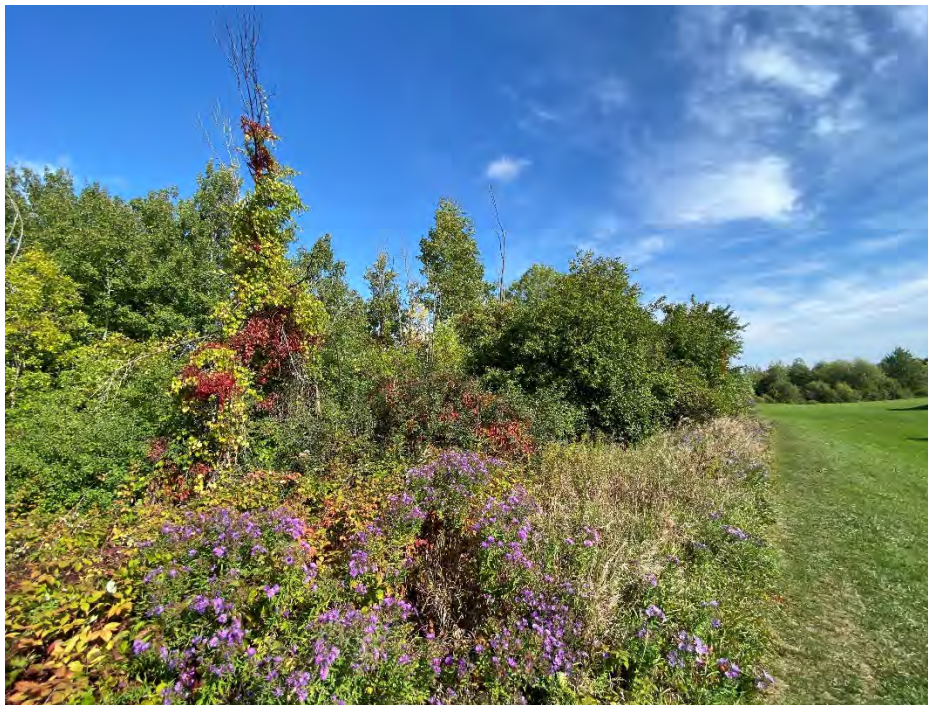
Photograph 4 – Vegetative area northwest of the site

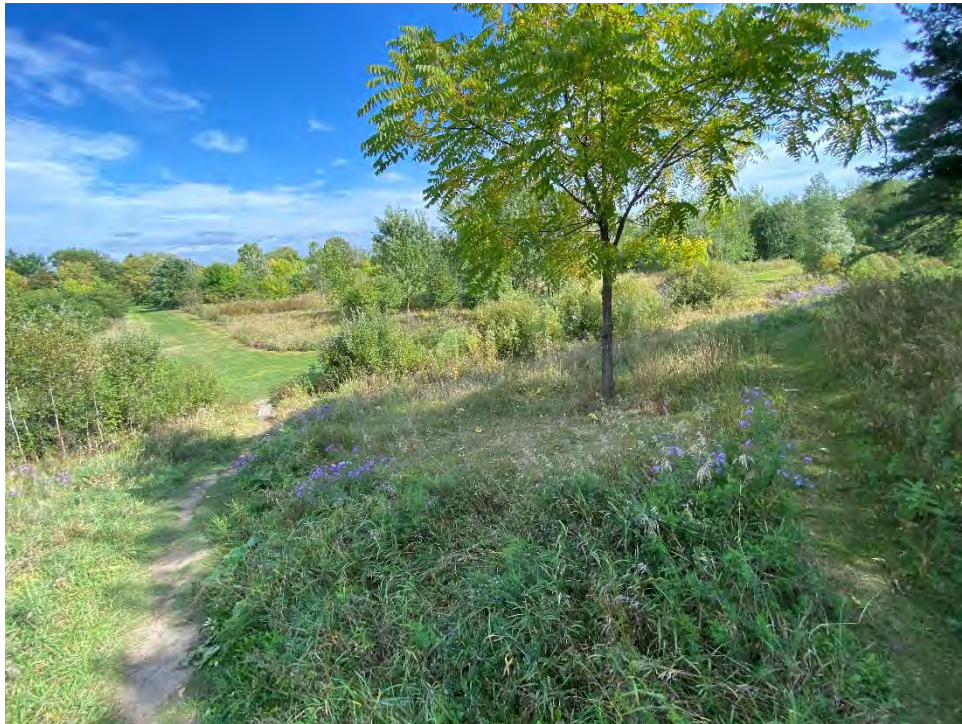
Photograph 5 – Example of unofficial path

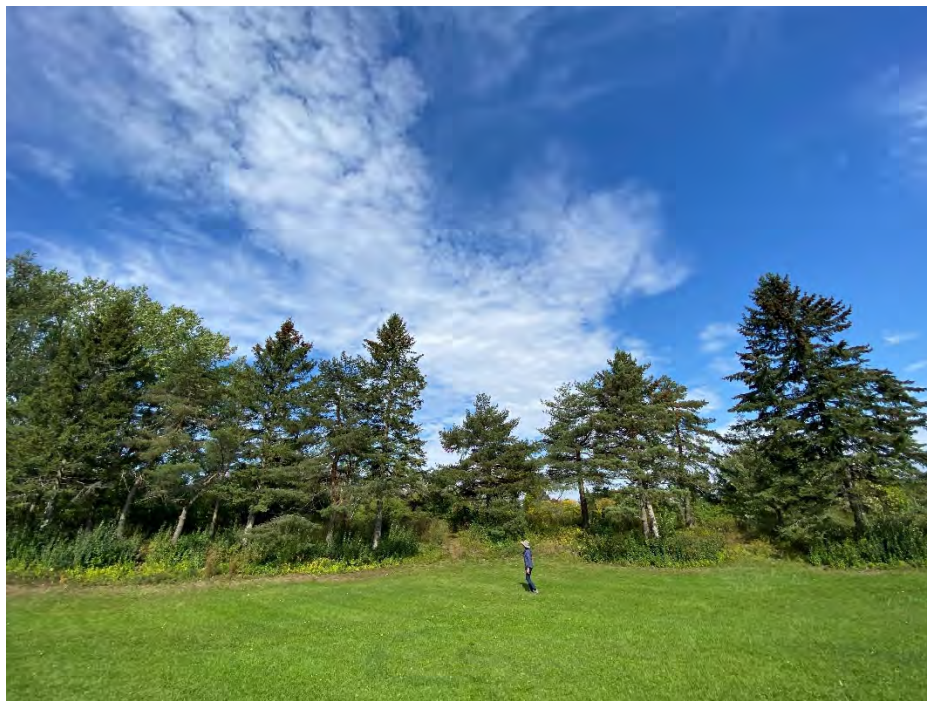
Photograph 6 – Grouping of coniferous trees along the northern property line

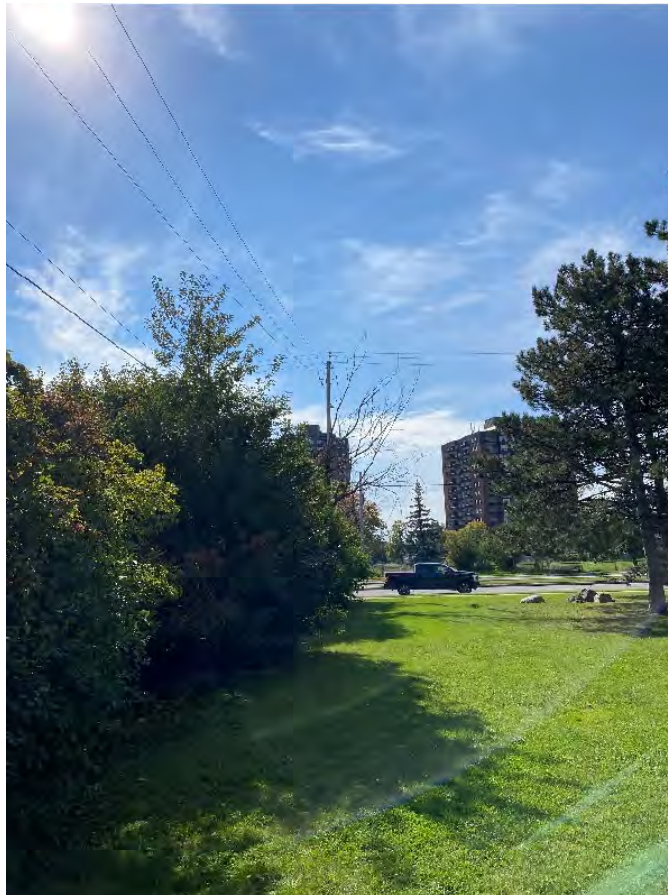
Photograph 7 – Boundary trees along the eastern property line
