# HERITAGE IMPACT ASSESSMENT & CONSERVATION PLAN\*

## 168 -174 MURRAY STREET, OTTAWA

**Owner: David Yoo**  
**Address: 168 – 174 Murray Street, Ottawa, Ontario**

**Revised March 2025**

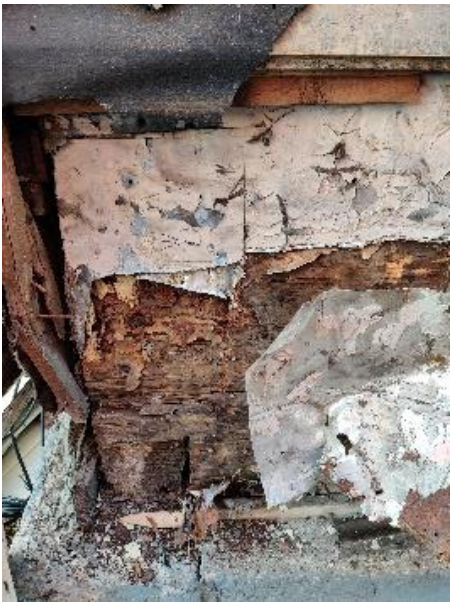
Figures 39 and 40 : The two views illustrate the multiple layers of finishes covering the squared timber, (tin panels insul-brick, ridged insulation, and vinyl siding.) Source David Yoo 2022.
