## Phase I Environmental Site Assessment

The Salvation Army Barrhaven Church  
102 Bill Leathem Drive  
Ottawa, Ontario

Report: PE3779-1

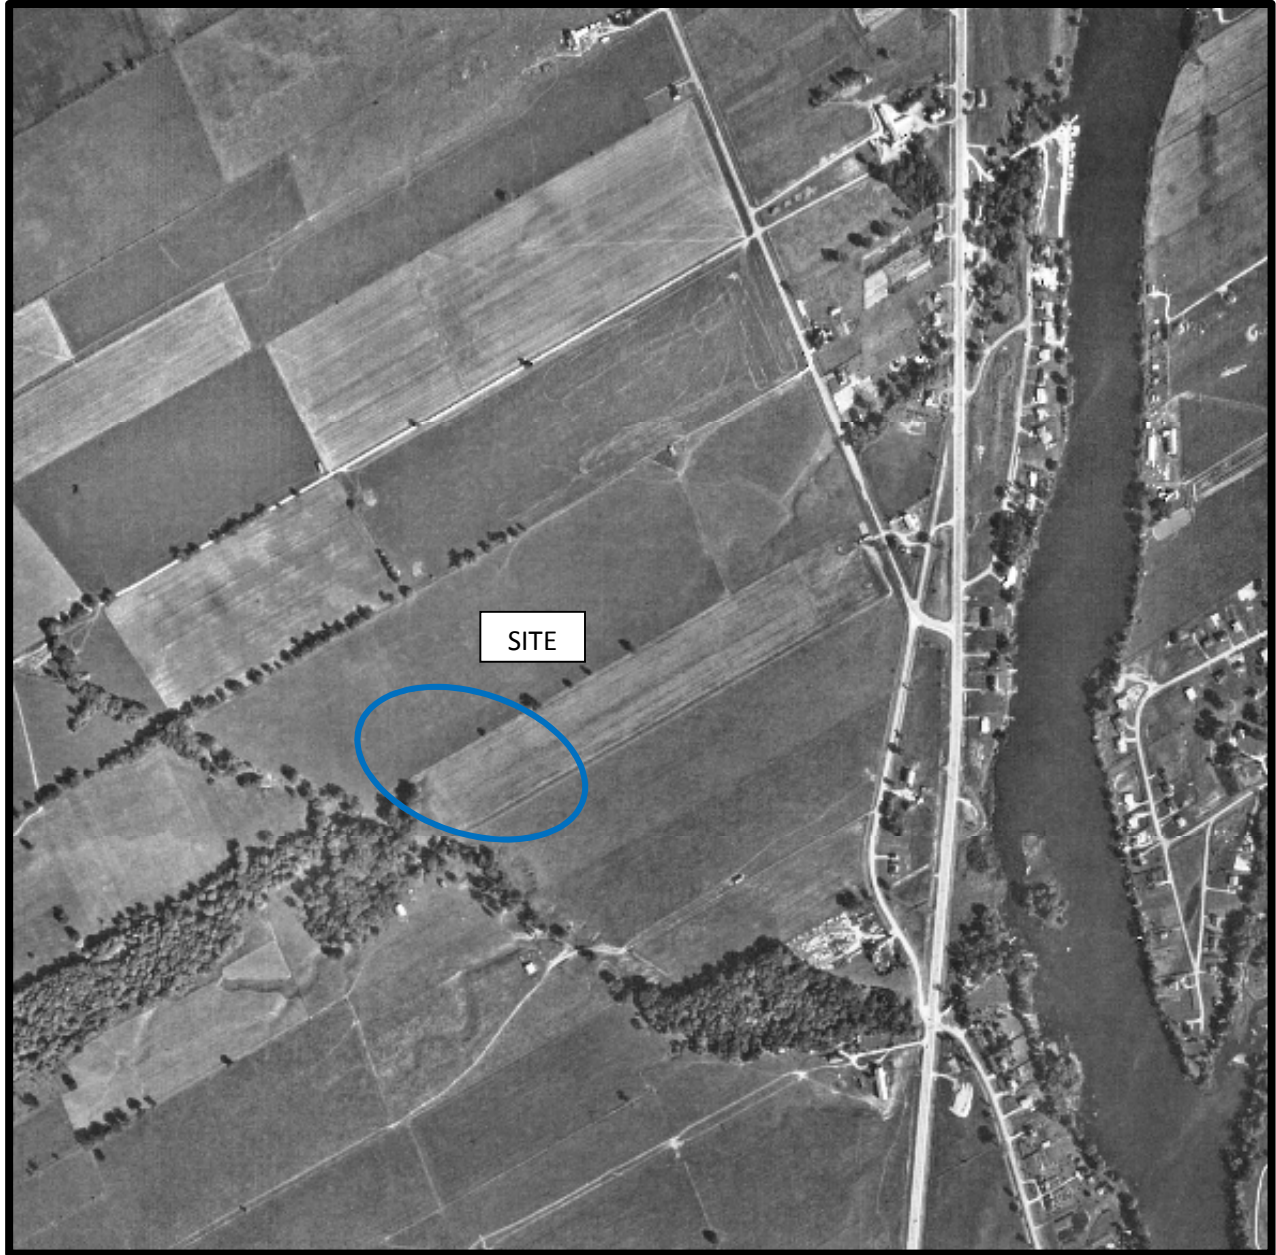
AERIAL PHOTOGRAPH  
1962

1962            The Phase I property and neighbouring lands are vacant and appear to be used for agricultural purposes at this time. What appears to be a ditch or creek is present to the southwest of the subject property, with a densely treed area further west. What appears to be a farmstead is present further to the south.

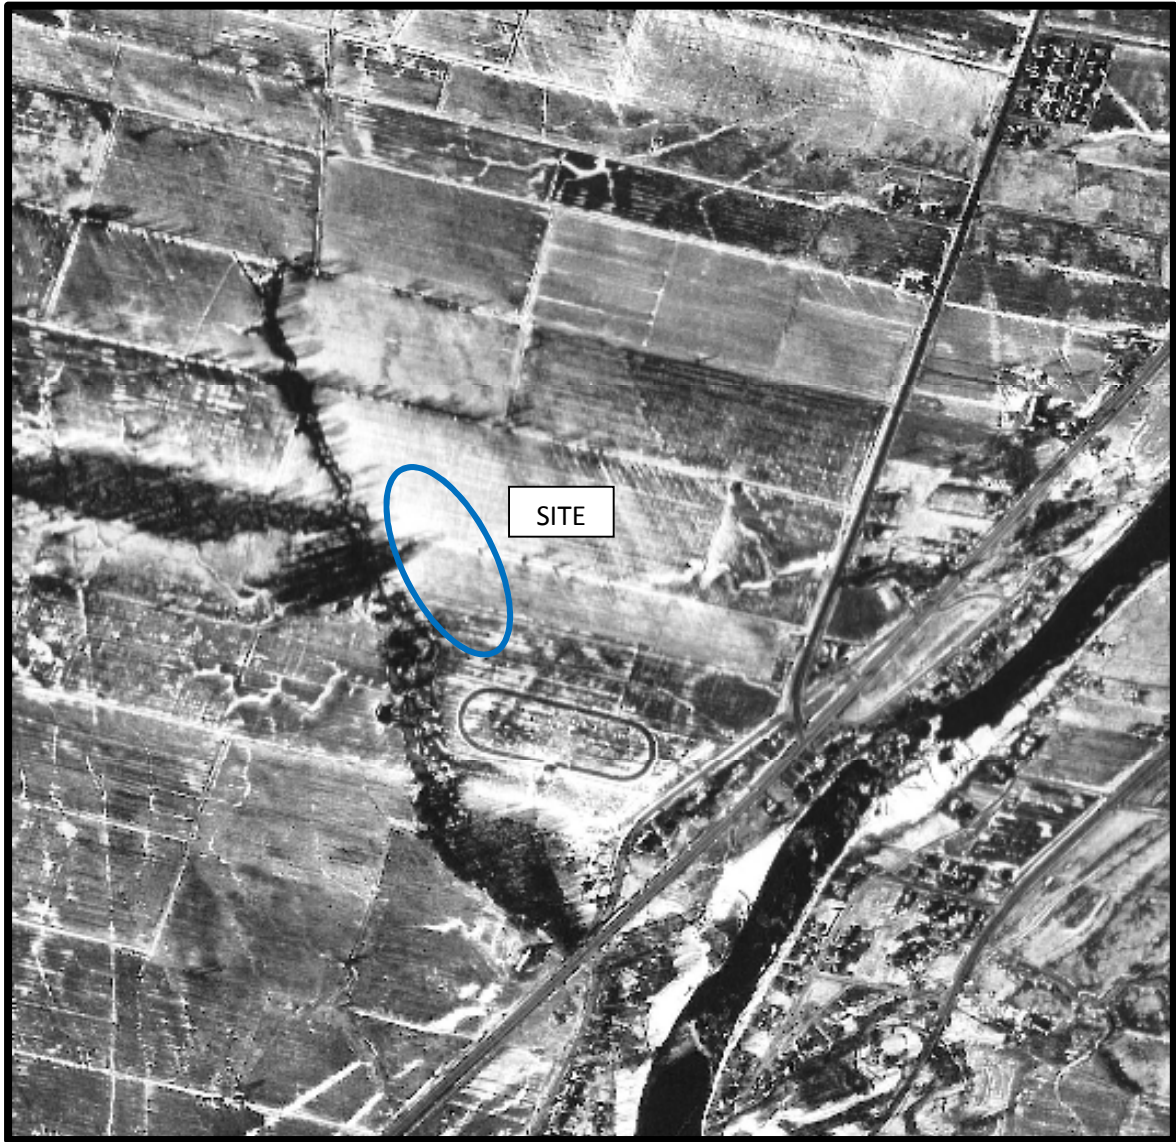
AERIAL PHOTOGRAPH  
1967

- 
- 1967      No significant changes appear to have been made to the Phase I property or surrounding properties since the previous photo.
- 1979      No apparent changes have been made to the Phase I property. What appears to be a pathway is present further to the south of the subject land. The roadway extends in an easterly direction from the aforementioned creek (clearly seen in this photo) to Queen Anne Crescent. Otherwise the adjacent and neighbouring properties appear to remain unchanged.

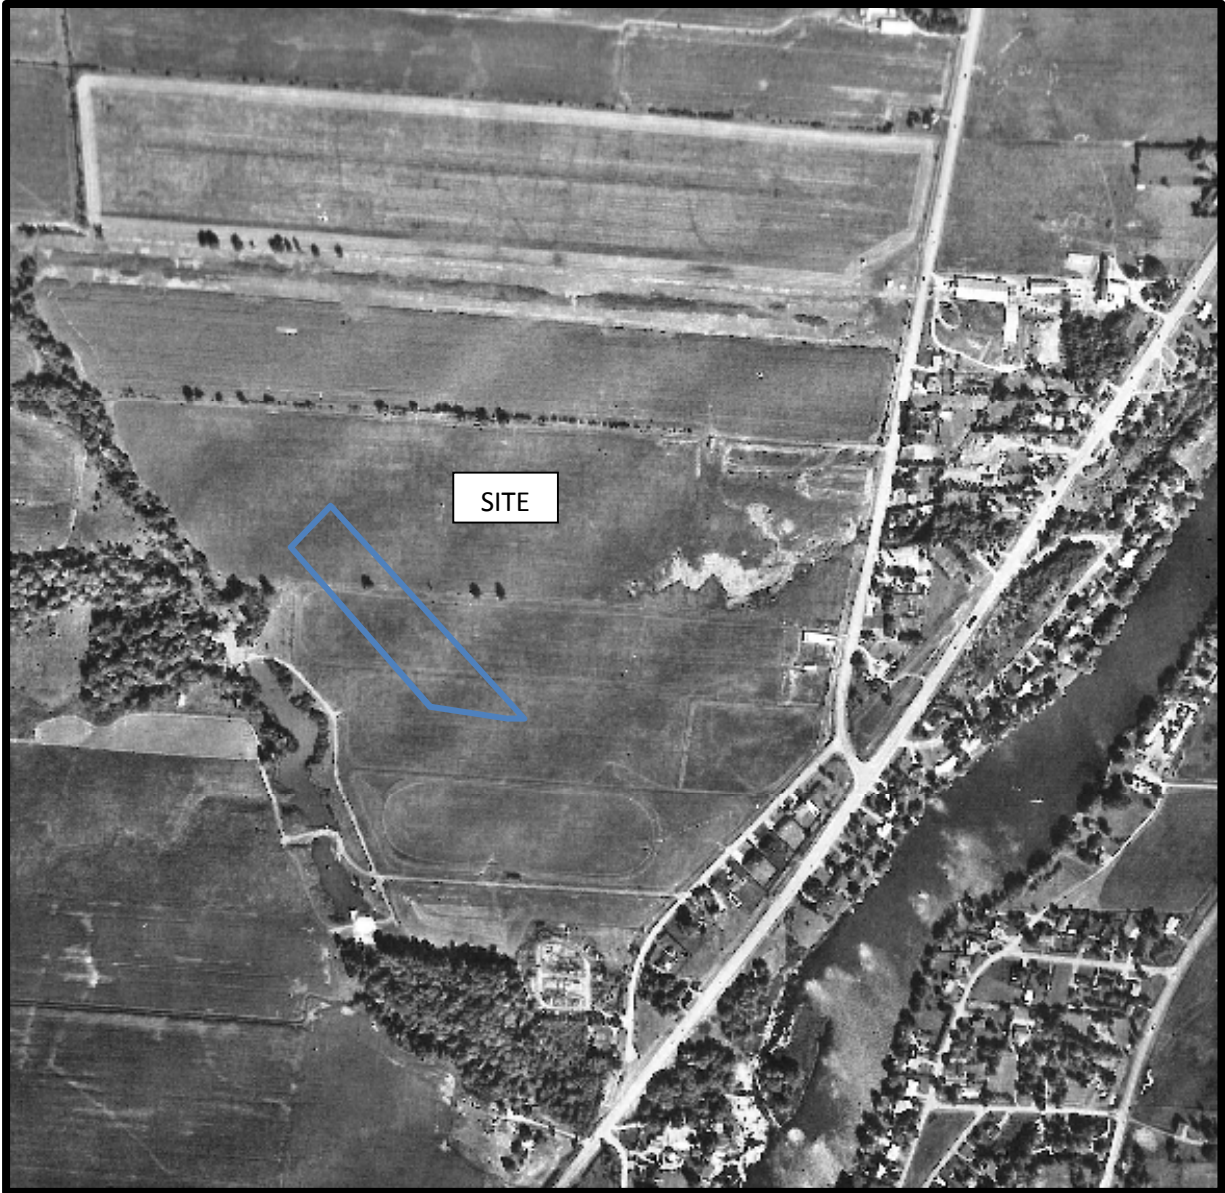
AERIAL PHOTOGRAPH  
1986

- 1986      The Phase I property remains unchanged from the previous photo. A second pathway is now present southwest of the site, extending in a southeasterly direction from the treed area to the roadway first seen in the 1979 photo. It appears as though construction activities may be related to the future construction of a stormwater management pond.

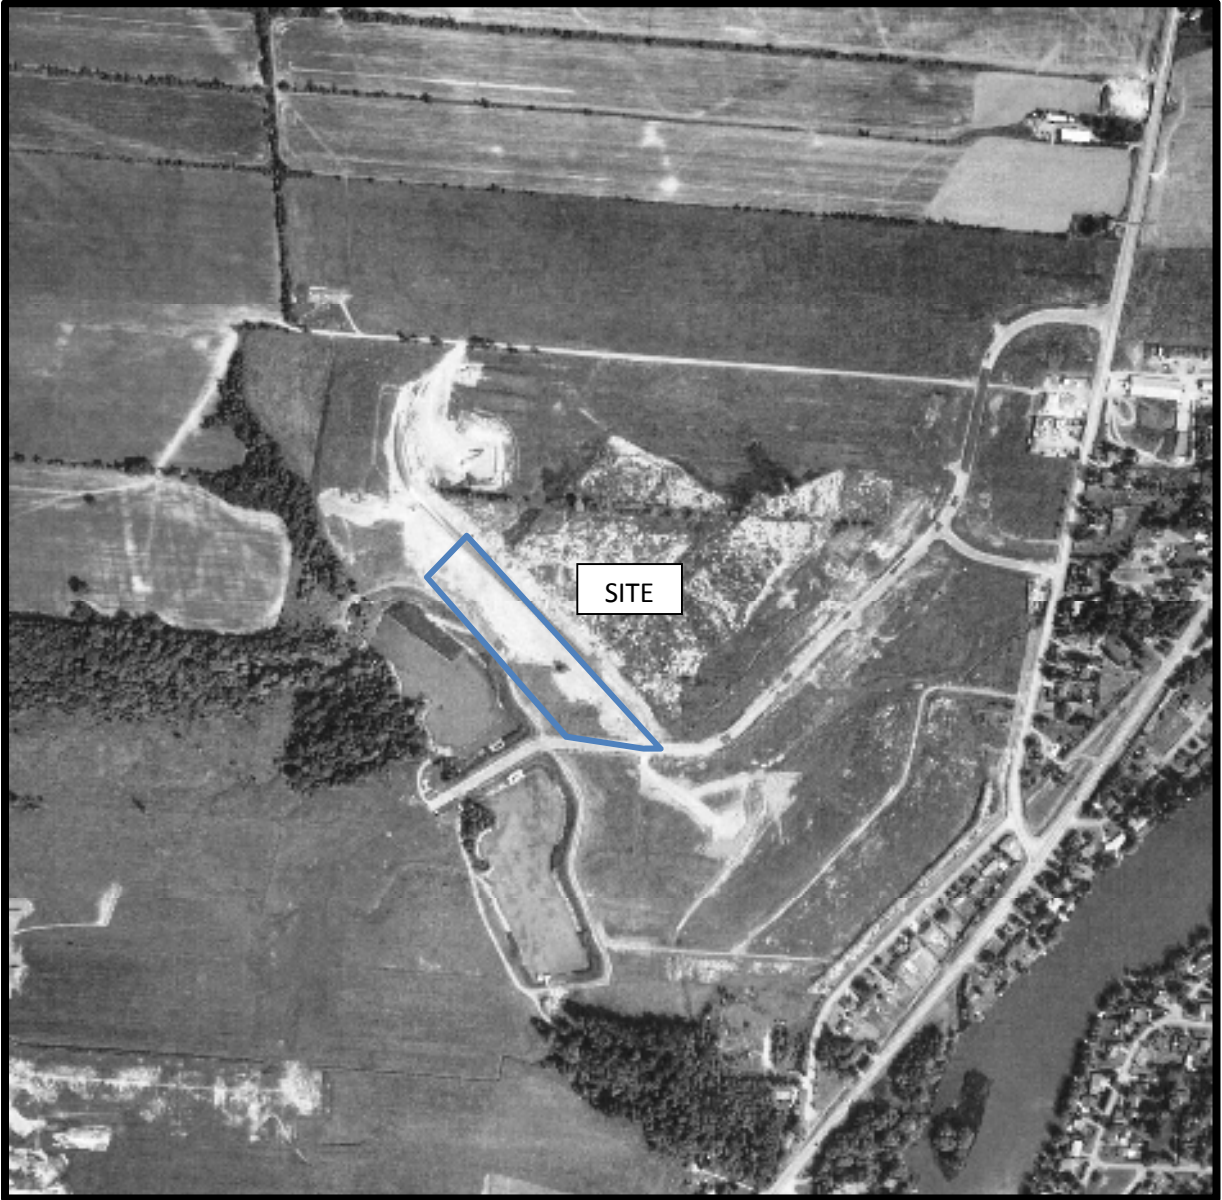
AERIAL PHOTOGRAPH  
1995

- 1995      A large portion of the Phase I property appears to have been either stripped of topsoil, or covered with fill material. Fill material is present on the vacant land to the north. The fill material is considered to be related to the construction of Bill Leathem Drive and Leiken Drive, which is underway at this time, or to the construction of the stormwater ponds which are complete in this photo.

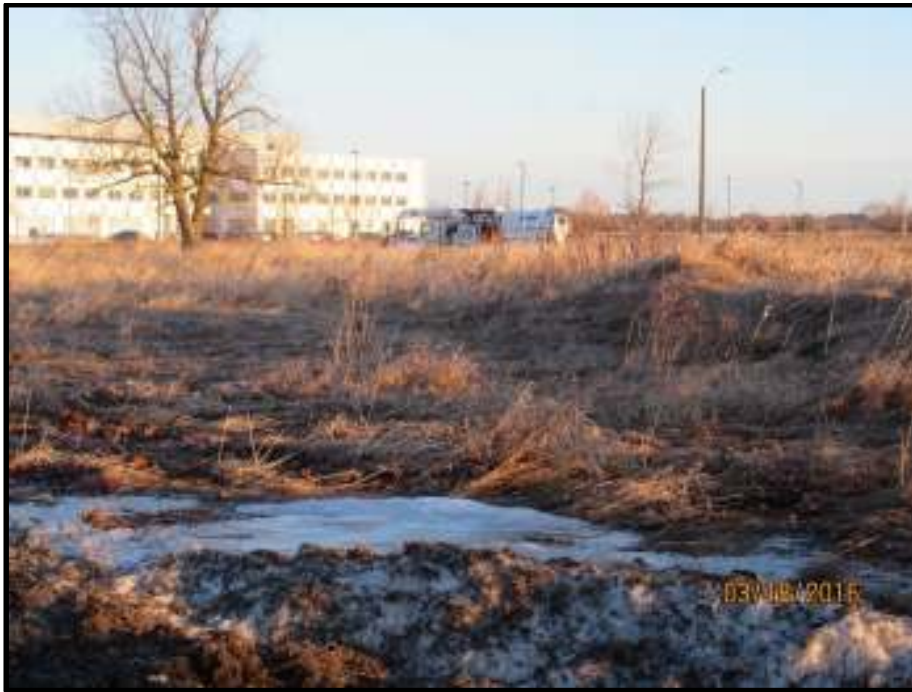
Photograph 1: View of eastern portion of the site and some fill material, facing northwest.

A small amount of fill material was noted on the southeastern portion of the site at the time of the site visit. As discussed previously, fill material was noted on adjacent and neighbouring properties during a previous Phase I ESA and also identified on the eastern portion of the subject site during a previous Geotechnical Investigation. The fill material consisted of native silty clay with some sand and gravel, and was considered to have resulted from the construction of the storm water management pond and pathway to the south and the construction of the adjacent roadways. The fill material was not considered to represent an APEC on the Phase I property.

Based on the findings of a current Geotechnical Investigation carried out for the Phase I property by Paterson in March of 2016, fill material was not identified in boreholes placed in the vicinity of the material noted above, or in any of the remaining boreholes placed on the site. The fill material discussed above is considered to be limited in quantity.

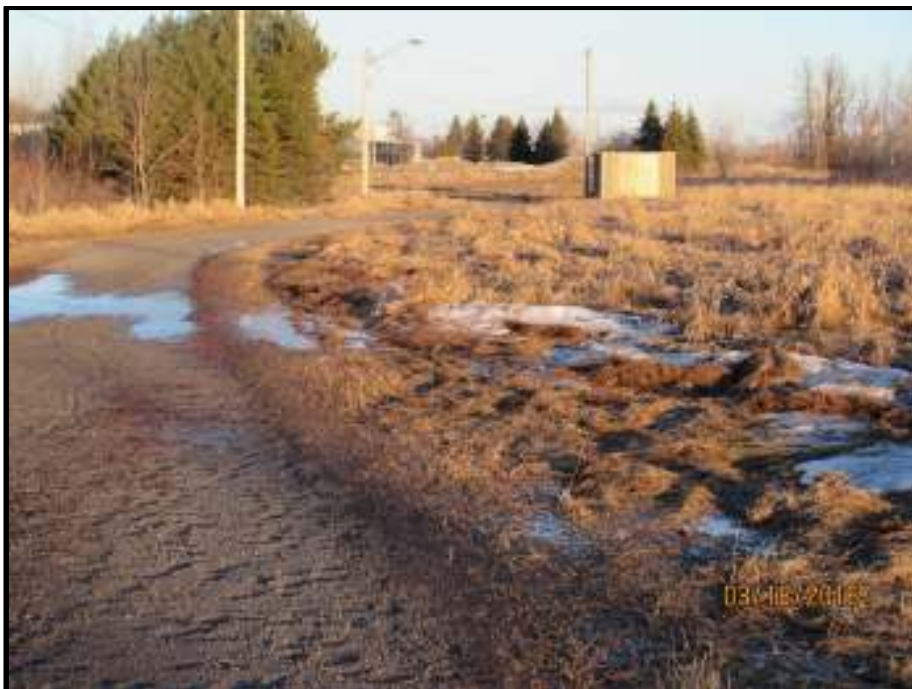
Photograph 2: View of the southeastern portion of the site, the adjacent path to the south, and the pumping station situated on the south-central portion of the property (not part of the subject property), facing east.

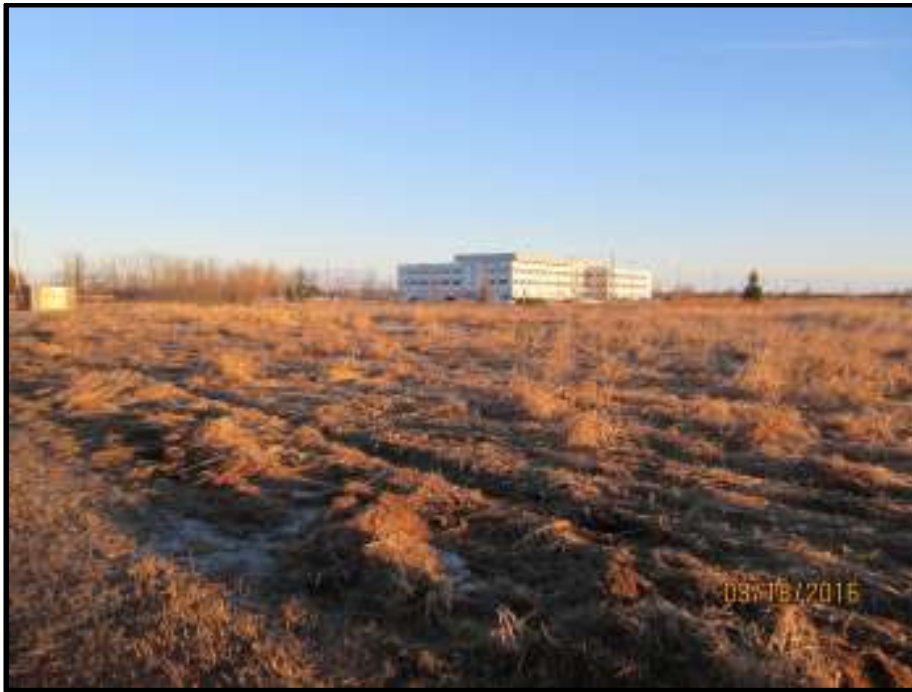
Photograph 3: View of eastern and central portions of site, facing northwest. Photo also shows JDS Uniphase building to the north, across Bill Leathem Drive.

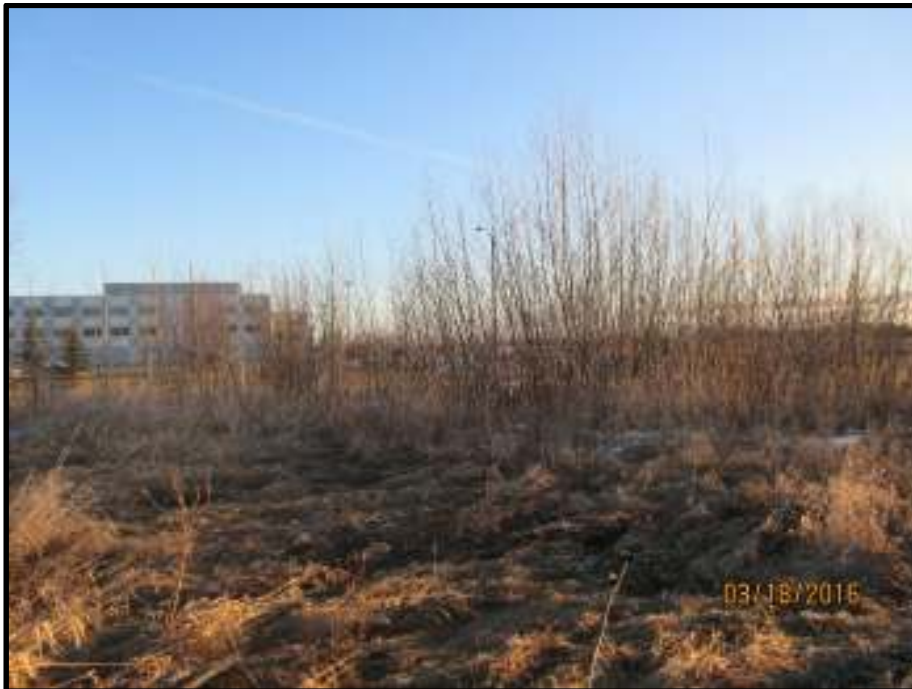
Photograph 4: View of treed area on central portion of site, facing north.

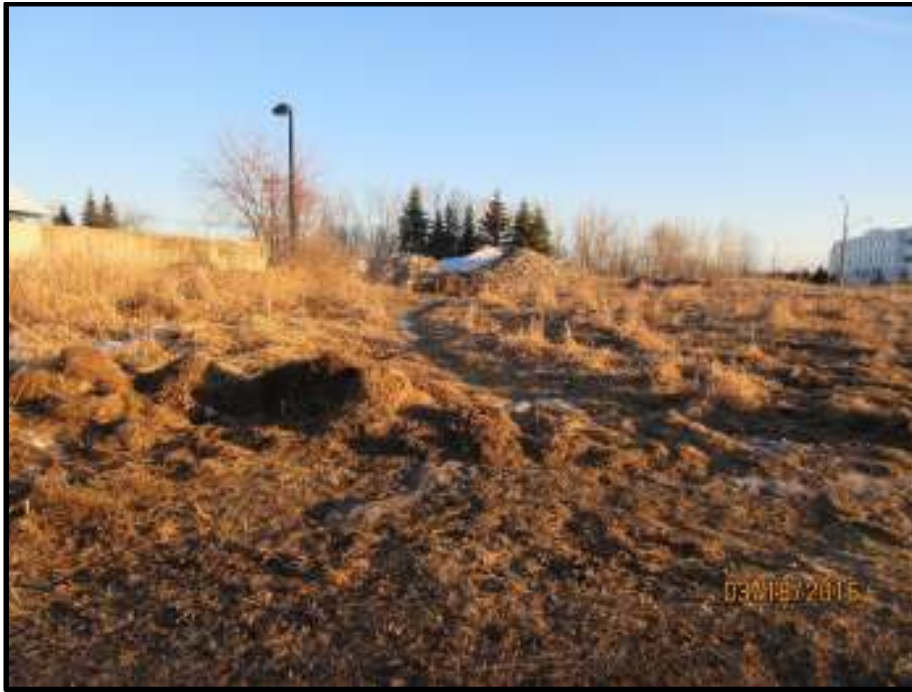
Photograph 5: View of western portion of site and some remaining snow, facing north.

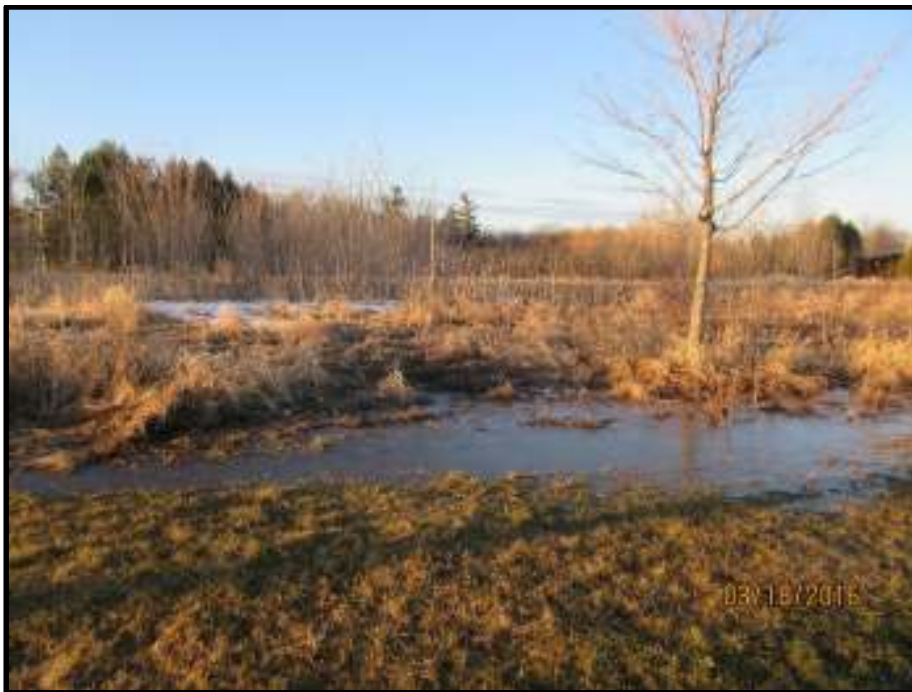
Photograph 6: View of ponded water on north-central portion of site, facing southwest.

The subject site is currently vacant and predominantly grass/brush covered. A small treed area was observed on the north-central portion of the site. Site drainage consists of infiltration. There was ponded water on the property at the time of the site visit. The water was clear with no signs of contamination. No areas of stained soil, vegetation or stressed vegetation, soil disturbance, or grading were observed on-site. Several small areas remained snow covered at the time of the site visit.

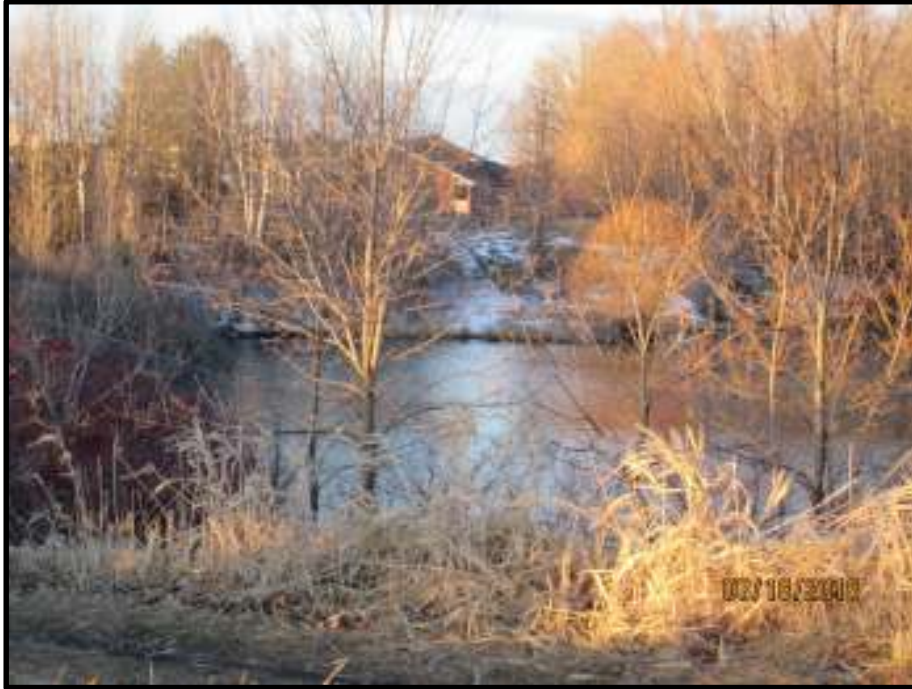
Photograph 7: View of stormwater pond adjacent to the south.

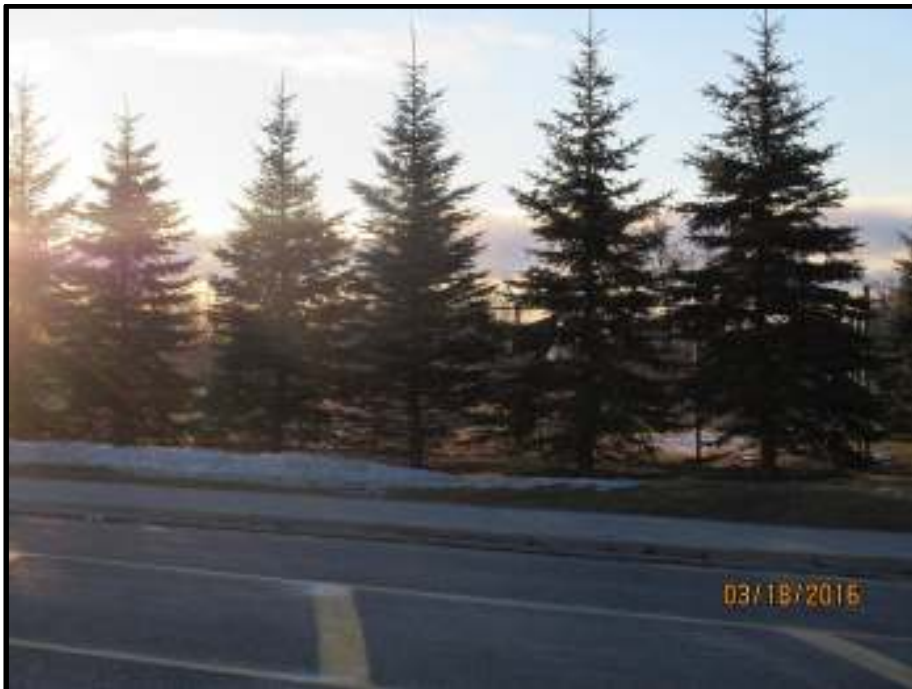
Photograph 8: View of RCMP property adjacent to the east, across Leikin Drive.

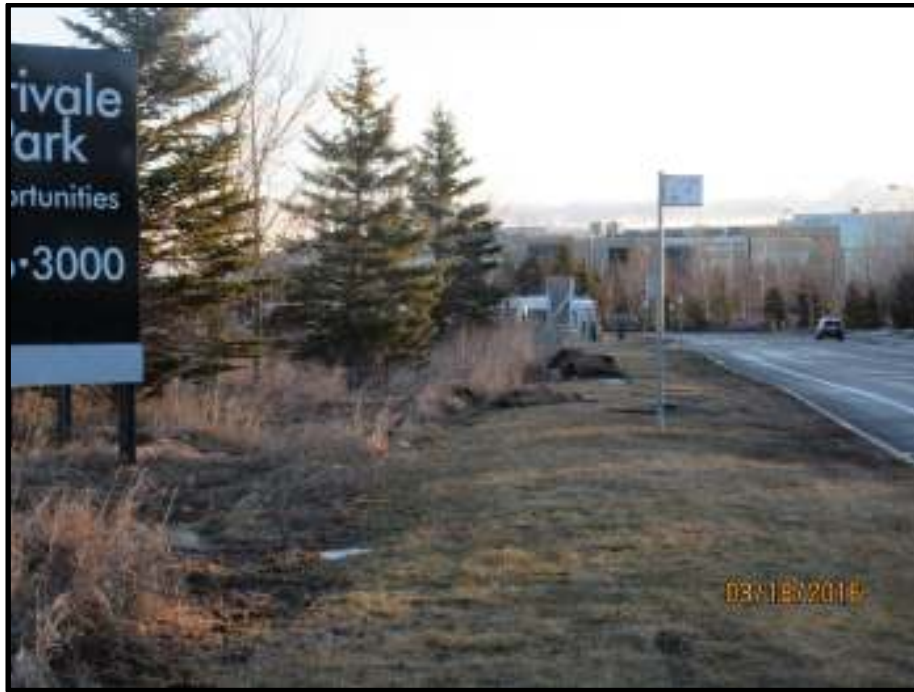
Photograph 9: View of eastern property line and RCMP Headquarters to the northeast.
