February 19, 2025
File: PE4914-LET.05

Subject: **Phase II-Environmental Site Assessment Update**
267 O'Connor Street
Ottawa, Ontario

Further to your request, Paterson Group (Paterson) has completed a Phase II Environmental Site Assessment (ESA) Update for the aforementioned property. This report updates a Phase II ESA Update entitled "Phase II - Environmental Site Assessment Update, 267 O'Connor Street, Ottawa, Ontario" prepared by Paterson Group, dated August 19, 2020.

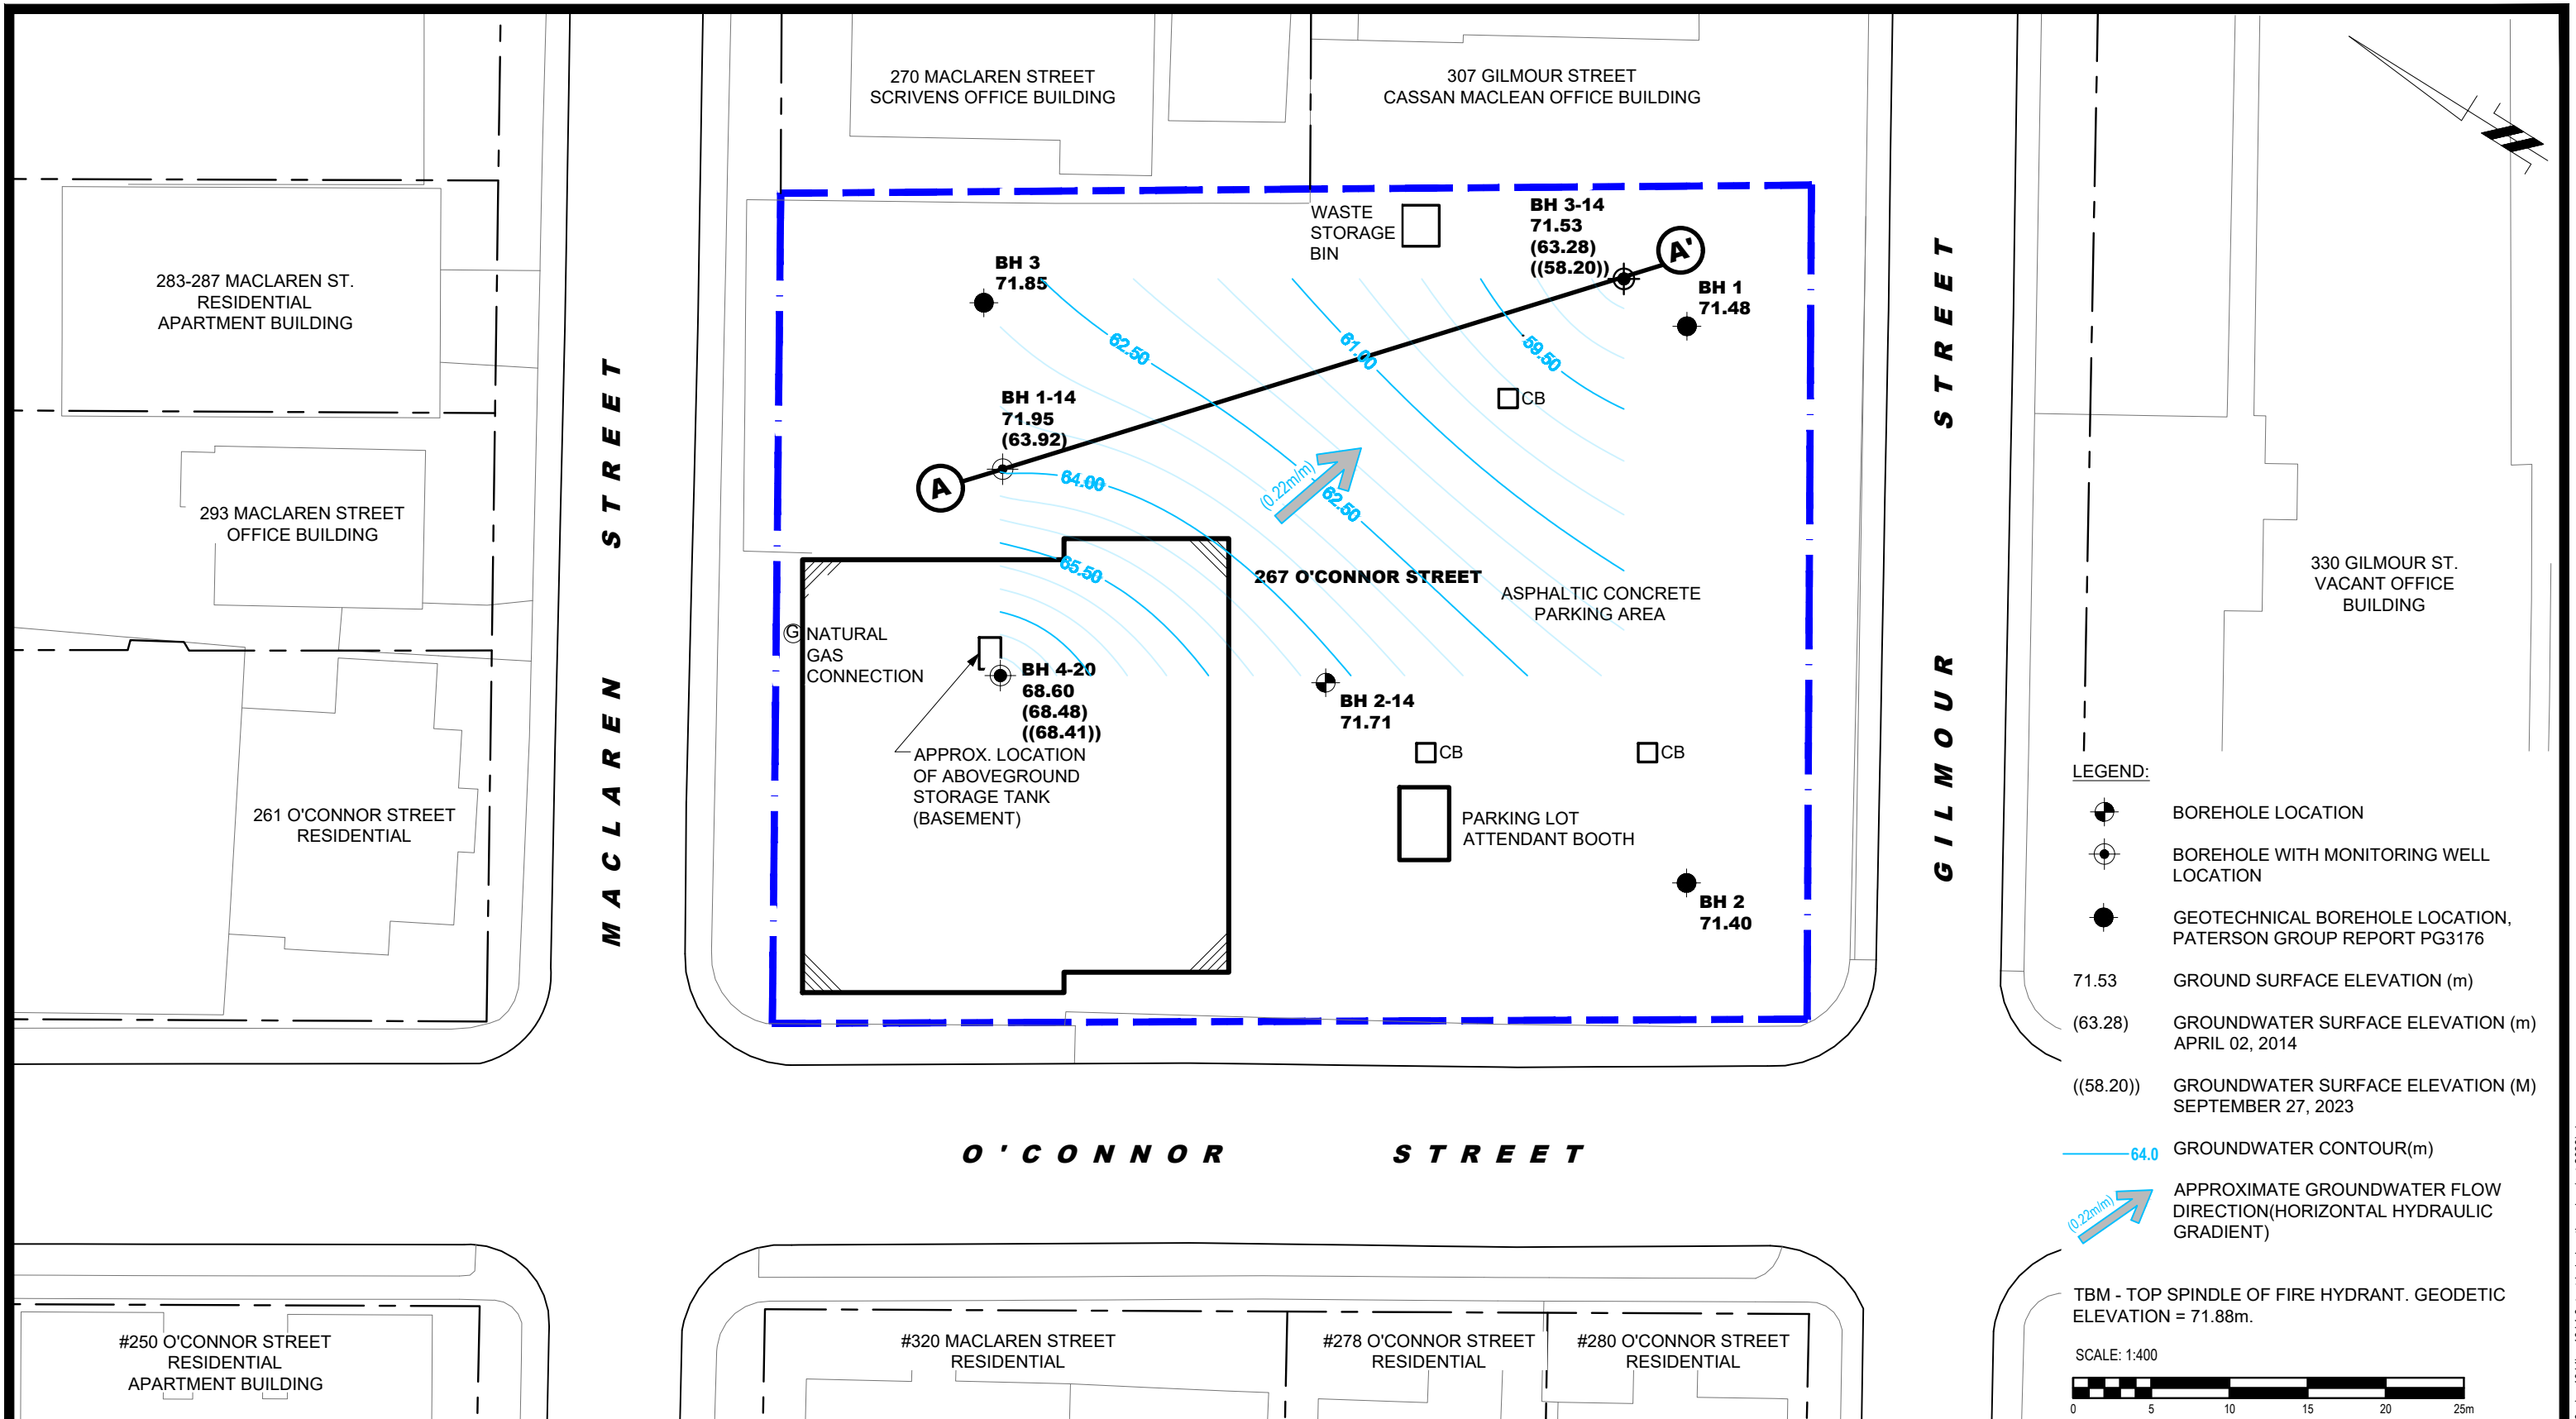
TEST HOLE LOCATION PLAN

Paterson completed groundwater sampling at BH3-14 and BH4-20 to update the groundwater quality at the Phase II ESA property. Groundwater levels were measured and then the wells were purged prior to collecting groundwater samples and a duplicate sample on September 27, 2023 by Paterson.

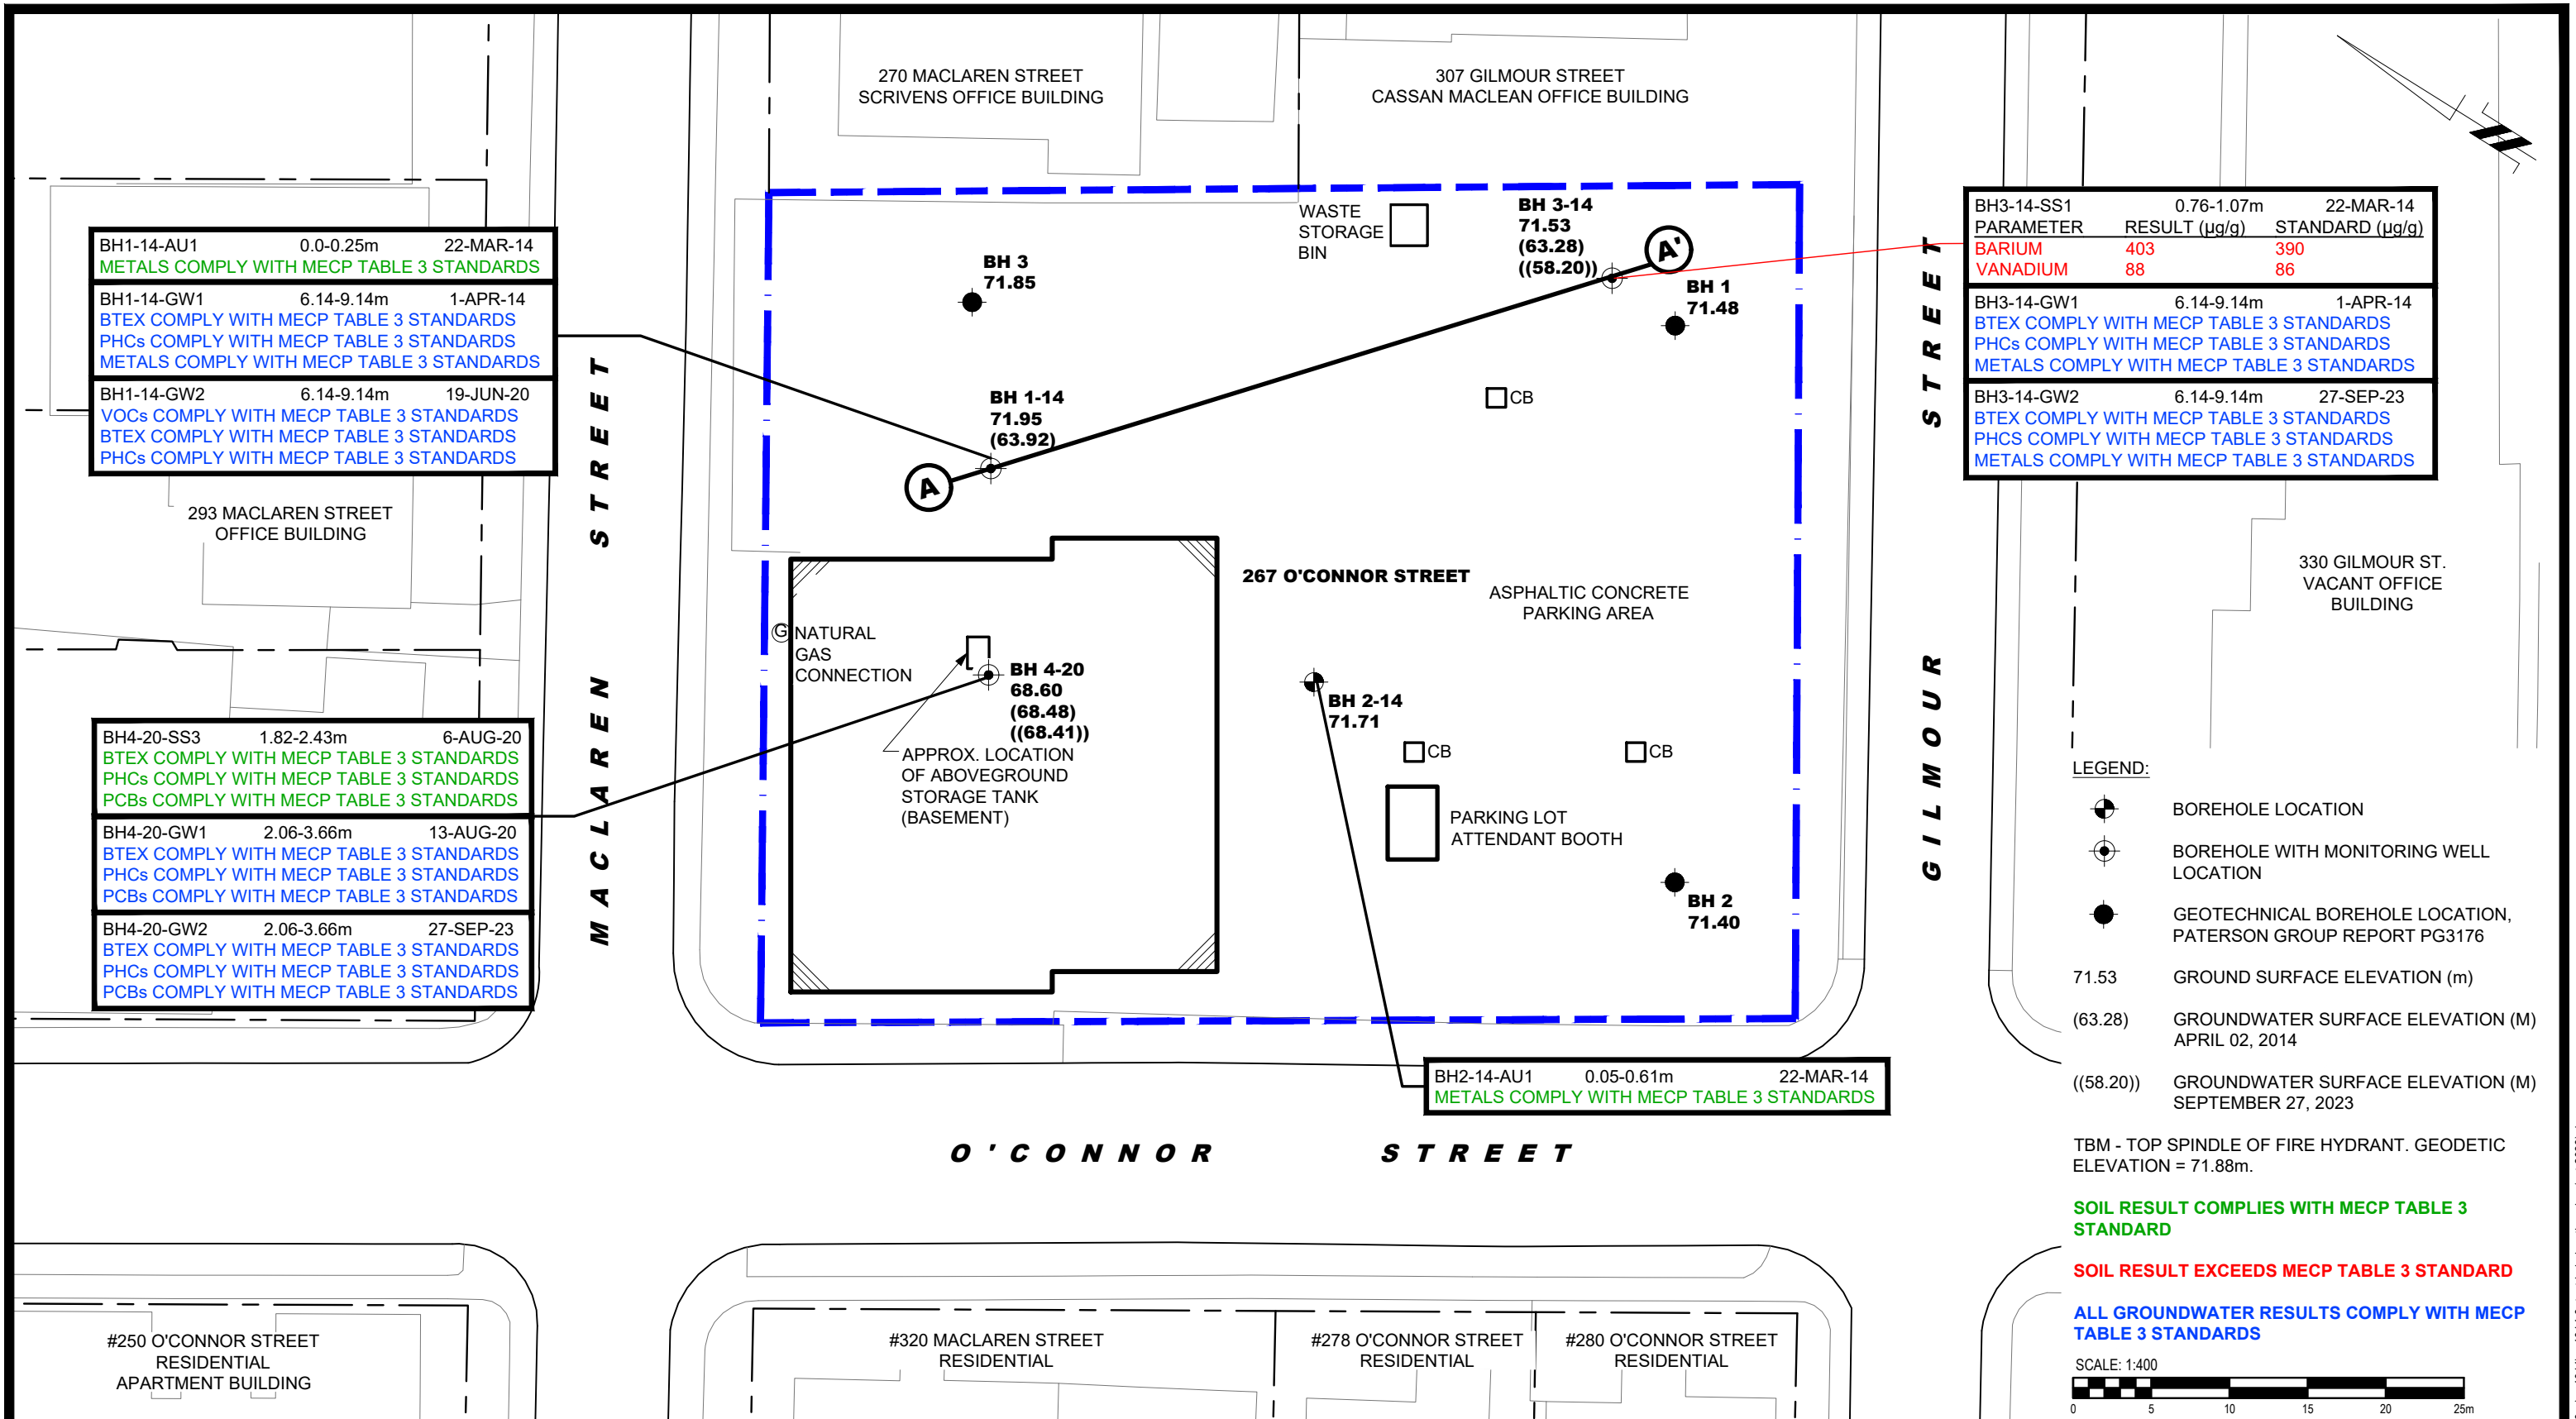
ANALYTICAL TESTING PLAN

The analytical results for the tested groundwater are shown on Drawing PE4914-4R – Analytical Testing Plan, appended to this report.

BH1-14-AU1	0.0-0.25m	22-MAR-14
METALS COMPLY WITH MECP TABLE 3 STANDARDS		
BH1-14-GW1	6.14-9.14m	1-APR-14
BTEX COMPLY WITH MECP TABLE 3 STANDARDS		
PHCs COMPLY WITH MECP TABLE 3 STANDARDS		
METALS COMPLY WITH MECP TABLE 3 STANDARDS		
BH1-14-GW2	6.14-9.14m	19-JUN-20
VOCs COMPLY WITH MECP TABLE 3 STANDARDS		
BTEX COMPLY WITH MECP TABLE 3 STANDARDS		
PHCs COMPLY WITH MECP TABLE 3 STANDARDS		
METALS COMPLY WITH MECP TABLE 3 STANDARDS

BH4-20-SS3	1.82-2.43m	6-AUG-20
BTEX COMPLY WITH MECP TABLE 3 STANDARDS		
PHCs COMPLY WITH MECP TABLE 3 STANDARDS		
PCBs COMPLY WITH MECP TABLE 3 STANDARDS		
BH4-20-GW1	2.06-3.66m	13-AUG-20
BTEX COMPLY WITH MECP TABLE 3 STANDARDS		
PHCs COMPLY WITH MECP TABLE 3 STANDARDS		
PCBs COMPLY WITH MECP TABLE 3 STANDARDS		
BH4-20-GW2	2.06-3.66m	27-SEP-23
BTEX COMPLY WITH MECP TABLE 3 STANDARDS		
PHCs COMPLY WITH MECP TABLE 3 STANDARDS		
PCBs COMPLY WITH MECP TABLE 3 STANDARDS

BH2-14-AU1	0.05-0.61m	22-MAR-14
METALS COMPLY WITH MECP TABLE 3 STANDARDS

BH3-14-SS1	0.76-1.07m	22-MAR-14
PARAMETER	RESULT (µg/g)	STANDARD (µg/g)
BARIUM	403	390
VANADIUM	88	86
BH3-14-GW1	6.14-9.14m	1-APR-14
BTEX COMPLY WITH MECP TABLE 3 STANDARDS		
PHCs COMPLY WITH MECP TABLE 3 STANDARDS		
METALS COMPLY WITH MECP TABLE 3 STANDARDS		
BH3-14-GW2	6.14-9.14m	27-SEP-23
BTEX COMPLY WITH MECP TABLE 3 STANDARDS		
PHCs COMPLY WITH MECP TABLE 3 STANDARDS		
METALS COMPLY WITH MECP TABLE 3 STANDARDS

Based on the 2014 soil results, fill material exists at the Phase II ESA Property which exceeds the MECP Table 3 Standards for Barium and Vanadium. It is our recommendation that a confirmatory sampling program be completed prior to redevelopment. If the confirmatory sampling program is unsuccessful, an environmental remediation will be required.

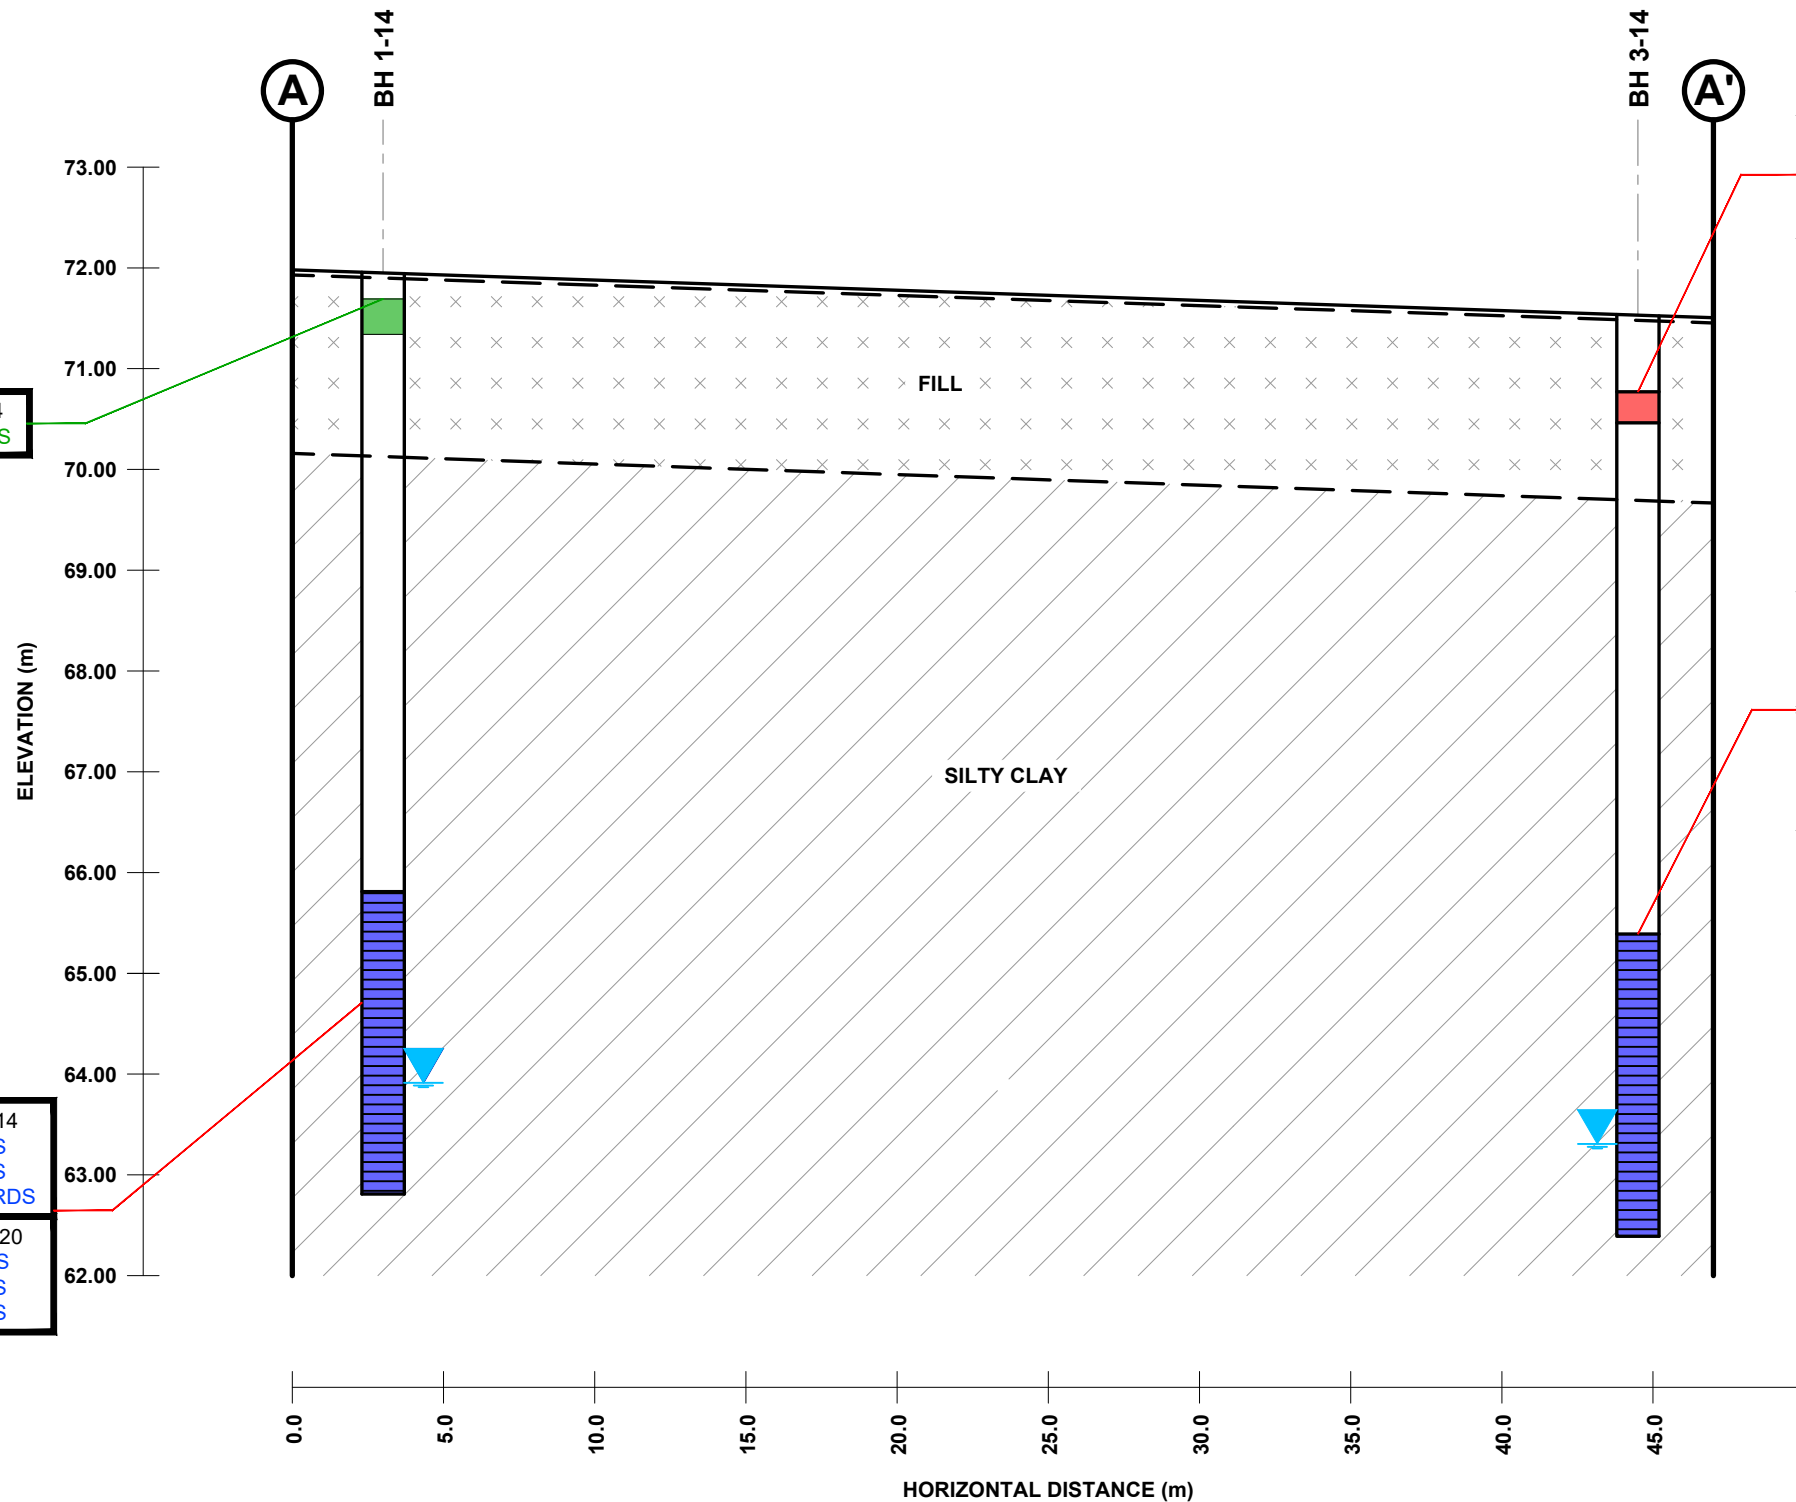
OTTAWA, ONTARIO
 Title: **CROSS-SECTION A-A'**

The site stratigraphy, from ground surface to the deepest aquifer or aquitard investigated, is illustrated on the attached cross-section. The stratigraphy of the Phase II Property generally consists of:

- ❑ Asphalt pavement structure with an approximate thickness of 0.06m.
- ❑ Fill material consisting of sand and gravel with trace building debris. The fill material is not expected to be a significant water generating unit at the Phase II ESA property.
- ❑ Silty clay starting beneath the fill material extending to the full depth of all boreholes. This is the deepest unit investigated. The silty clay is considered to function as the main aquifer at the Phase II ESA property.

BH1-14-AU1 0.0-0.25m 22-MAR-14
METALS COMPLY WITH MECP TABLE 3 STANDARDS

BH3-14-SS1	0.76-1.07m	22-MAR-14
PARAMETER	RESULT (µg/g)	STANDARD (µg/g)
BARIUM	403	390
VANADIUM	88	86

BH3-14-GW1	6.14-9.14m	1-APR-14
BTEX COMPLY WITH MECP TABLE 3 STANDARDS		
PHCs COMPLY WITH MECP TABLE 3 STANDARDS		
METALS COMPLY WITH MECP TABLE 3 STANDARDS		
BH3-14-GW2	6.14-9.14m	27-SEP-23
BTEX COMPLY WITH MECP TABLE 3 STANDARDS		
PHCs COMPLY WITH MECP TABLE 3 STANDARDS		
METALS COMPLY WITH MECP TABLE 3 STANDARDS

BH1-14-GW1 6.14-9.14m 1-APR-14
 BTEX COMPLY WITH MECP TABLE 3 STANDARDS
 PHCs COMPLY WITH MECP TABLE 3 STANDARDS
 METALS COMPLY WITH MECP TABLE 3 STANDARDS

BH1-14-GW2 6.14-9.14m 19-JUN-20
 VOCs COMPLY WITH MECP TABLE 3 STANDARDS
 BTEX COMPLY WITH MECP TABLE 3 STANDARDS
 PHCs COMPLY WITH MECP TABLE 3 STANDARDS
