**Headwater Drainage Feature Assessment
6150 Thunder Road, Ottawa**

April 26, 2021

KILGOUR & ASSOCIATES LTD.
www.kilgourassociates.com
Project Number: AVE1118.1

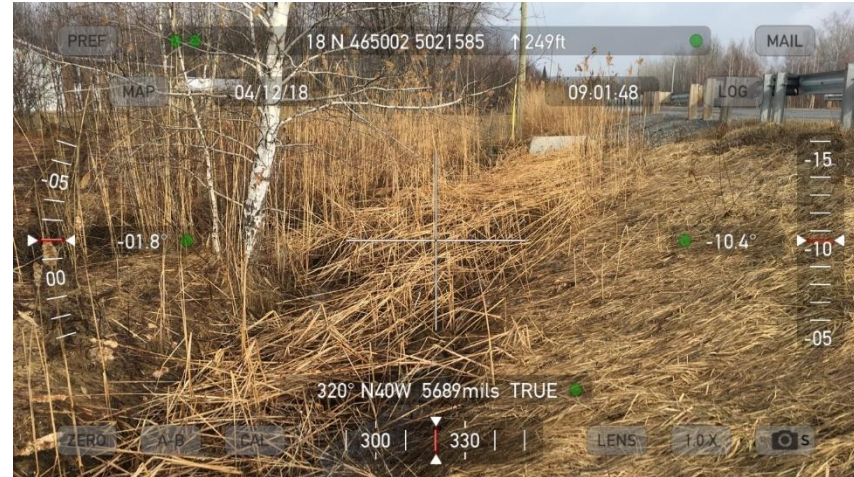
Reach 1

Channel R1 is the roadside ditch along Thunder Road. This feature is unlikely to altered (realigned) in any meaningful way under future development plans. All other channels on site had been (i.e. in 2018) located

Upstream view

Downstream view

This chain of classification descriptors leads to a management directive of **Mitigation**. These features are not required to be maintained per se, but their functionality must be replicated or enhanced through lot level conveyance measures as part of the site stormwater management system. As the features convey runoff to more ecologically important reaches, replacement features/systems, should be vegetated to mimic online wet vegetation pockets to the extent possible, and should convey water to the same final receiver (i.e. R7), though natural channel design is not required.

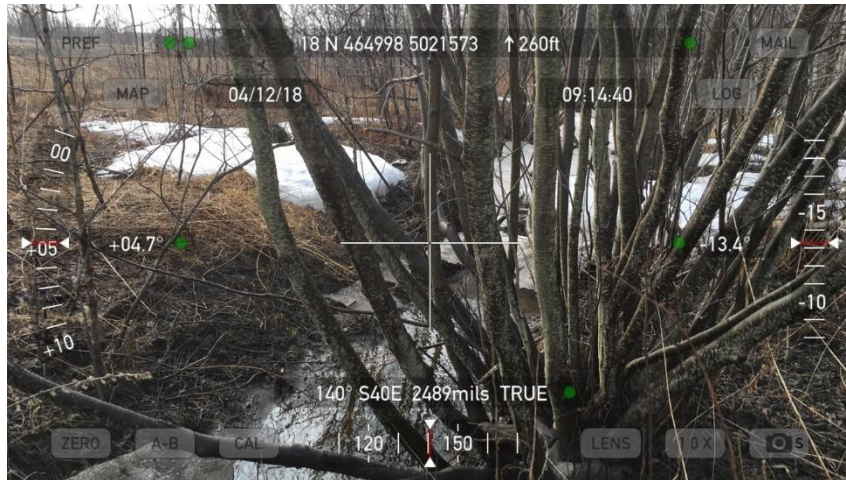
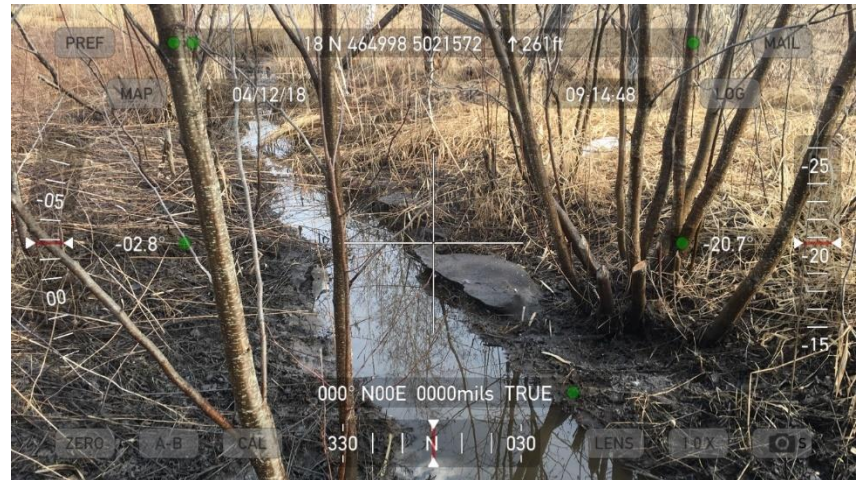
Reach 2

Upstream view

Downstream view

This chain of classification descriptors would typically lead to a management directive of **Protection** for this reach, based in part on the assessment of “Important Riparian Vegetation”. Under a management directive of **Protection**, the feature should not generally be relocated. For this feature, however, the assessment of “Important Riparian Vegetation” comes from only the west side. The east side of the channel has limited vegetation and is generally located within <30 m of the Thunder Road (it connects with R7 within 3 m of the roadway), thus preventing options for an undisturbed, naturalized buffer on that side. The management recommendation for this feature is thus **Conservation** to allow its relocation.

The feature should be realigned westward to allow for an improved, naturalized setback with an enhancement of the riparian corridors. Drainage must still be conveyed to R7 and stormwater management systems on the site must be designed to avoid impacts (i.e. sediment, temperature) to this headwater channel.

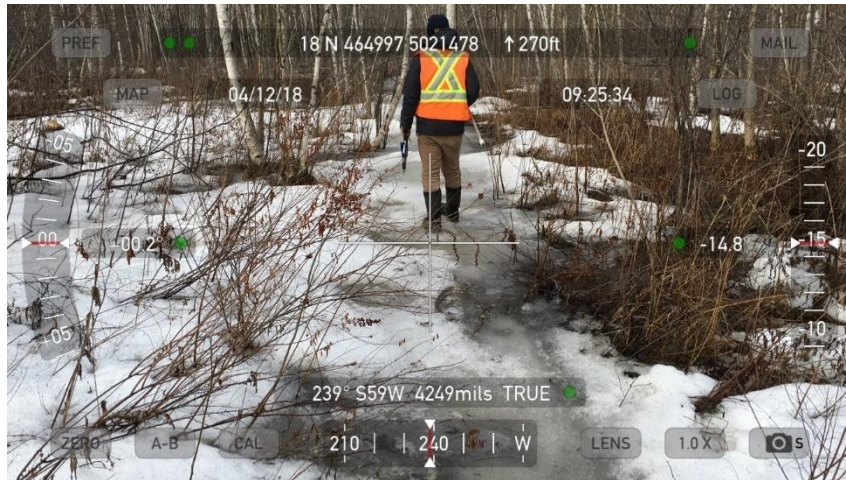
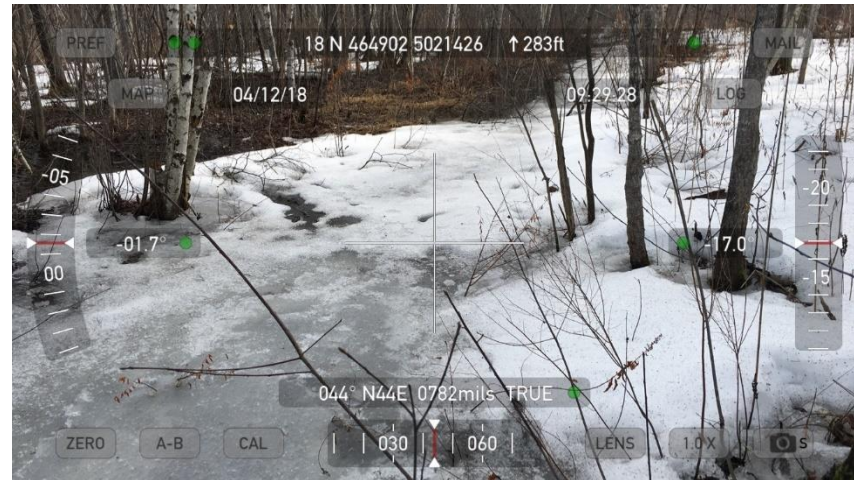
Reach 3

Upstream view

Downstream view

This chain of classification descriptors leads to a management directive of **Conservation** for this reach. The feature may be maintained or, if necessary relocated, using natural channel design techniques to maintain or enhance the overall productivity of the reach. If realigned, the features may be relocated on or off the Site. In any case, the riparian corridors must be maintained or enhanced. If catchment drainage will be removed due to diversion of stormwater flows, lost functions should be restored through enhanced lot level controls (e.g. restore original catchment using clean roof drainage).

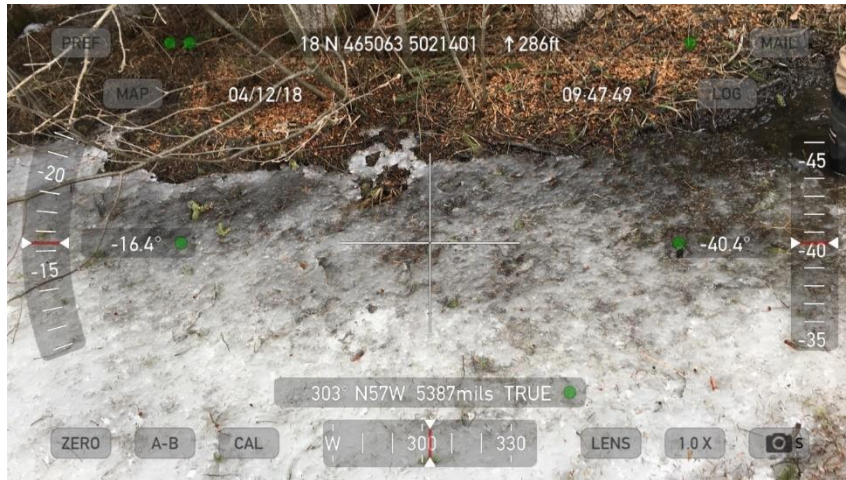
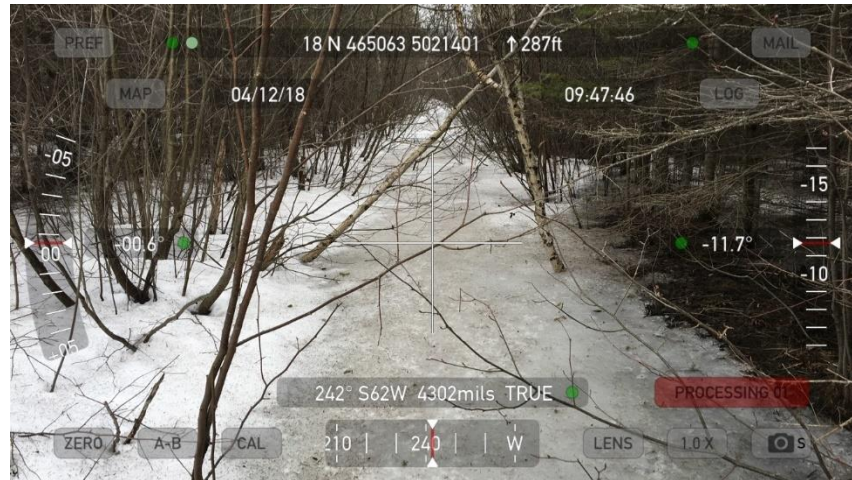
Reach 4

within young, early successional wooded areas and coniferous plantation covering former agricultural fields. A single small wetland pocket was observed at the upstream end of the Channel R4. Natural landcover along Channels R6, R5 and most of R2 was completely removed in 2019.

Upstream view

Downstream view

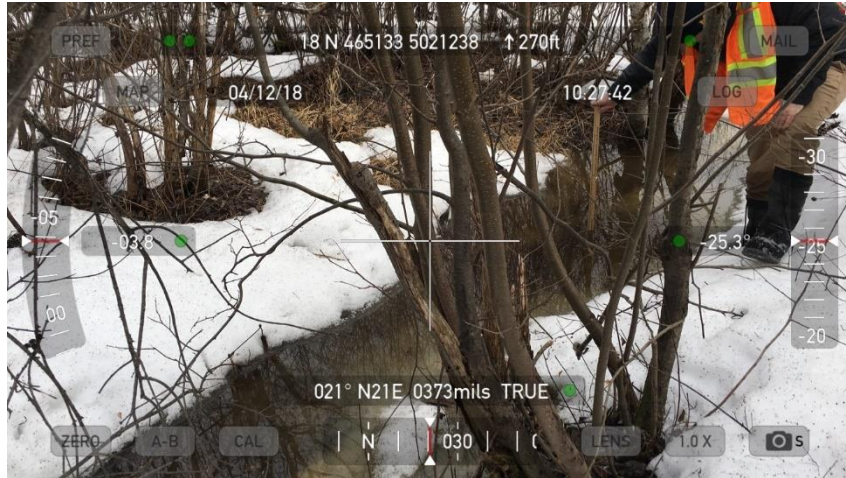
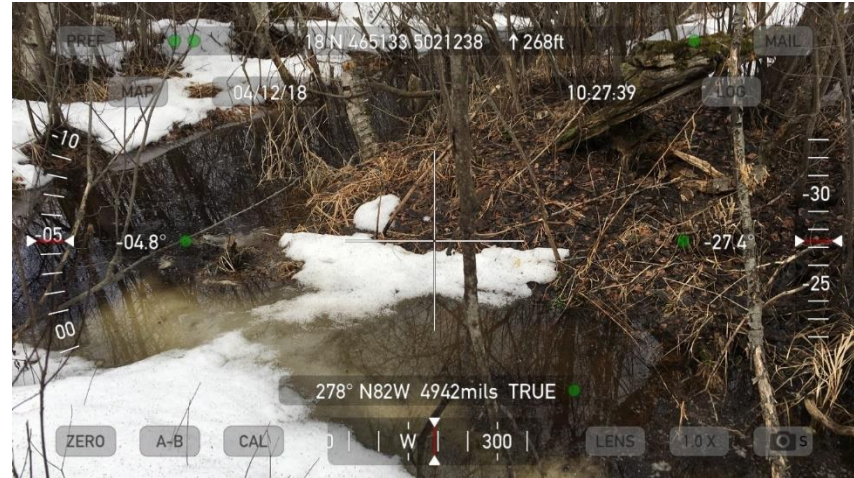
Reach 6

Upstream view

Downstream view

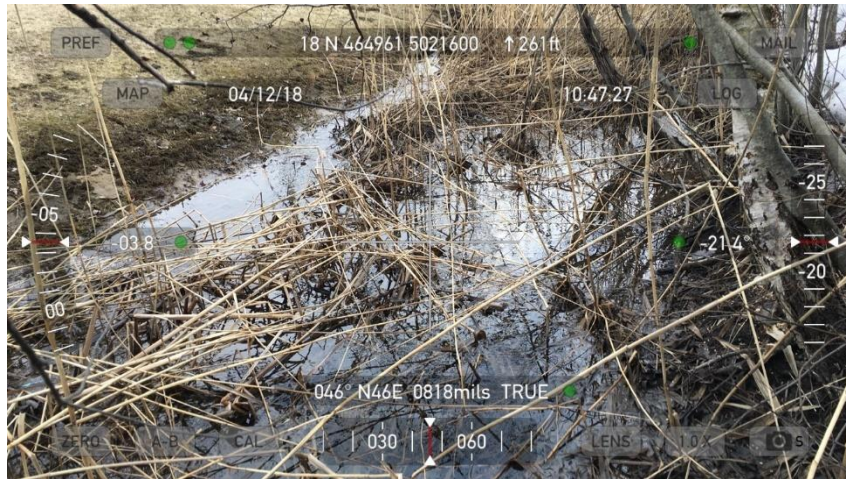
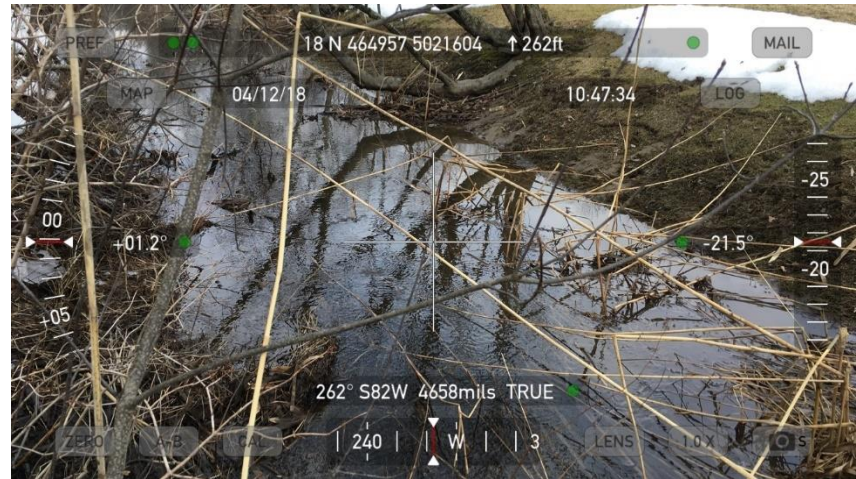
Reach 7

Channel 7, the permanent watercourse crossing the north end of the Site is highly linearized, U-shaped drainage channel, though it does not have status as a municipal or ward drain. All other channels are small, shallow, linear, U-shaped agricultural ditches that ultimately connect to Channel 7.

Upstream view

Downstream view

This perennial channel conveys off-site flows across the property. As a permanent stream, it does not qualify as headwater feature. As feature with important hydrology, it automatically receives a management directive of **Protection**. As such, this reach may be maintained and/or enhanced, but should not generally be relocated. Improvements, however, could be possible to its overall channel form and thus some minor realignment may be considered within that context. The riparian zone should be protected and enhanced where feasible. The hydro-period must be maintained. Use natural channel design techniques or wetland design to restore and enhance existing habitat features if and where needed. Stormwater management systems must be designed to avoid impacts (i.e. sediment, temperature) to this headwater channel.
